ENVIRONMENTAL MONITORING REPORT

Power Lines from Kendal/Kusile to Zeus Substation Bravo Integration Project – Bravo 4: Construction of two 400 kV lines

DEA EIA Ref # 12/12/20/1095 DEA BAR Ref # 14/12/16/3/3/1/1584

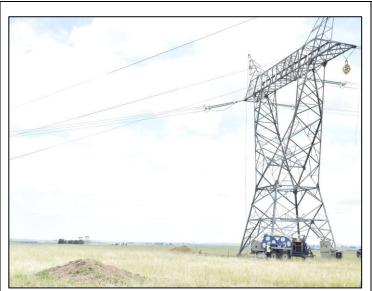
Figure 2: Getting ready for stringing.

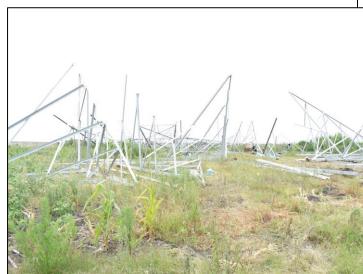
Figure 3: Assembling Tower

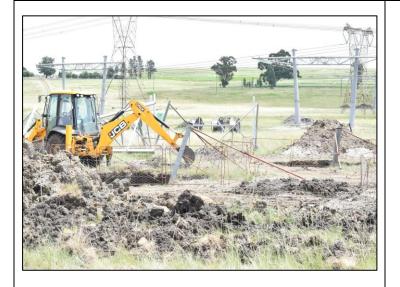
Figure 4: Excavation
