Camden Power Station

ROUTINE MONITORING PHASE 57
APRIL 2014

Project no.: 220-22-mon.697
Current Phase: Ph57 Final Report
Report no.: RVN 697.2/1471

Final Report - Routine Monitoring Phase 57

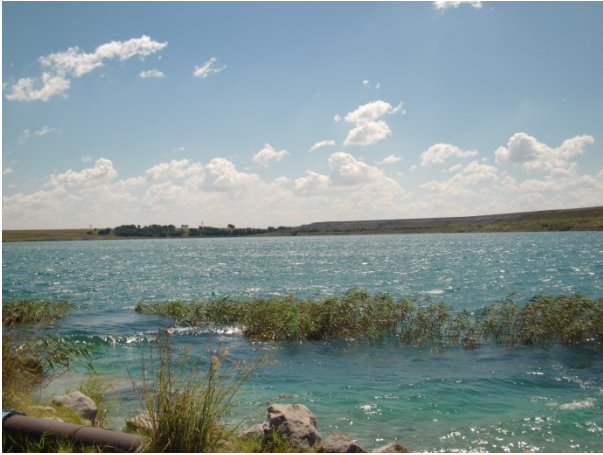
Photo 1. – Extremely high water level in the De Jager Pan P09.

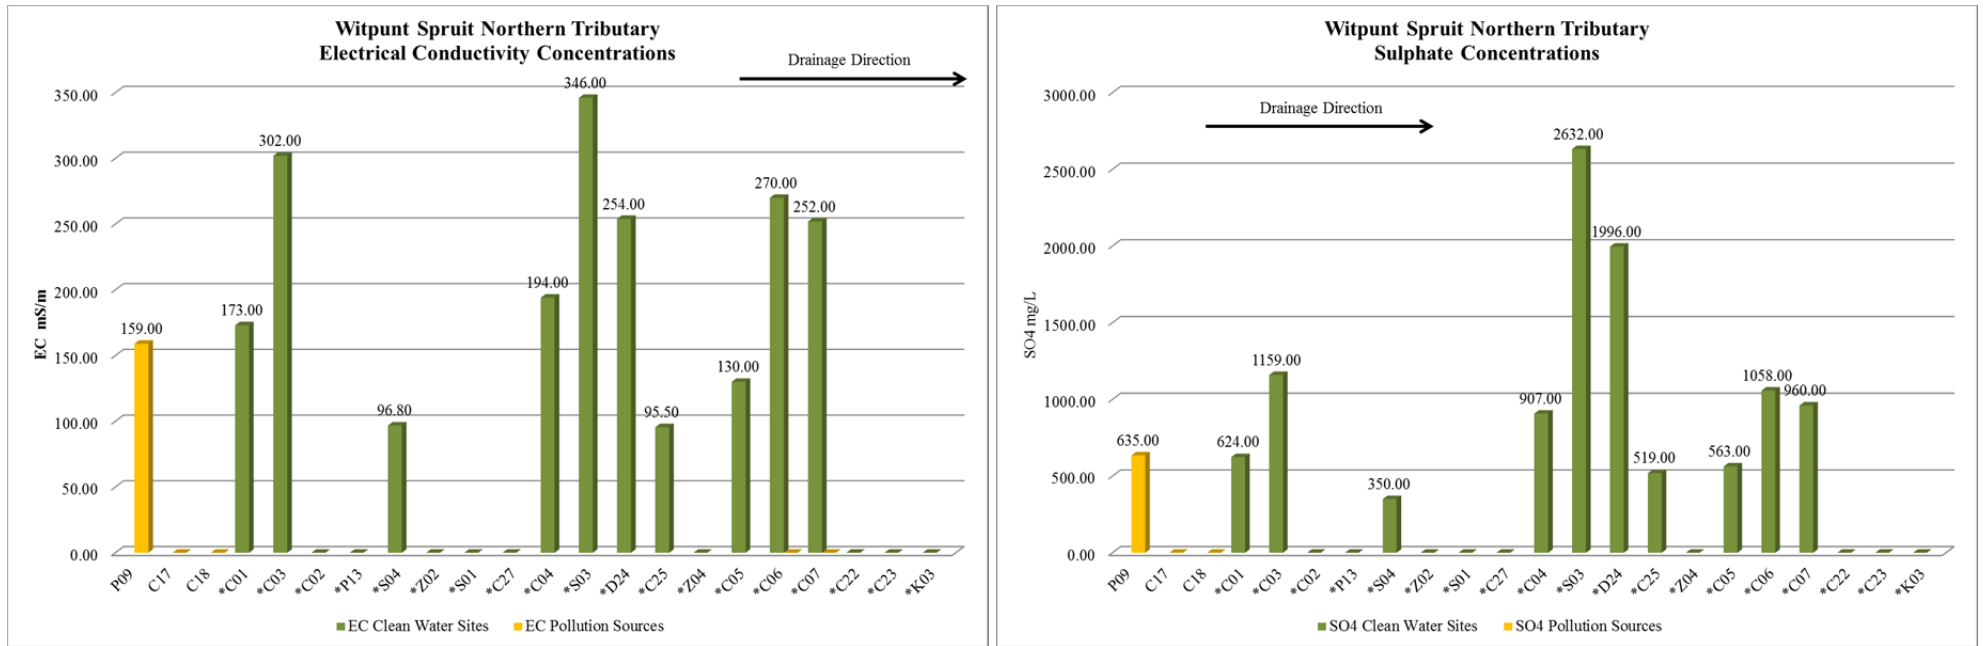
Figure 2. Bar charts of the sulphate and electrical conductivity concentrations at sampling sites along the Witpunt Spruit Northern Tributary Drainage System.

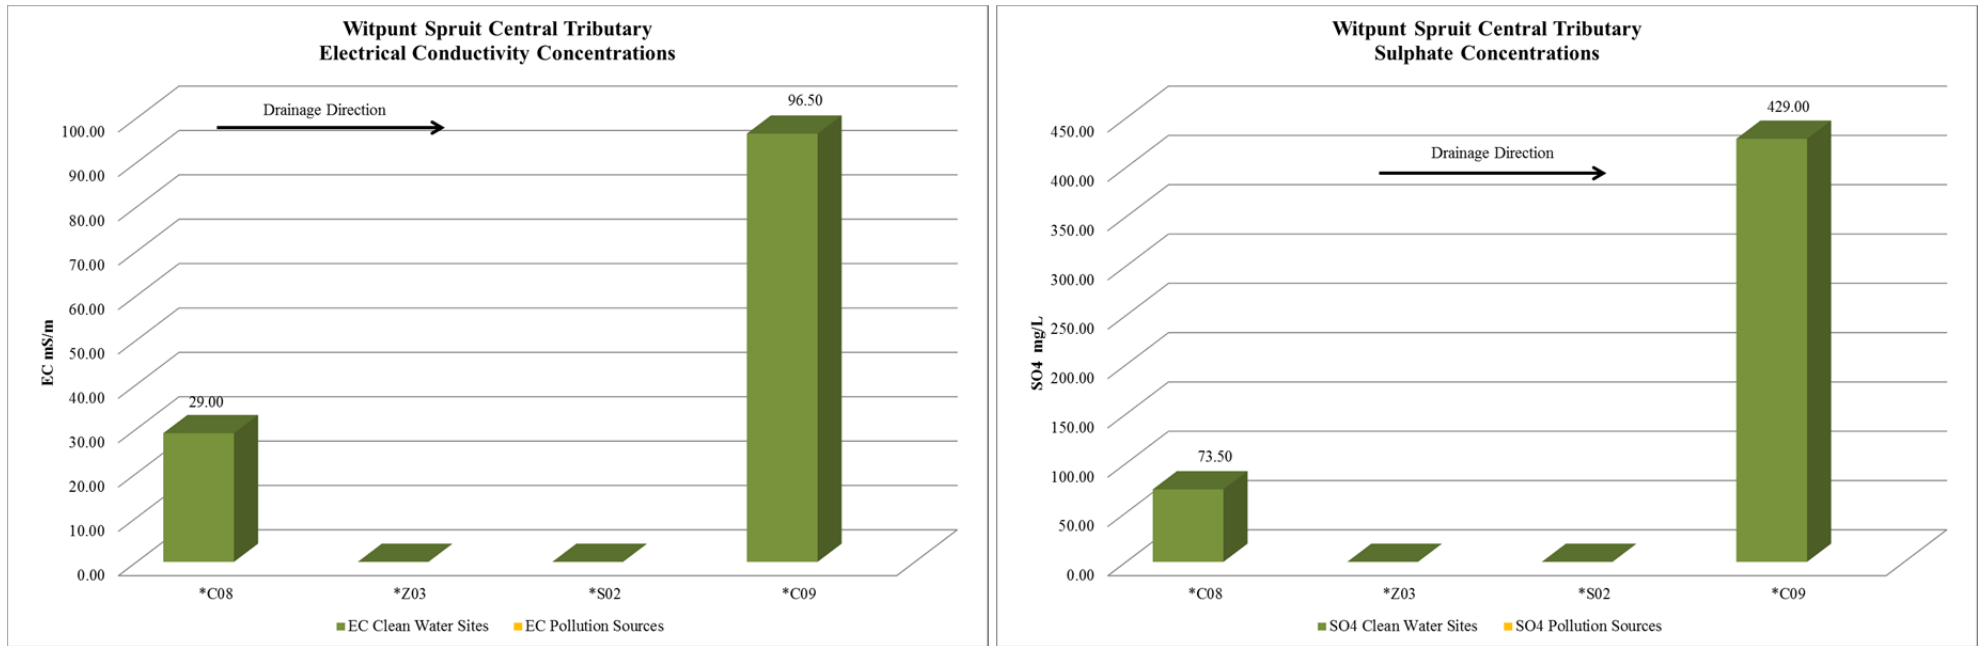
Figure 5. Bar charts of the sulphate and electrical conductivity concentrations at sampling sites along the Witpunt Spruit Central Tributary Drainage System.

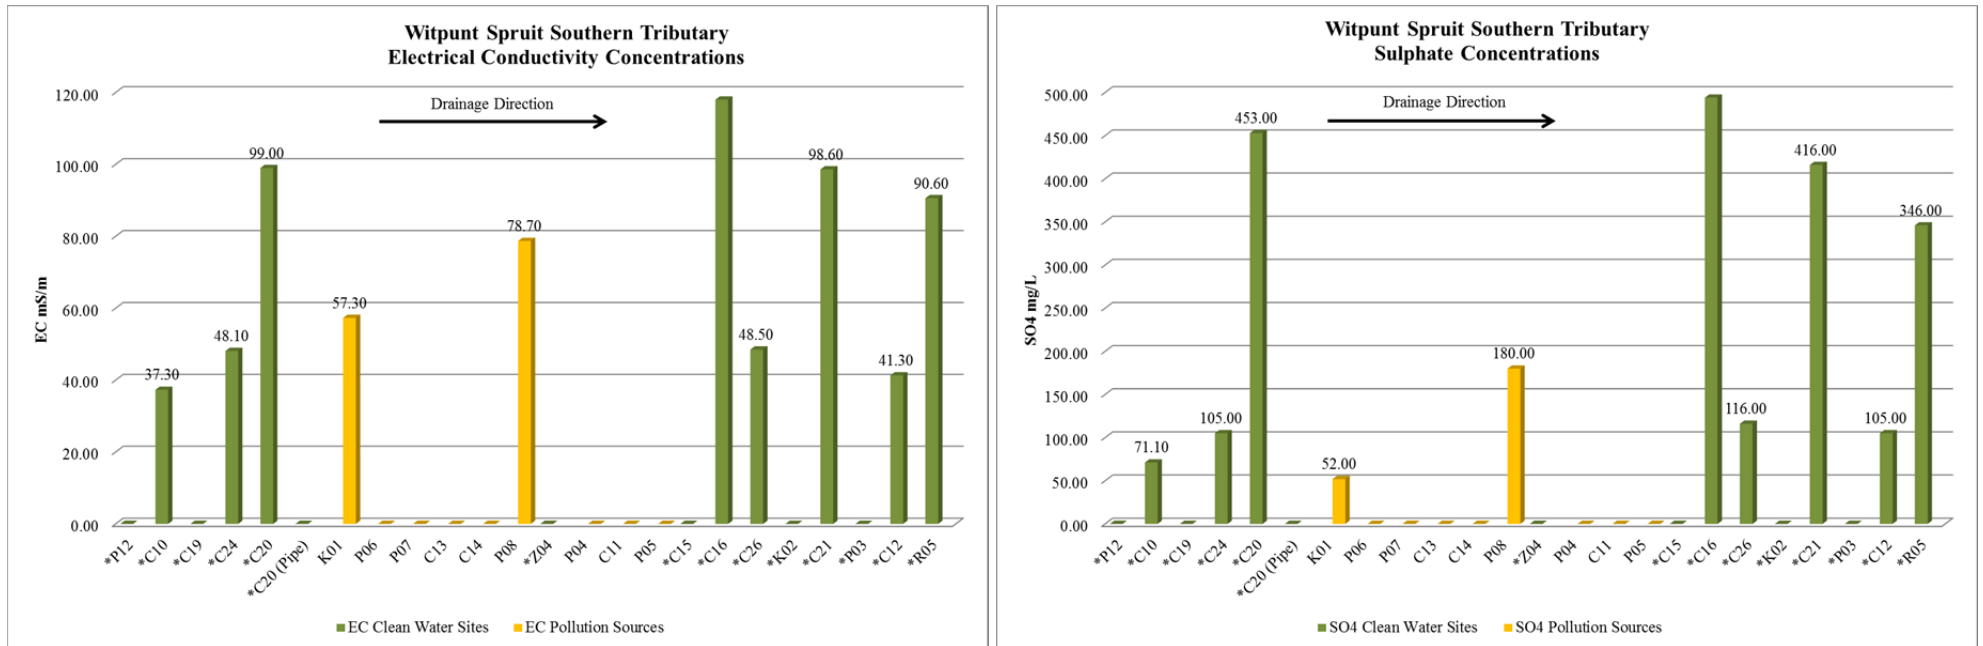
Figure 8. Bar charts of the sulphate and electrical conductivity concentrations at sampling sites along the Witpunt Spruit Southern Tributary Drainage System.

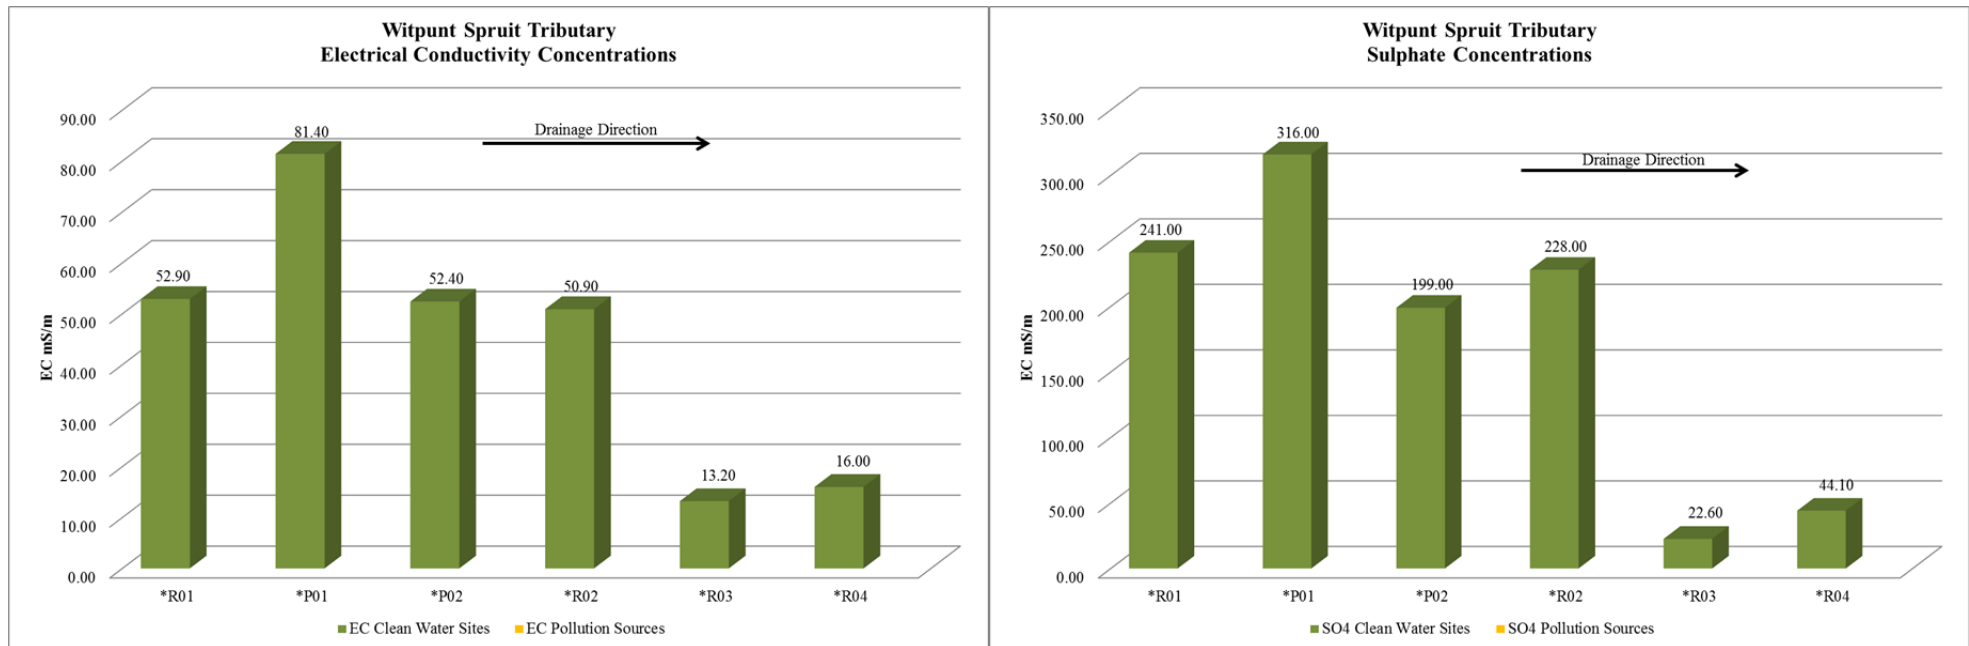
Figure 11. Bar charts of the sulphate and electrical conductivity concentrations at sampling sites along the Witpunt Spruit Drainage System.
