# 1 INTRODUCTION AND BACKGROUND INFORMATION

ESKOM intends to close the existing waste site, also known as the "Rock Dump" at Matimba Power Station.

Blue Rock Consulting (Pty) Ltd was appointed as an independent consultant to conduct an investigation for the geohydrological requirements for the application for authorisation.

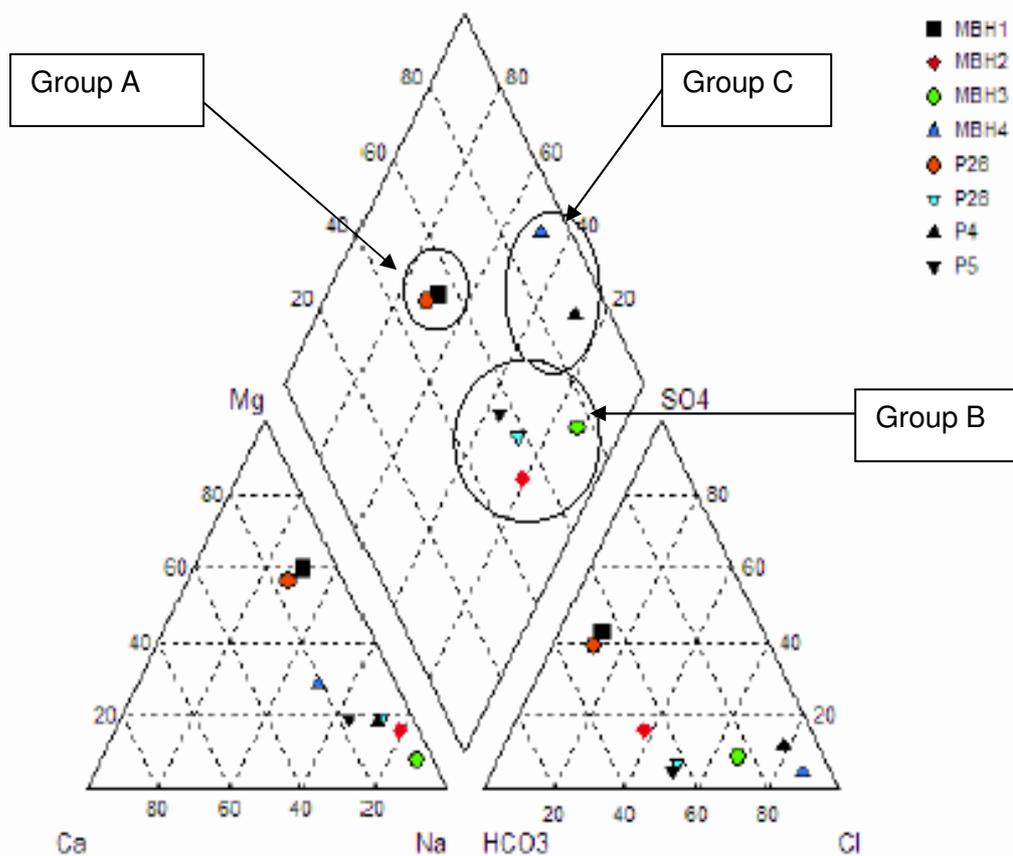
**Figure 1: Piper diagram of the boreholes sampled on 9 April 2009.**

The analytical results of the samples collected on 9 April 2009 were plotted on a Piper diagram to establish any similarities in chemical character between the boreholes. The Piper diagram is shown in Figure 1. Three groupings have been identified:

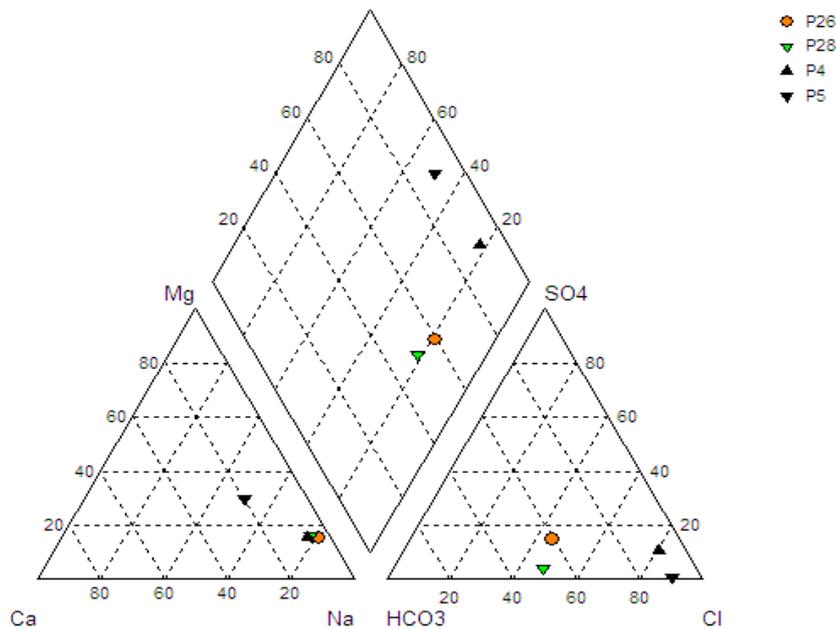
**Figure 2: Piper diagram of 2006 analytical results (Vermeulen, 2006)**

The analytical data reported by Vermeulen (2006) were plotted on the Piper diagram shown in Figure 2. P4 and P28 show good similarity to the present 2009 results. The anion values for boreholes P5 and P26 show fair similarity to the 2009 results but the cation values do not correspond with the 2009 characterization. It is recommended that monitoring and analyses be carried out by the same accredited laboratory in future to determine if the variations in values analysed are seasonal or due to analytical or other errors.
