Komati Power Station
HYDROLOGICAL & GEOHYDROLOGICAL BASELINE STUDY
DECEMBER 2008

KOMATI POWER STATION

Project no.: 149-14-ghd.537
Current Phase: Final V1.2
Report no.: RVN 537.5/909

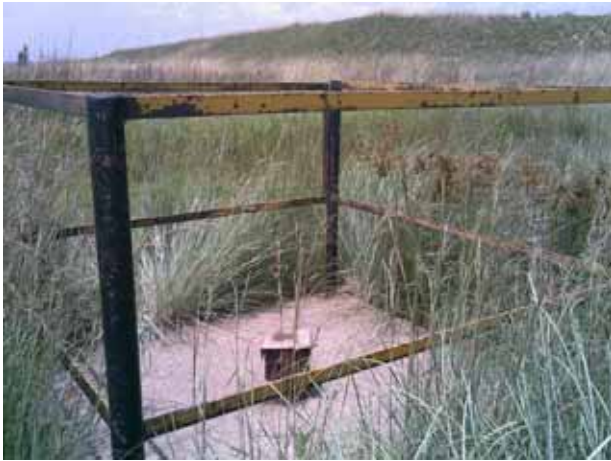
Photo 1. AB01

Group / Area	Number on map	Longitude (°E)	Latitude (°S)	Elevation (mamsl)	Site Description	Site Type	Photo No.	Current Condition	
GROUP 1 Komati Power Station	Ashing Area	AB01	29.46653	-26.10885	1645	Monitoring borehole north and downstream of old rehabilitated domestic waste site.	Borehole	1	No marker post, lock, pin or cap.
		AB02	29.46809	-26.10053	1626	Monitoring borehole downstream and north of small ash dam as well as west of large ash dams.	Borehole	2	No marker post, lock, pin or cap.
		AB03	29.46826	-26.09855	1621	Monitoring borehole downstream and north of small ash dam as well as west of large ash dams.	Borehole	3	No marker post, lock, pin or cap. Colapsed to 7.5m
		AB04	29.46831	-26.09615	1613	Monitoring borehole north-west of ash dams and south of dam AP02.	Borehole	4	No marker post, lock, pin or cap.
		AB05	29.46438	-26.08999	1601	Monitoring borehole next to Komati Spruit west of power station.	Borehole	5	No lock, pin or cap. Colapsed to 8.5m

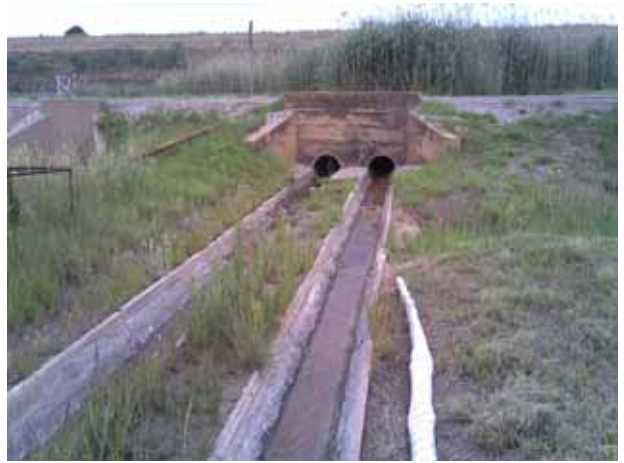
Photo 12. AC05.

AC05	29.47773	-26.09571	1615	Dirty water canal north of ash dam. Sample at culvert underneath sealed road.	Canal	12	Satisfactory condition. Flowing moderately.
		*AC09	29.47575	-26.09454	1615	Small canal running parallel with new ash transfer pipes. Sample at culvert underneath sealed road.	Canal	13	Satisfactory condition. Flowing slowly.
		AP01	29.47422	-26.09605	1615	Pool areas and dams on top of north-western part of ash dams.	Dam	14	Satisfactory condition.
		*AP02	29.46882	-26.09543	1612	Clean water dam where Komati Spruit originates west of ash water return dam.	Dam	15	Satisfactory condition. Flowing moderately.
		AP03	29.47755	-26.09321	1610	Seepage recovery dam north of ash dam complex & east of power station.	Dam	16	AP03 has recently overflow.
		AP08	29.47353	-26.09493	1615	New ash water return dam.	Dam	17	Satisfactory condition.
	Coal Stockyard Area	CB09	29.47110	-26.08481	1602	Monitoring borehole north and downstream of coal stockyard dirty water dam CP06.	Borehole	18	No marker post, lock, pin or cap.

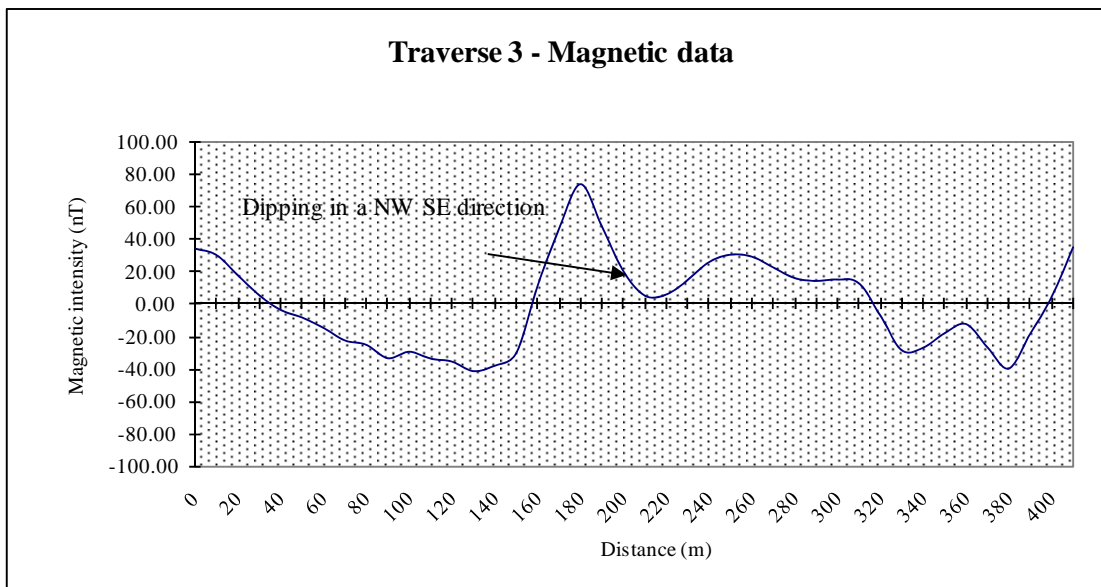
Figure 6. SW-NE magnetic profile of Traverse 3.

An anomaly was recorded on Traverse 3 indicating the possible presence of a dolerite sill with a dip in a northwest southeast direction.

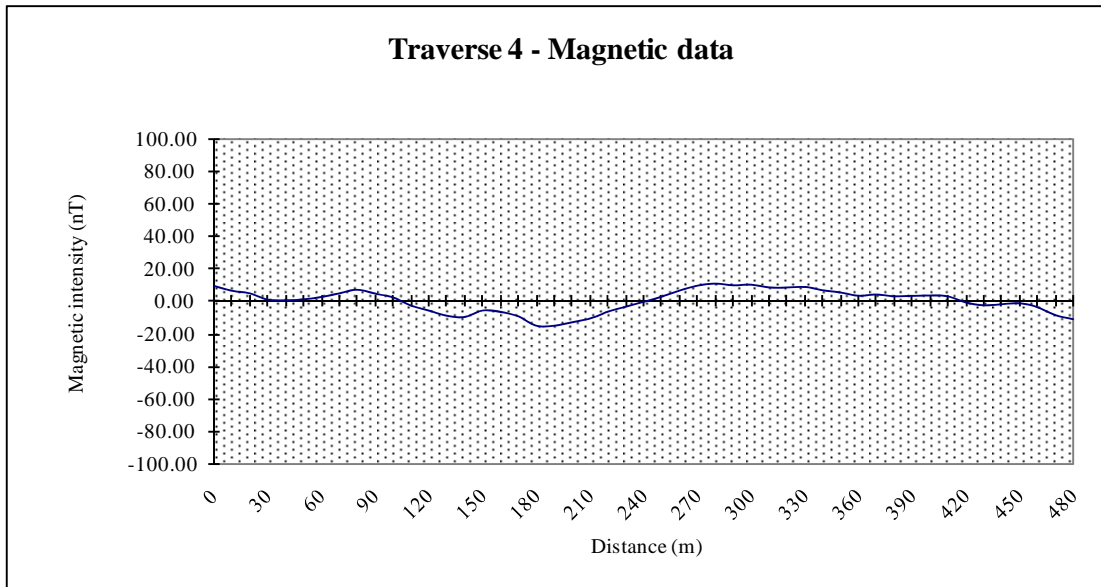
Figure 7. W-E magnetic profile of Traverse 4.

Data was recorded on one traverses south of the Ash Dam with an approximate west/east strike (Traverses 4). No magnetic anomalies of any significance were recorded on traverse 4.

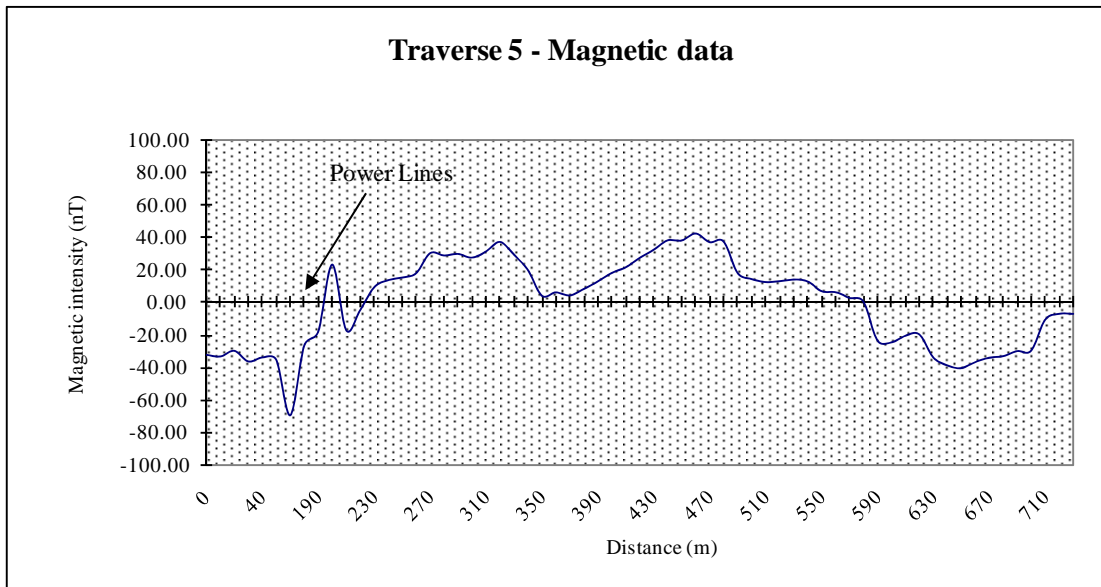
Figure 8. SW-NE magnetic profile of Traverse 5.

Anomalies were recorded on two of the traverses namely, Traverses 5 and 9. These anomalies are due to the presence of power lines. No magnetic anomalies of any significance were recorded on the other traverses on the eastern side of the Ash Dam.

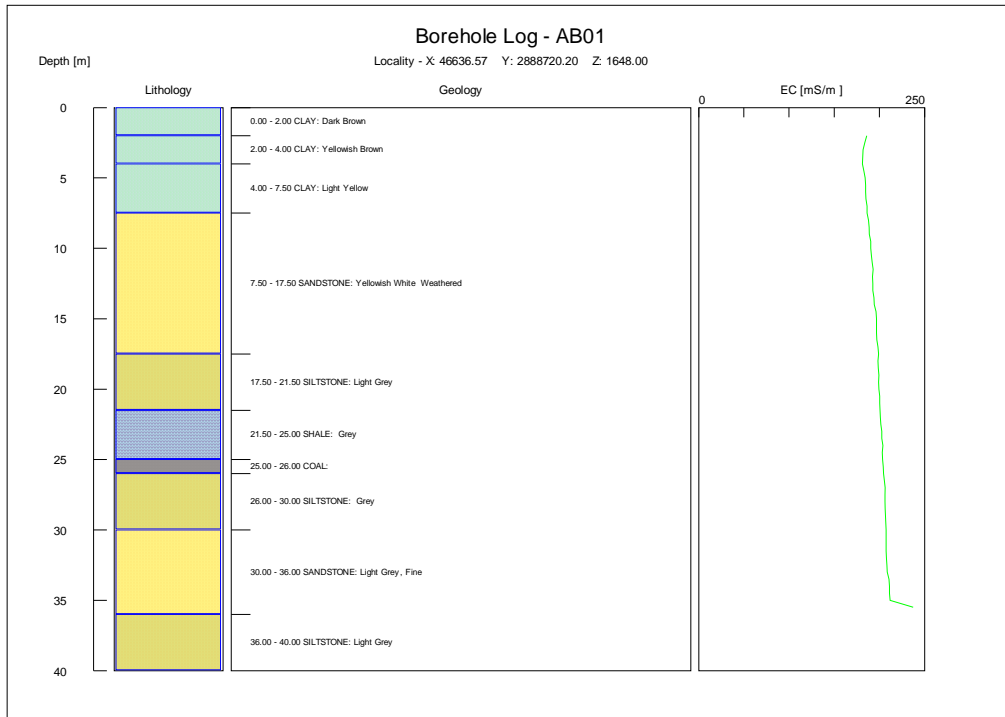
Figure 24. Monitoring borehole AB01.

The EC of the groundwater in borehole AB01 display a gradual increase with depth from 186 mS/m to 212 mS/m.

This borehole is currently sampled at a depth of 15 mbgl. The EC values remain within a very narrow range along the length of the borehole. No preferential pathways for groundwater migration and contaminant migration can be identified. It is recommended that sampling be continued at this depth.

It should be noted that AB01 was drilled to a depth of 40 metres but has since silted up to a depth of around 35.5 metres.

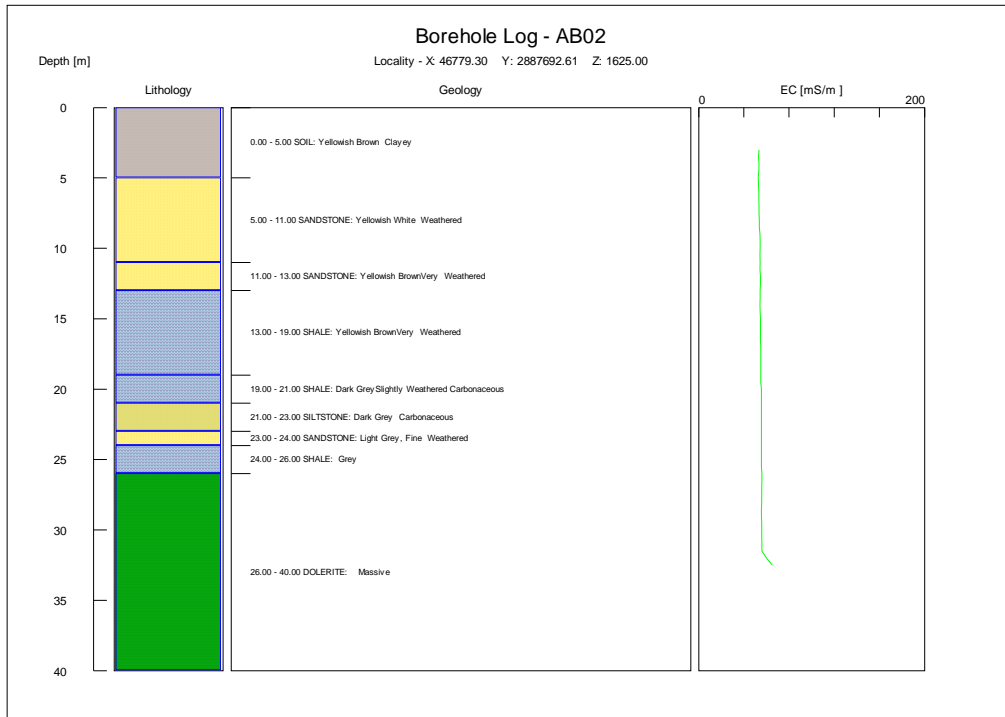
Figure 25. Monitoring borehole AB02.

This borehole is currently sampled at a depth of 20 mbgl within a sandstone layer. Since the EC values remain within a very narrow range along the length of the borehole and no clear preferential pathways for groundwater migration and contaminant migration can be identified, it is recommended that sampling be continued at this depth.

It should be noted that AB02 was drilled to a depth of 40 metres but has since silted up to a depth of around 32.5 metres.

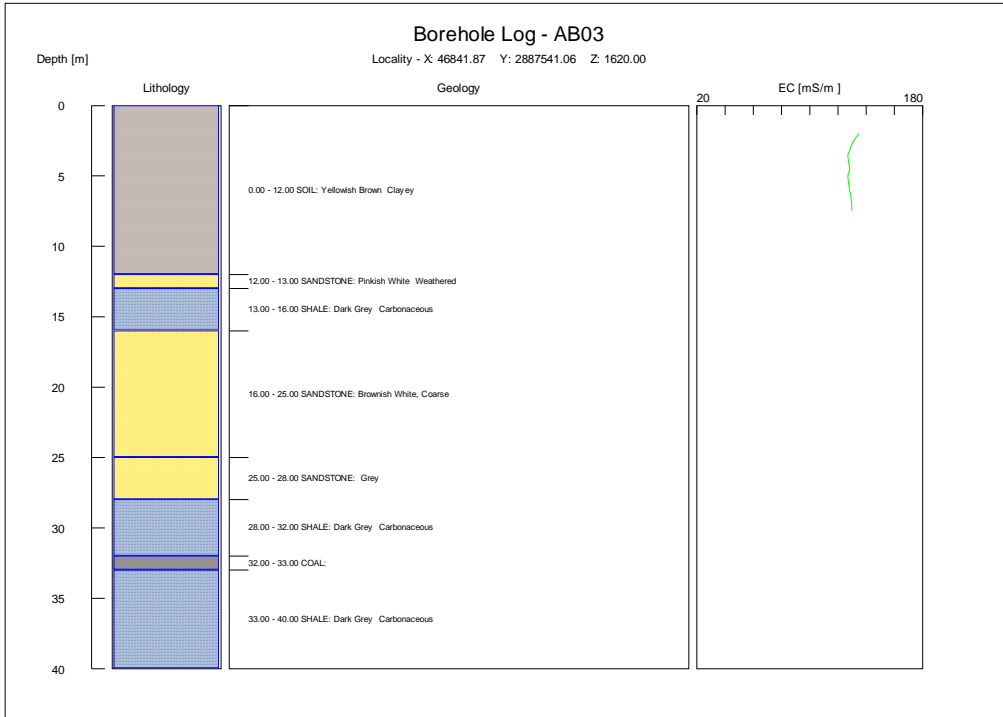
Figure 26. Monitoring borehole AB03.

Borehole AB03 is currently sampled at a depth of 6 mbgl. It is recommended that sampling be continued at this depth.

It should be noted that AB03 was drilled to a depth of 40 metres but has since collapsed or silted up to a depth of around 7.5 metres.

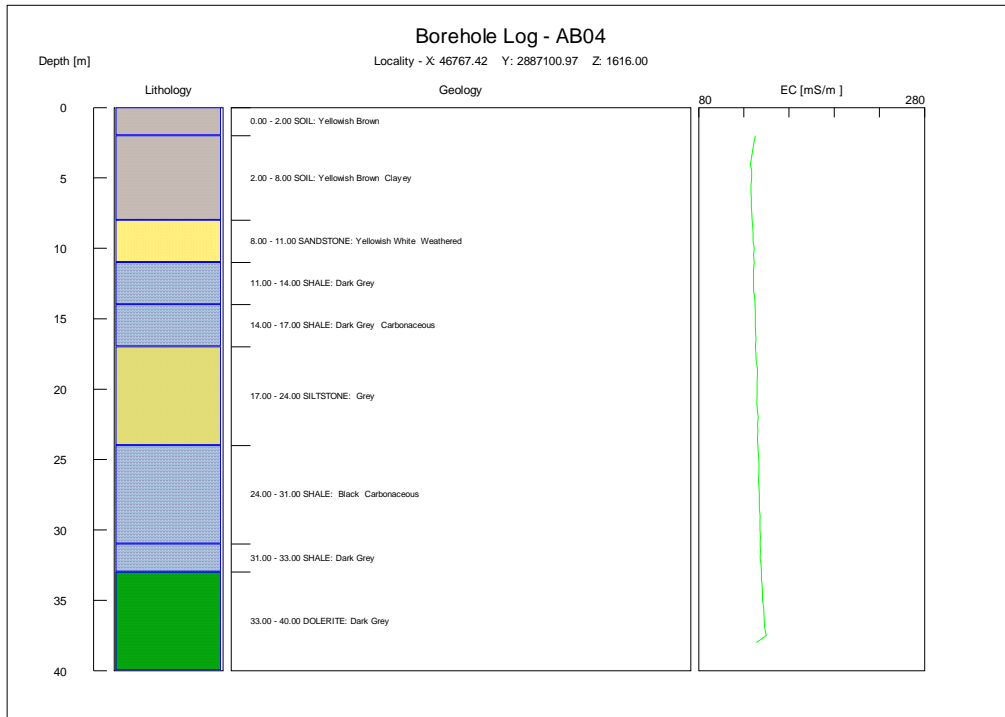
Figure 27. Monitoring borehole AB04.

This borehole is currently sampled at a depth of 19 mbgl. It is recommended that sampling be continued at this depth.

It should be noted that AB04 was drilled to a depth of 40 metres but has since silted up to a depth of around 38 metres.

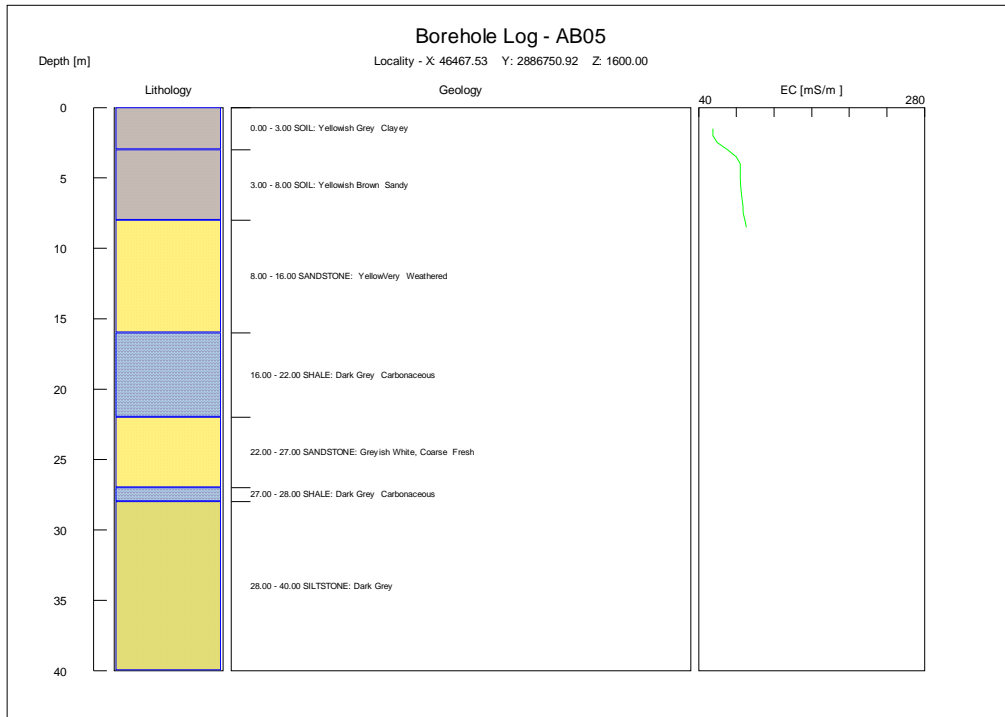
Figure 28. Monitoring borehole AB05.

It should be noted that AB05 was drilled to a depth of 40 metres but has since silted up or collapsed to a depth of around 8.5 metres.

This borehole is currently sampled at a depth of 8.5 mbgl within a sandstone layer.

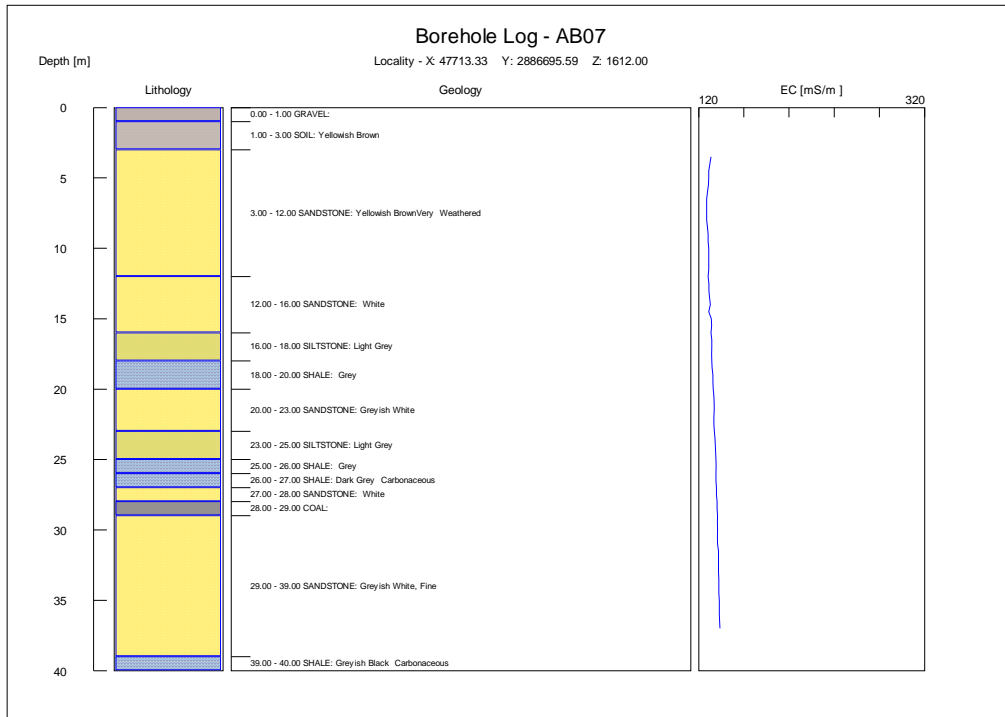
Figure 29. Monitoring borehole AB07.

Since the EC values remain within a very narrow range along the length of the borehole, no clear preferential pathways for groundwater migration and contaminant migration can be identified. This borehole is currently sampled at a depth of 15 mbgl. It is recommended that sampling be continued at this depth.

It should be noted that AB07 was drilled to a depth of 40 metres but has since silted up to a depth of around 37 metres.

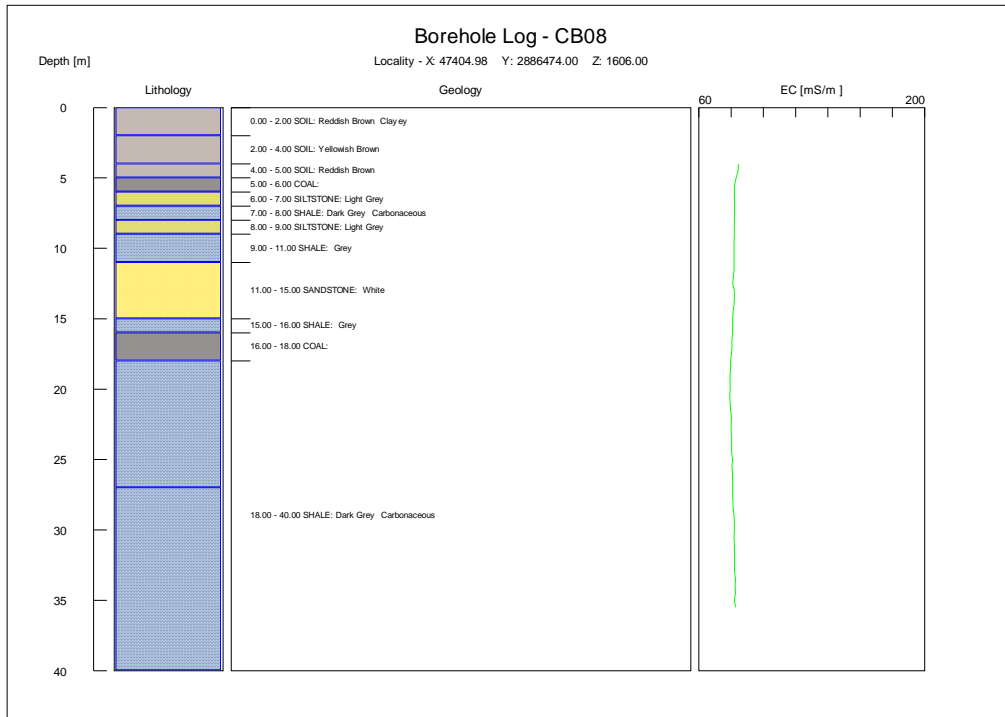
Figure 30. Monitoring borehole PB08.

This borehole is currently sampled at a depth of 13 mbgl within a sandstone layer. Since the EC values remain within a very narrow range along the length of the borehole and no clear preferential pathways for groundwater migration and contaminant migration can be identified, it is recommended that sampling be continued at this depth.

Borehole PB08 was drilled to a depth of 40 metres but has since silted up to a depth of around 35.5 metres.

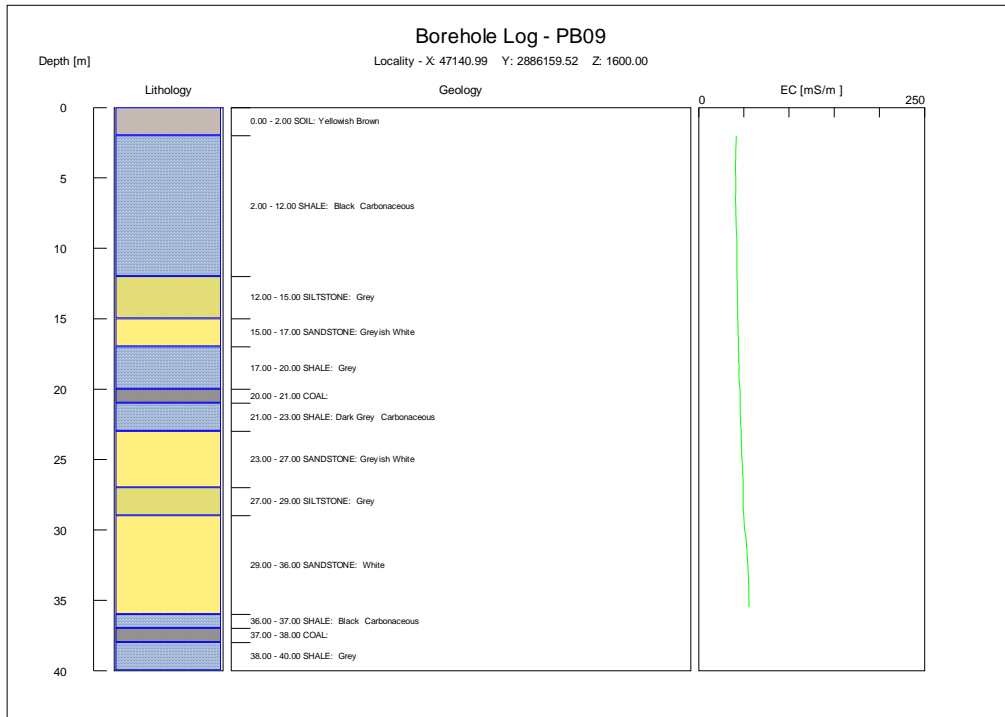
Figure 31. Monitoring borehole CB09.

This borehole is currently sampled at a depth of 31 mbgl. It is recommended that sampling be continued at this depth.

Borehole CB09 was drilled to a depth of 40 metres but has since silted up to a depth of around 35.5 metres.
