## Komati Power Station ROUTINE MONITORING NOVEMBER 2012 FINAL REPORT PHASE 49

Project no.: 149-19-mon.581  
Current Phase: Phase 49  
Report no.: RVN 581.16/1374

Start Date: February 2011  
Start Date: November 2012  
Report Date: December 2012

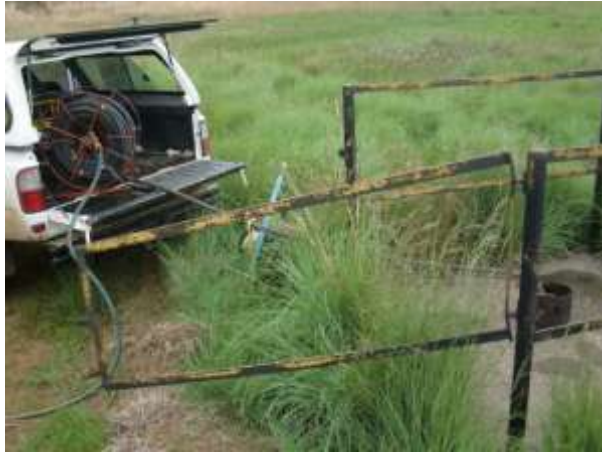
Photo 1. AB01

- AP03 (seepage recovery dam north of ash dam complex & east of power station) is overgrown. Clear vegetation.
- The water quality of borehole AB01 is classified as above the recommended standard due to a high EC, Na, Ca and Mg concentrations.

- Borehole AB01, AB06, AB07 has no locknut. Locknuts must be installed.
- A borehole cap must be installed at borehole AB04.
- The cap at borehole AB47 is wedged. Borehole cap repaired.

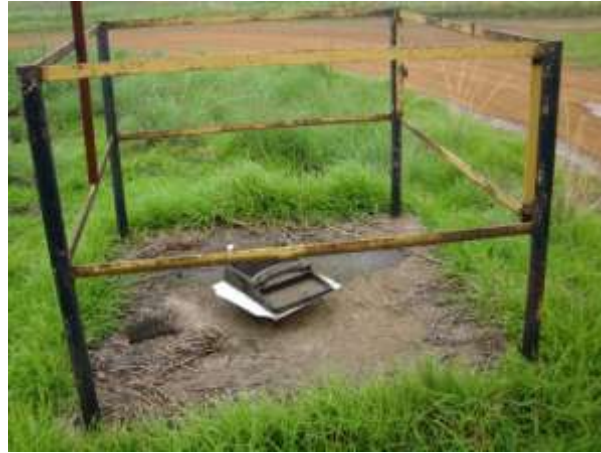
Photo 2. AB04

- The water quality at borehole AB06 is classified as above the recommended standard due to a high Mn concentration.
- The water of boreholes AB04 and AB07 is classified as above the recommended standard due to the high SO<sub>4</sub> concentration.

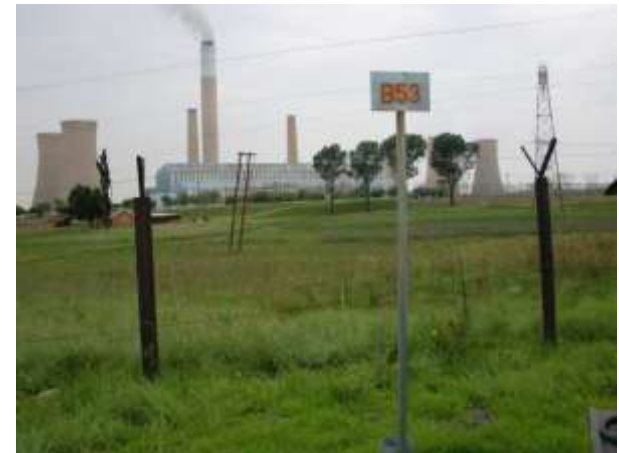
Photo 6. AB53

The groundwater depths at the borehole of the ashing area show mostly stable table trends except at borehole AB53 and AB63. The increasing trend at AB53 is possibly due to a human error. AB63 has a decreasing trend.

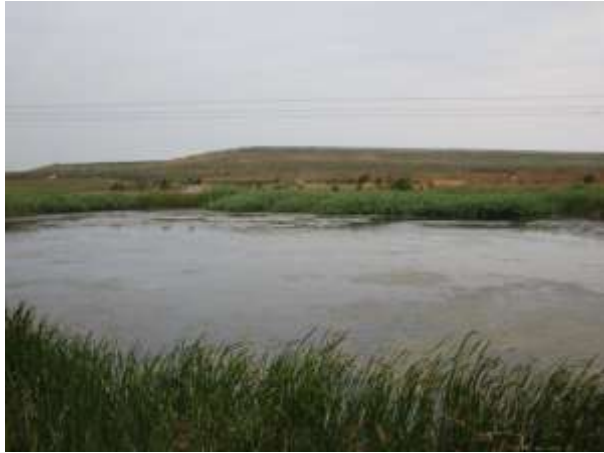
*Photo 19. AP02*

- The water quality at site AC05 are classified above the recommended standard due to EC, Na, SO<sub>4</sub> and F concentrations.
- The EC, Na, SO<sub>4</sub> and Mn concentrations observed at site AP02 exceeds the recommended standard and is unsuitable for human consumption.

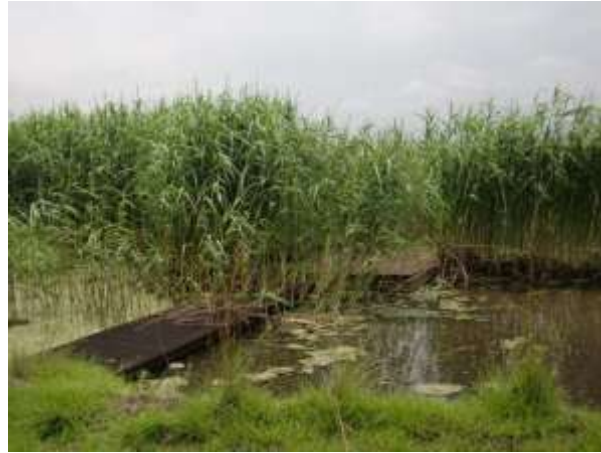
*Photo 20. AP03*

- Surface water site AP03 is above the recommended standard and unsuitable for human consumption due to a high Mn concentration.

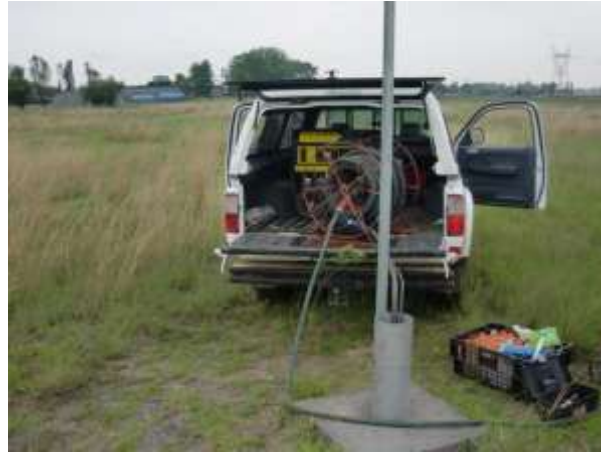
Photo 22. CB50

Stable trends are observed at the groundwater depth of most of the borehole except at borehole CB52 and CB50. Decreasing trend is observed at borehole CB52 and an increasing trend is observed at CB50.

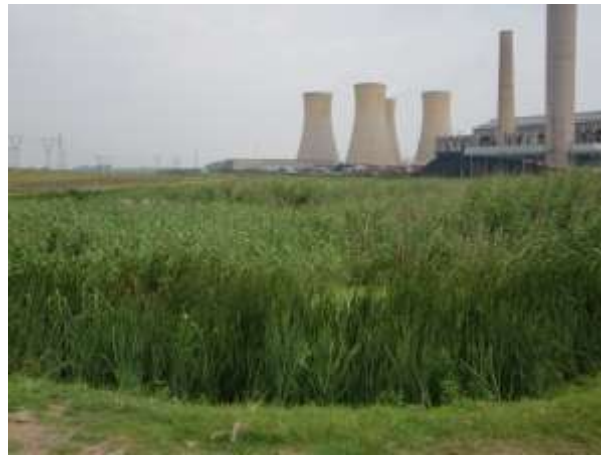
Photo 25. CC07

CC07	Coal stockyard dirty water run-off canal. Sample at security fence.	~	N	Ph 43	Silted with coal.	The canal must be cleaned to prevent overflows into the environment.	None.	No.	14-Nov-12	13:15	Low	Y	25	Silted with coal.	The canal must be cleaned to prevent overflows into the environment.	
	CP06	Coal stockyard settling pond and dirty water run-off dam.	~	V	PH 43	Satisfactory.	Arrange access when necessary	None.	No.	14-Nov-12	13:12	Low	N		Satisfactory.	Arrange access when necessary	
	CP07	Old coal stockyard settling and dirty water run-off dam.	~	N		Satisfactory.				14-Nov-12	13:13		N		Satisfactory.

- Canal CC07 is silted up with coal. This canal must be kept clean to prevent any blockages and overflowing.
- The fence at the sewage plant area must be upgrade to prevent drowning accidents.
- Borehole CB49 has an above the recommended standard water quality due to high F concentration. The high F concentration is associated with the geology of this borehole.
- The Mn concentration observed at borehole CB51 exceeds the recommended standard and is unsuitable for human consumption.

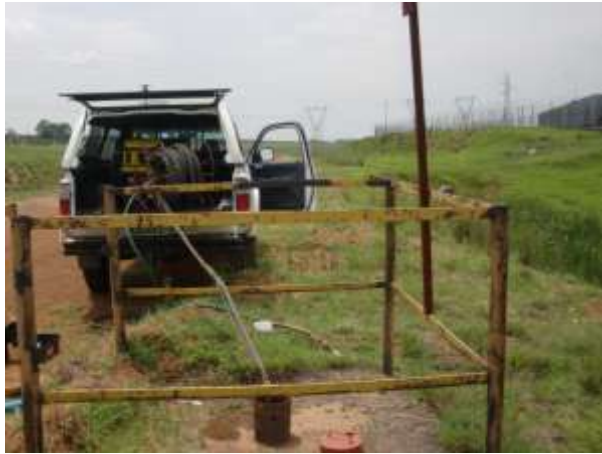
Photo 26. PB08

Decreasing trends is observed at the groundwater depth of most of the boreholes PB08 and PB60.

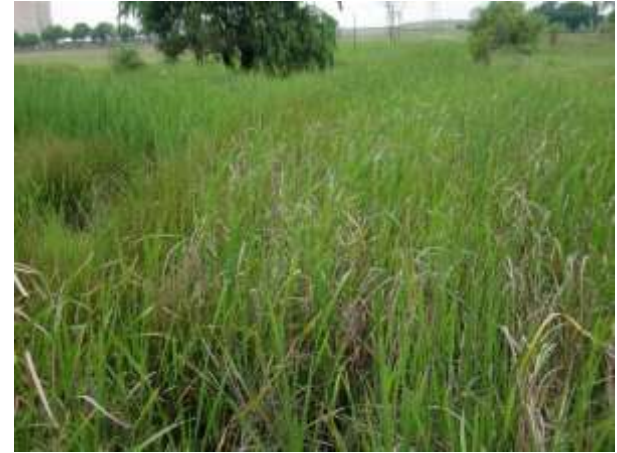
*Photo 31. KMR02*

*KMR02	Komati Spruit downstream form dam KMR01. Sample at culvert underneath sealed road.		N&B		The bacterial activity at these sites is an indication that inadequate treatment is taking place.	The sewage water/effluent must be treated properly.	None.	No.	14-Nov-12	13:38	Low	Y	31	The bacterial activity at these sites is an indication that inadequate treatment is taking place.	The sewage water/effluent must be treated properly.	Bacteriological parameters to high
	*KMR07	Komati Spruit downstream form dam KMR02 and dam receiving purified sewage effluent. Sample at culvert underneath dirt road.		N&B		The bacterial activity at these sites is an indication that inadequate treatment is taking place.	The sewage water/effluent must be treated properly.	None.	No.	14-Nov-12	15:40	Low Slow	Y		The bacterial activity at these sites is an indication that inadequate treatment is taking place.	The sewage water/effluent must be treated properly.	ARS - NH4 9.7 mg/l Bacteriological parameters to high
