**Infinity Consulting**  
**Sandriver Middle Reaches**

**General Geological and Environmental  
Observations.**  
**Compiled by Frank Silberbauer**  
**November 2011**

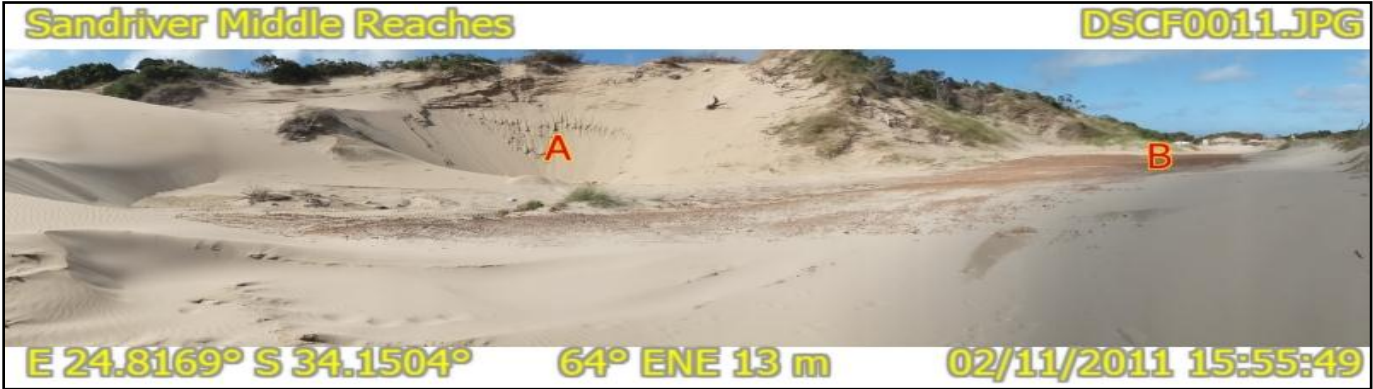
Attributes	
Title	Sandriver Middle Reaches
Comment	A = New Sandmine excavations B = Previous Sandmine excavations. If those excavating this sandmine remove the remaining dune marked A then the result could impact on the viability of the proposed new bridge as one would be opening up the 'throat' to a spread of flow during periodic flood events. Consequent flooding of a much wider area downstream would result if this happened thus increasing the potential threat to properties on the other side of the main road.
Latitude	S 34.1504°
Longitude	E 24.8169°
Elevation	13 m
Photo Direction	64° ENE
Date Time Stamp	02/11/2011 15:55:49
File Name	DSCF0011.JPG

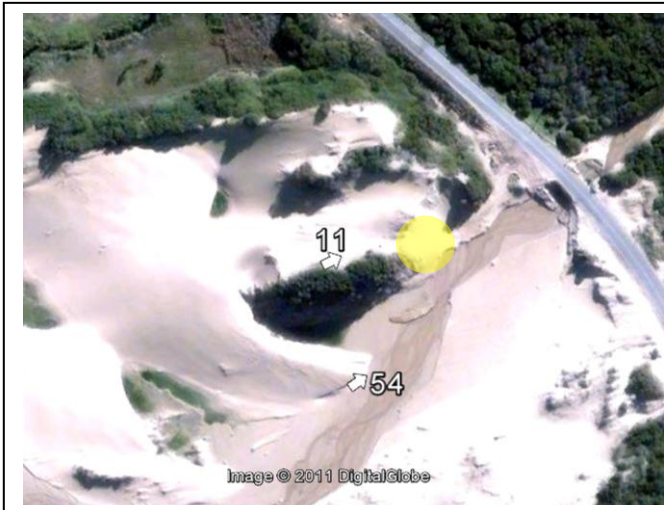
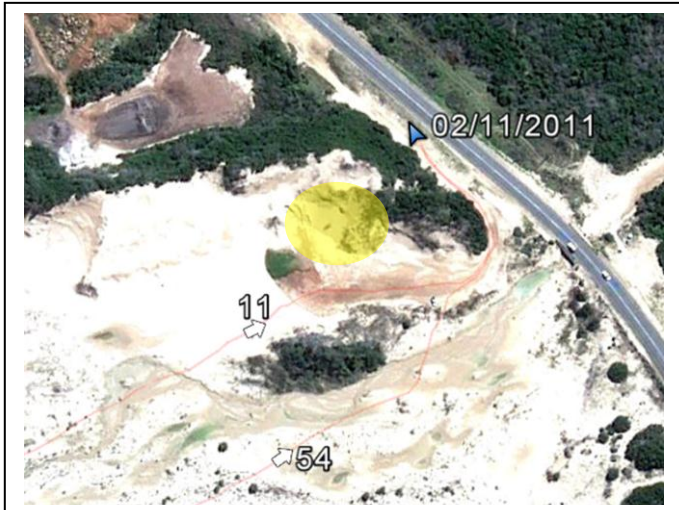
Attributes	
Title	Sandriver Middle Reaches
Comment	The two Google images above show a close view of the Sandriver sandmine on the left 2003 and the right 2010. The yellow areas show how the main mining areas have shifted over 8 years. If the dune where the 2010 mining is removed, it is probable that a much greater area along the MR381 road will be exposed to potential flooding. This is a cause of concern as if such a situation develops a much wider area below the road will be vulnerable to flooding. This fact could also have implications on the design of the proposed new bridge over the Sandriver.

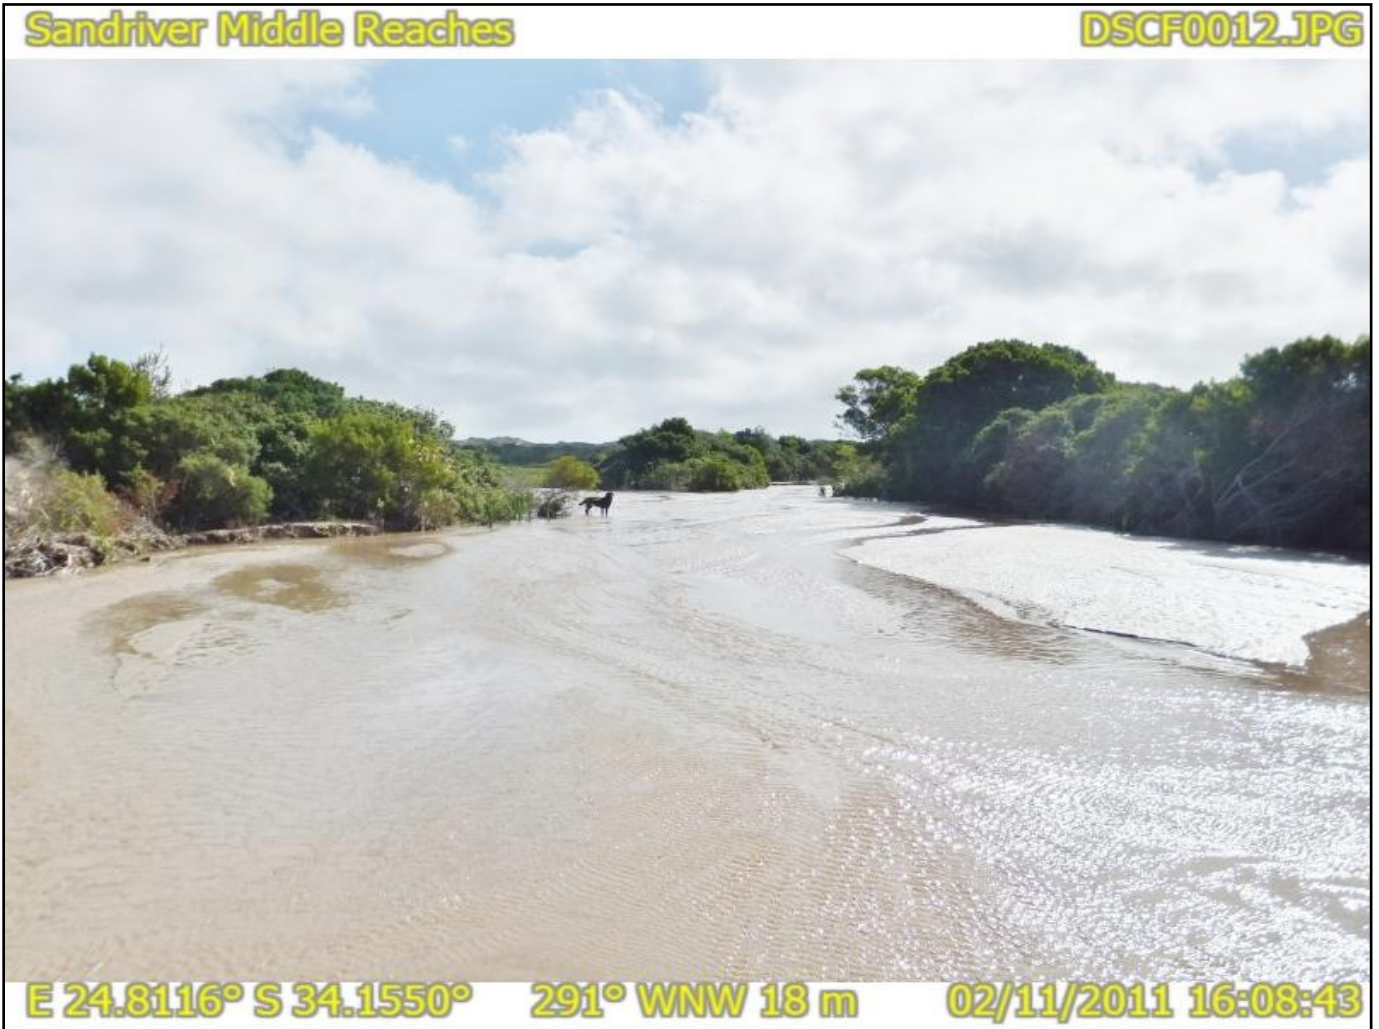
Title	Sandriver Middle Reaches
Comment	General view up stream with the split between 'Lionel's Dam' on the left and the main flow channel of the Sandriver on the right in the far centre. The exact dates of this breach is not known but it could have been during the 1996 floods.
Latitude	S 34.1550°
Longitude	E 24.8116°
Elevation	18 m
Photo Direction	291° WNW
Date Time Stamp	02/11/2011 16:08:43
File Name	DSCF0012.JPG

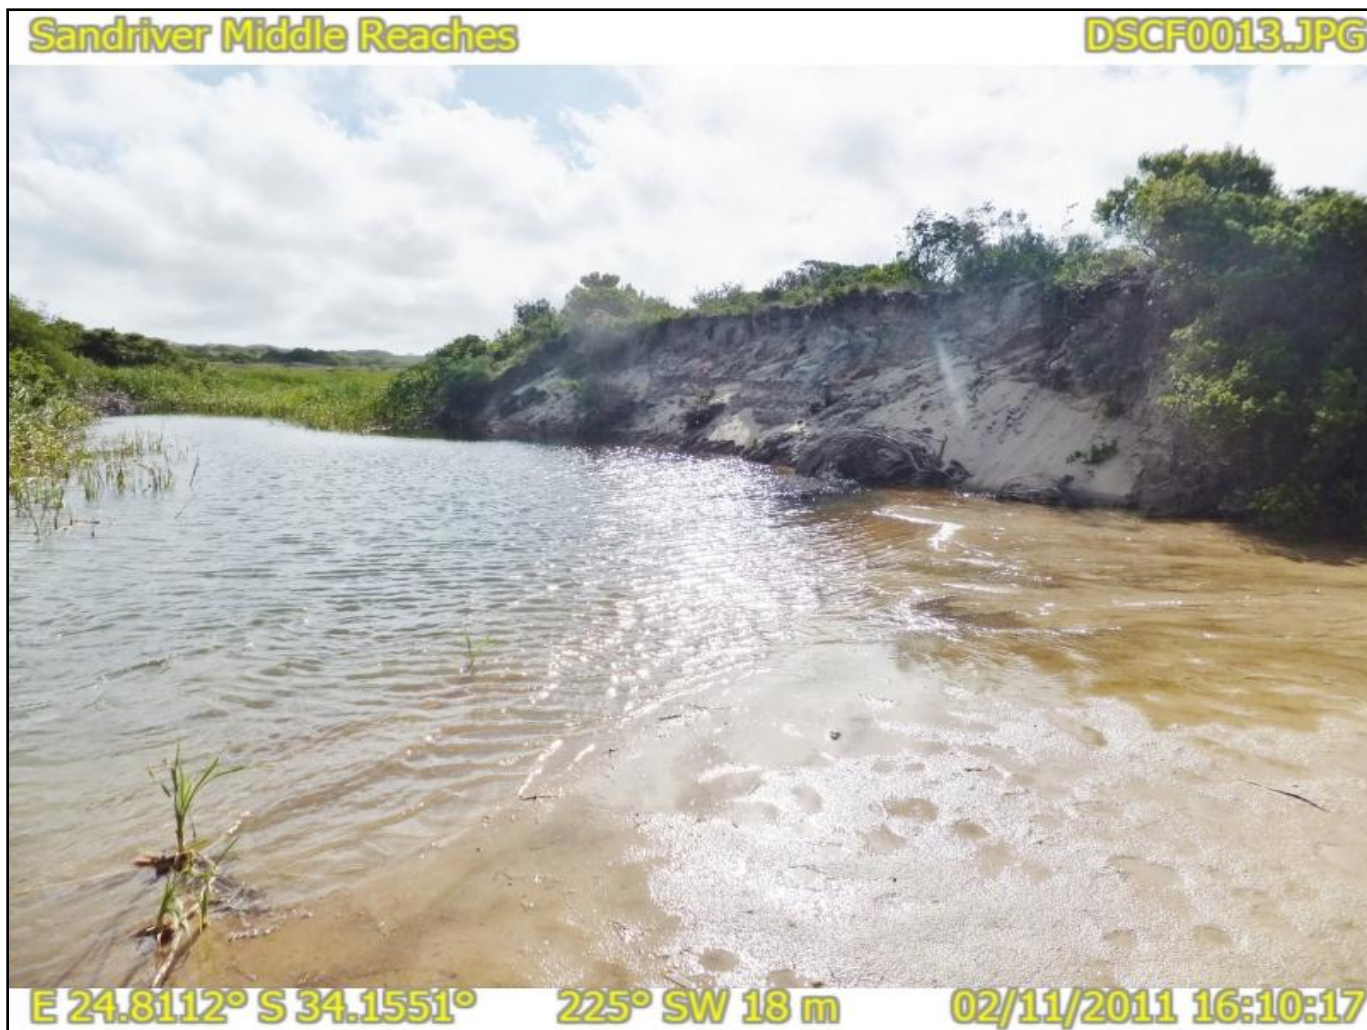
<b>Attributes</b>	
Title	Sandriver Middle Reaches
Comment	View into the breach of 'Lionel's Dam' from the main flow channel. The section on the right shows a layered stratigraphy varying between a grey calcium rich band which is believed to be an old Pleistocene landsurface overlying wind blown dune sand.
Latitude	S 34.1551°
Longitude	E 24.8112°
Elevation	18 m
Photo Direction	225° SW
Date Time Stamp	02/11/2011 16:10:17
File Name	DSCF0013.JPG

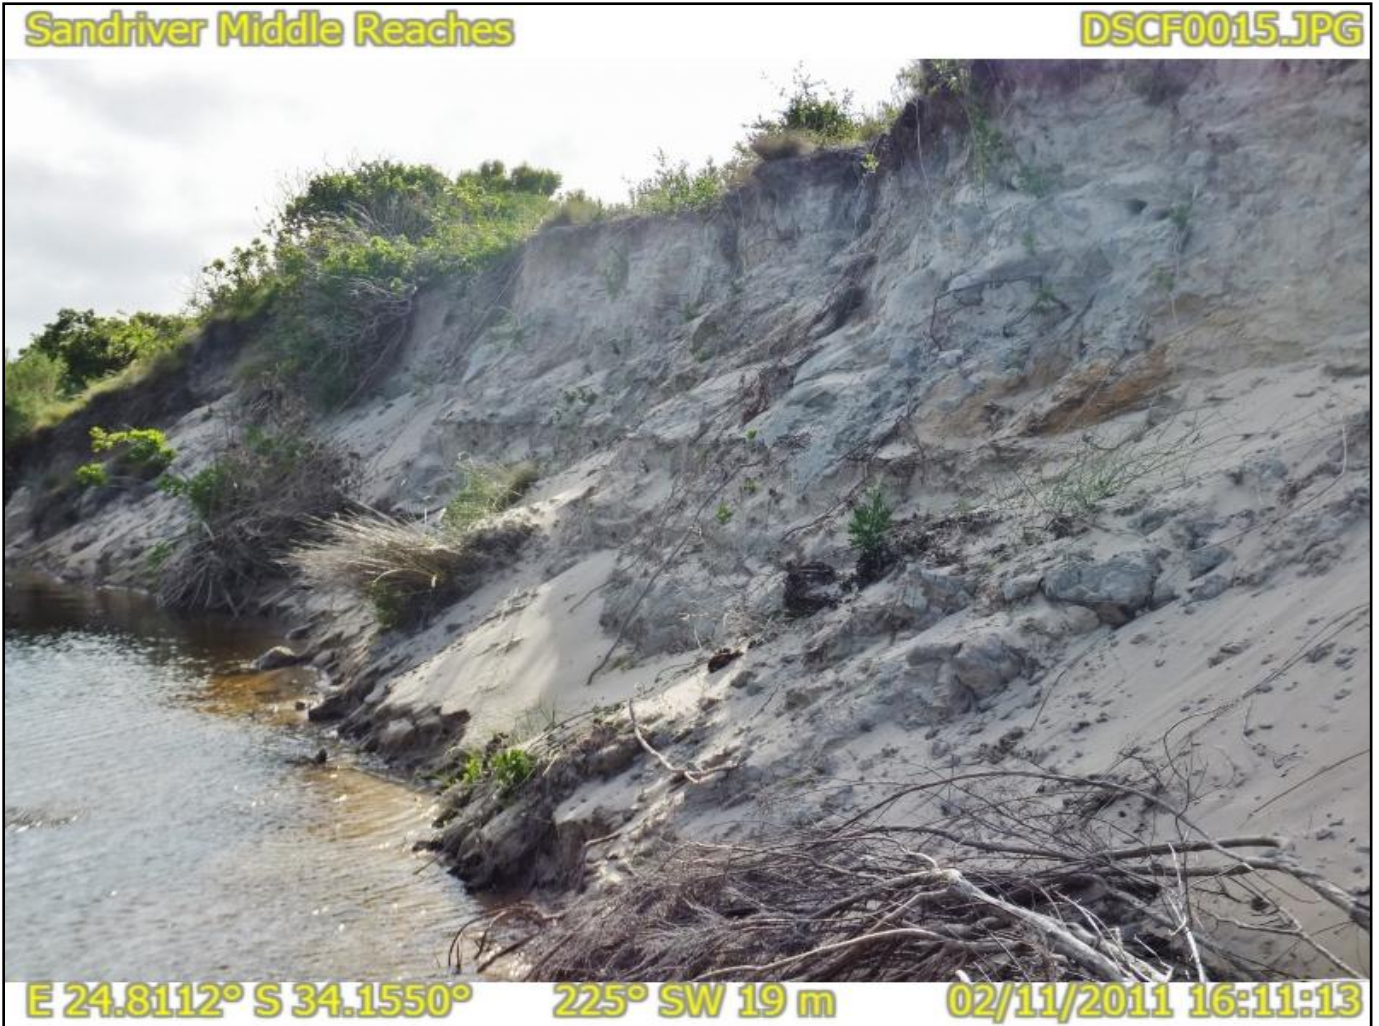
Attributes	
Title	Sandriver Middle Reaches
Comment	A detailed view of the right / northern bank of the breach of 'Lionel's Dam'. On closer inspection the top dark layer consists of disturbed material lying over a dark thin humic horizon, with the dune sand below. It is postulated that the top dark layer represents materials excavated from the main body of the dam and mechanically placed the previous sand dune landsurface.
Latitude	S 34.1550°
Longitude	E 24.8112°
Elevation	19 m
Photo Direction	225° SW
Date Time Stamp	02/11/2011 16:11:13
File Name	DSCF0015.JPG

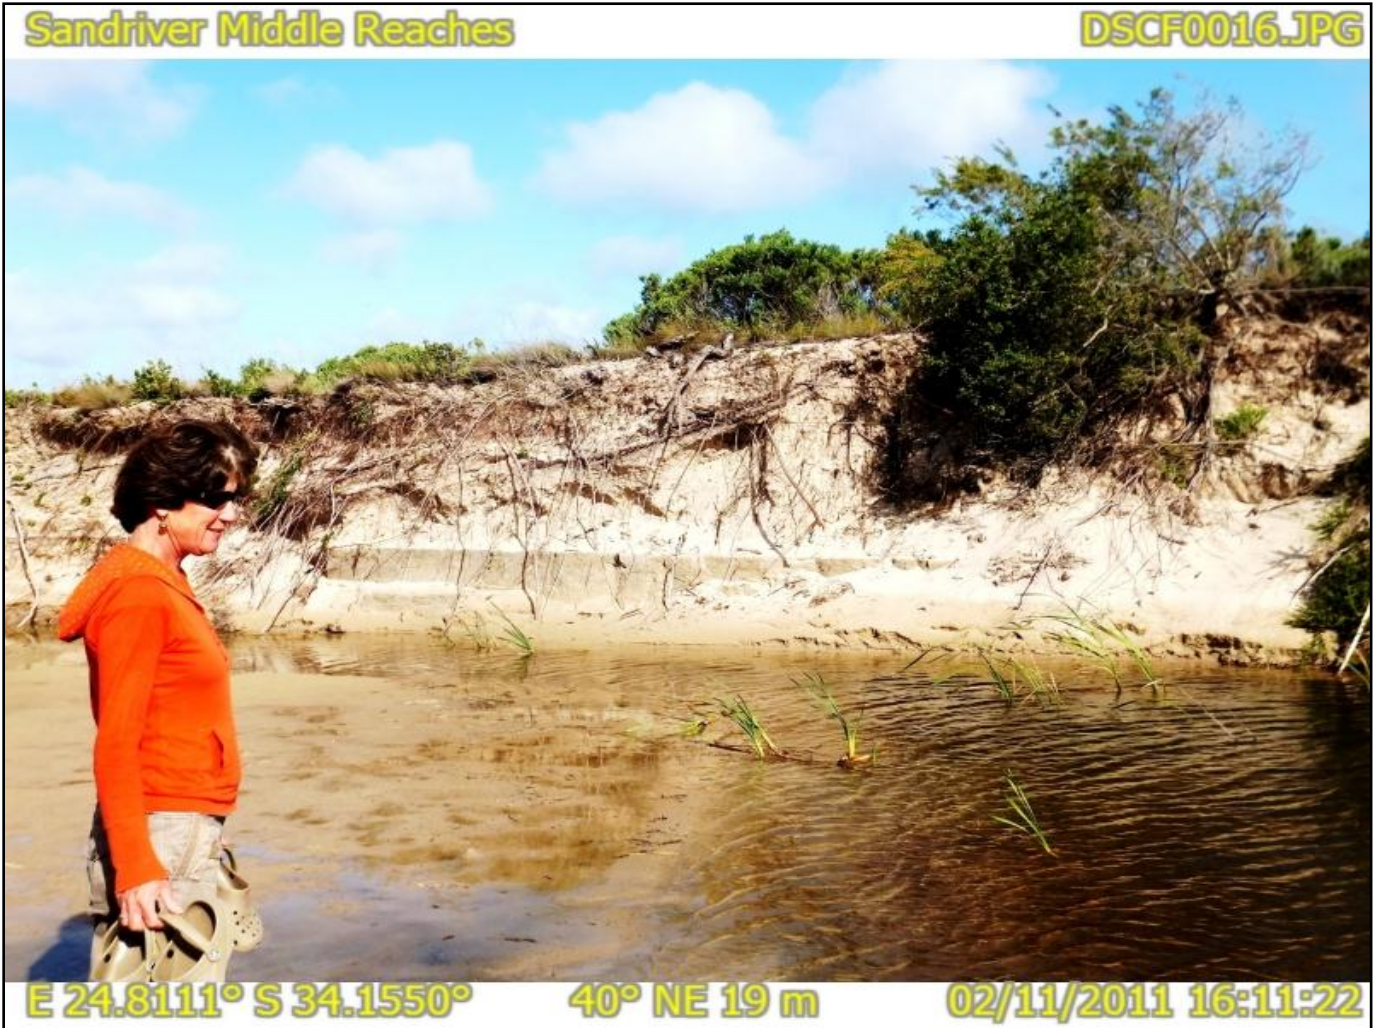
Attributes	
Title	Sandriver Middle Reaches
Comment	View of the south (left) bank of the breach of 'Lionel's Dam'. This opposite view reveals a common stratigraphy of this area of windblown dune sand. The darker layer visible at the bottom is wet and represents a firm band of wind blown of water transported dune sand.
Latitude	S 34.1550°
Longitude	E 24.8111°
Elevation	19 m
Photo Direction	40° NE
Date Time Stamp	02/11/2011 16:11:22
File Name	DSCF0016.JPG

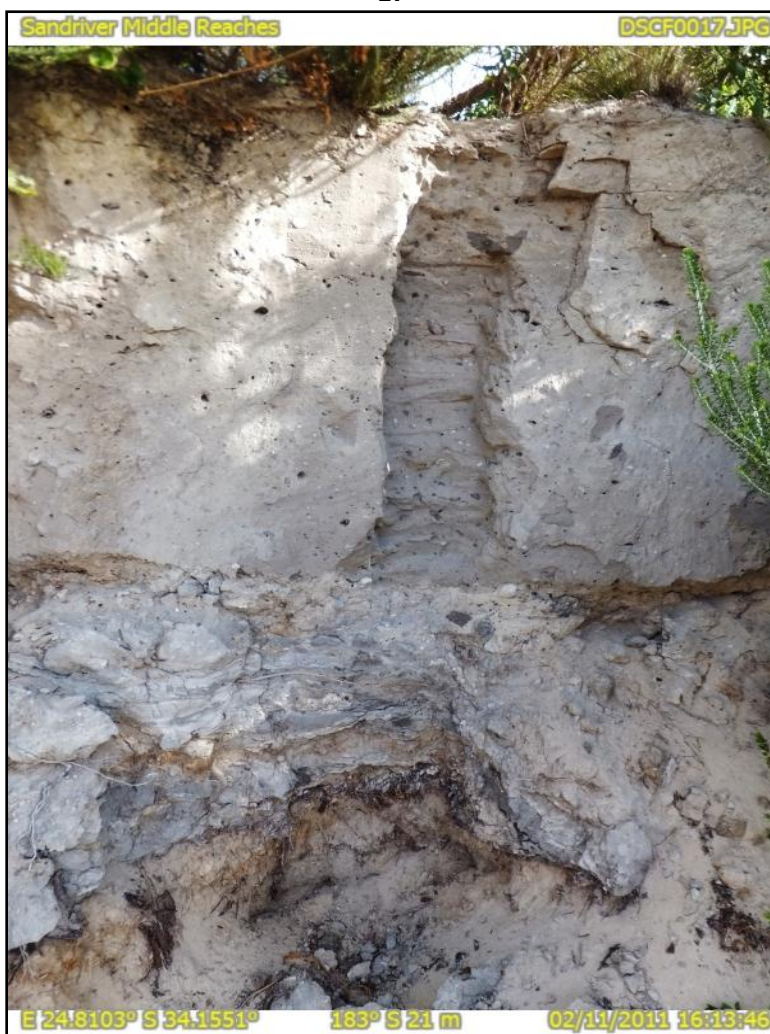
Attributes	
Title	Sandriver Middle Reaches
Comment	Section cut on the south bank of Sandriver of the northern sandriver face wall of 'Lionel's Dam'. This section is close to that recorded by Dr. Ellery in photos 794 and 797. This section is a cut on the northern side of the dam wall eroded by the Sandriver. The top material is extensively disturbed and overlies a humic rich horizon consisting of plant material consistent with the Acacia sp being aliens that infested this area in the recent past. Underlying this humic band is windblown or water transported dune sand.
Latitude	S 34.1551°
Longitude	E 24.8103°
Elevation	21 m
Photo Direction	183° S
Date Time Stamp	02/11/2011 16:13:46
File Name	DSCF0017.JPG

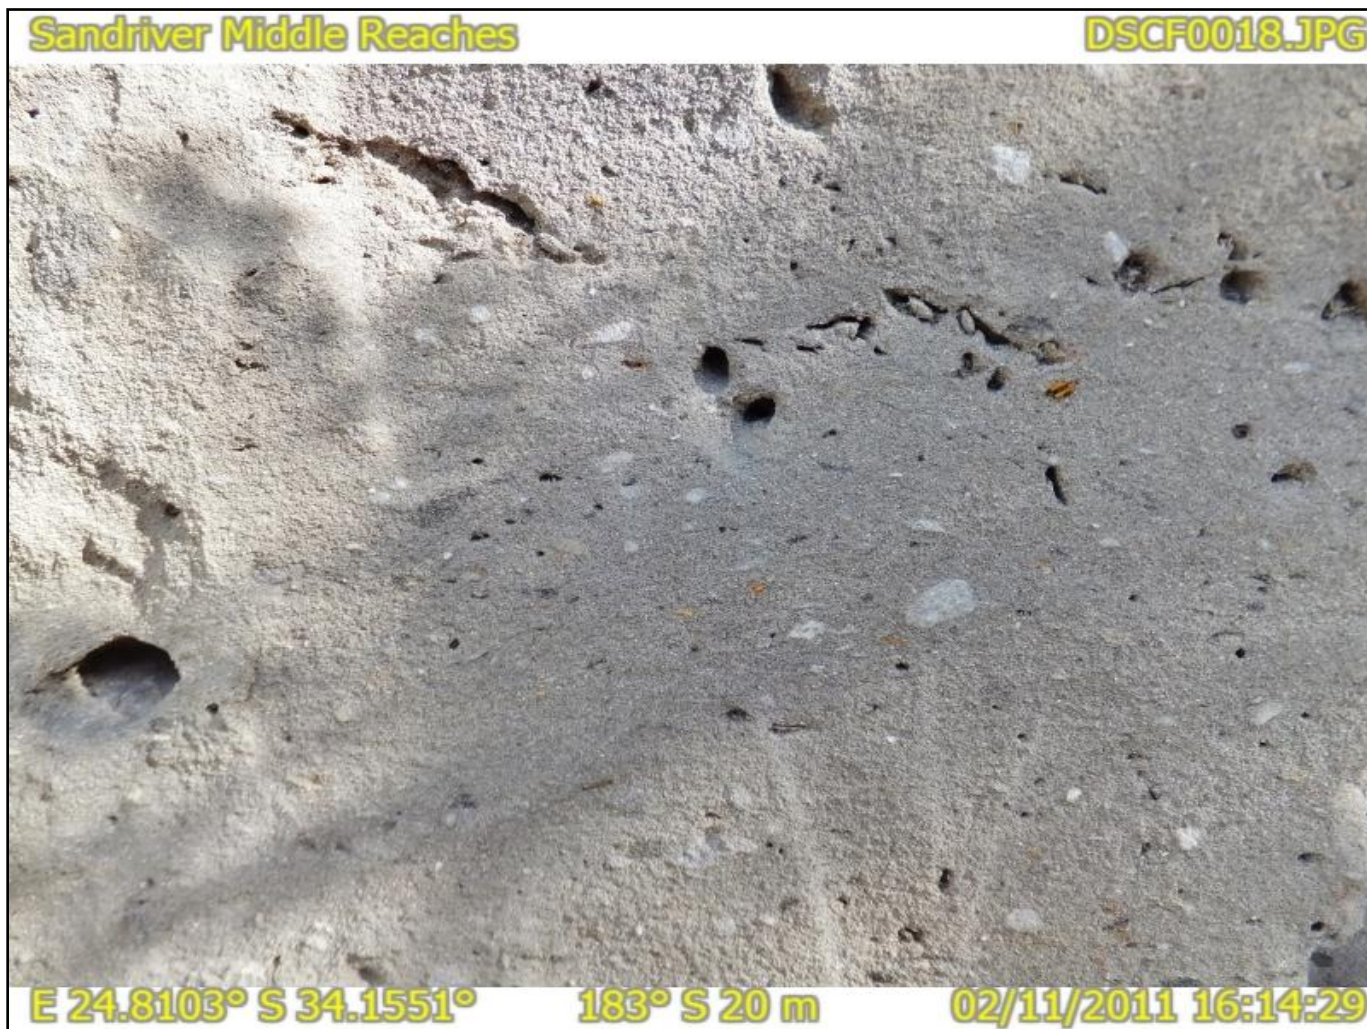
<b>Attributes</b>	
Title	Sandriver Middle Reaches
Comment	A close up view of the previous slide 18 being the top member being a gray quartzitic clay sand indispersed with calcrete nodules not greater than 20mm in diameter. Root intrusion is evident. The face has been trimmed with a trowel.
Latitude	S 34.1551°
Longitude	E 24.8103°
Elevation	20 m
Photo Direction	183° S
Date Time Stamp	02/11/2011 16:14:29
File Name	DSCF0018.JPG

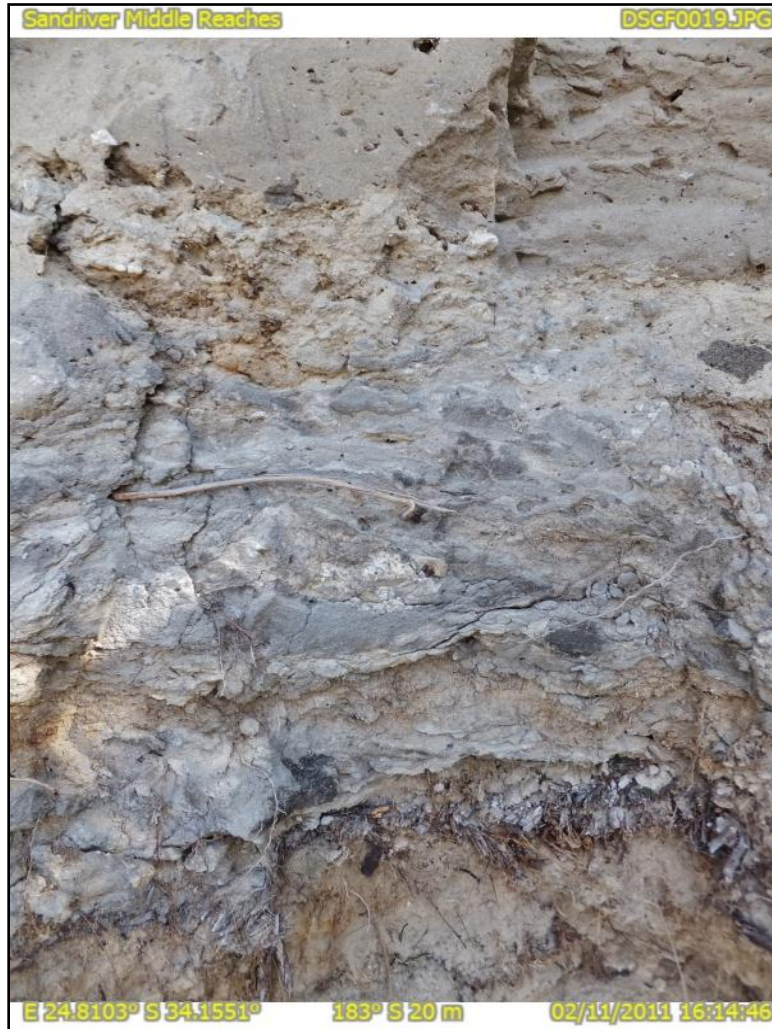
<b>Attributes</b>	
Title	Sandriver Middle Reaches
Comment	Close up of section of the bottom member of the section in slide 17. It is evident that the material described in the previous slide 18 overlies a material which originated from the top layer of a pan or exposed basin. The underlying humic vegetated layer shows materials clearly identifiable which have not reached an advanced stage of decomposition which top the underlying dune sands. It is suggested that these deposits represent excavated materials from the dam on the other side of this berm / wall.
Latitude	S 34.1551°
Longitude	E 24.8103°
Elevation	20 m
Photo Direction	183° S
Date Time Stamp	02/11/2011 16:14:46
File Name	DSCF0019.JPG

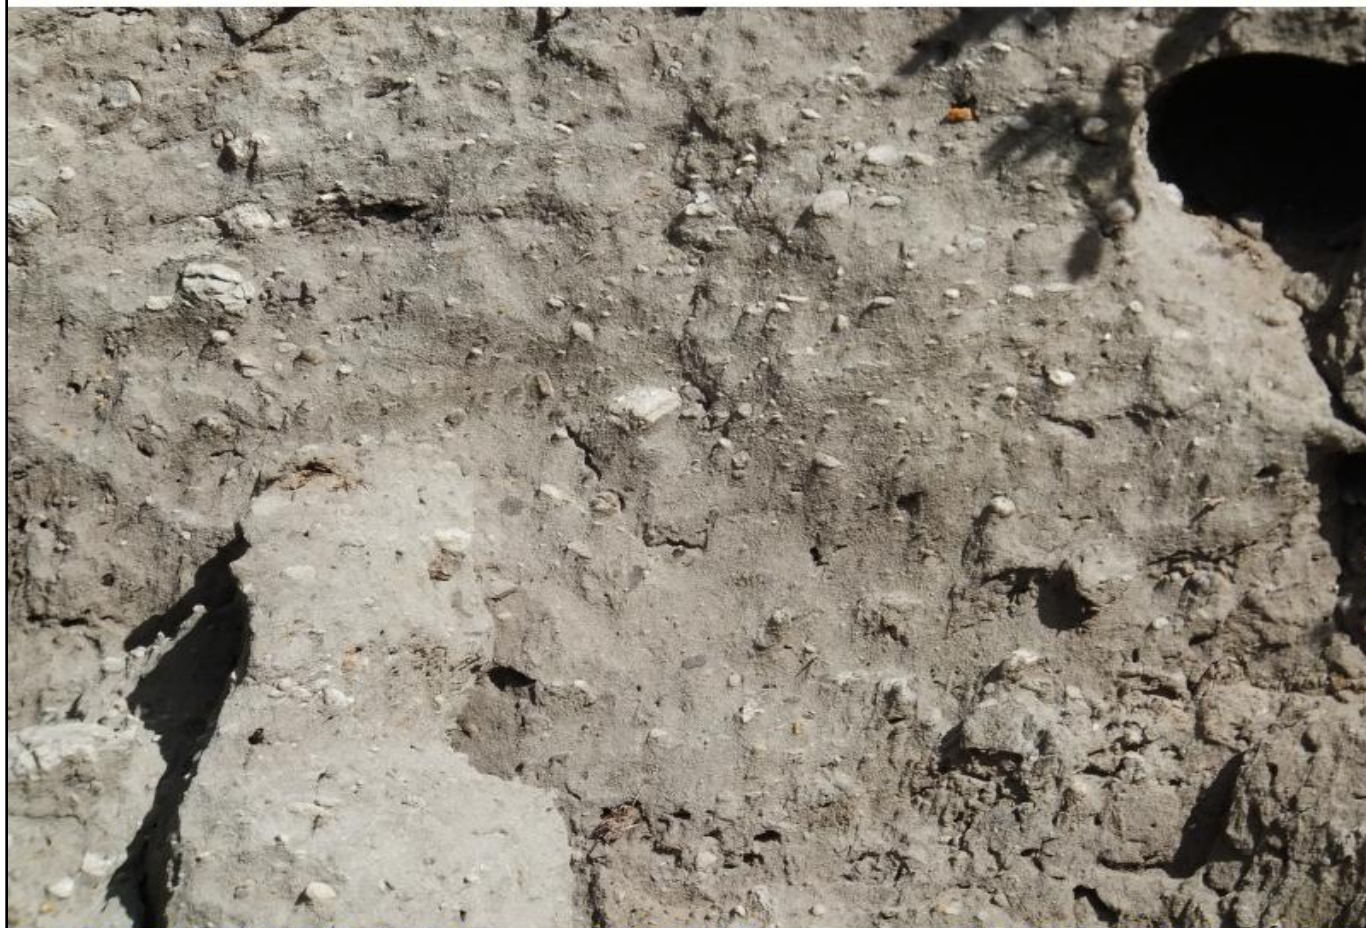
Title	Sandriver Middle Reaches
Comment	This is a view of the cut of the same berm but further upstream providing a closeup view of the top overburden.
Latitude	S 34.1550°
Longitude	E 24.8102°
Elevation	21 m
Photo Direction	183° S
Date Time Stamp	02/11/2011 16:15:20
File Name	DSCF0020.JPG

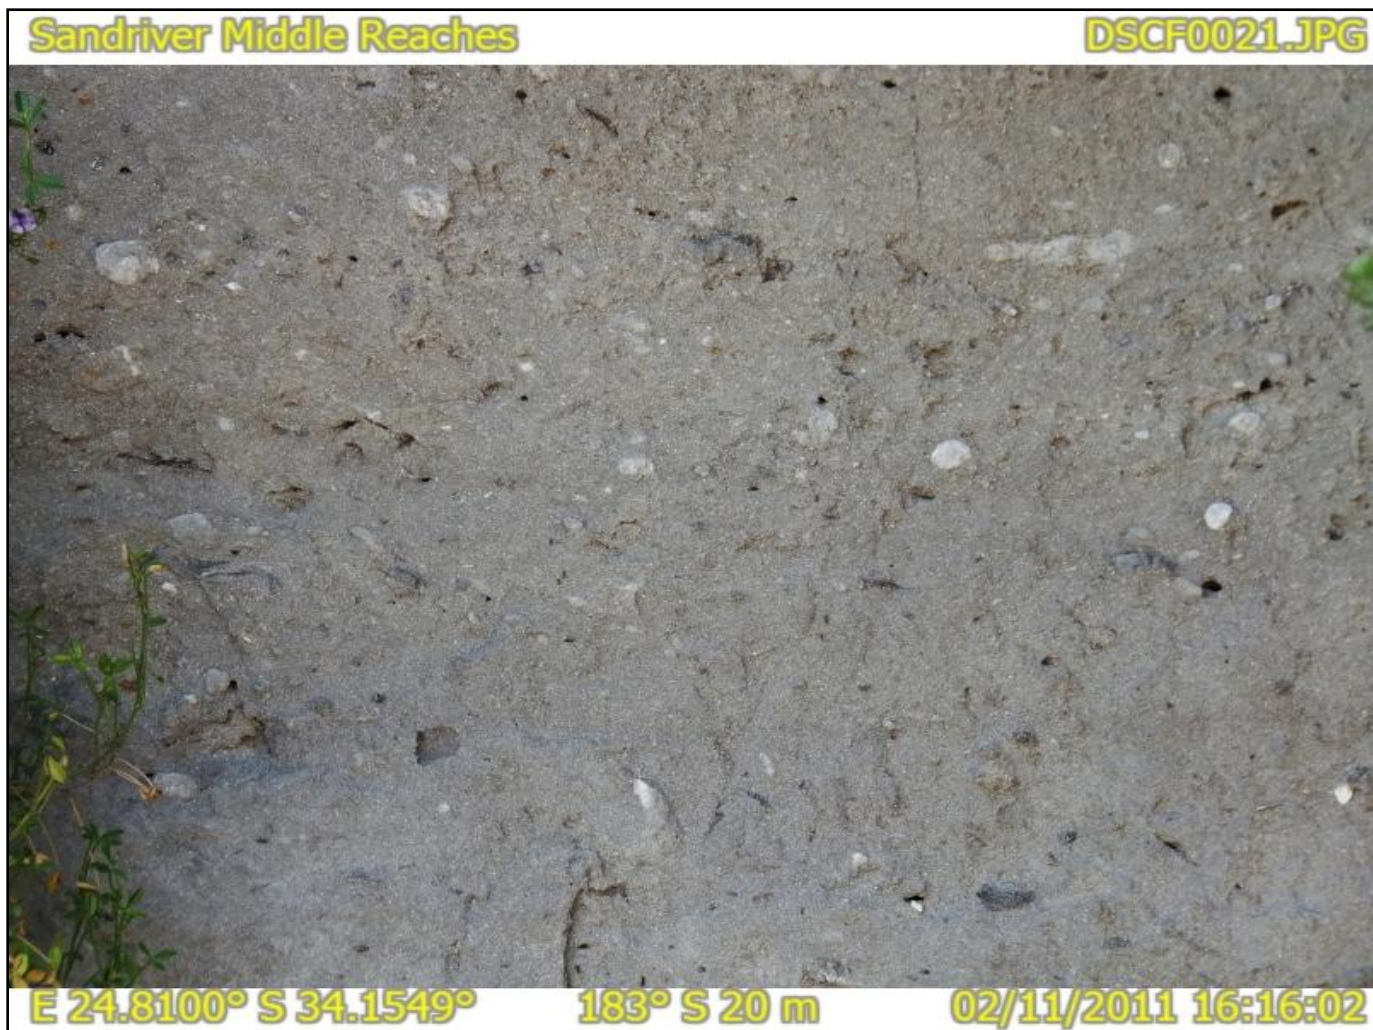
<b>Attributes</b>	
Title	Sandriver Middle Reaches
Comment	A further cut 18m upstream of the same berm a closeup being a closeup view of the exposed section.
Latitude	S 34.1549°
Longitude	E 24.8100°
Elevation	20 m
Photo Direction	183° S
Date Time Stamp	02/11/2011 16:16:02
File Name	DSCF0021.JPG

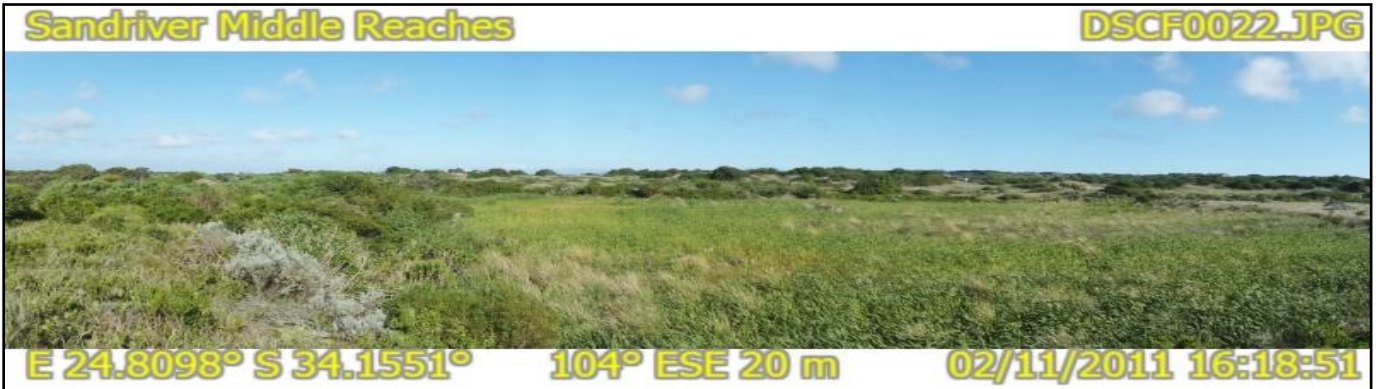
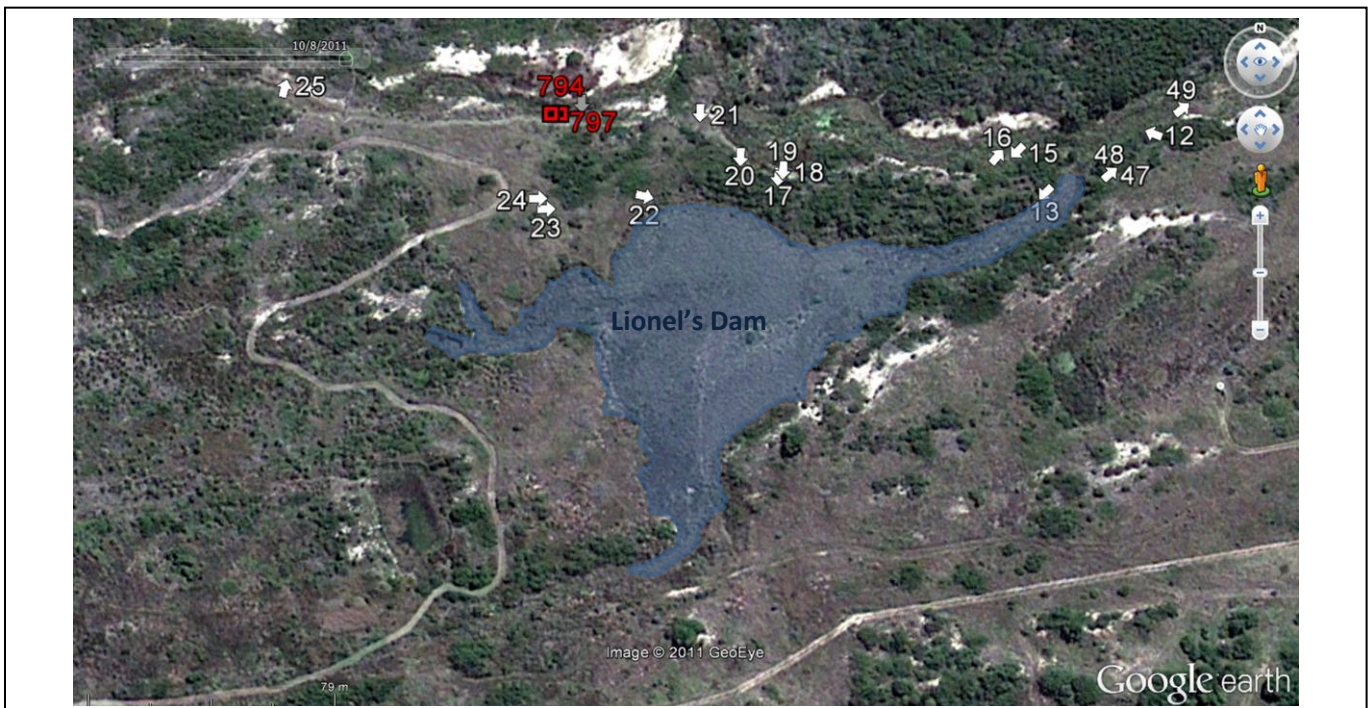
Attributes	
Title	Sandriver Middle Reaches
Comment	A 120 degree panoramic view of 'Lionel's Dam' with the north berm on the left of the slide. This berm was constructed with a TLB and excavator and materials were dumped on top of the area separating the dam from the Sandriver to protect the dam area from the Sandriver. (M. Donnelly pers comm) The sections shown on the previous slides 17 to 21 are a result of erosion cuts on along this area as a result of periodic flooding along the Sandriver on the northern face of this berm. As this dam represents an area of approx 1HA excavated to a depth of 3 to 4m it is logical that the north wall would have to be built up to withstand any intrusion of the main channel of the Sandriver. The above Google image gives the location of the dam area.
Latitude	S 34.1551°
Longitude	E 24.8098°
Elevation	20 m
Photo Direction	104° ESE
Date Time Stamp	02/11/2011 16:18:51

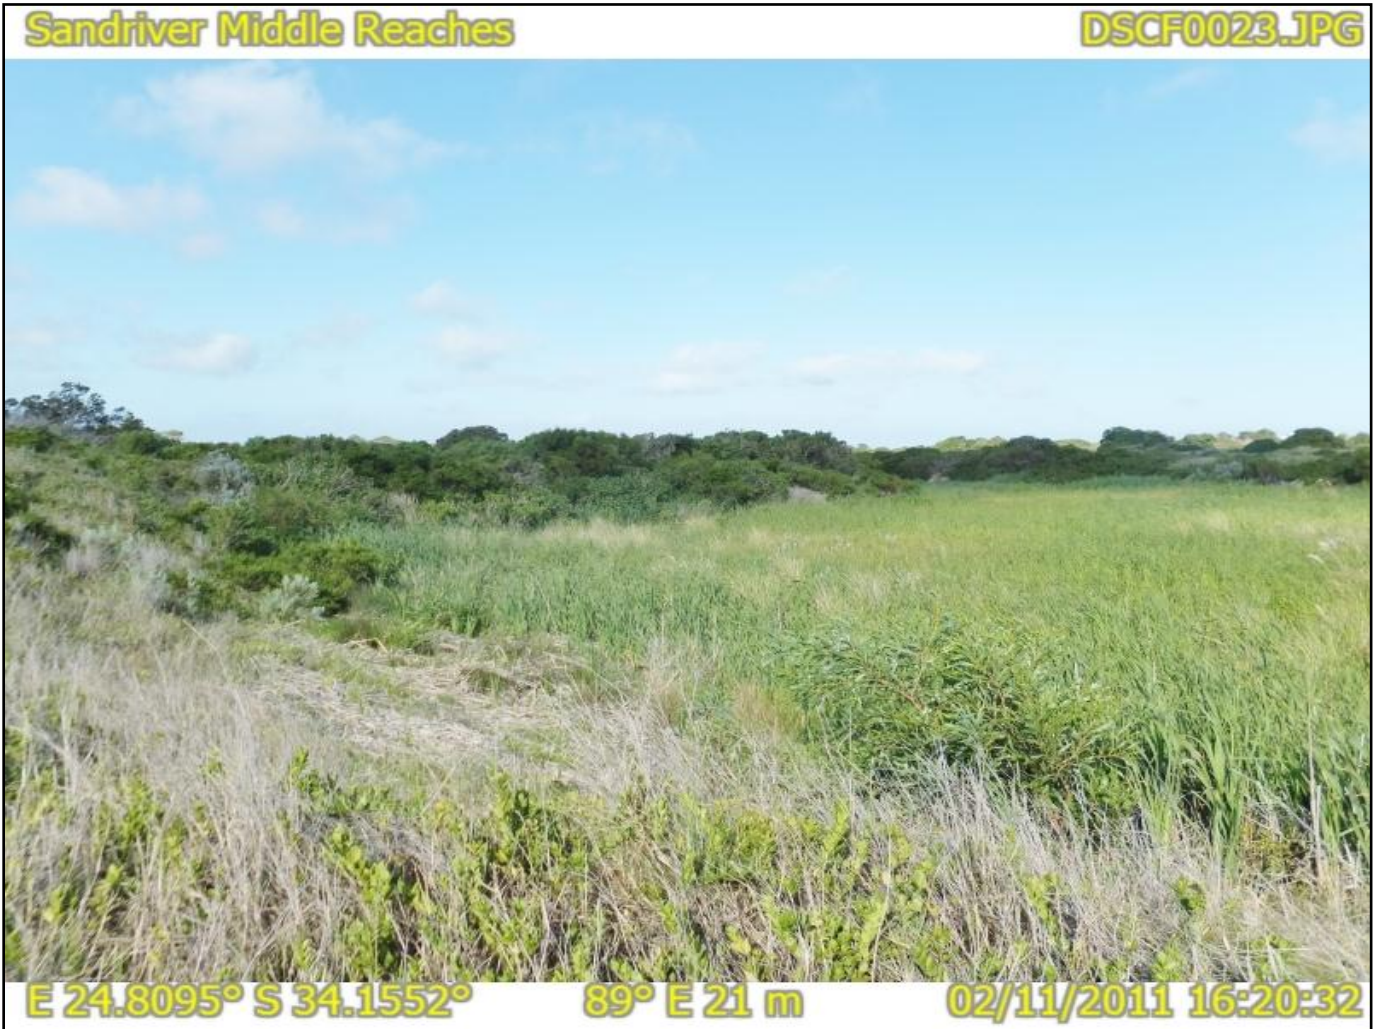
Attributes	
Title	Sandriver Middle Reaches
Comment	A closeup view of the north dam berm / wall. The slope is consistent of an angle which would allow heavy machinery to move materials from the base of the dam to the top of the north berm.
Latitude	S 34.1552°
Longitude	E 24.8095°
Elevation	21 m
Photo Direction	89° E
Date Time Stamp	02/11/2011 16:20:32
File Name	DSCF0023.JPG

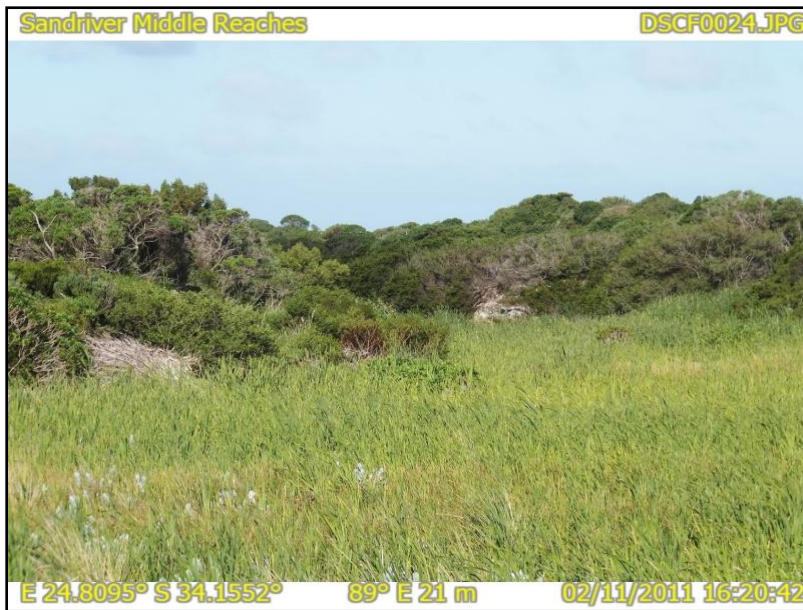
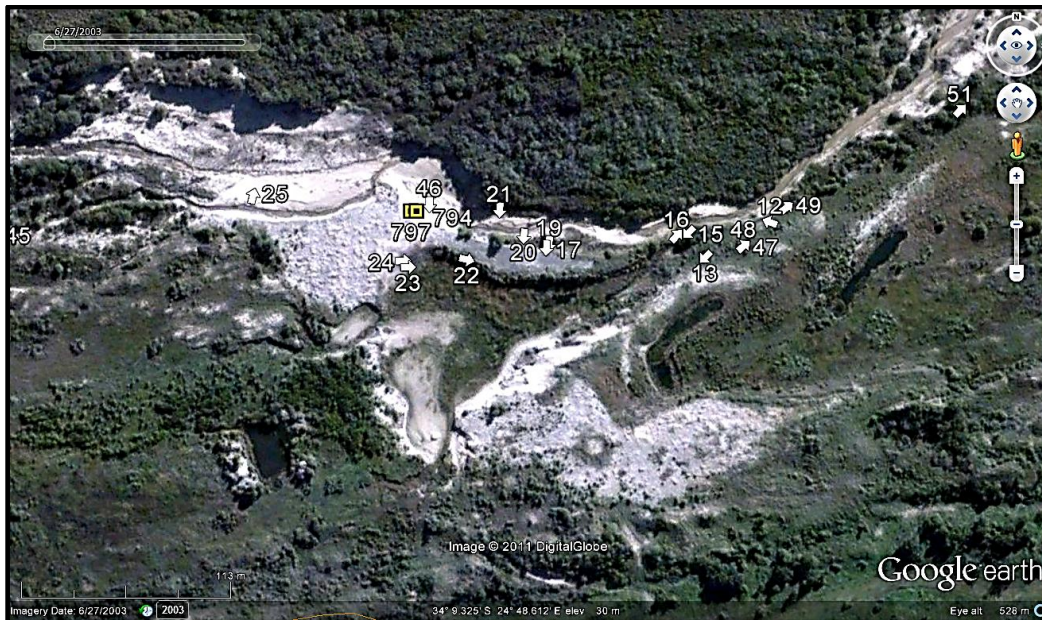
Attributes	
Title	Sandriver Middle Reaches
Comment	Slide 24 is a close up view of the breached portion of 'Lionel's Dam'. The Google imagery date is 2003 and the area surrounding the dam area is still devoid of vegetation providing evidence that earth moving activities were conducted over the area of the section slides shown previously. It is probable that this breach occurred at the intersection of excavated material and natural sand dune as shown in Slides 15 and 16 which would have been a 'weak point' in the dam wall. The breach would have occurred soon after a rain event which would have filled the dam and 'topped' the lowest point in the wall and emptied into the Sandriver. This phenomenon of dune topping is common within the dune bypass system when dune bays fill up and overflow taking the sand materials downstream.
Latitude	S 34.1552°
Longitude	E 24.8095°
Elevation	21 m
Photo Direction	89° E

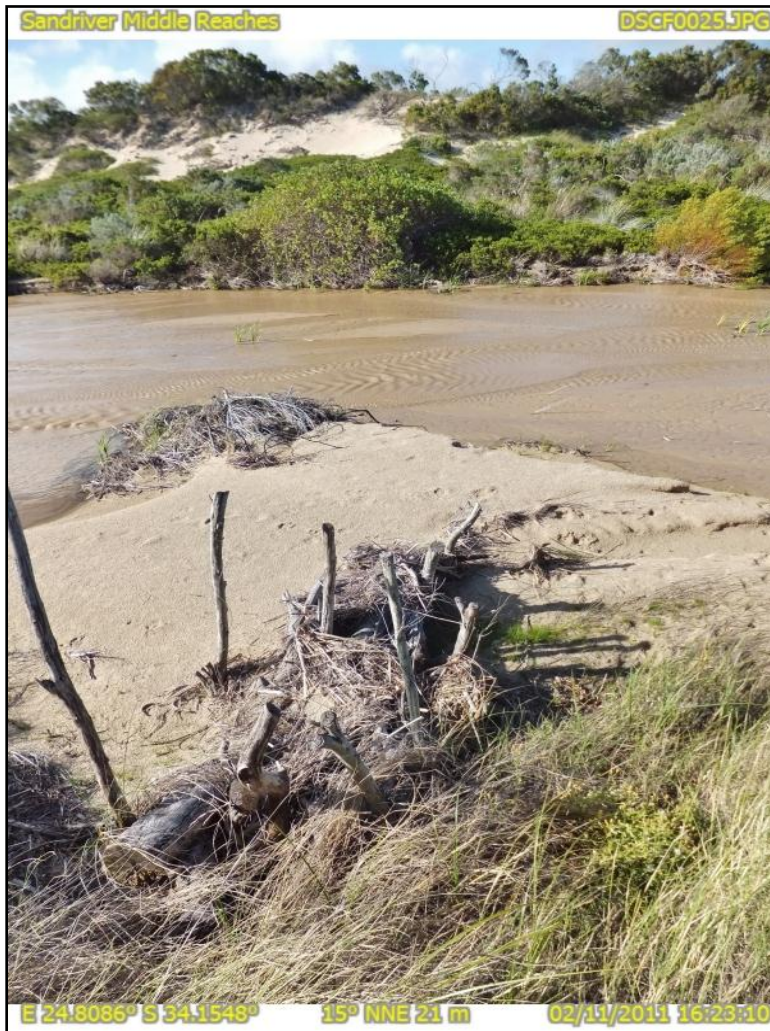
Attributes	
Title	Sandriver Middle Reaches
Comment	What remains of a timber structure set up post the 2006/7 floods to slow down the head cut which was endangering the wetland area further upstream. The force of the 2011 floods has removed the main portion of this structure.
Latitude	S 34.1548°
Longitude	E 24.8086°
Elevation	21 m
Photo Direction	15° NNE
Date Time Stamp	02/11/2011 16:23:10
File Name	DSCF0025.JPG

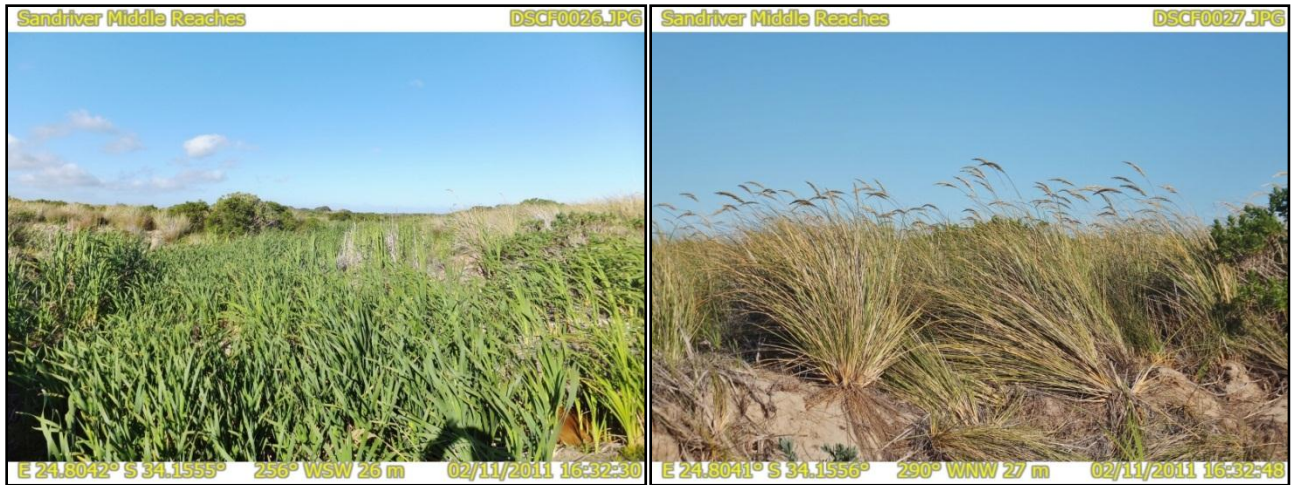
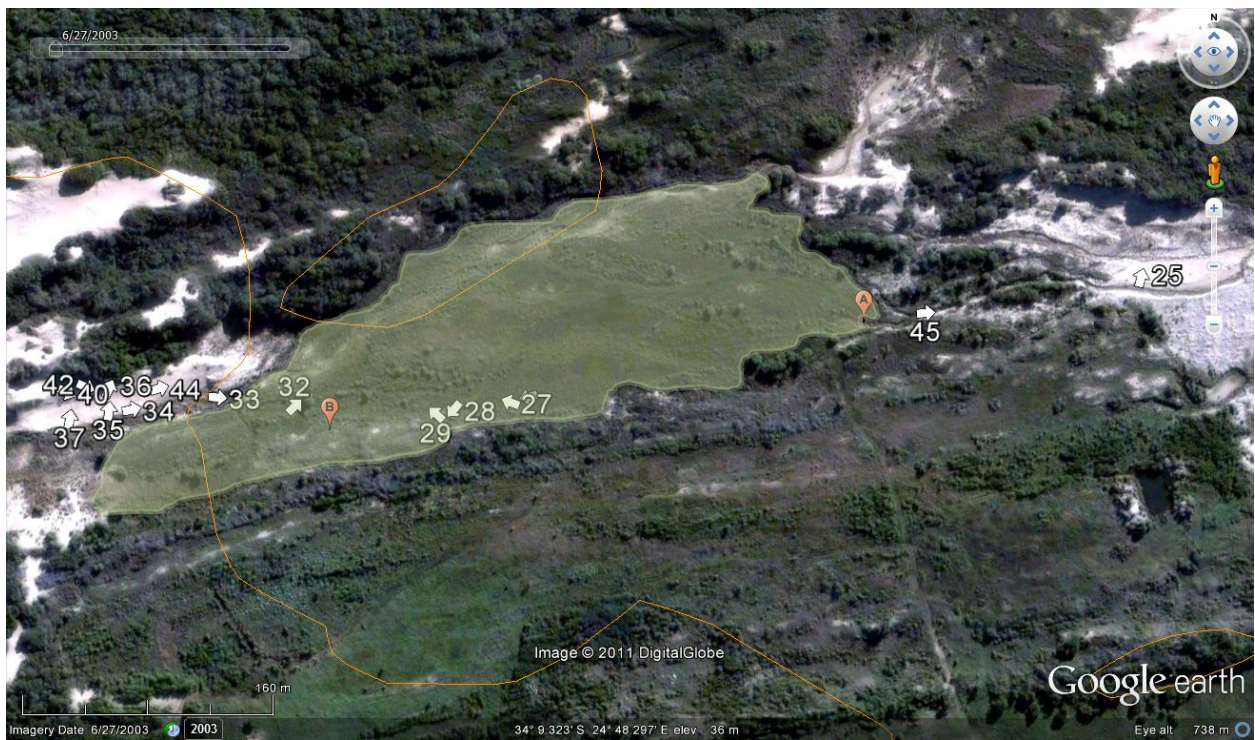
Title	Wetland area slides 26 & 27
Comment	Slide 26 shows a view up what was the original main course of the Sandriver. The 2006/7 floods caused a head cut to form at point A and the consequent 2011 floods the head cut has migrated upriver to point B. This area is of environmental significance as an endemic population of <i>Merxmuellera cincta</i> (Nees) Conert subsp. <i>cincta</i> (Slide 27 above), a Red Data species is now threatened due to the head cut which is draining the wetland area shaded green on the above 2003 Google image. There is also evidence of peat deposits and this area and a rare species of Sand Toad known to frequent this area.
Latitude	S 34.1555°
Longitude	E 24.8042°
Elevation	26 m
Photo Direction	256° WSW
Date Time Stamp	02/11/2011 16:32:30
File Name	DSCF0026.JPG

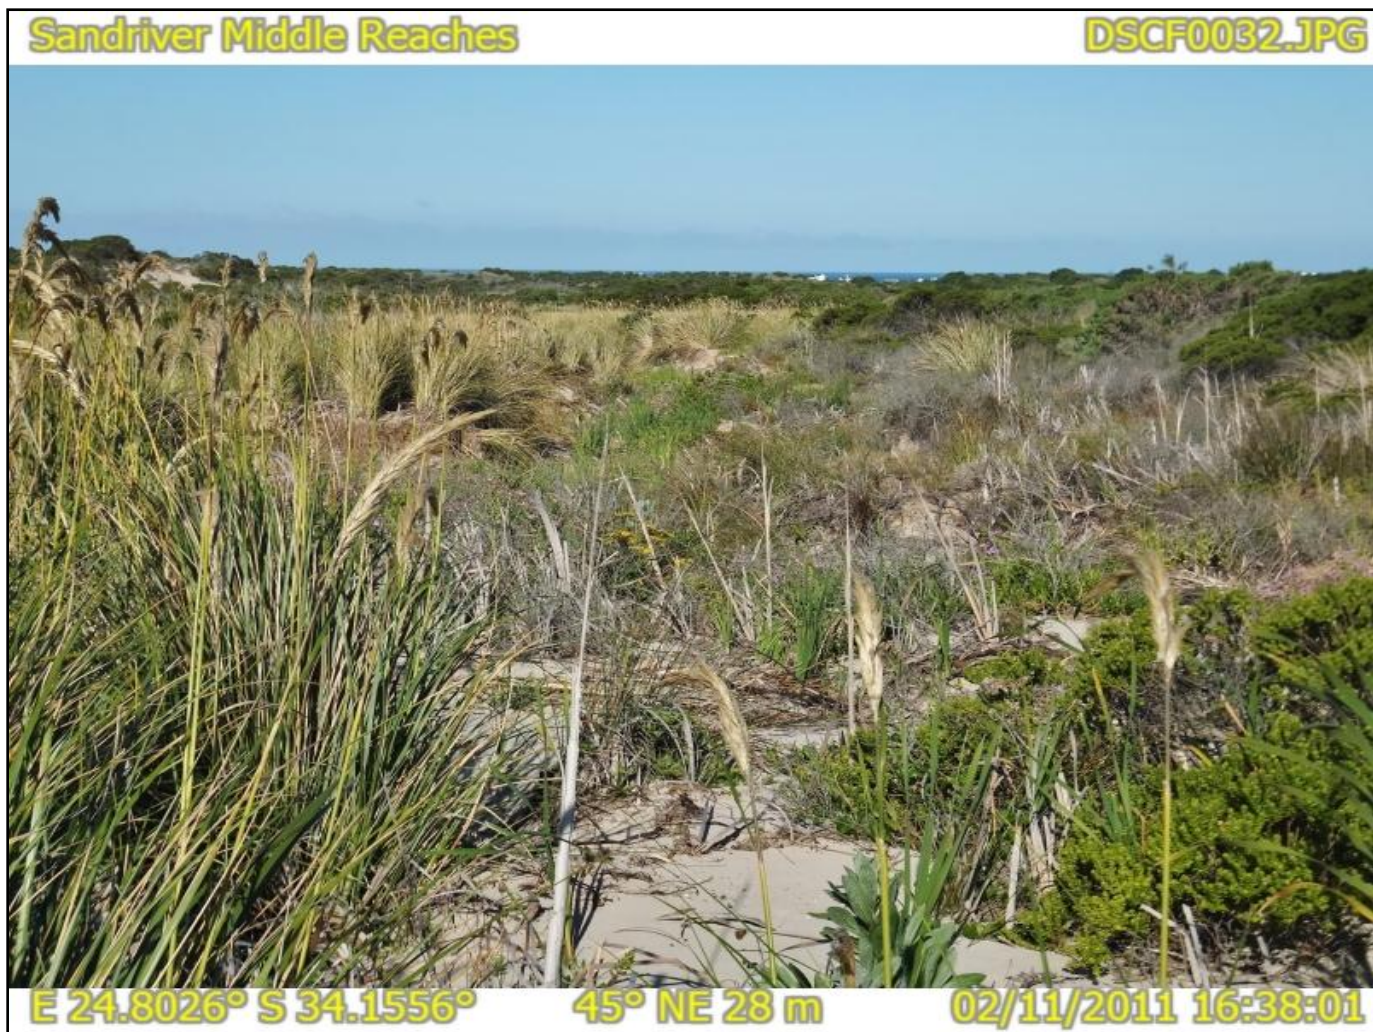
Attributes	
Title	Sandriver Middle Reaches
Comment	A view downstream showing the upper reaches of the head cut which is now filled in with windblown sand. This channel is now blocked and the Sandriver has moved to the north away from this area.
Latitude	S 34.1556°
Longitude	E 24.8026°
Elevation	28 m
Photo Direction	45° NE
Date Time Stamp	02/11/2011 16:38:01
File Name	DSCF0032.JPG
