**Infinity Consulting**  
**Sandriver Middle Reaches**

**General Geological and Environmental  
Observations.**  
**Compiled by Frank Silberbauer**  
**November 2011**

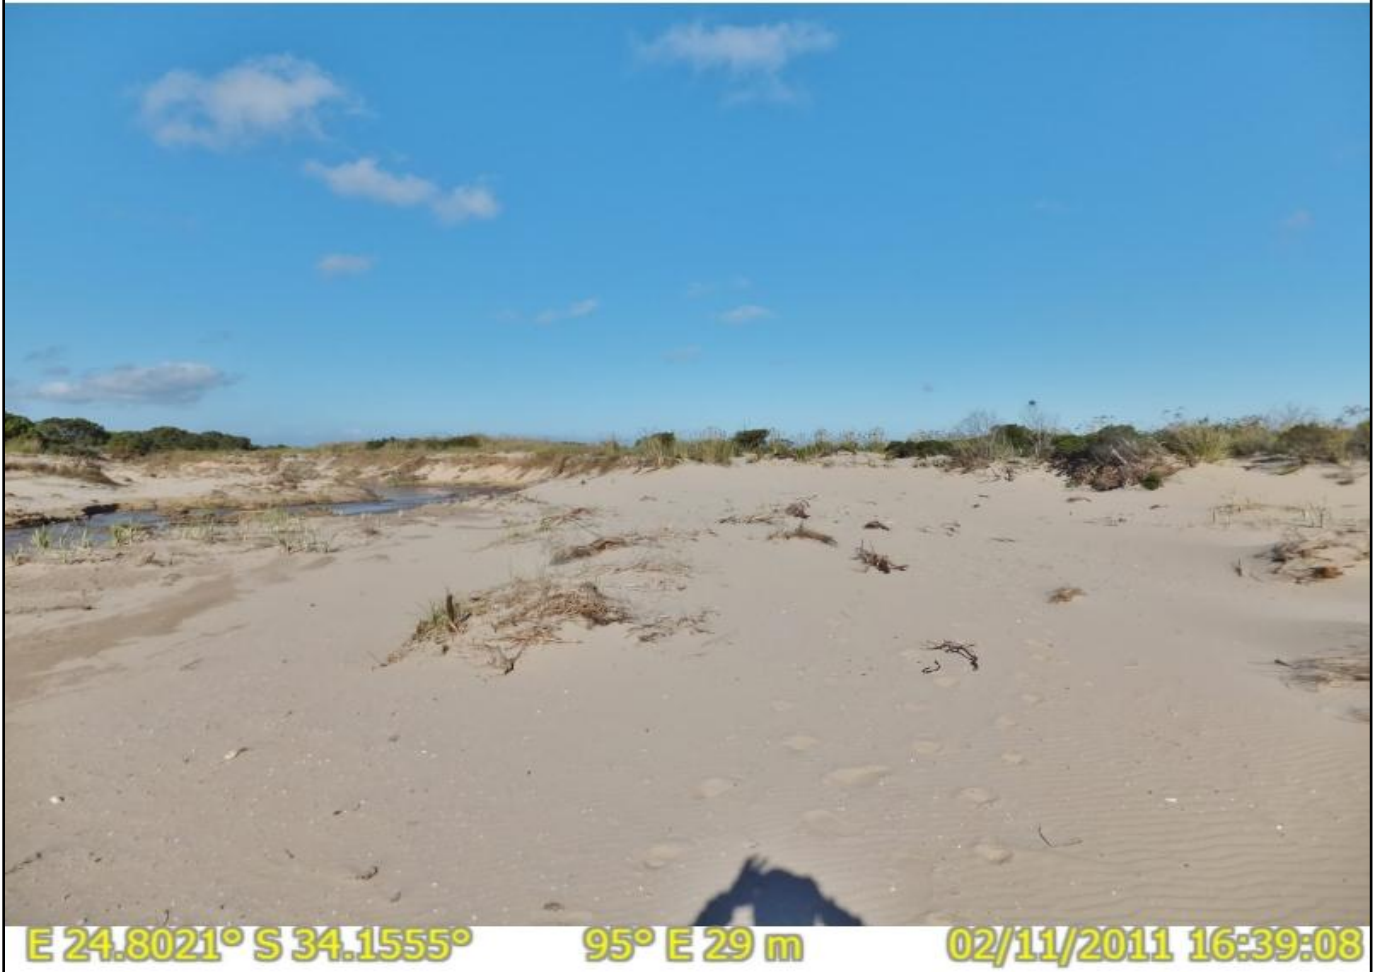
Attributes	
Title	Sandriver Middle Reaches
Comment	The build up of sand as a result of the wind has closed off the previous 'Old' flow channel the flow channel has now moved to the left around the wetland area.
Latitude	S 34.1555°
Longitude	E 24.8021°
Elevation	29 m
Photo Direction	95° E
Date Time Stamp	02/11/2011 16:39:08
File Name	DSCF0033.JPG

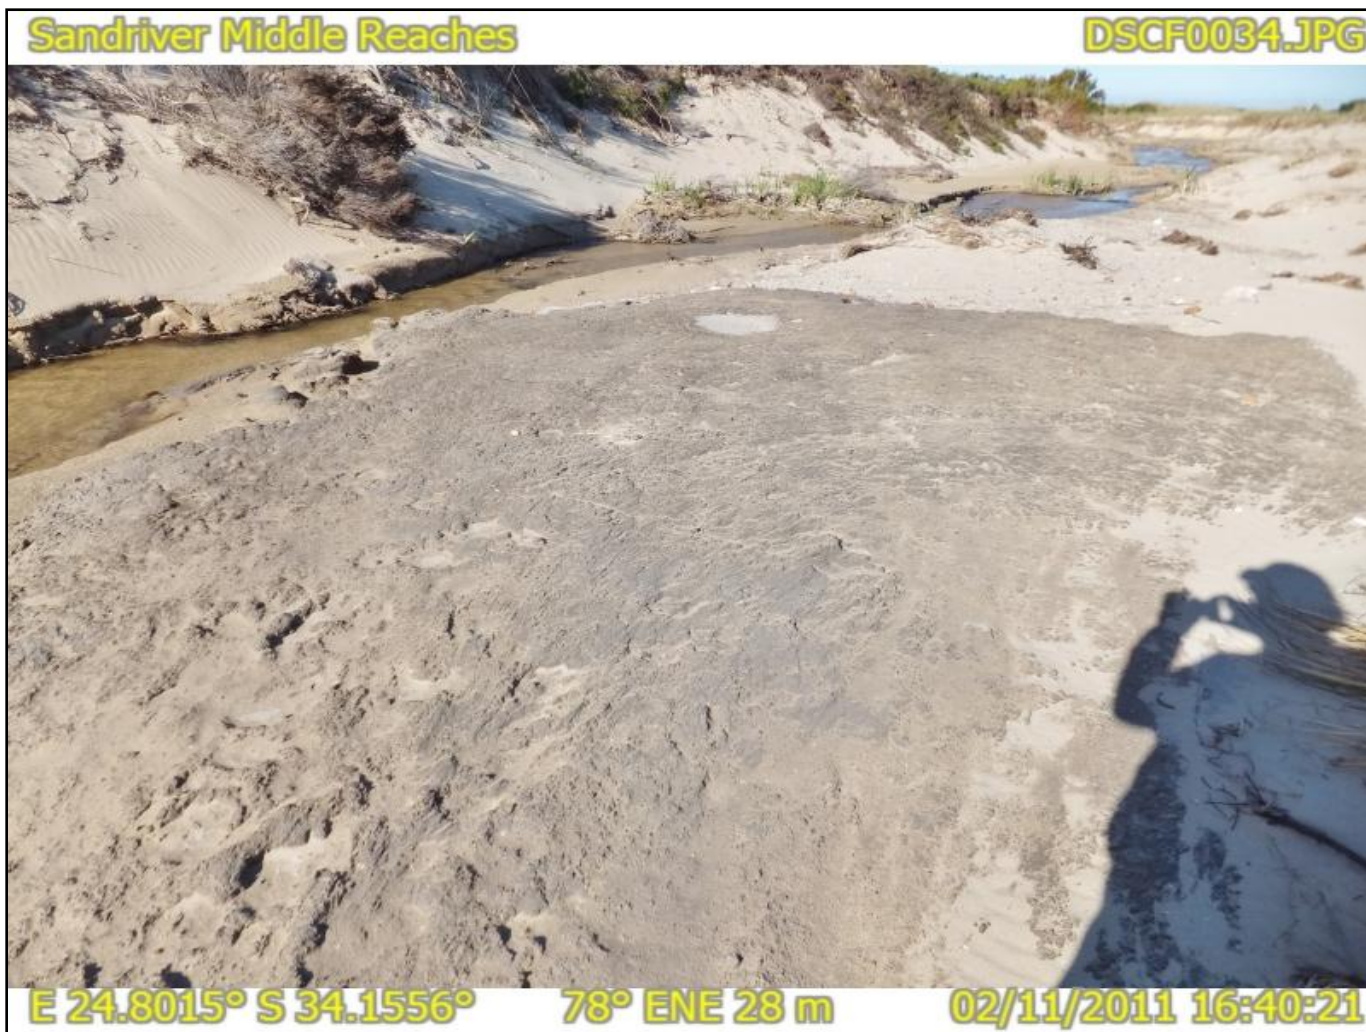
<b>Attributes</b>	
Title	Sandriver Middle Reaches
Comment	A view of a Pleistocene land surface which has been exposed by the shifting of the flow channel of the Sandriver in this area.
Latitude	S 34.1556°
Longitude	E 24.8015°
Elevation	28 m
Photo Direction	78° ENE
Date Time Stamp	02/11/2011 16:40:21
File Name	DSCF0034.JPG

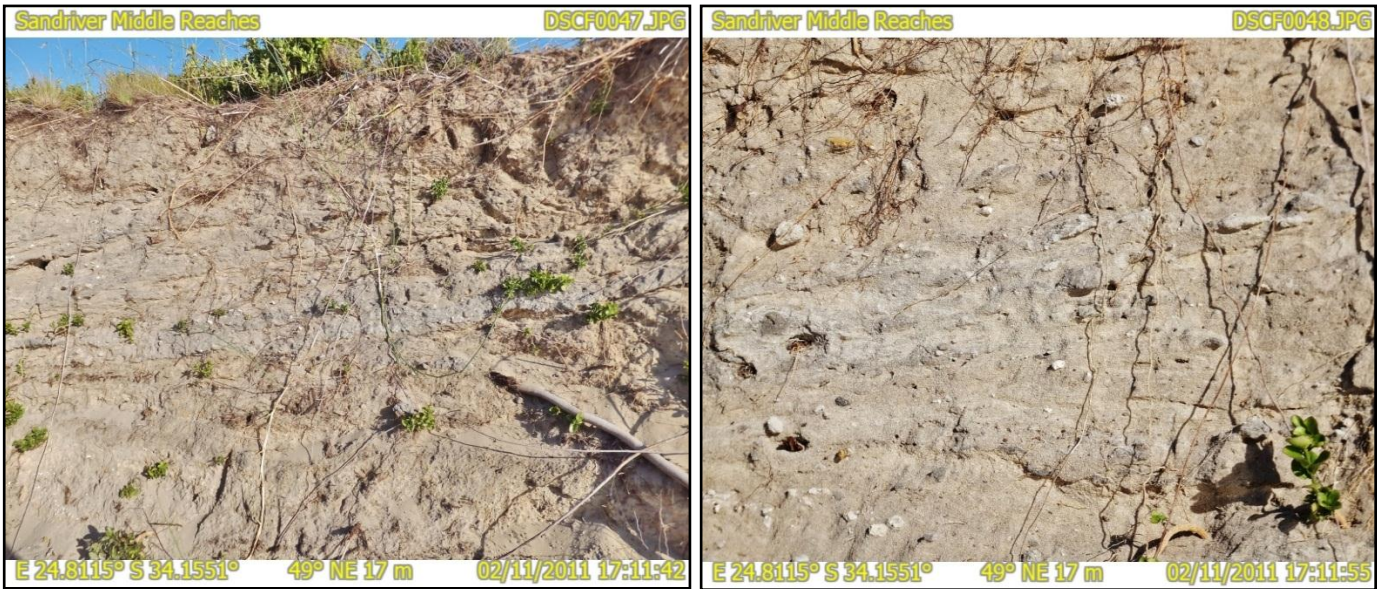
Attributes	
Title	Sandriver Middle Reaches
Comment	A further view of the sediments revealed in a cut on the south bank of the main flow channel. This location is situated 40m downstream of the confluence of the Breach and the main flow channel. Slide 48 shows a close up of the same.
Altitude	S 34.1551°
Longitude	E 24.8115°
Elevation	17 m
Photo Direction	49° NE
Date Time Stamp	02/11/2011 17:11:42
File Name	DSCF0047.JPG & DSCF0048.JPG

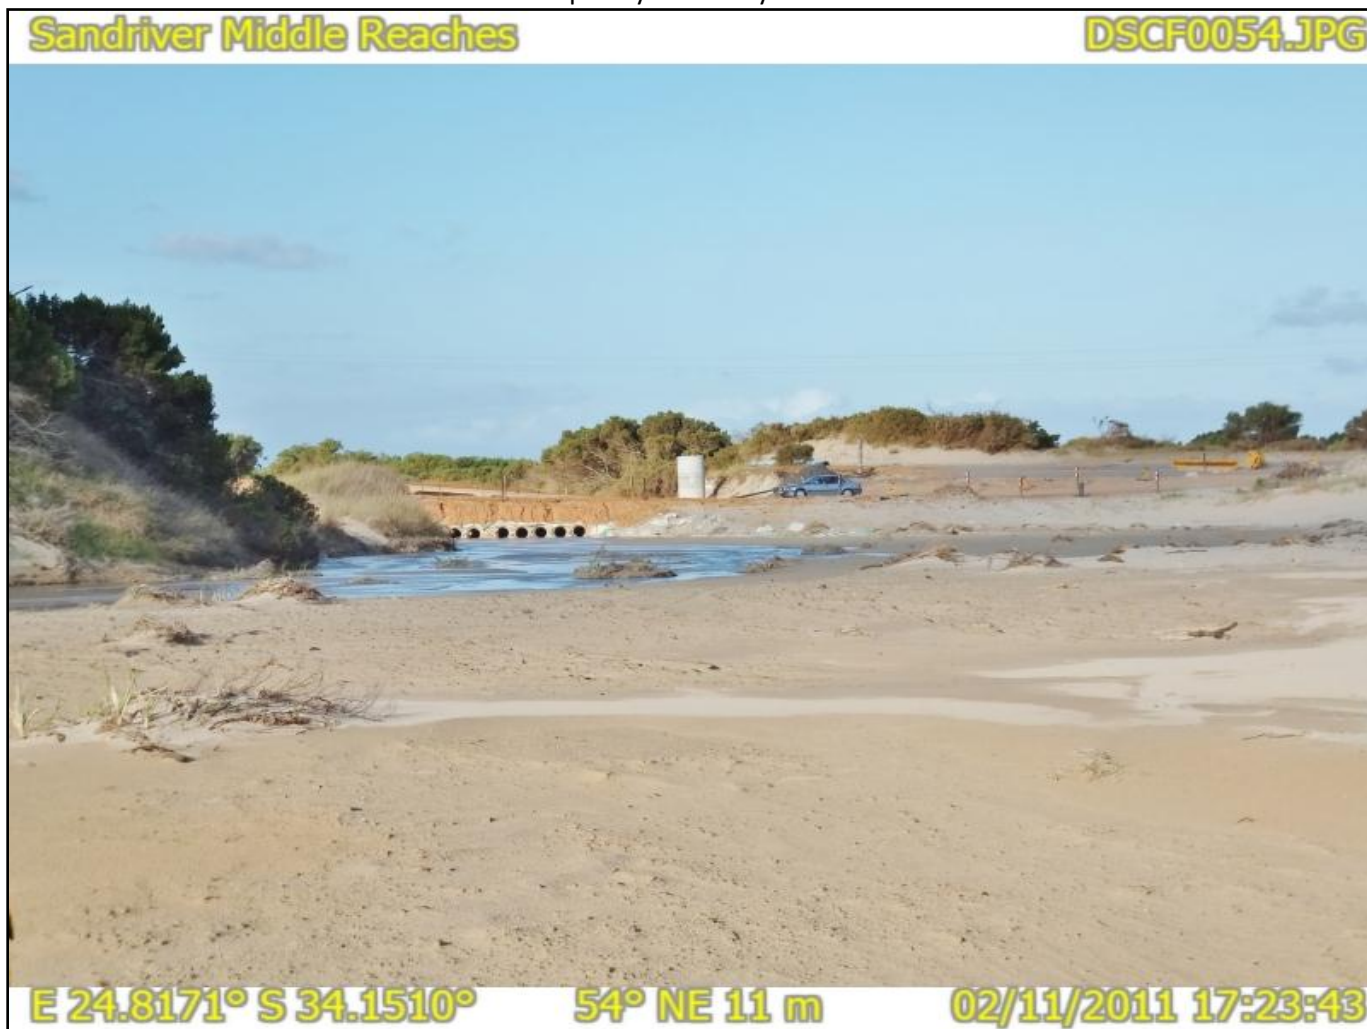
View of the temporary causeway over the Sandriver.

Attributes	
Title	Sandriver Middle Reaches
Comment	View of the temporary causeway over the Sandriver.
Latitude	S 34.1510°
Longitude	E 24.8171°
Elevation	11 m
Photo Direction	54° NE
Date Time Stamp	02/11/2011 17:23:43
File Name	DSCF0054.JPG
