Ref Kendal Power Station AEL (17/4/AEL/MP312/11/15)

**KENDAL POWER STATION'S EMISSIONS REPORT FOR THE MONTH OF OCTOBER 2021.**

# KENDAL POWER STATION MONTHLY EMISSIONS REPORT

Atmospheric Emission License 17/4/AEL/MP312/11/15

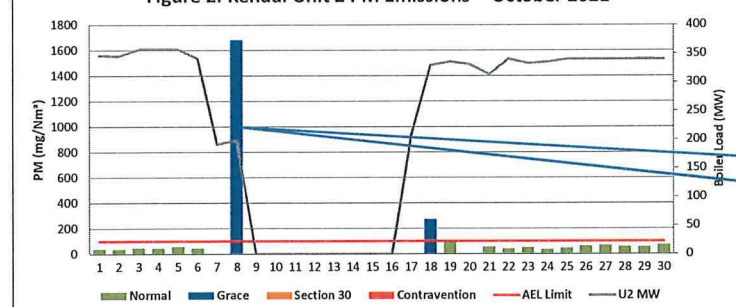
Figure 2: Kendal Unit 2 PM Emissions - October 2021

The high emissions can be attributed to boiler trip, tripping on no steam flow path due to cold reheat non-return valves failing to close.

**Findings** The high emissions can be attributed to boiler trip, tripping on the no steam flow path due to cold reheat non-return valves failing to close.

**Resolution** Cold reheat non-return valves were fixed.

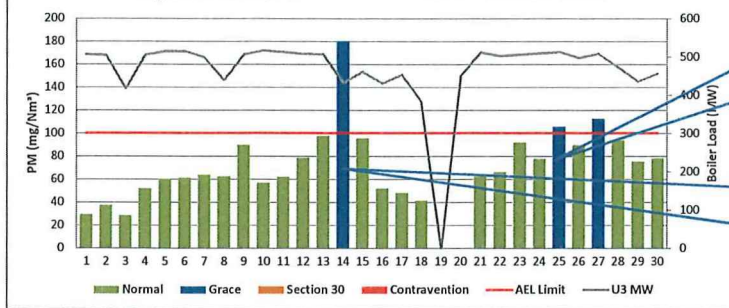
Figure 3: Kendal Unit 3 PM Emissions - October 2021

High PM emissions can be attributed to SO3 that was plant tripping on temperature burner outlet high.

The high PM emissions can be attributed to SO3 plant out of service for google flange and burner outlet temperature high.

**Findings** High PM emissions can be attributed to SO3 was that plant tripping on temperature burner outlet high, SO3 plant out of service for goggle flange and burner outlet temperature high.

**Resolution** The SO3 plant was returned back to service after repairs.

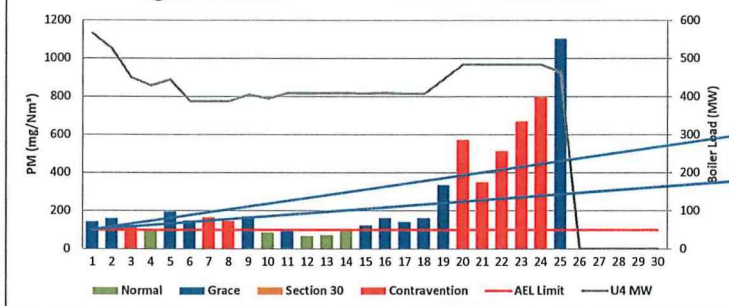
Figure 4: Kendal Unit 4 PM Emissions - October 2021

High PM emissions can be attributed to DHP not in service due to stream 2 bucket elevator chute blocked and high compartment levels high, SO3 plant on hold due steam temperature low, no sulphur flow, precip fields number, 21, 22 & 23 were under voltage, DHP precip conveyor tripped due to compartment levels high. Precip field 35

**Findings** High PM emissions can be attributed to DHP not in service due to stream 2 bucket elevator chute blocked and compartment levels high, SO3 plant on hold due to steam temperature low, no sulphur flow, precip fields number 21, 22 & 23 were under voltage, DHP precip conveyor tripped due to compartment levels high. Precip field 35 tripping on relay fault.

**Resolution** The unit was shut-down for repairs.

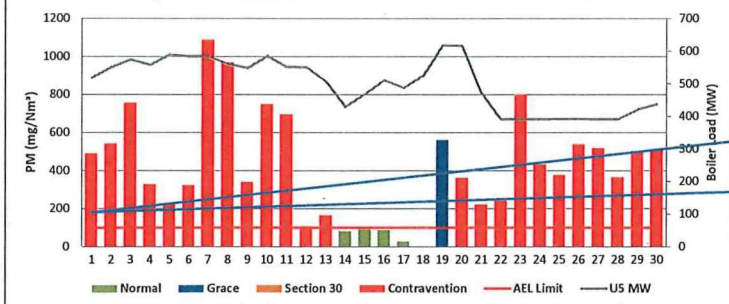
Figure 5: Kendal Unit 5 PM Emissions - October 2021

High PM emissions can be attributed to damaged Precip inlet ducts screens affecting flue gas flow distribution into the Precip casing.  
- Dust Handling Plant poor availability that occurred in the past causing damages to precip hopper baffle plates resulting into dust particles re-entrainment back into the flue gas flow stream towards smokestack chimney

**Findings** High PM emissions can be attributed to damaged Precip inlet ducts screens affecting flue gas flow distribution into the Precip casing. Dust Handling Plant poor availability that occurred in the past causing damages to precip hopper baffle plates resulting into dust particles re-entrainment back into the flue gas flow stream towards smokestack chimney.

**Resolution** Opportunity maintenance was done to execute some of the scope.

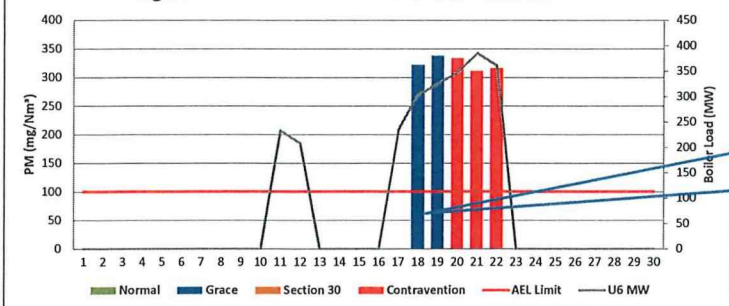
Figure 6: Kendal Unit 6 PM Emissions - October 2021

The high PM emissions can be attributed to DHP tripping due to stream one second collecting conveyor, SO3 plant not in service because of low sulphur flow, second collector conveyor stream 1 trips on overload, primary conveyor 14 choked and tripped due to poor tension. Unit 6 was also on light up conditions. Average emissions value were used for the 17th and 18th due to defective monitor.

**Findings** The high PM emissions can be attributed to DHP tripping due to stream one second collecting conveyor, SO3 plant not in service because of low sulphur flow, second collector conveyor stream 1 trips on overload, primary conveyor 14 choked and tripped due to poor tension. Unit 6 was also on light up conditions. Average emissions value were used for the 17th and 18th due to defective monitor.

**Resolution** DHP plant, SO3 plant and dust monitor were repaired.
