Title: **Matla Power Station Monthly Emissions Report**

Document Identifier: **06C-31482**

### MATLA POWER STATION MONTHLY EMISSIONS REPORT FOR THE MONTH OF OCTOBER 2024

This document serves as the monthly emissions report required in terms of Section 7.6 of Matla Power Station Provisional Atmospheric Emission License (AEL), 17/4/AEL/MP312/11/14

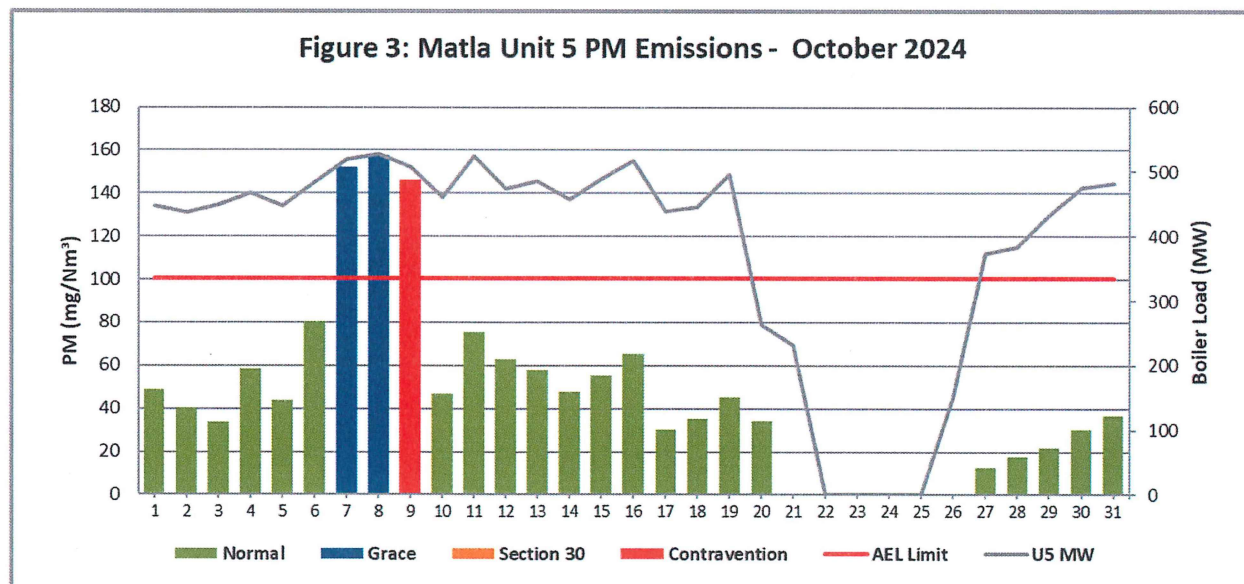
Figure 3: Matla Unit 5 PM Emissions - October 2024

Unit 5 at Matla Power Station incurred PM emissions exceedances which exceeded the 48-hour upset conditions and resulted in a legal contravention against the station's AEL. The Exceedances at unit 5 were due to poorly performing precip fields which started on the 07<sup>th</sup> to the 09<sup>th</sup> of October 2024, where L/H precip field 1 to 4 dropped to below 200 mA for prolonged time. The Dust Handling Plant (DHP) hopper levels accumulation resulting to blockages on the conveying lines which caused L/H Row 2 & 4 to trip. On the 09<sup>th</sup> of October 2024, the hoppers with levels reduced and recovery was demonstrated. The following actions were done to ensure the emissions are within limit:

- Reset and restart the Precips on the (L/H 1 to L/H 4),
- Rapping L/H Precip field 4 and 3
- Clearing of hopper levels with vacuum trucks.

- unblocking the L/H Row 2 and 4.

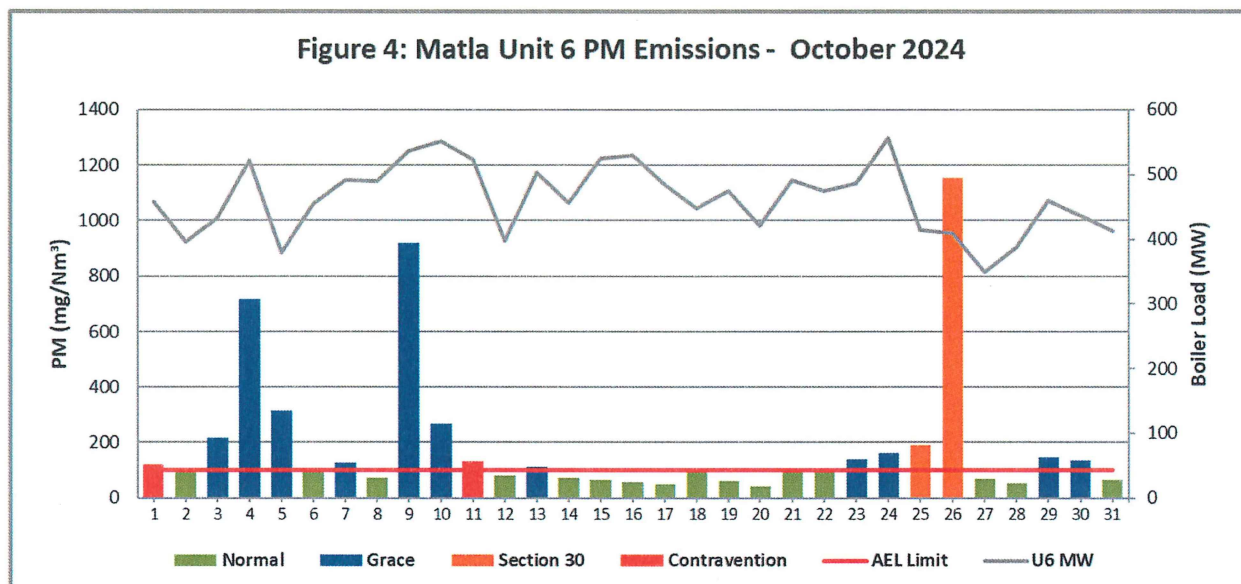
Matla Power Station unit 6 incurred PM emissions exceedances which exceeded the 48-hour upset conditions and resulted in a legal contravention against the station's AEL. The Exceedances were due to unavailability of SO<sub>3</sub> plant.

On the 30 of September 2024 the ESP performance dropped at (04:01) until the 1st of October 2024 at (19:35) the poorly performing on L/H Precip field 1 was poor performing as well as L/H Precip field 2, their milli Amps were trending below 200 mA. The SO<sub>3</sub> plant was out of service on the 30th of September 2024 just after midnight at (03:54), due to burner inspection stub valve failure and malfunctioning of the SO<sub>3</sub> control valve (Air Leak) and the SO<sub>3</sub> plant was back in service at (11:24) on the same day.

On the 09 – 11 October 2024 at (13:11) the SO<sub>3</sub> plant was unavailable, due to burner inspection stub valve failure recurring, however the SO<sub>3</sub> was back in service on the 10 of October at (06:02), resulting to emission exceedance. The following corrective actions were taken:

Matla Power Station unit 6 incurred PM emissions exceedances which exceeded the 48-hour upset conditions and resulted in a Section 30 incident on 25 October 2024. Unit 6 exceeded the AEL limit due to failed rapping system. L/H Precip field 6 and 8 failed causing a partial free flow on Precip path 2,4,6 and 8. This failure was unexpected.

On the 23 October 2024, unit 6 started exceeding due to failed rapping system and high hopper levels. The rapping system was discovered to be defective and almost half of DE rappers were not working on auto. This resulted on poor Precip fields performance.

On the 24 October 2024, L/H Precip field 6 was lost adding to the poor performance of the precip and the unit was not able to recover. Manual rapping was attempted, and it assisted temporarily however emissions continued to be above the limit.

On the 25 October 2024 L/H Precip field 8 failed due to broken insulators which caused a dead short. With 2 Precip fields off following each other there was a partial free flow which resulted on high emissions.

On the 26 October L/H Precip fields Permit to work was taken for open circuit test for L/H Precip field 8. Transformer was tested successfully, and further fault finding was done. Upon inspections of the DE insulators, the insulators were found broken and caused a dead short, this resulted to high Particulate Emissions. The station requires unit 6 outage/ shut down to address the rapping defects, which is planned for November 2024.

- Repair the inspection valve,
- Repaired the air leak on the SO<sub>3</sub> control valve put SO<sub>3</sub> back in service after the leak repairs.
- Reset and re-start (L/H Precip field8)
- Rapping done on L/H Precip field 2, 4 and 6
- Unblocking of the Dust Handling Plant on L/H Row 1 and R/H 2.
