Ref: Kendal Power Station AEL (17/4/AEL/MP312/11/15)

**SUBMISSION OF KENDAL POWER STATION'S EMISSIONS REPORT FOR THE MONTH OF AUGUST 2025.**

# KENDAL POWER STATION MONTHLY EMISSIONS REPORT Atmospheric Emission License: 17/4/AEL/MP312/11/15

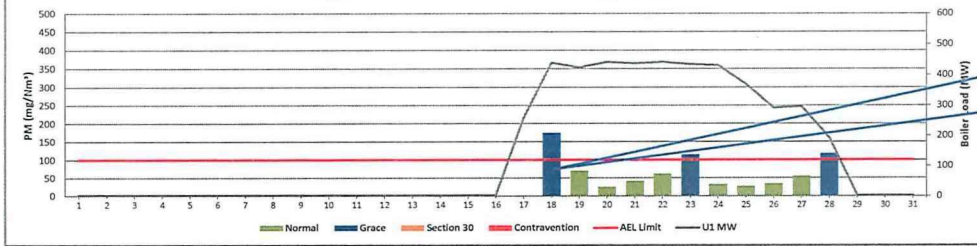
Figure 1: Kendal Unit 1 PM Emissions - August 2025

High PM emissions can be attributed to ash backlogs that affected F11, F21, F31, and F42. Gearbox issues on CE Rapper No. 7 Right Hand (F37/F47) and tripping of CE Rappers on F26 further contributed to the problem. A faulty transformer on F46.

Findings: High PM emissions can be attributed to ash backlogs that affected F11, F21, F31, and F42. Gearbox issues on CE Rapper No. 7 Right Hand (F37/F47) and tripping of CE Rappers on F26 further contributed to the problem. A faulty transformer on F46.

➤ Resolution: Plant repaired.

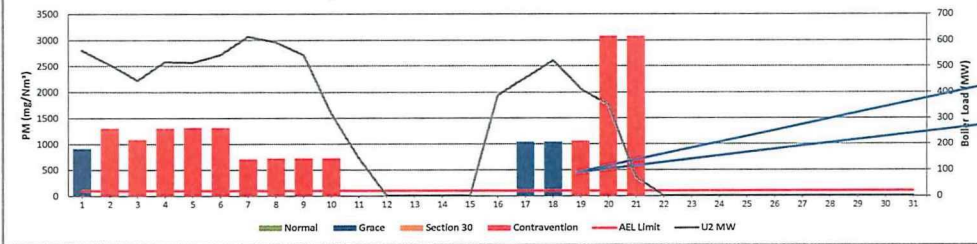
Figure 2: Kendal Unit 2 PM Emissions - August 2025

High PM emissions can be attributed to unreliable DHP system due to vacuum issues, which led to ash backlogs. Faulty controllers on F17 and F36, a malfunctioning CE Rapper motor on F13, and the SO<sub>2</sub> plant failing to operate due to no sulphur flow.

Findings: High PM emissions can be attributed to unreliable DHP system due to vacuum issues, which led to ash backlogs. Faulty controllers on F17 and F36, a malfunctioning CE Rapper motor on F13, and the SO<sub>2</sub> plant failing to operate due to no sulphur flow.

➤ Resolution: Plant repaired.

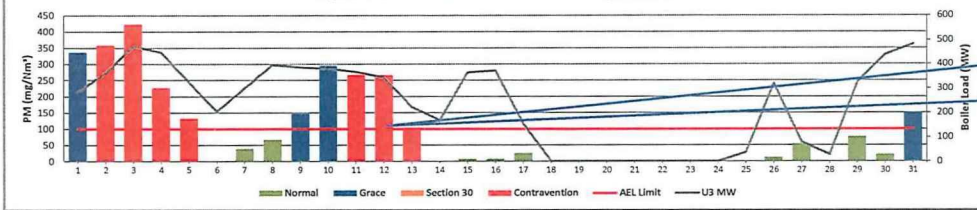
Figure 3: Kendal Unit 3 PM Emissions - August 2025

High PM emissions can be attributed to the sootblowing that was incomplete and the shutdown of PCP11-24 knife gates 1-4. Short circuits on F21 and F41, and an open output condition on F42.

Findings: High PM emissions can be attributed to the soothblowing that was incomplete and the shutdown of PCP11-24 knife gates 1-4. Short circuits on F21 and F41, and an open output condition on F42.

➤ Resolution: Plant repaired.

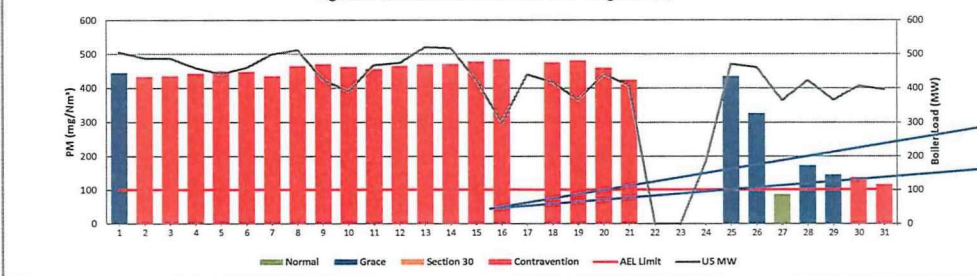
Figure 5: Kendal Unit 5 PM Emissions - August 2025

High PM emissions can be attributed to the SO<sub>2</sub> plant that was on hold mode due to low BET levels, communication bus faults on F13, and ash backlogs with ten fields that was showing internal damage. The DHP remained offline with all knife gates shut, and only four pulse controllers were operational in Stream 1. Signal issues on CE Rapper No. 5 LH.

Findings: High PM emissions can be attributed to the SO<sub>2</sub> plant that was on hold mode due to low BET levels, communication bus faults on F13, and ash backlogs with ten fields that was showing internal damage. The DHP remained offline with all knife gates shut, and only four pulse controllers were operational in Stream 1. Signal issues on CE Rapper No. 5 LH.

➤ Resolution: Plant repaired.

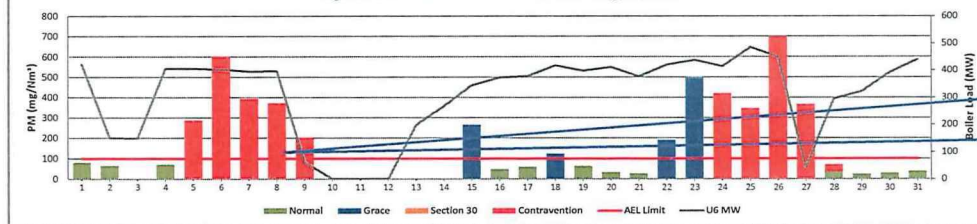
Figure 6: Kendal Unit 6 PM Emissions - August 2025

High PM emissions can be attributed to low high-voltage DC conditions on F37 and F47, with multiple fields (F31-F47) having tripped due to low voltage. Malfunctioning RH CE Rappers 1-4, permanently open circuits on F11 and F21 due to structural damage, ash backlogs, a failed fan on F12, and low coolant levels on F31.

Findings: High PM emissions can be attributed to low high-voltage DC conditions on F37 and F47, with multiple fields (F31-F47) having tripped due to low voltage. Malfunctioning RH CE Rappers 1-4, permanently open circuits on F11 and F21 due to structural damage, ash backlogs, a failed fan on F12, and low coolant levels on F31.

➤ Resolution: Plant repaired.

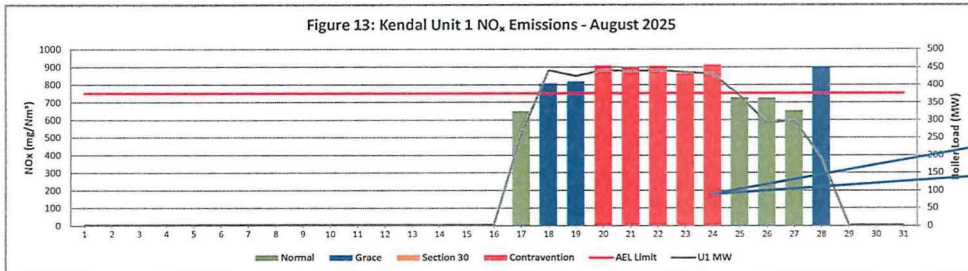
The station's gas monitors appear to be malfunctioning and providing inaccurate readings. Restoration efforts are currently underway, after which a verification process will be conducted to ensure accuracy.

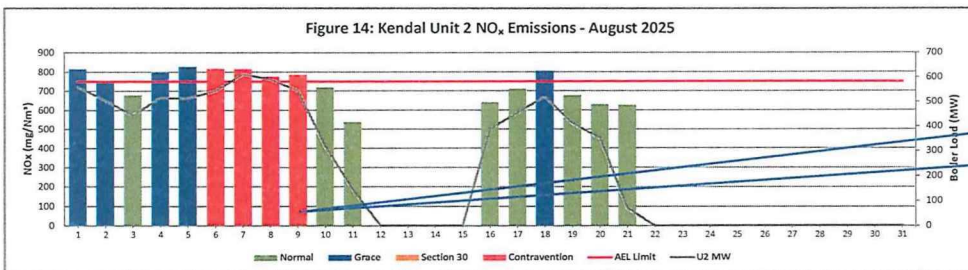
The station's gas monitors appear to be malfunctioning and providing inaccurate readings. Restoration efforts are currently underway, after which a verification process will be conducted to ensure accuracy.

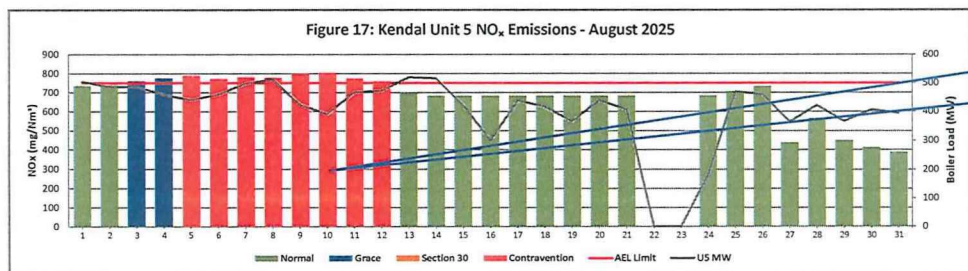
The station's gas monitors appear to be malfunctioning and providing inaccurate readings. Restoration efforts are currently underway, after which a verification process will be conducted to ensure accuracy.

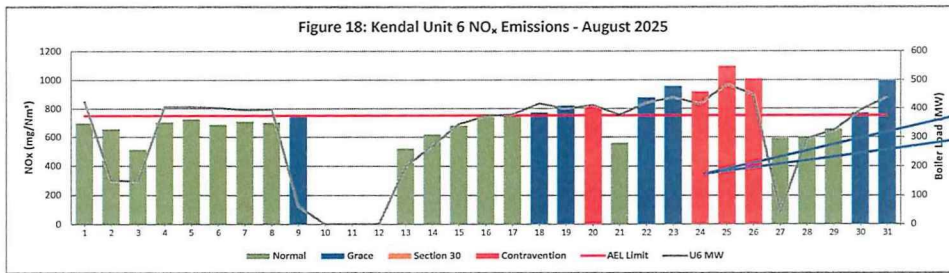
Figure 18: Kendal Unit 6 NO<sub>x</sub> Emissions - August 2025

The station's gas monitors appear to be malfunctioning and providing inaccurate readings. Restoration efforts are currently underway, after which a verification process will be conducted to ensure accuracy.
