Ref: Kendal Power Station AEL (17/4/AEL/MP312/11/15)

SUBMISSION OF KENDAL POWER STATION'S EMISSIONS REPORT FOR THE MONTH OF OCTOBER 2025.

KENDAL POWER STATION'S EMISSIONS REPORT FOR THE MONTH OF OCTOBER 2025

KENDAL POWER STATION MONTHLY EMISSION REPORT

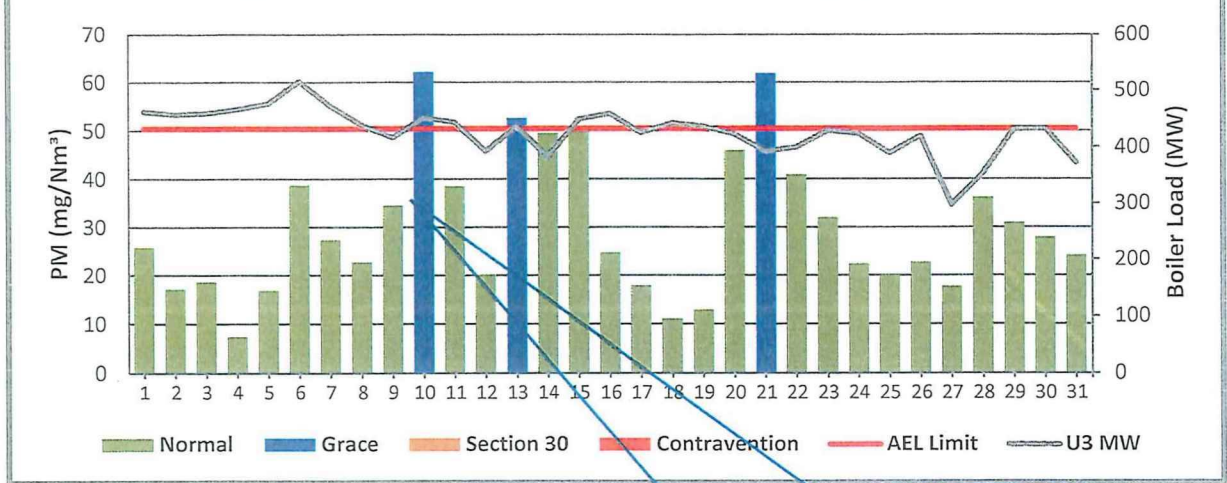
Figure 3: Kendal Unit 3 PM Emissions - October 2025

High particulate matter (PM) emissions resulting in an exceedance of the MES limit of 50 mg/Nm³ on Unit 3 were attributed to Soot blowing that was unavailable due to a faulty cable, and the SO₃ injector lance was found to be leaking. Field 21 experienced repeated trips caused by DC link faults, while Field 22 remained offline due to a faulty fan. In addition, Field 24 encountered a high-voltage fault, with 125A fuses blown.

Findings: High particulate matter (PM) emissions resulting in an exceedance of the MES limit of 50 mg/Nm³ on Unit 3 were attributed to Soot blowing that was unavailable due to a faulty cable, and the SO₃ injector lance was found to be leaking. Field 21 experienced repeated trips caused by DC link faults, while Field 22 remained offline due to a faulty fan. In addition, Field 24 encountered a high-voltage fault, with 125A fuses blown.

Resolution: Plant repaired

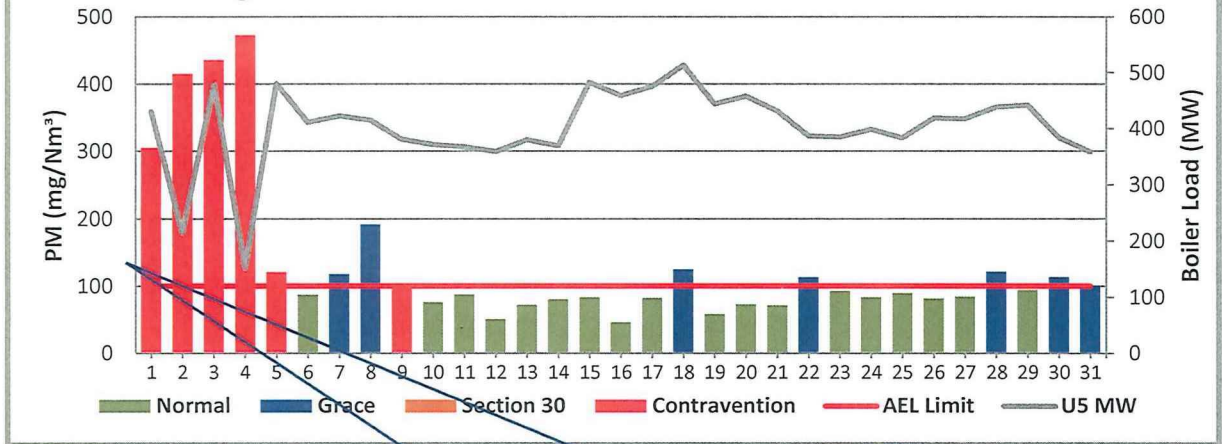
Figure 5: Kendal Unit 5 PM Emissions - October 2025

High particulate matter (PM) emissions resulting in an exceedance of the MES limit of 100 mg/Nm³ on Unit 5 were attributed to structural damage identified on fields F11, F12, F21, and F22. 5A Mill was put in service with unknown defective classifiers, which affected the combustion process and resulted in disturbances in PM emissions. Field 35 operated in local mode due to a communications bus issue, while Fields 43 and 44 were tripping because of high ash backlogs.

Findings: High particulate matter (PM) emissions resulting in an exceedance of the MES limit of 100 mg/Nm³ on Unit 5 were attributed to structural damage identified on fields F11, F12, F21, and F22. 5A Mill was put in service with unknown defective classifiers, which affected the combustion process and resulted in disturbances in PM emissions. Field 35 operated in local mode due to a communications bus issue, while Fields 43 and 44 were tripping because of high ash backlogs.

Resolution: Plant repaired

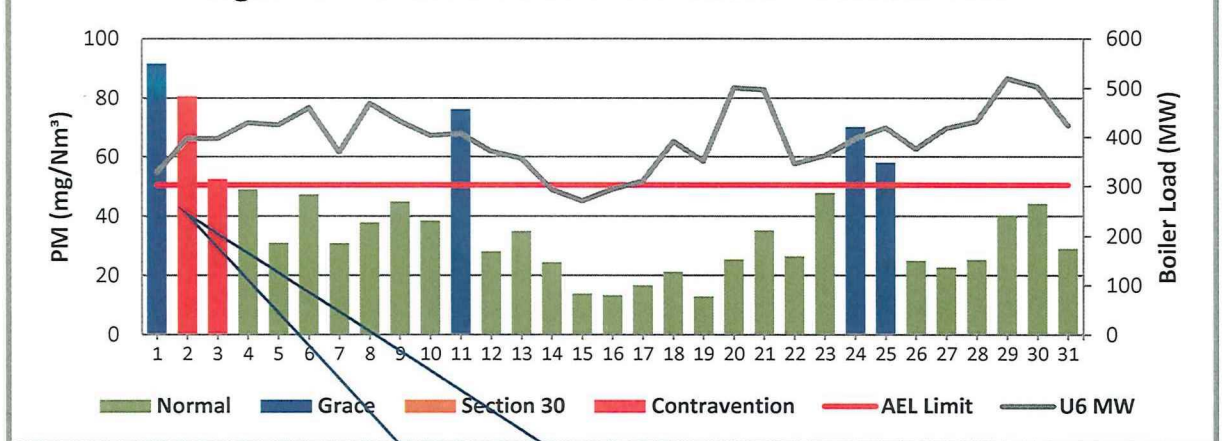
Figure 6: Kendal Unit 6 PM Emissions - October 2025

High particulate matter (PM) emissions resulting in an exceedance of the MES limit of 50 mg/Nm³ in Unit 6 were attributed to electrostatic precipitator (ESP) fields that were experiencing undervoltage faults. Field 11 and 21 were permanently out of commission due to structural damage, affecting 21/26 fields performance. BETs indicated a temperature imbalance at 114°C and 132°C, which affected overall efficiency.

Findings: High particulate matter (PM) emissions resulting in an exceedance of the MES limit of 50 mg/Nm³ in Unit 6 were attributed to electrostatic precipitator (ESP) fields that were experiencing undervoltage faults. Field 11 and 21 were permanently out of commission due to structural damage, affecting 21/26 fields performance. BETs indicated a temperature imbalance at 114°C and 132°C, which affected overall efficiency.

Resolution: Plant repaired
