Ref: Kendal Power Station AEL (17/4/AEL/MP312/11/15)

SUBMISSION OF KENDAL POWER STATION'S EMISSIONS REPORT FOR THE MONTH OF NOVEMBER 2025.

KENDAL POWER STATION MONTHLY EMISSION REPORT

Atmospheric Emission License: 17/4/AEL/MP312/11/15

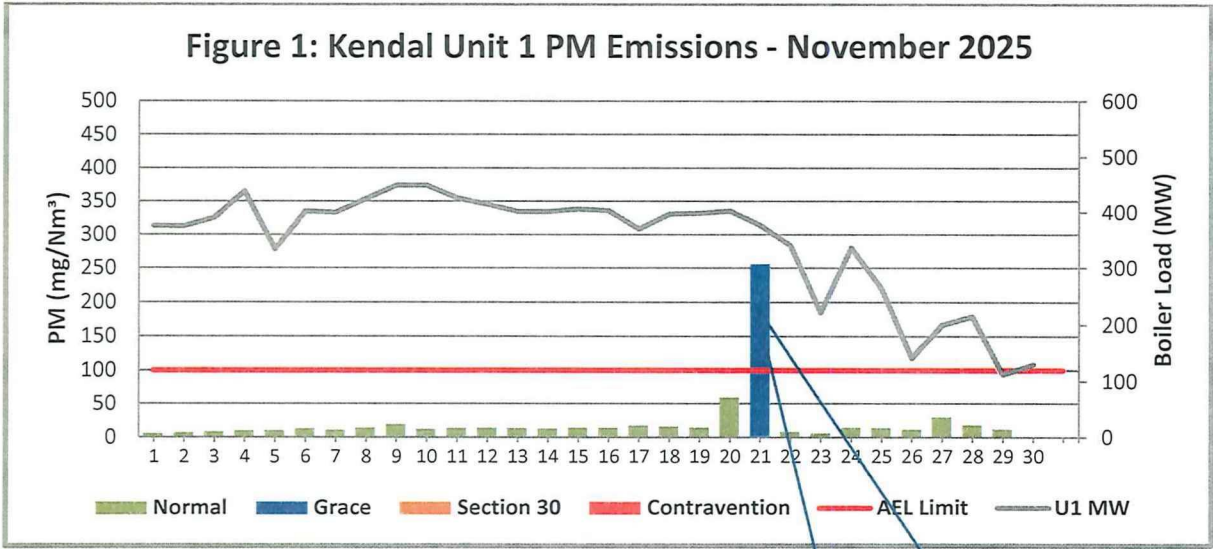
Findings: High particulate matter (PM) emissions, which resulted in an exceedance of the MES limit of 100 mg/Nm³ on Unit 1, were attributed to Monitor measuring path was partially blocked, due to high volumes of dust exposure

Resolution: Plant repaired

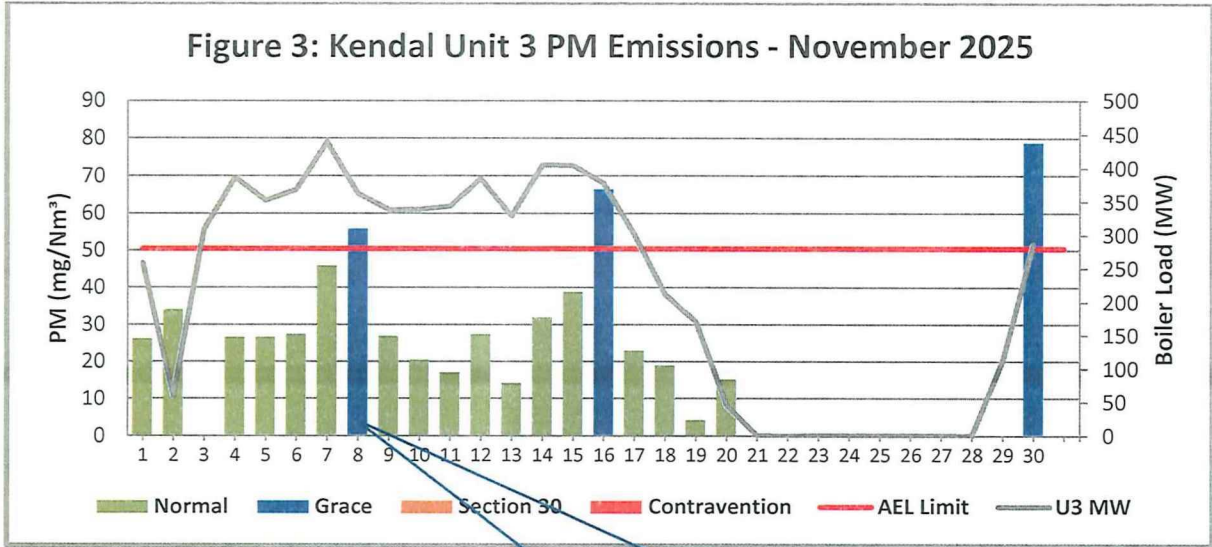
Figure 3: Kendal Unit 3 PM Emissions - November 2025

High particulate matter (PM) emissions, which resulted in an exceedance of the MES limit of 50 mg/Nm³ on Unit 3, were attributed to soot blowing that was unavailable due to a faulty cable, and the SO₂ injector lance which was found to be leaking. Field 21 experienced repeated trips caused by DC link faults, while Field 22 remained offline due to a faulty fan. Field 14 failed to start and tripped on high voltage, and Field 24 encountered a high-voltage fault with 125A fuses blown. Additionally, CE Rapper No. 4 LH was tripping, and CE Rapper No. 1 RH was running on local control.

Findings: High particulate matter (PM) emissions, which resulted in an exceedance of the MES limit of 50 mg/Nm³ on Unit 3, were attributed to soot blowing that was unavailable due to a faulty cable, and the SO₃ injector lance which was found to be leaking. Field 21 experienced repeated trips caused by DC link faults, while Field 22 remained offline due to a faulty fan. Field 14 failed to start and tripped on high voltage, and Field 24 encountered a high-voltage fault with 125A fuses blown. Additionally, CE Rapper No. 4 LH was tripping, and CE Rapper No. 1 RH was running on local control

Resolution: Plant repaired

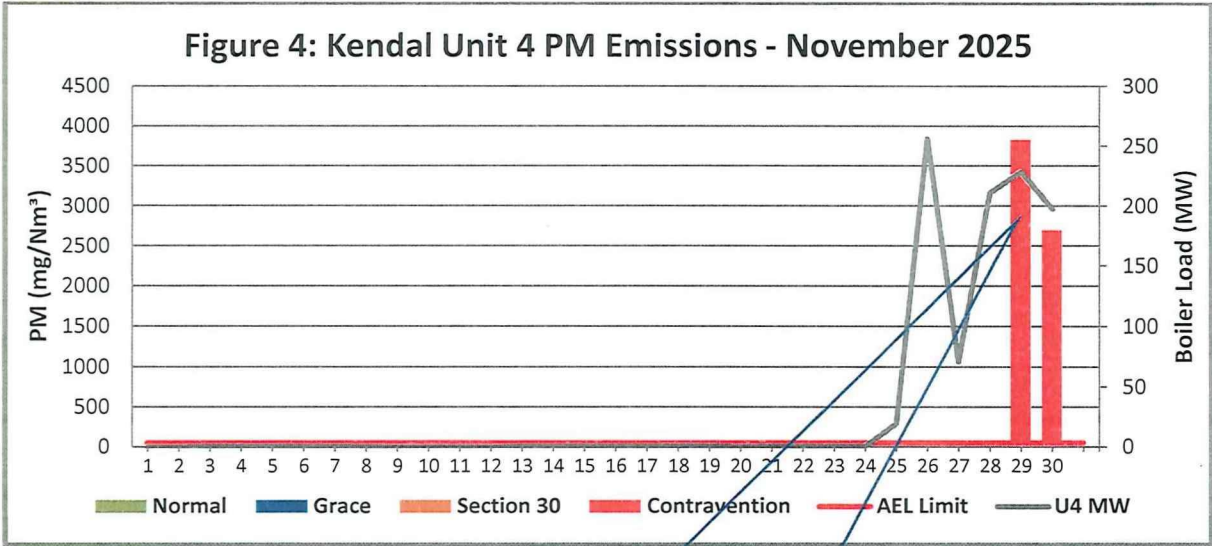
Figure 4: Kendal Unit 4 PM Emissions - November 2025

Unit 4 was supplemented with fuel oil supply during start up and was experiencing LH/RH forced draft fan vibration. Low BETs due to reduced load had resulted in SO₂ plant temperatures dropping below 110 °C. LH Dust Extractor Rapper 5 was tripping on overload, while F16 and F35 were scheduled for commissioning. F45 had a high-temperature fault, and F36 was operating in local control. Additionally, LH Induced Draft (ID) fan issues were impacting BET performance. Cladding and lagging on the Fisher valves needed to be reinstated.

Findings: Unit 4 was supplemented with fuel oil supply during start up and was experiencing LH/RH forced draft fan vibration. Low BETs due to reduced load had resulted in SO₃ plant temperatures dropping below 110 °C. LH Dust Extractor Rapper 5 was tripping on overload, while F16 and F35 were scheduled for commissioning. F45 had a high-temperature fault, and F36 was operating in local control. Additionally, LH Induced Draft (ID) fan issues were impacting BET performance. Cladding and lagging on the Fisher valves needed to be reinstated

Resolution: Plant repaired

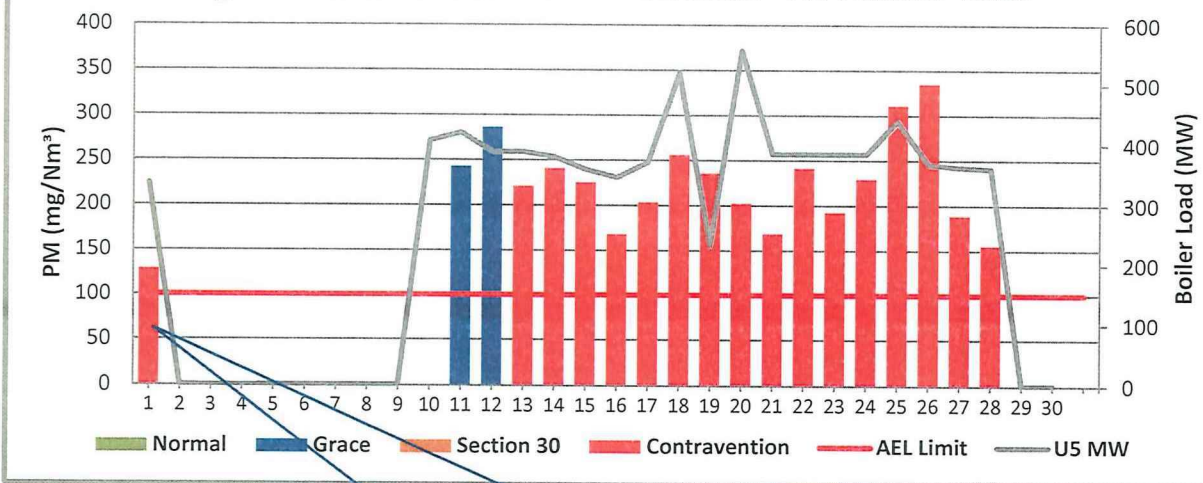
Figure 5: Kendal Unit 5 PM Emissions - November 2025

High particulate matter (PM) emissions, which resulted in an exceedance of the MES limit of 100 mg/Nm³ on Unit 5, were attributed to structural damage that was identified on fields F11, F12, F21, and F22. 5A mill was shut down due to unknown defective classifiers, and 5D mill was put in service, which affected the combustion process and caused disturbances in PM emissions. Field 35 was operating in local mode because of a communications bus issue, while fields 12, 27, 43, and 44 were tripping due to high ash backlogs. Additionally, fields were frequently tripping because of undervoltage, suspected to be caused by wire breakage. The SO₃ plant was offline due to low steam temperature.

Findings: High particulate matter (PM) emissions, which resulted in an exceedance of the MES limit of 100 mg/Nm³ on Unit 5, were attributed to structural damage that was identified on fields F11, F12, F21, and F22. 5A mill was shut down due to unknown defective classifiers, and 5D mill was put in service, which affected the combustion process and caused disturbances in PM emissions. Field 35 was operating in local mode because of a communications bus issue, while fields 12, 27, 43, and 44 were tripping due to high ash backlogs. Additionally, fields were frequently tripping because of undervoltage, suspected to be caused by wire breakage. The SO₃ plant was offline due to low steam temperature.

Resolution: Plant repaired

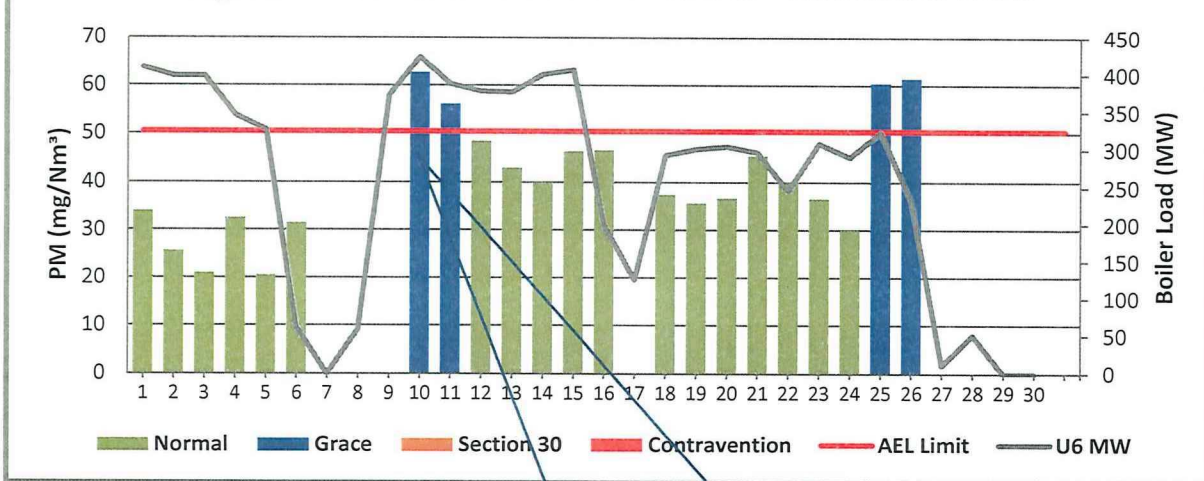
Figure 6: Kendal Unit 6 PM Emissions - November 2025

High particulate matter (PM) emissions, which resulted in an exceedance of the MES limit of 50 mg/Nm³ in Unit 6, were attributed to electrostatic precipitator (ESP) fields that were experiencing undervoltage faults. Fields 11 and 21 were permanently out of commission due to structural damage, which affected the performance of fields 21/26. BET readings indicated a temperature imbalance of 114 °C and 132 °C. The SO₃ plant was on hold mode due to low steam temperature, and CE Rappers 1 and 2 were frequently tripping.

Findings: High particulate matter (PM) emissions, which resulted in an exceedance of the MES limit of 50 mg/Nm³ in Unit 6, were attributed to electrostatic precipitator (ESP) fields that were experiencing undervoltage faults. Fields 11 and 21 were permanently out of commission due to structural damage, which affected the performance of fields 21/26. BET readings indicated a temperature imbalance of 114 °C and 132 °C. The SO₃ plant was on hold mode due to low steam temperature, and CE Rappers 1 and 2 were frequently tripping.

Resolution: Plant repaired
