2nd AUDIT REPORT
For
FREEDOM PARK SUBSTATION AND 160M 88KV LOOP IN-OUT POWERLINE
NEAR RUSTENBURG, NORTH WEST PROVINCE

04 March to 31 March 2016
(March period)

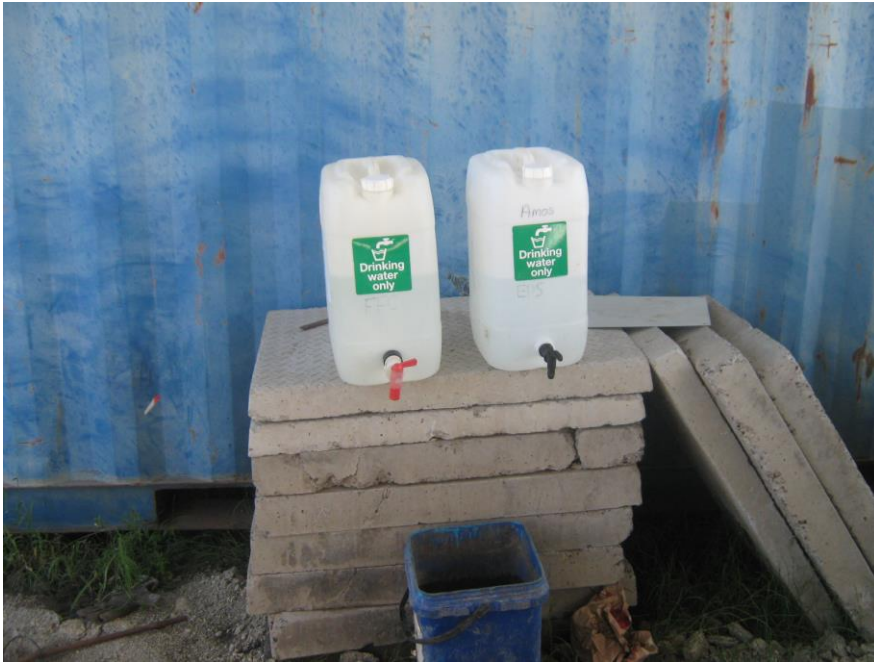
Photo 3: The provision of drinking water for all staff.

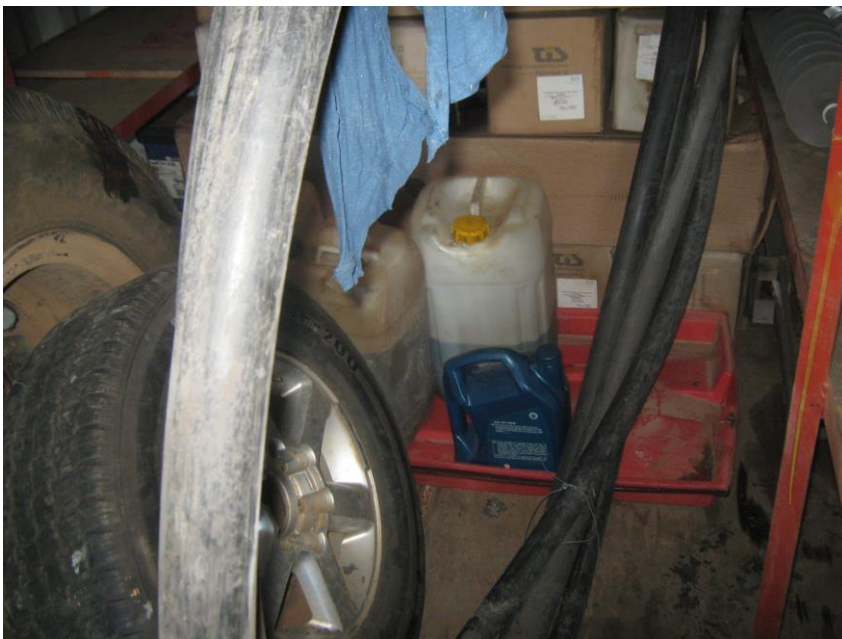
The ECO noted that the hazardous materials store is not yet in place however there is work in progress into building the store. The ECO noted that the contractor has brought in building structures related to establishing the store. The ECO emphasised the importance of having a bunded, impervious Hazardous Material Store as soon as possible. Currently, all hazardous materials are kept in a secondary container.

Photo 4: Hazardous chemicals stored in the secondary container.

- A dedicated store area for hazardous materials should be built immediately as it was a concern in the previous audit. Vehicles parked for long periods must place drip trays underneath.
- An alien invasive plan/method statement should be created and implemented.
- The contractor must source a service agreement the toilet service provider has with the local municipality as proof of correct disposal of toilet waste.
- Integrated waste management must be practised to encourage the principle of incorporating reduction, recycling, re-use. Also, waste bins must have appropriate lids.
- The availability of the project complaints register must be in place.
- The EMPr and the EA must be used as a blue print, to ensure sound environmental management of this development takes place.

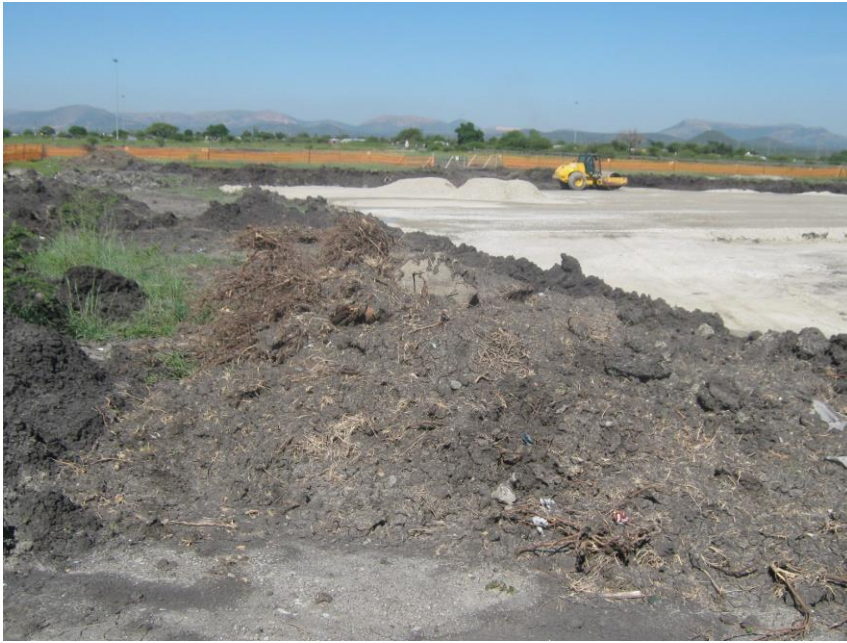
Photo 5: Topsoil being preserved for future rehabilitation purposes.

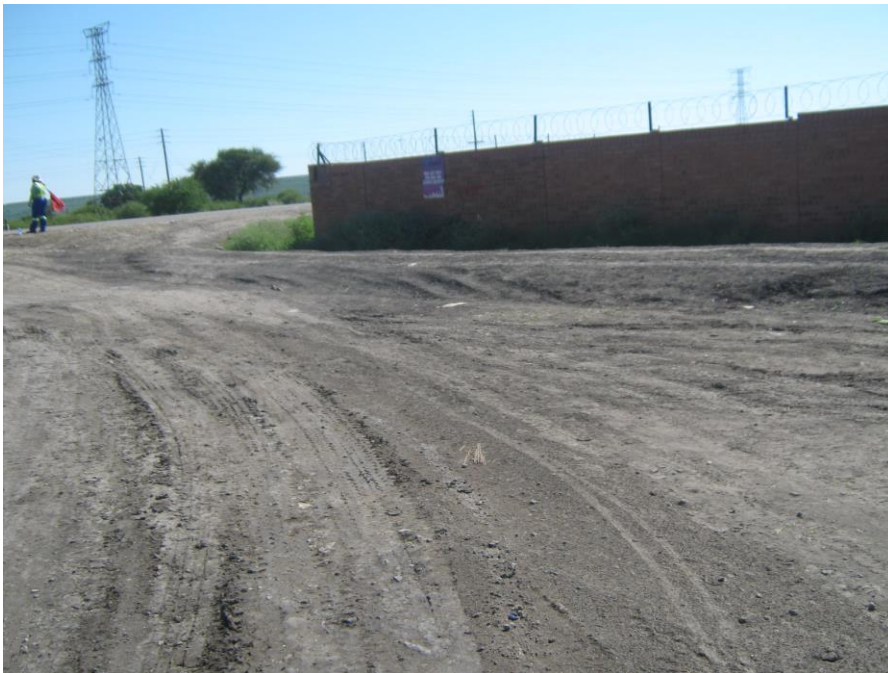
On inspection the ECO noted that there are some measures in place to manage both storm water and erosion. The contractor has established erosion berms on certain sections of the site to curb erosion. Also, the ECO noted that the contractor has created cut off trenches and diversion berms on areas susceptible to storm water run-off and accumulation.

Photo 6: A storm water diversion berm near the site camp entrance.

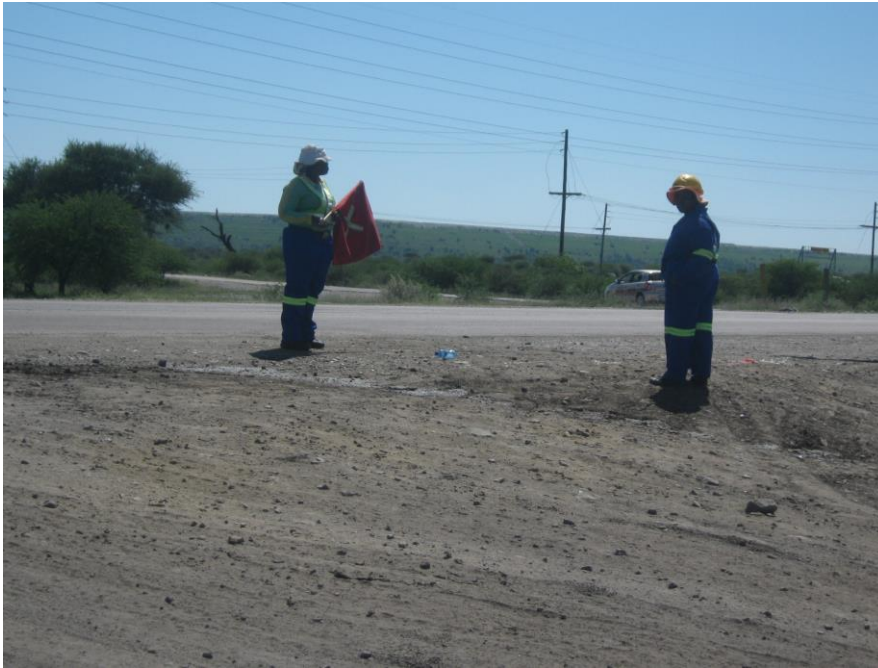
Photo 7: Traffic points personnel along the adjacent secondary road.

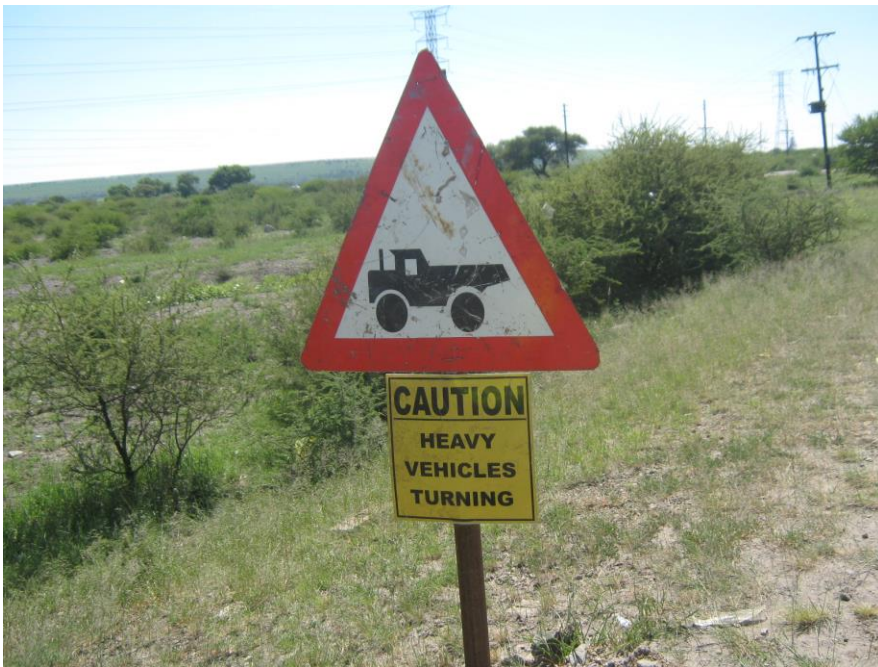
Photo 8: Traffic caution signs on both sides of the adjacent road.

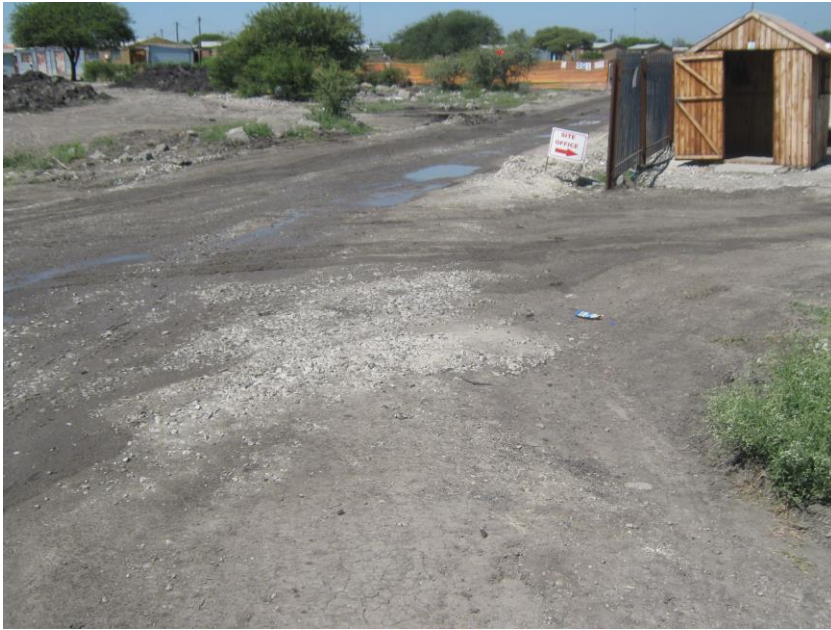
Photo 9: Dust suppression on the access track leading to the active construction site.

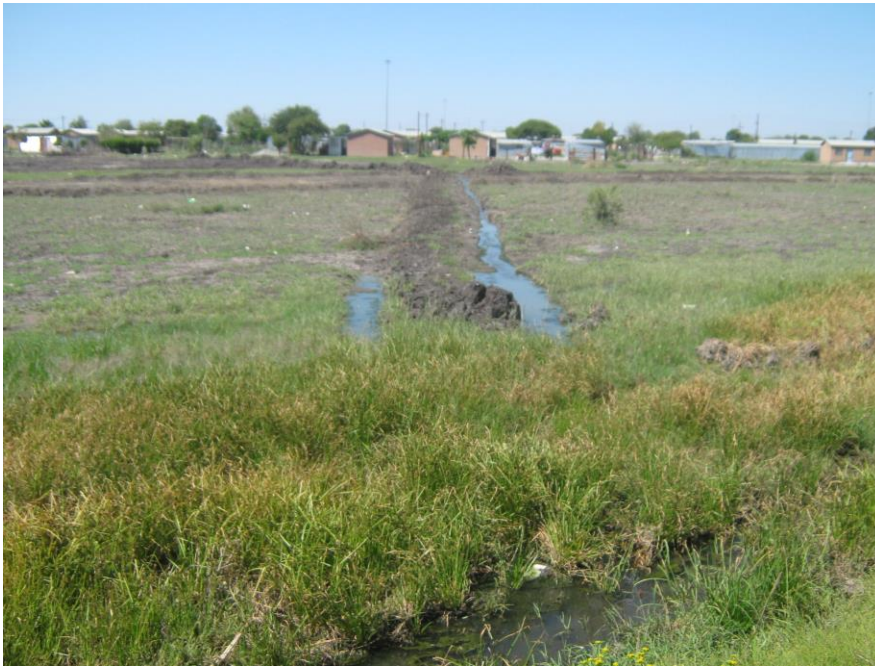
Photo 10: A cut-off trench on the west side of the construction site.
