NUCLEAR POWER STATION ('NUCLEAR 1') AND ASSOCIATED INFRASTRUCTURE

Addendum to Dune Geomorphology Impact Assessment: debris flows in the Sand River and potential for flood damage to the R330

September 2010

Prepared by: Illenberger & Associates

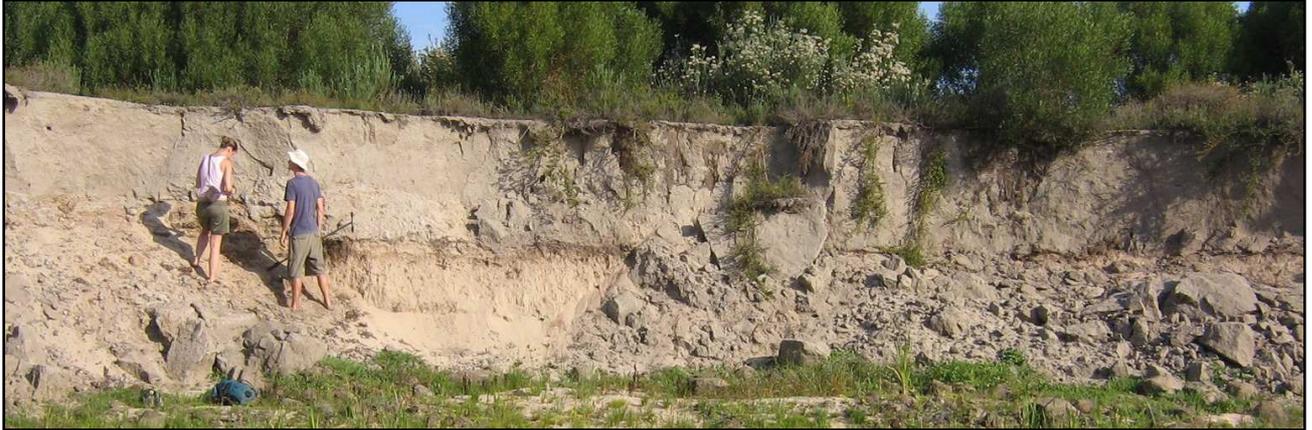
Figure 2.2. Overall view of the deposits. Photograph by Pete Illgner.

The opinion of the above specialists is that the supposed debris flow deposits are river flood deposits of sand, some mud, a few pebbles, and some plant debris, that were entrained and later deposited by the Sand River when in flood. The Sand River carries a high sediment load (“hyperconcentrated flow”), so sedimentary structures are often poorly developed. The sediments portrayed in Figures 2.2, 2.3 & 2.4 were probably deposited by a flood event of the Sand River like the one illustrated in Figure 2.7.

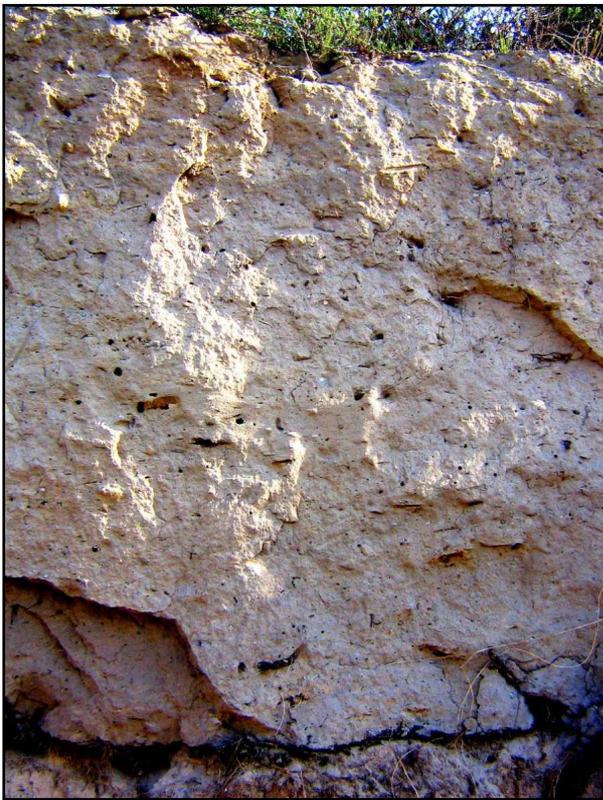
Figure 2.3. Complete vertical section through the deposit. Photograph by Pete Illgner.

“Biological material has been buried by a 1.5 to 2 m thick debris deposit. The debris deposit includes mainly fine sand (the material in the source area that is well known to you) together with coarse fragments and vegetation. There are no small-scale sedimentary features that result from gradual movement and

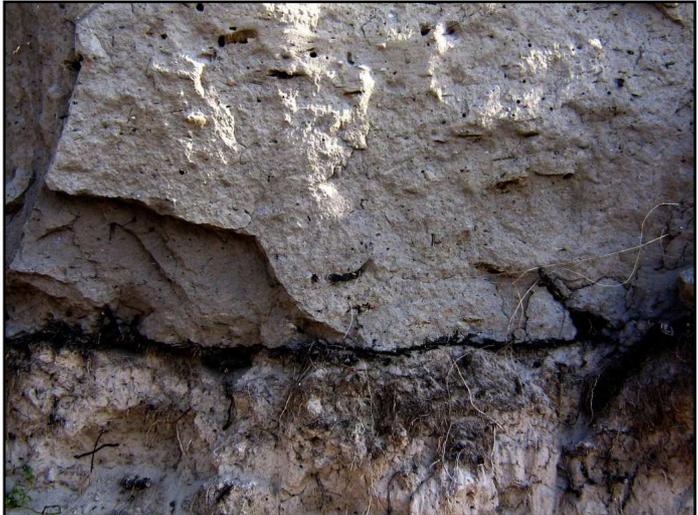
Figure 2.4. Base of the deposit. Photograph by Pete Illgner.

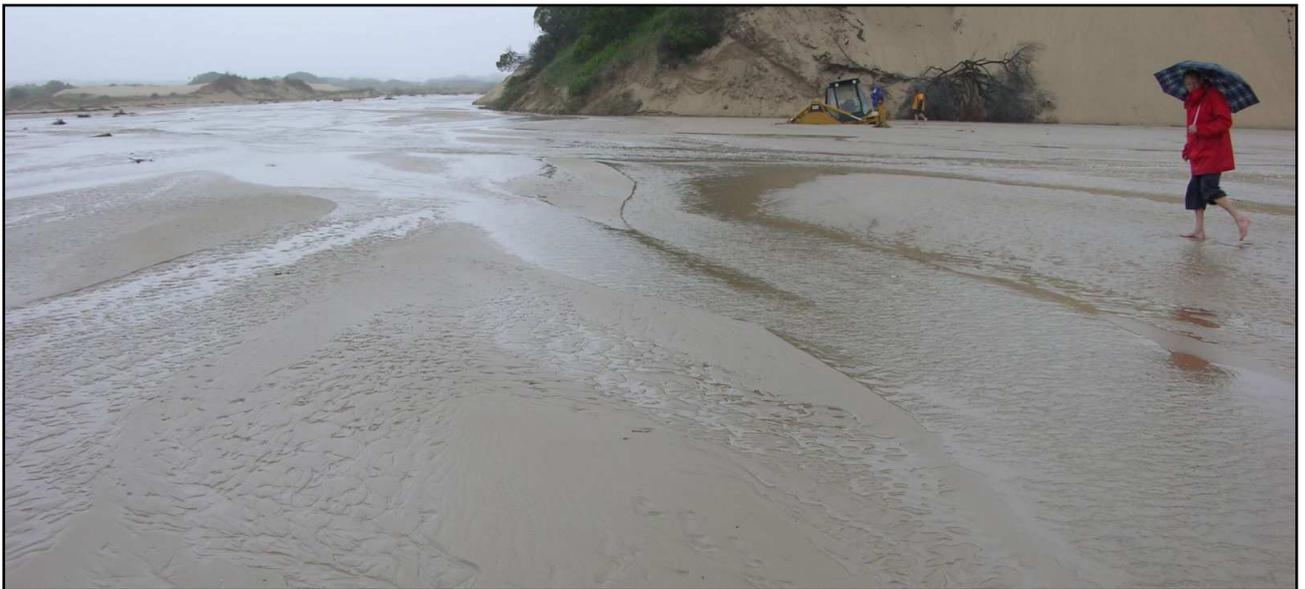
Figure 2.7. View up the Sand River from the R330 after the flood event of 3 August 2006. The front-end loader at the top right that has settled into the bed of the river is discussed in Chapter 3. Photographed 19 August 2006.

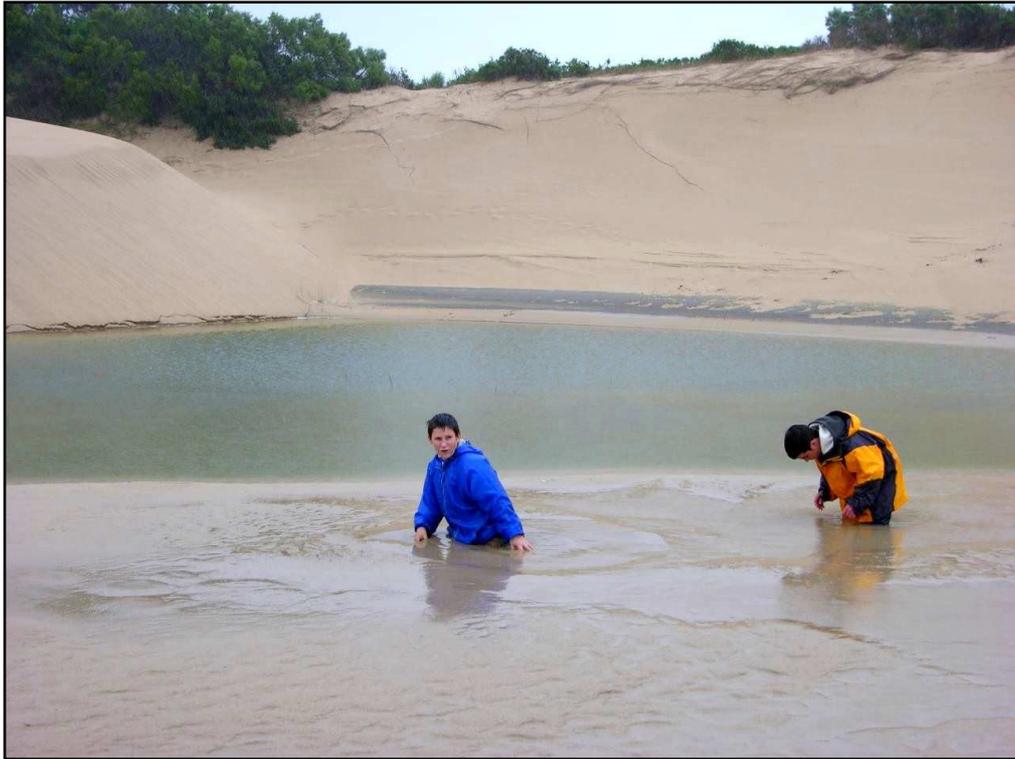
Quicksands often occur in the mobile dunes of the Oyster Bay dunefield: many people have experienced all terrain vehicles being bogged down while driving through the dunefield during wet periods. The quicksands are mostly formed when loosely consolidated sand is inundated (e.g. Figure 3.1).

Figure 3.1. Quicksand next to an interdune hollow formed when loosely consolidated sand was inundated during the flood event of 3 August 2006. Photographed 19 August 2006.

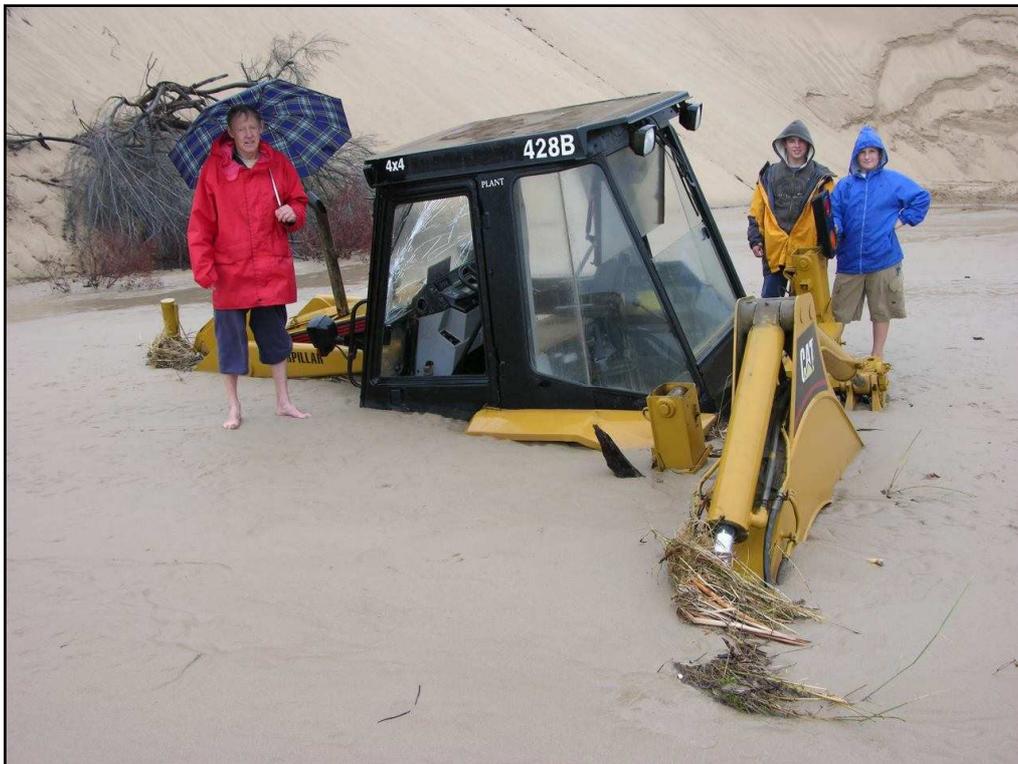
Figure 3.2. The front-end loader used for sand mining just upstream of the R330, which settled into the bed of the Sand River during the flood event of 3 August 2006. Photographed 19 August 2006.

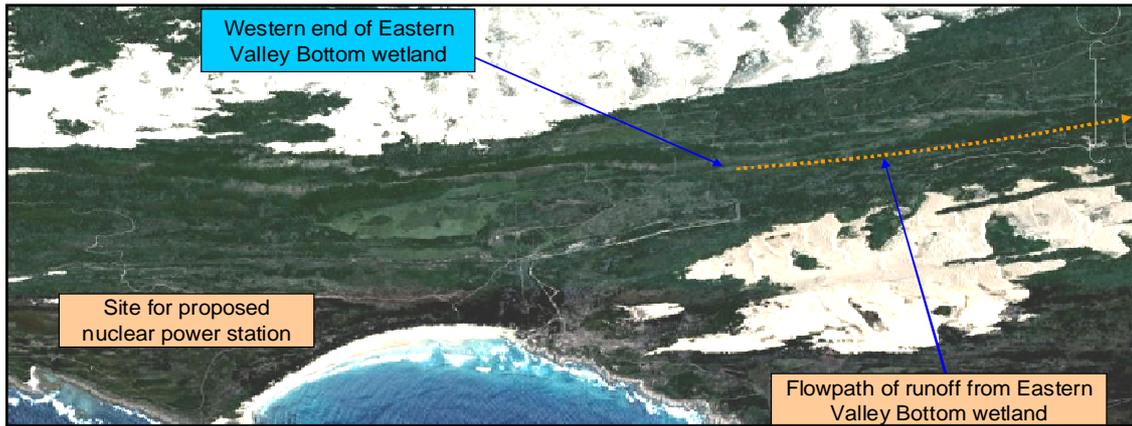
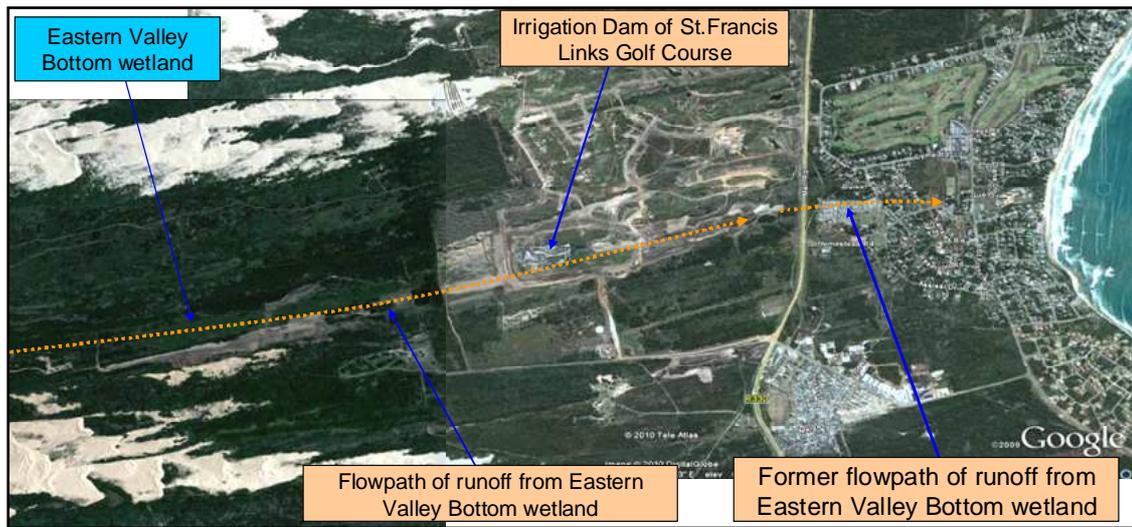
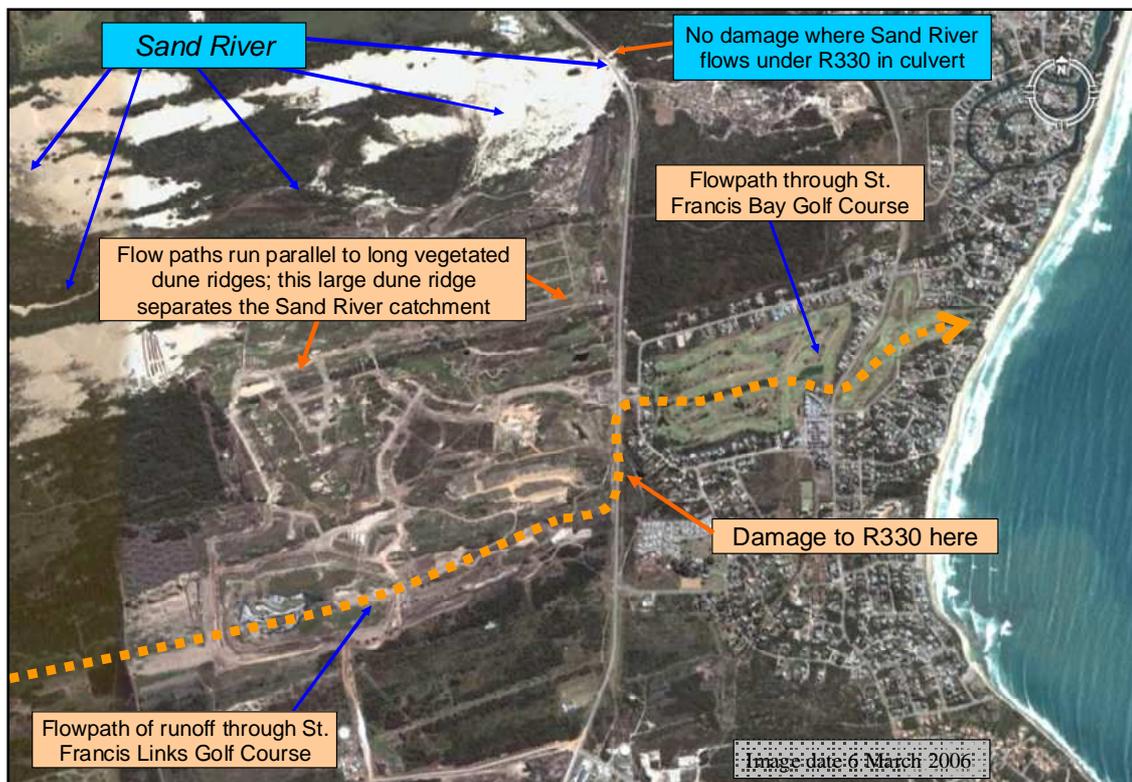
Figure 4.1. Flow path of floodwater that damaged the R330 on 23-24 November 2007. The map is in three parts, top to bottom is from west to east.

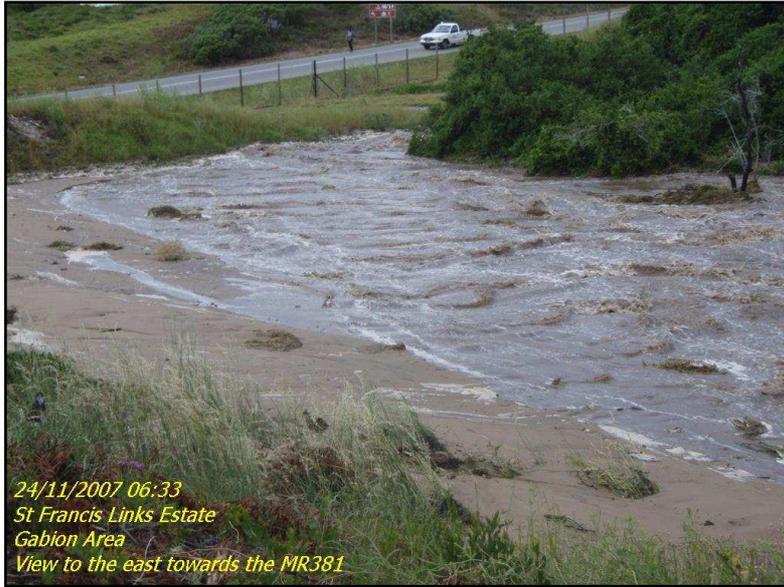
Figure 4.2.
Floodwater as it approached the R330 off the Links Golf Course. Photograph taken by Keith Simon on 24 November 2007.

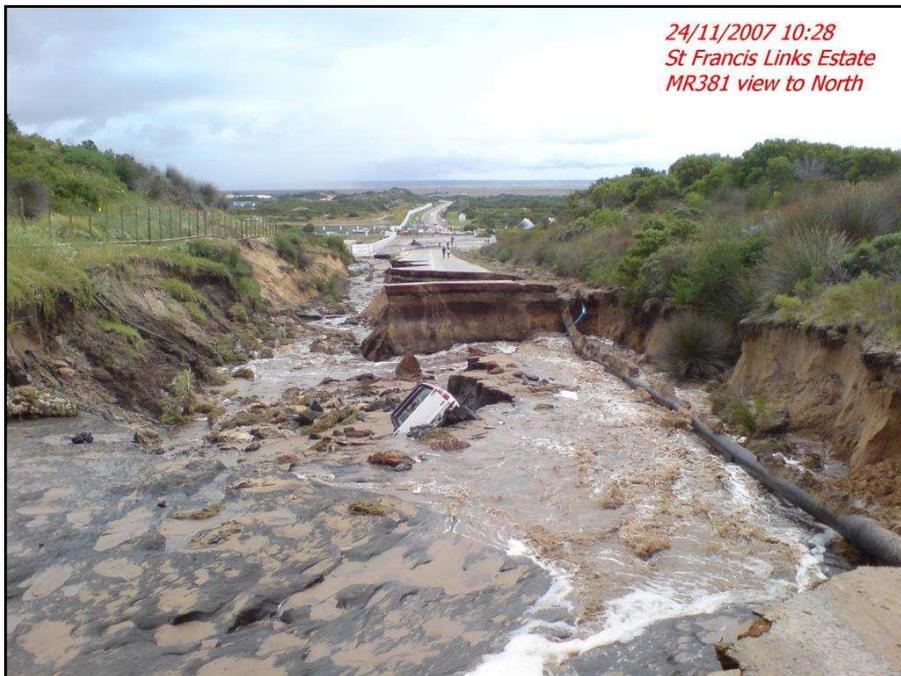
The main erosional damage caused by the November 2007 flood resulted from erosion of sediments by floodwaters flowing down the steep V-drain along the R330, that ultimately eroded away the whole width of the R330 (Figure 4.3). Damage due to

Figure 4.3.
Flood damage to the R330. Photograph taken by Frank Silberbauer on 24 November 2007.

The question that arises is how likely a similar flood with associated damage could happen again. The flood is estimated to be a 1:200 year event, and stormwater drainage is normally designed to handle a 1:50 year event. It is recommended that road engineers check that stormwater drainage is adequate along this section of the R330. Ninham Shand (2008) and Chris Roberts (personal communication 2010) proposed improvements to stormwater drainage that would considerably reduce the chances of such damage occurring again:

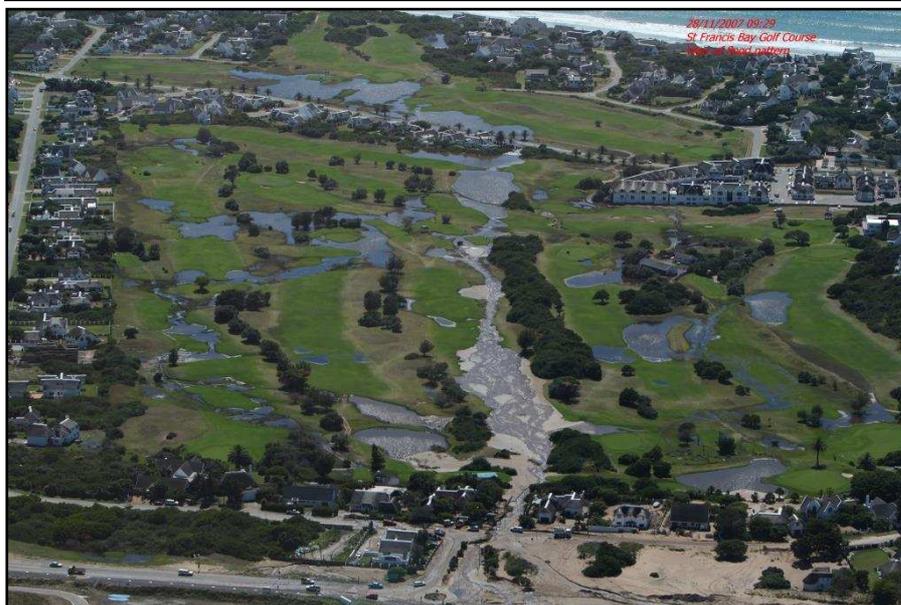
Figure 4.4.
Oblique aerial view looking east, showing flow path of floodwater and areas where sediment was deposited in the St. Francis Bay Golf Course. Photograph taken by Frank Silberbauer on 28 November 2007.

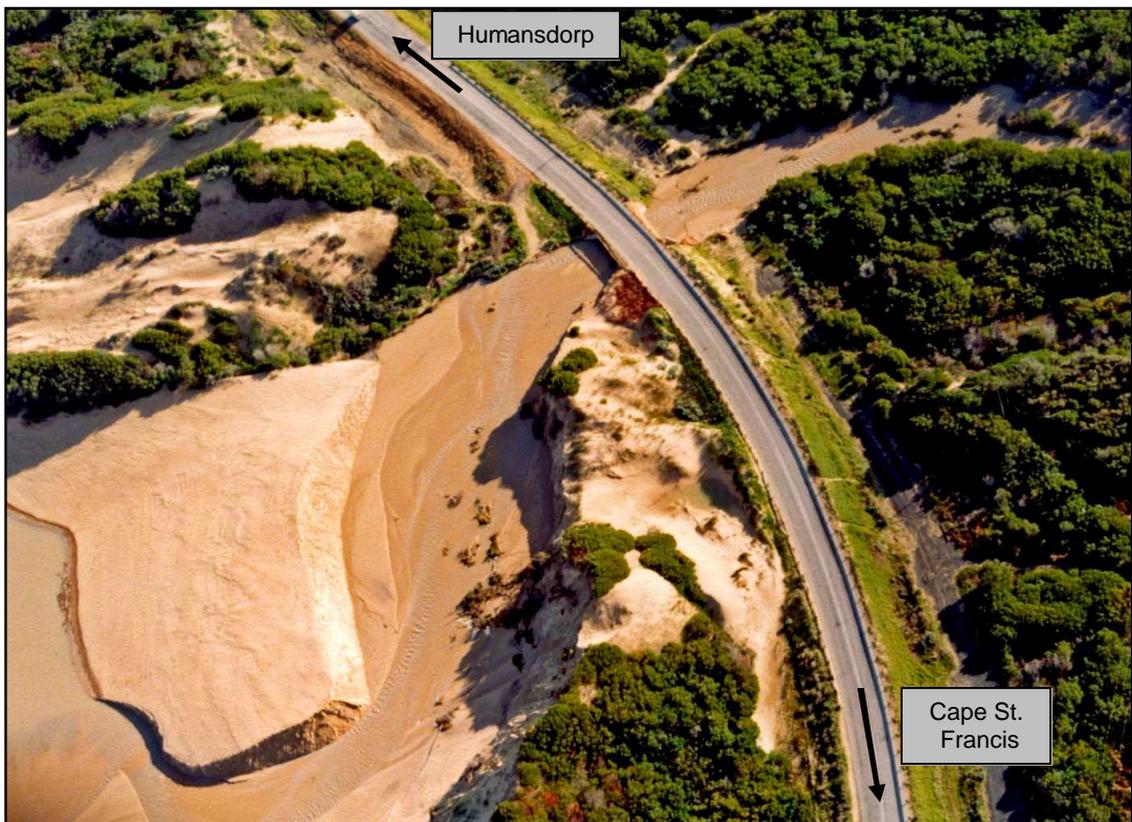
The R330 needs to be able to handle floods without significant damage so that access to the possible nuclear power station is not interrupted. The following information has been assembled to assess the R330 where it crosses the Sand River in a box culvert (Figures 5.1 & 5.2).

Figure 5.1. Oblique aerial view looking south, showing typical situation where the Sand River crosses the R330. About one third of the large transverse dune that had blocked the dunefield had been eroded away (see text and Figures 5.3, 5.4 & 5.5). Photograph taken by Jenny Burkinshaw on 15 June 1993.

- The wing walls on either side of the culvert be repaired;
- Road engineers should check what flood recurrence interval the culvert can handle, and improvements should be made if necessary;
- The culvert should be checked regularly to see that it is not blocked by sand; and
- The culvert should be checked during floods and any debris that is caught across it should be removed.

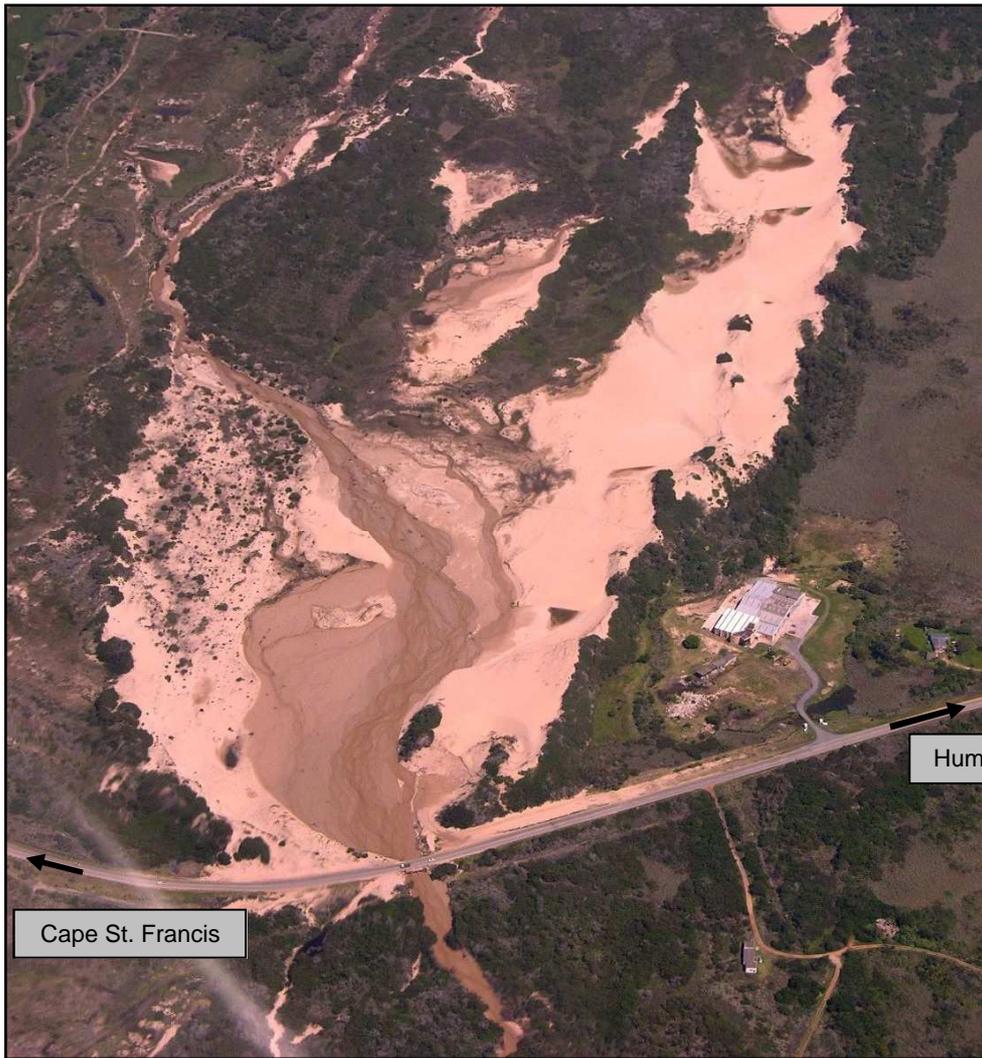
Figure 5.2. Oblique aerial view looking west, showing typical situation where the Sand River crosses the R330. Photograph taken on 6 October 2006 after the flood of 3 August 2006

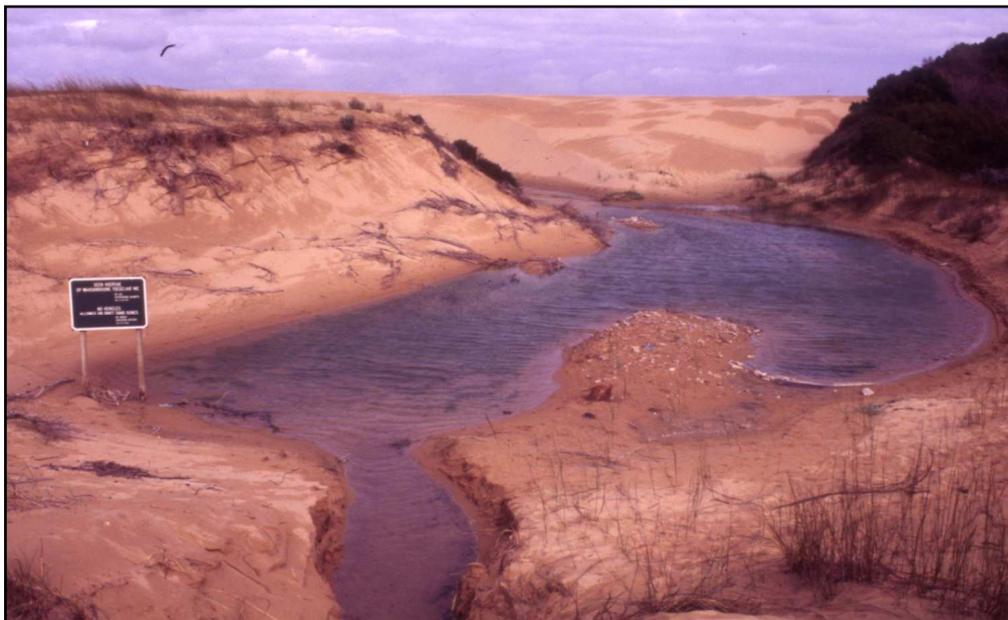
An unusual incident occurred in June 1992, when a large transverse dune had completely blocked the Sand River, causing the Sand River to dam up to create a large body of water (Figures 5.3, 5.4 & 5.5). This natural dam was breached during a high rainfall event sometime before November 1992. The flowing water eroded a channel through the dune, and a large volume of water flowed down to the R330 and then ran down along the west side of the R330 to the Kromme estuary, because the culvert was blocked with sand (Owen Putzier, personal communication, September 2010). The road was not damaged.

Figure 5.3. View up the Sand River from the R330 showing the large transverse dune that had completely blocked the Sand River. Photograph taken by Jenny Burkinshaw on 28 July 1992.

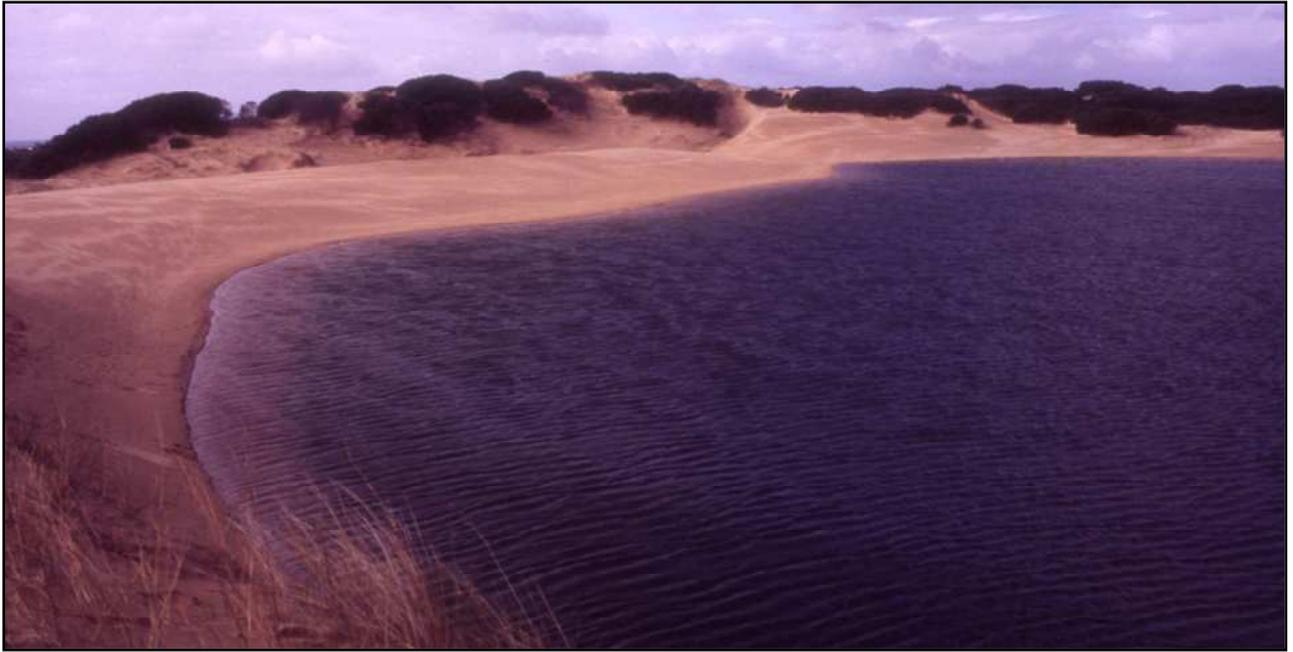
Figure 5.4. The large body of water that dammed up against the large transverse dune, looking southeast. Photograph taken by Jenny Burkinshaw on 28 July 1992.

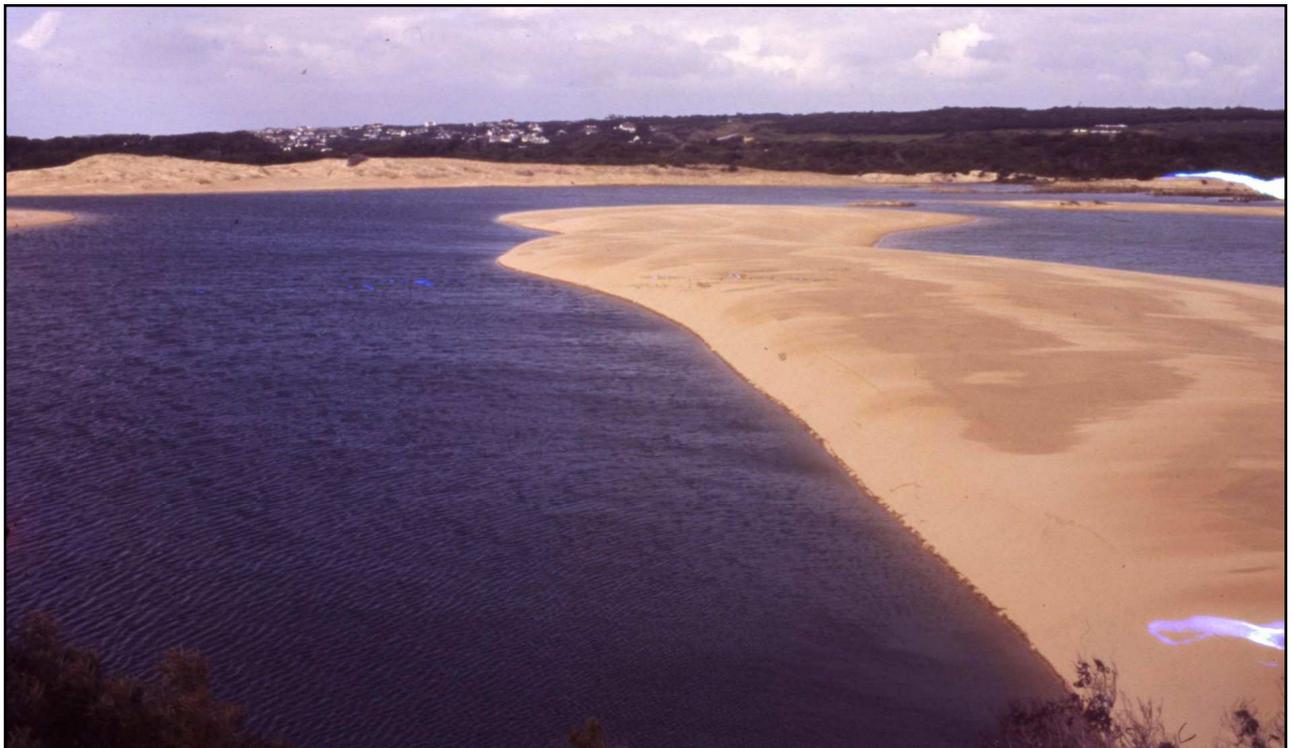
Figure 5.5. The large body of water that dammed up against the large transverse dune, looking south. Photograph taken by Jenny Burkinshaw on 28 July 1992.
