#### EXPANSION OF THE KOMSBERG MAIN TRANSMISSION SUBSTATION AND ASSOCIATED INFRASTRUCTURE NEAR SUTHERLAND, WITH THE KAROO HOOGLAND LOCAL MUNICIPALITY IN THE NORTHERN CAPE

#### MONTHLY MONITORING REPORT

DATED: 30 NOVEMBER 2019

DEA REF: 14/12/16/3/3/1/1482

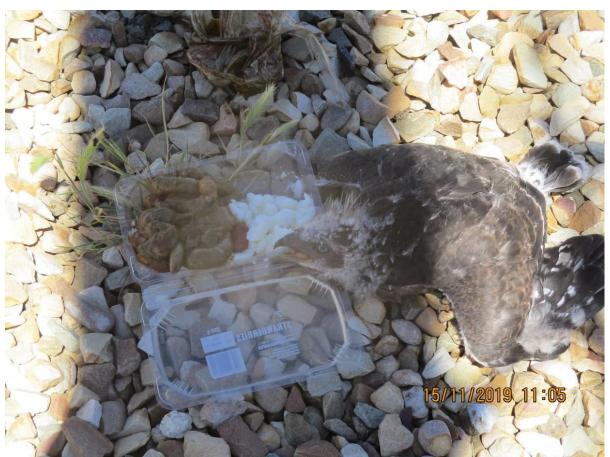
Unknown juvenile bird was found at the existing capacity bank 1, the bird was injured and could not fly or eat. It was evidenced that it fall from the nest built on top of the light mast. The ECO fed the bird with water and food and placed under the shade. The ECO took the bird to Aquila Animal Rescue and Rehabilitation Conservation Centre in Touwsrivier.

Photo: Injured and heat exhausted unknown juvenile bird found at the capacitor bank 1.

The ECO recommend a regular awareness on conservation of fauna to all employees on site and the role each play on the ecosystem.

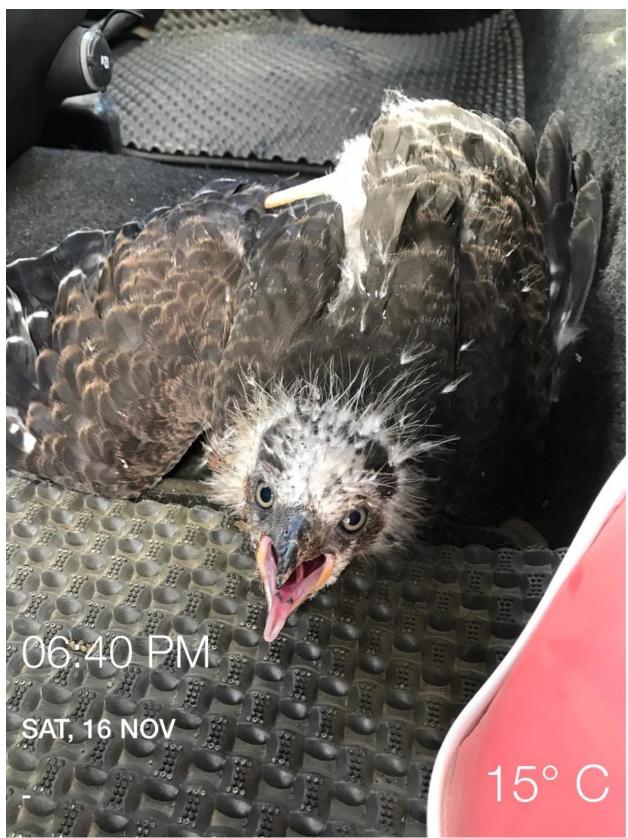
Photo: Injured unknown juvenile bird taken to Aquila Animal Rescue and Rehabilitation Conservation Centre in Touwsrivier

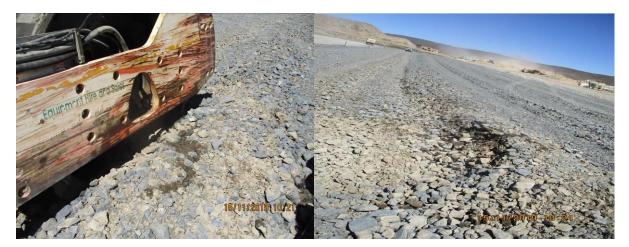
Currently there is no NCR issued by ECO, One (1) Incidents (minor or insignificant oil spill due to hydraulic pipe burst from smooth drum roller).

Photo: Hydraulic pipe burst from smooth drum roller.

No.	Date	Description	Quantity	Location	Reported	Reported	Action	Close-out	Was a flash
		of the incident			by	to	taken	date	report completed?
1	15/11/2019	The roller pipe was leaking hydraulic oil	100 ml	400 kV yard, Section D	Operator and Mechanic	EO	The spillage was cleaned	15/11/2019	No

The contractor shall be strongly advised to make every effort to prevent spills and leakages on site. Regular maintenance and inspections of construction vehicle is essential to prevent unnecessary oil spills. One (1) insignificant or minor hydrocarbon spills due to hydraulic pipe burst from the smooth drum roller. The spill was immediately cleaned after the new hydraulic pipe burst was installed. It is recommended that all spills must be assessed to determine the significance of the spill, reported to ECO and cleaned immediately.

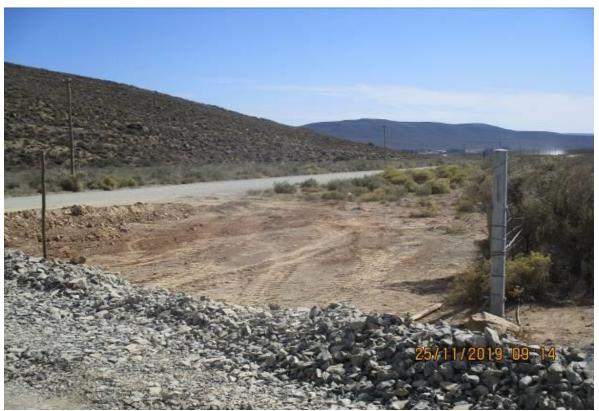
Rehabilitation will be required on most of the area along new permanent access road, this are areas disturbed by heavy plant such as grader turning during construction of such road and excavators when preparing the V-drain along the permanent road. Other areas that need rehabilitation is the heavy plant parking area, old farm tracks deviated from the permanent access road, laydown area and office area for the Earthwork Contractor after disestablishment of the site and removal of all temporary structure that are not required. The method of rehabilitation shall include ripping, seeding with Karoo seed mix and watering.

Photos: Damaged area used as a turning point by graders and excavators require rehabilitation.

All area that are badly damaged needs to be rehabilitated as soon as possible or as required, the rest of the area will be rehabilitation during the completion earth work contract and the rest of the area will be rehabilitated at the end of the construction phase before commissioning. Alien species that might have been introduced during construction phase must be monitored, controlled and removed.

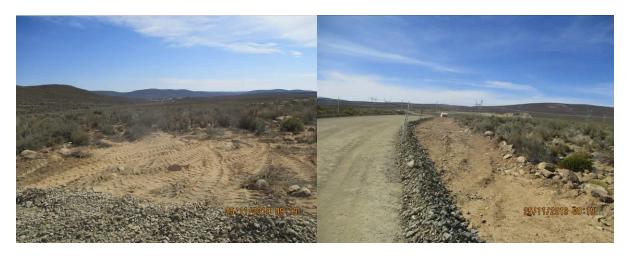
Photos: Damaged area used as a turning point by graders, excavators during preparation of culverts and V-drain require rehabilitation.

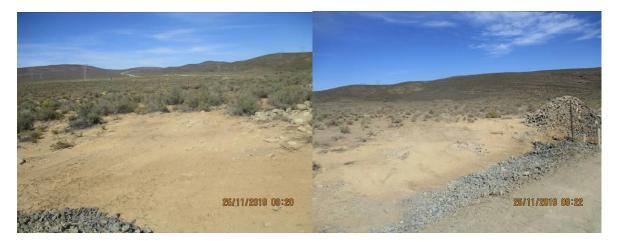
Photos: Damaged area used by excavators during preparation of culverts and V-drain require rehabilitation.
