ENVIRONMENTAL MONITORING REPORT

**Power Lines from Kendal/Kusile to Zeus Substation Bravo
Integration Project – Bravo 4: Construction of two 400 kV lines**

DEA Ref # 12/12/20/1095

Date: 30 June 2017

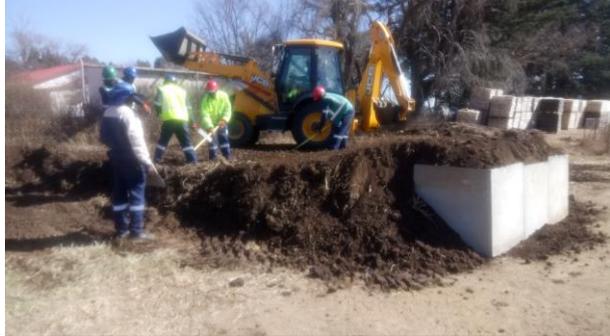
29/06/2017	B	Using stockpiled topsoil for construction activities,	Waiting for feedback from Babcock	Open

Stockpiled topsoil used for construction activities at B	Diesel bowser needs to be cleaned at B

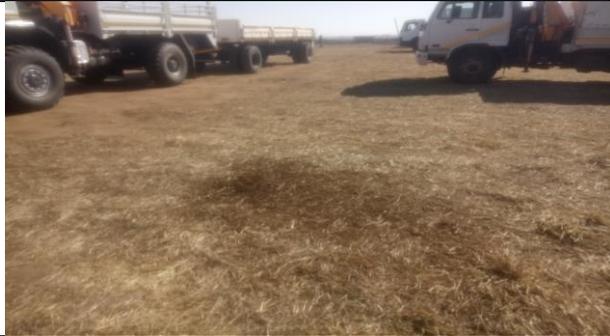
Spills not cleaned nor reported	Various rehabilitation work due

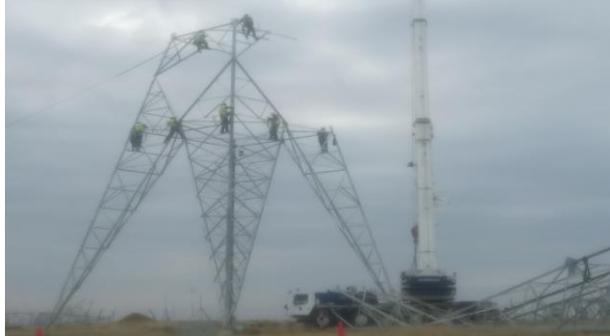
Assembly & lifting activities	Housekeeping taking place

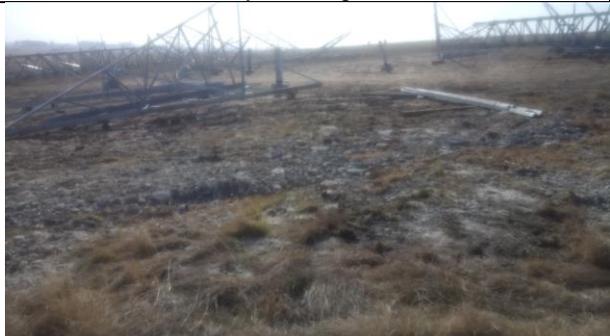
Inadequate backfilling	Graves identified and barricaded off
