ENVIRONMENTAL MONITORING REPORT

**Power Lines from Kendal/Kusile to Zeus Substation Bravo
Integration Project – Bravo 4: Construction of two 400 kV lines**

DEA Ref # 12/12/20/1095

Date: 31 March 2017

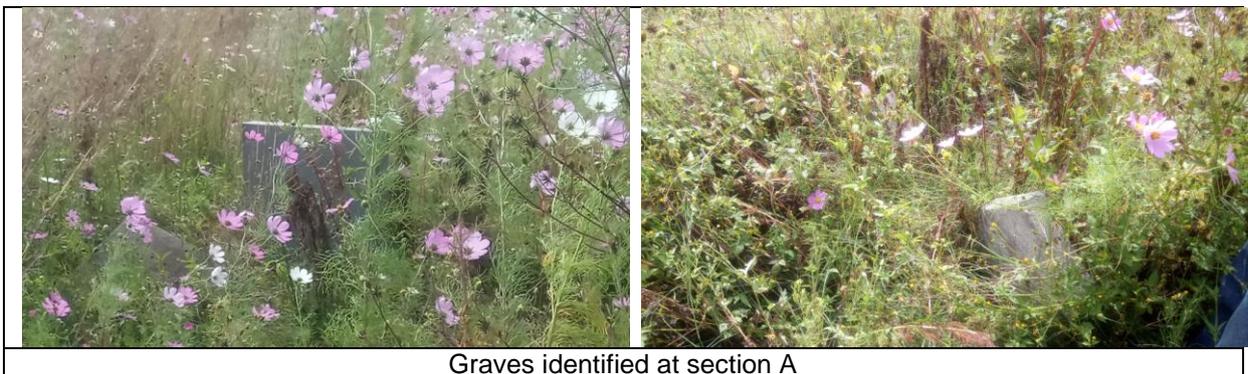
- Spill kit training needs to be provided from both contractors
- Various tower position relocated after landowner negotiations at Site A
- Grave that was not previously identified has been found at site A

Graves identified at section A

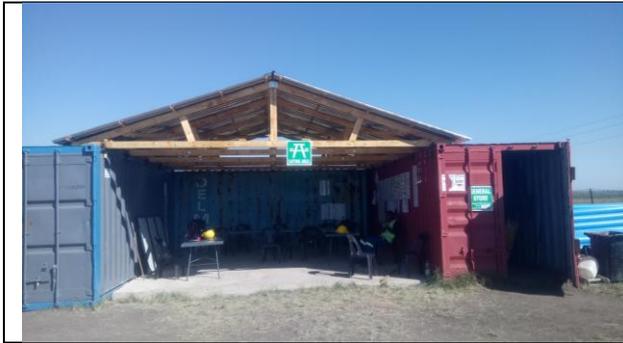
Eating area constructed at section A

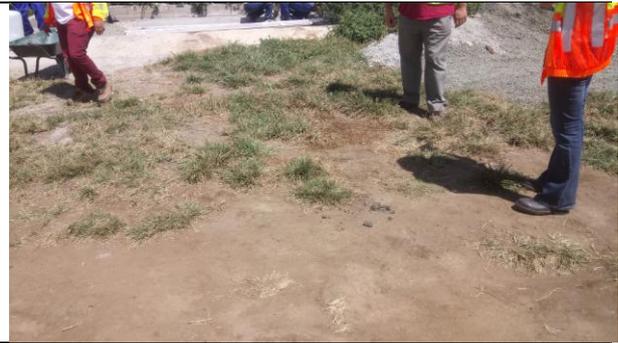
- Incidents are not being reported , Section B - Babcock
- Damage claim received from landowner, Section B – Babcock
- Method statements not communicated to workers, Section B – Babcock

Spills not being reported or cleaned at section B

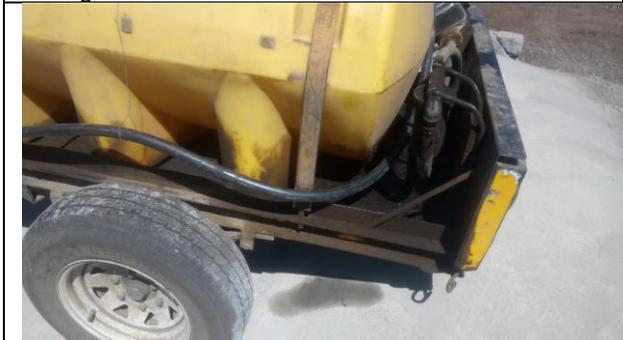
Leaking diesel browser at section B

- Diesel bower instructed to be cleaned or removed from site by ECO, Section B – Babcock
- Official warning given for poor barricading , Section B – Babcock – NCR already issued

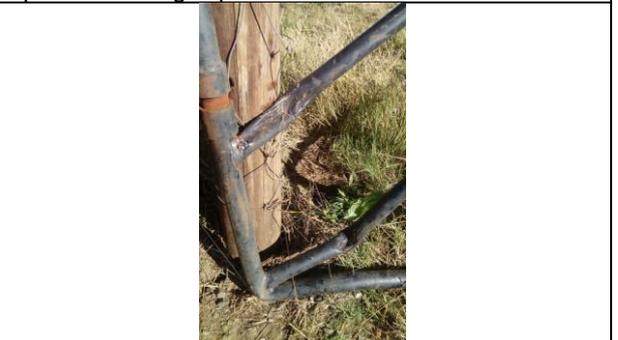
- Section of work postponed at section B due to hunting season, work areas cleared and backfilled
- Repeat offences taking place, Section B
- Property damage not being resolved, Section B

Property damage at section B – Not reported

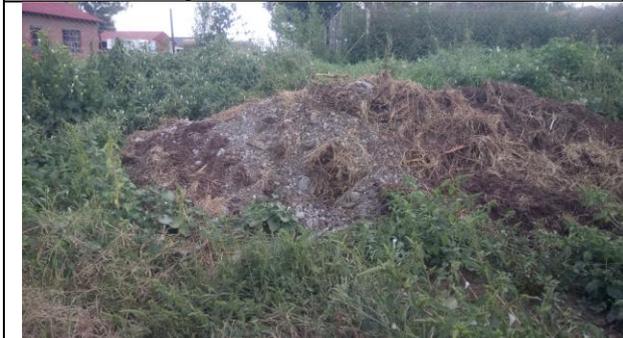
Concrete mixed with topsoil in topsoil berm at section B

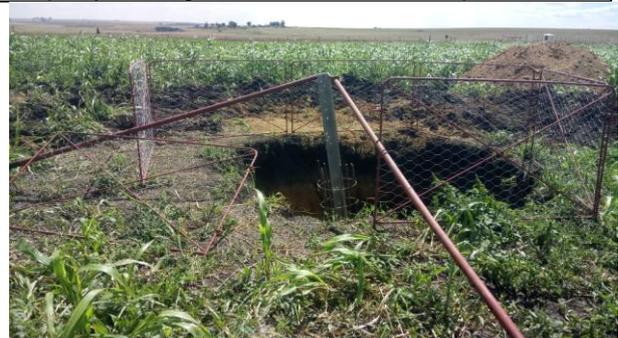
Inadequate barricading at section B

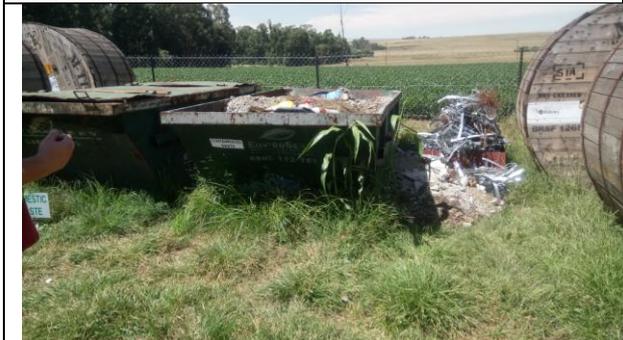
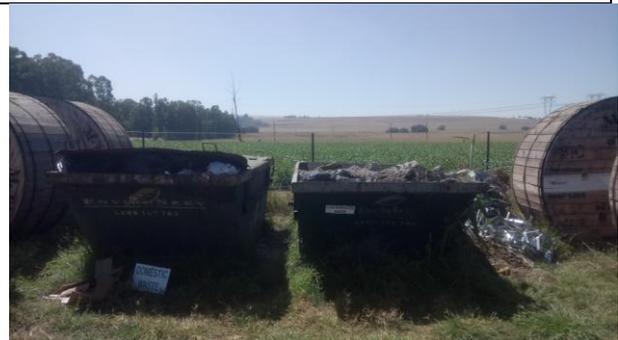
Poor waste management at section B – Photo`s more than 3 weeks apart

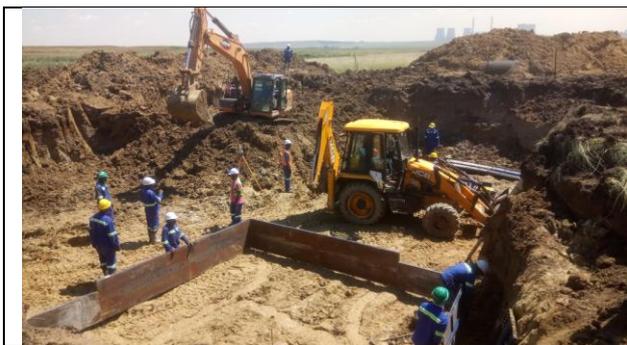
- Extensive rehabilitation and landscaping is going to be required at tower Ke-Ze 28 at section A
- Water quality monitoring as per WUL requirements taking place

Workings at tower Ke-Ze 28

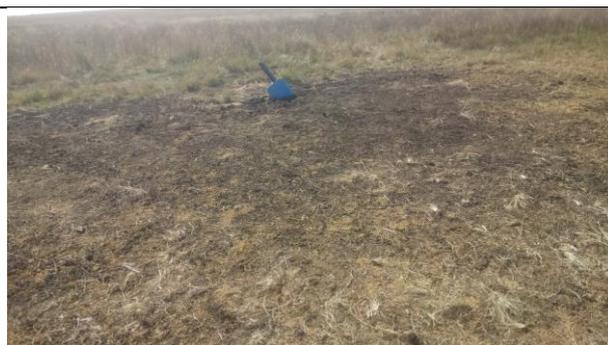
Good backfilling practices at section B
