ENVIRONMENTAL MONITORING REPORT

**Power Lines from Kendal/Kusile to Zeus Substation Bravo
Integration Project – Bravo 4: Construction of two 400 kV lines**

DEA EIA Ref # 12/12/20/1095

Date: 31 March 2018

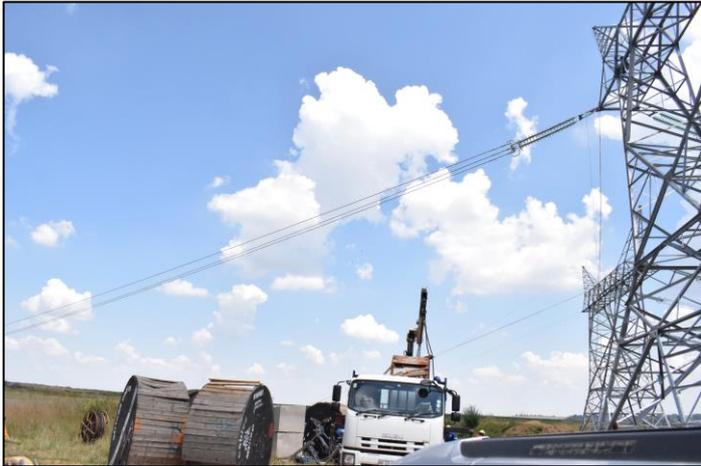
Figure 2: Stringing activities

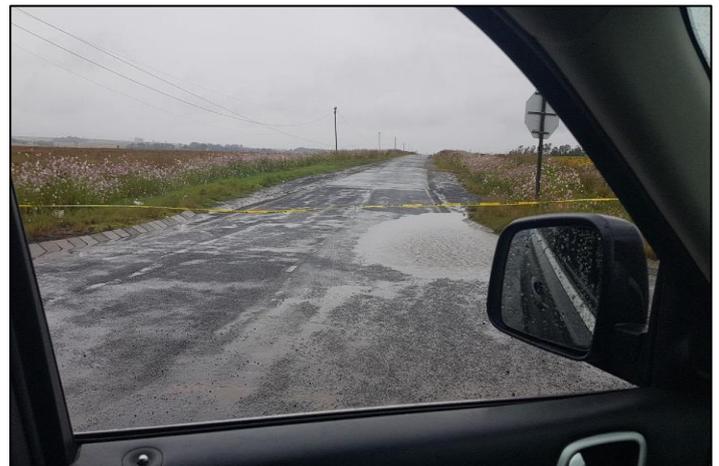
Section A – Conco
Contractor is not formally closing off NCR`s
Difficult to work during the rainy season as some farmers refuse access should it be raining or to muddy.

Figure 3: Road closed due to the heavy rains.

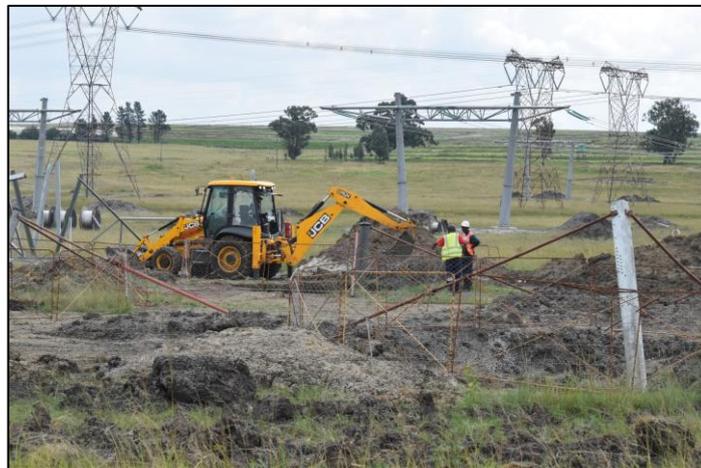
Figure 4: Excavation

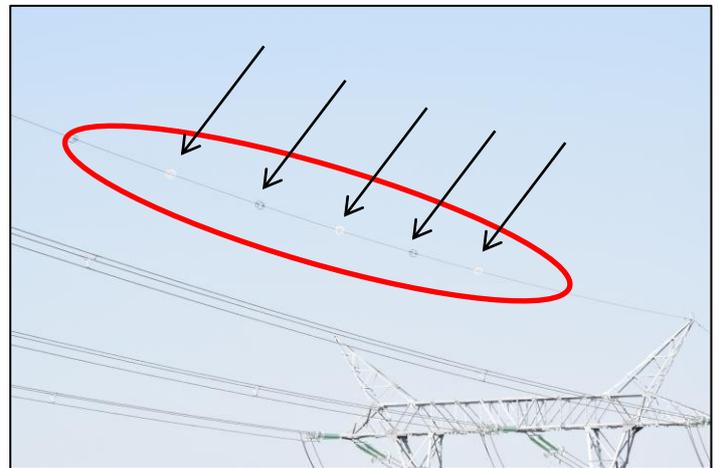
Figure 5: Some bird-diverters have been installed.

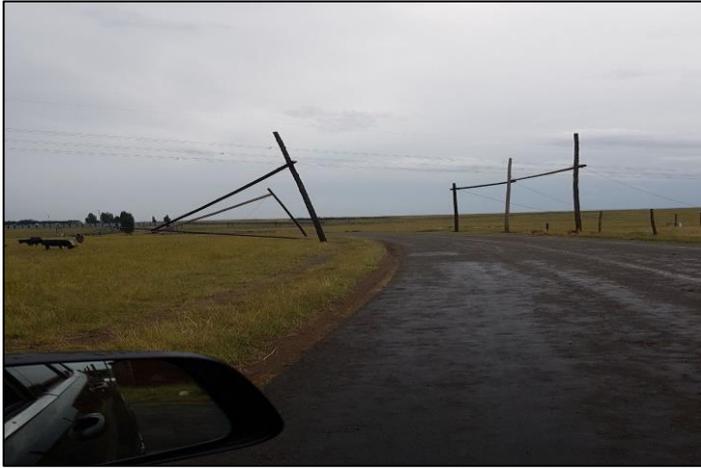
Figure 6: H-poles collapsed due to heavy rains

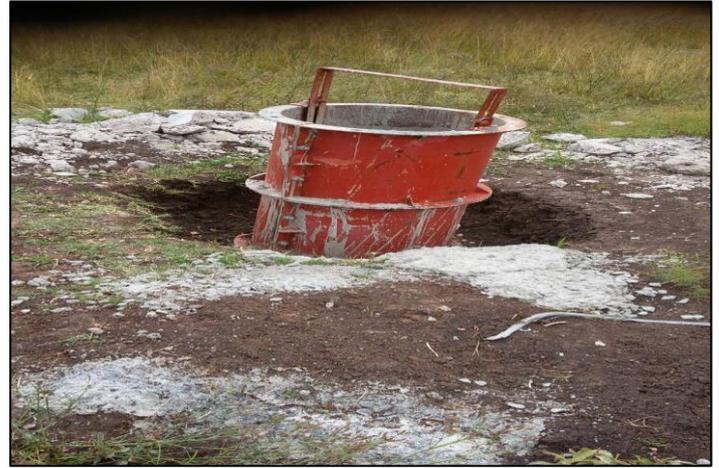
Figure 7: Filling up foundation of tower
