## ENVIRONMENTAL MONITORING REPORT

**Power Lines from Kendal/Kusile to Zeus Substation Bravo  
Integration Project – Bravo 4: Construction of two 400 kV lines**

**DEA Ref # 12/12/20/1095**

**Date:** 30 November 2017

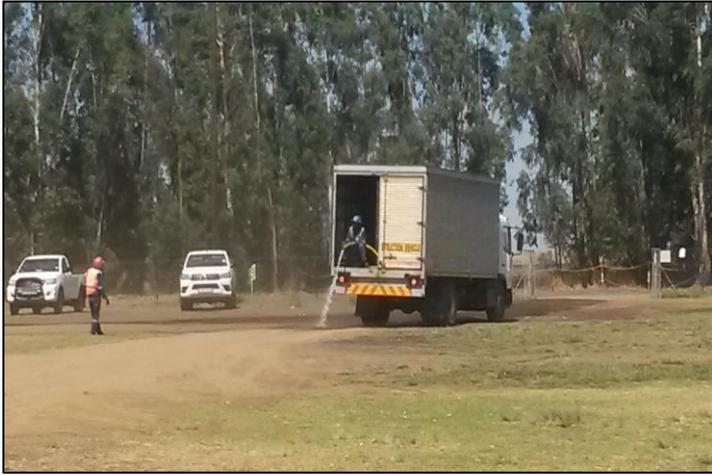
Figure 2: Spraying water for dust control.

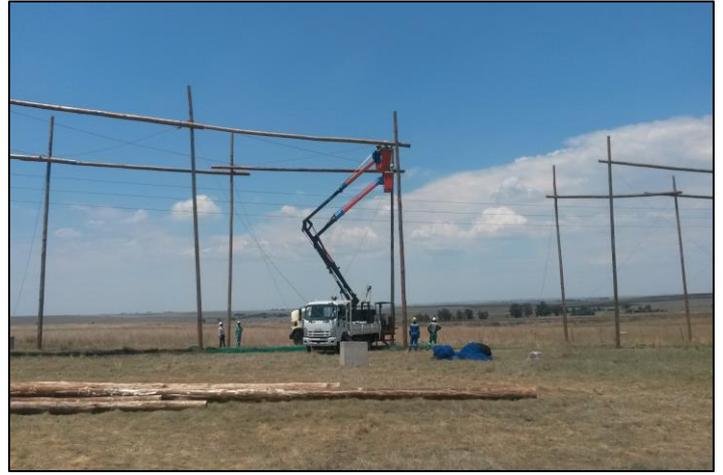
Figure 3: Erecting of H- poles.

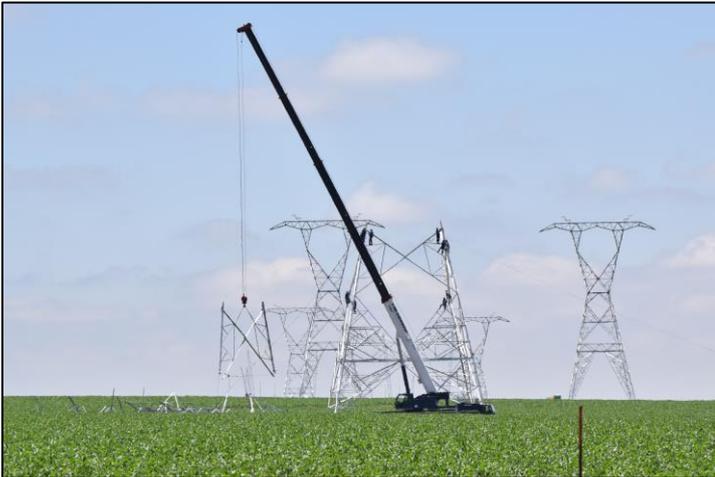
Figure 4: Tower Erecting.

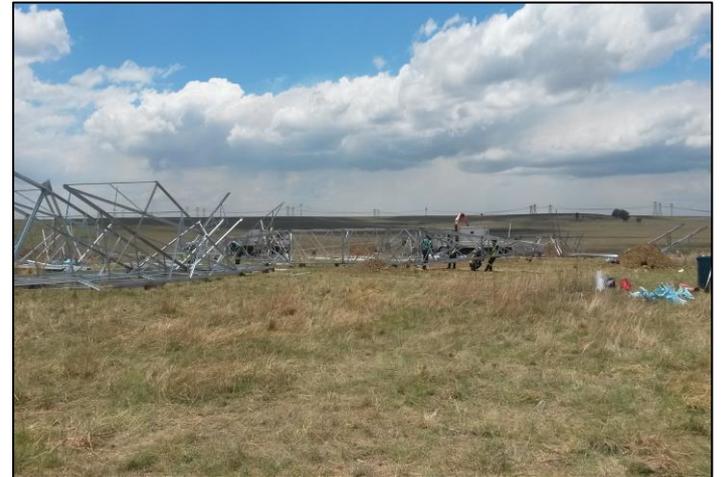
Figure 5: Assembling towers.

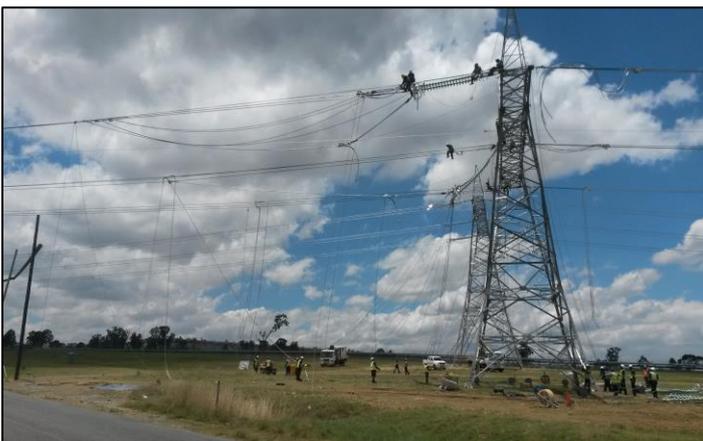
Figure 6: Stringing.

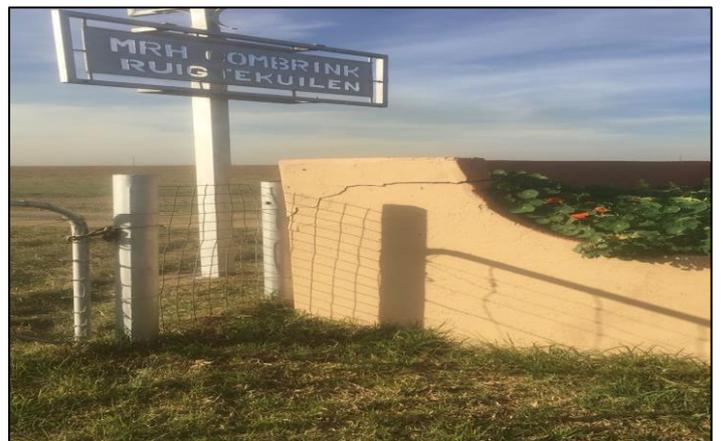
Figure 7: Farmer's damaged gate.
