## ENVIRONMENTAL MONITORING REPORT

**Power Lines from Kendal/Kusile to Zeus Substation Bravo  
Integration Project – Bravo 4: Construction of two 400 kV lines**

**Duvha By-Pass for Phase 5 of the Bravo Integration Project:  
Construction of 4 Towers**

# Kendal /Kusile to Zeus Environmental Monitoring Report

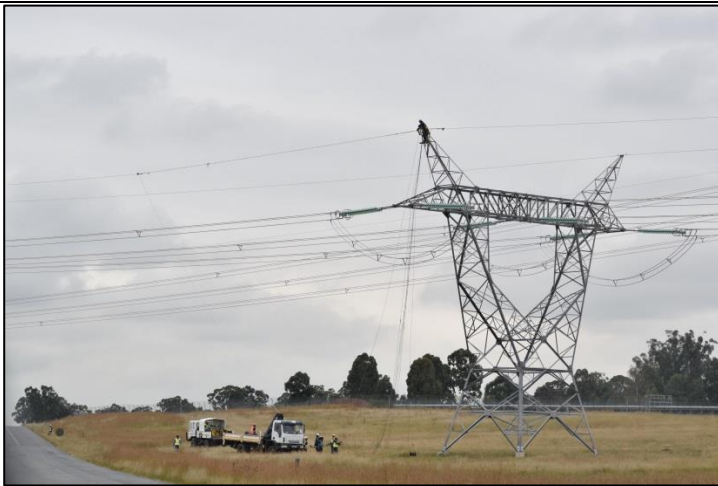
Figure 2: Stringing activities

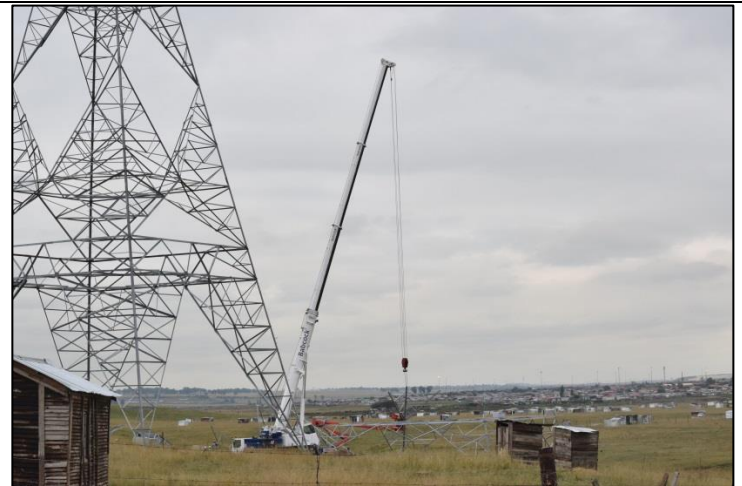
Figure 3: Crane assisting with tower erection.

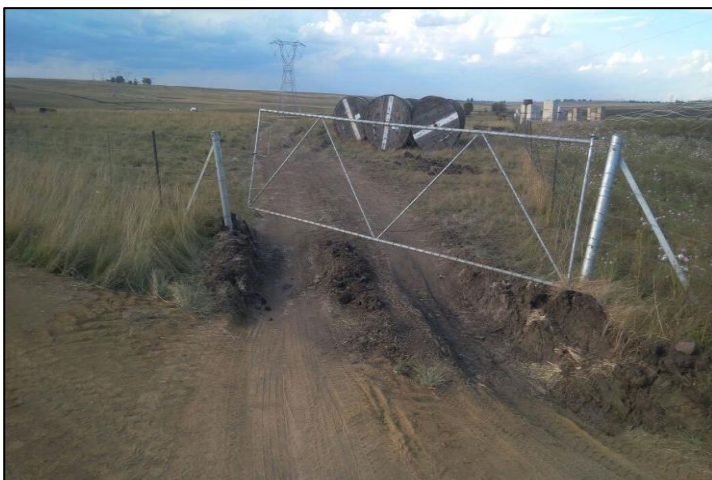
Figure 4: Damage gate on one of the farms
