ENVIRONMENTAL MONITORING REPORT

**Power Lines from Kendal/Kusile to Zeus Substation Bravo
Integration Project – Bravo 4: Construction of two 400 kV lines**

DEA Ref # 12/12/20/1095

Date: 31 August 2017

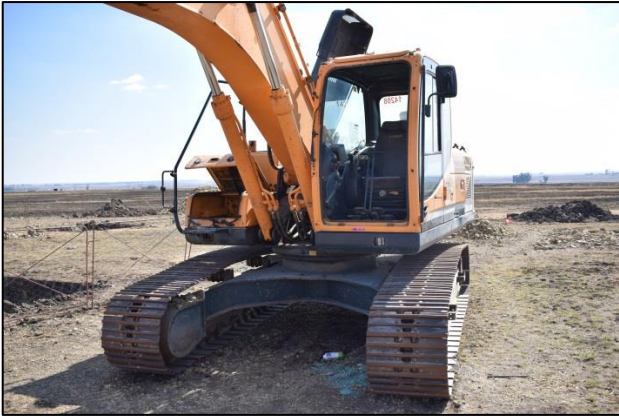
Section B - Babcock
Contractor is not formally closing off NCR`s
Truck drivers exceeding the speed limit on the farm roads
Environmental Officer not notifying the farmers prior when entering the farm.
Theft on an Excavator were the battery and some diesel was stolen

Figure 2: Theft at excavator

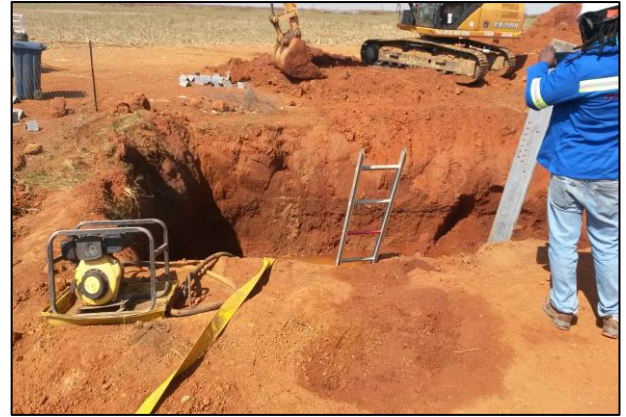
Figure 3: Pumping water out of excavated area

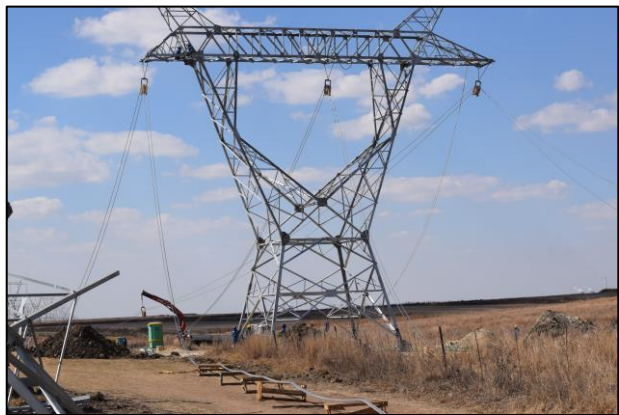
Figure 4: Stringing activities

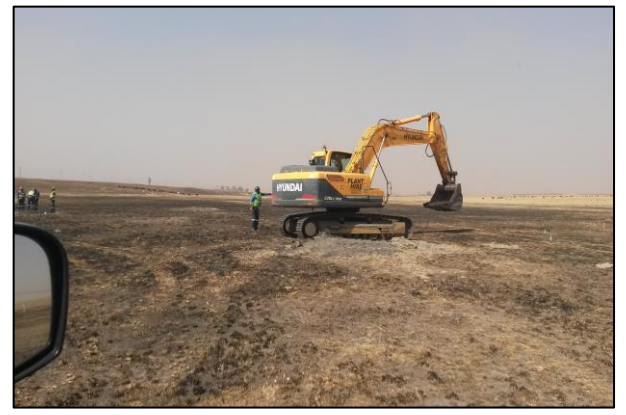
Figure 5: Excavator commencing with excavation

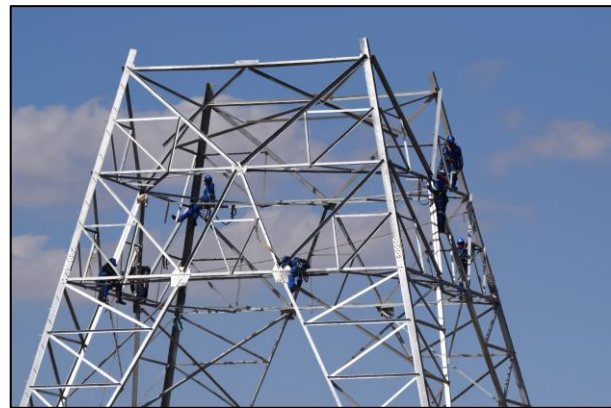
Figure 6: Tower Assembly

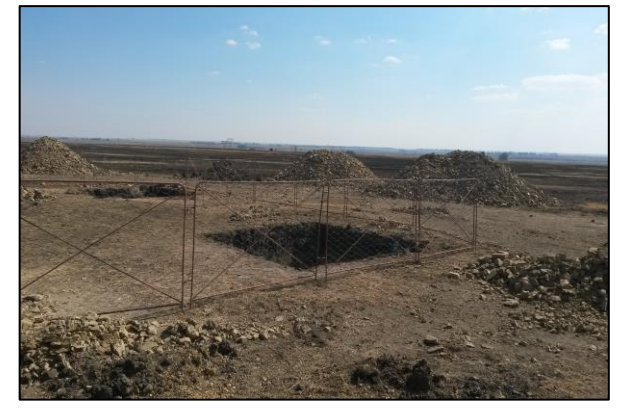
Figure 7: Fenced excavation
