ENVIRONMENTAL MONITORING REPORT

**Power Lines from Kendal/Kusile to Zeus Substation Bravo
Integration Project – Bravo 4: Construction of two 400 kV lines**

DEA Ref # 12/12/20/1095

Date: 29 September 2017

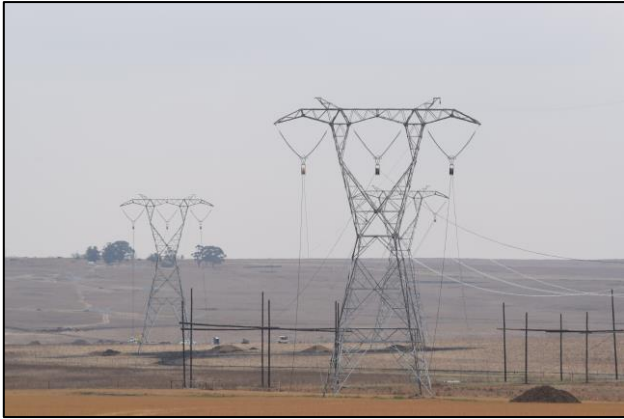
Figure 2: Stringing activities

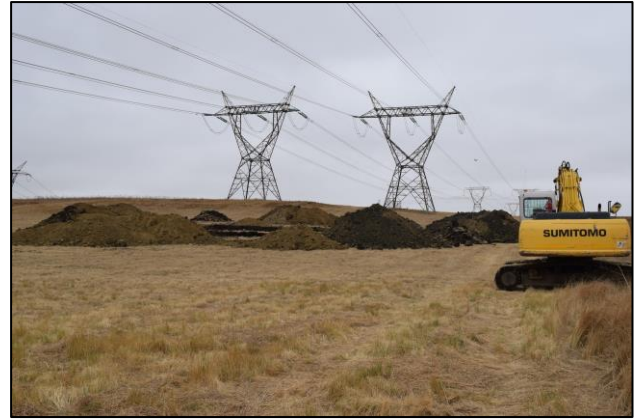
Figure 3: Excavating activities

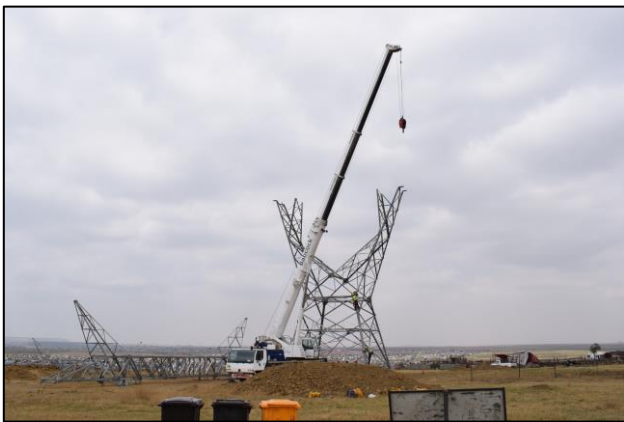
Figure 4: Tower Erecting

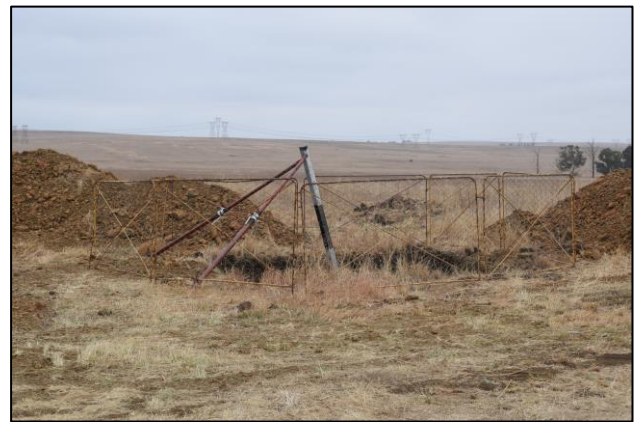
Figure 5: Fenced around trenches

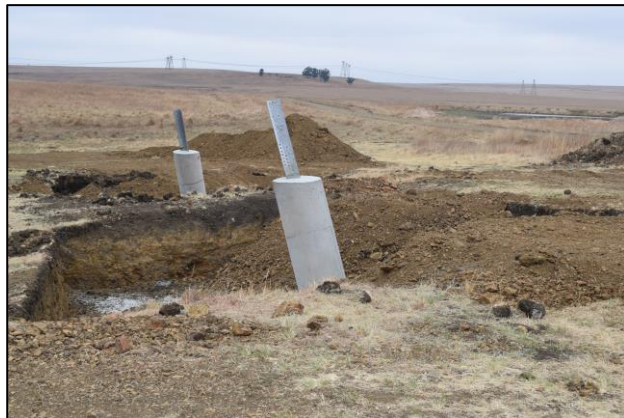
Figure 6: Backfilling

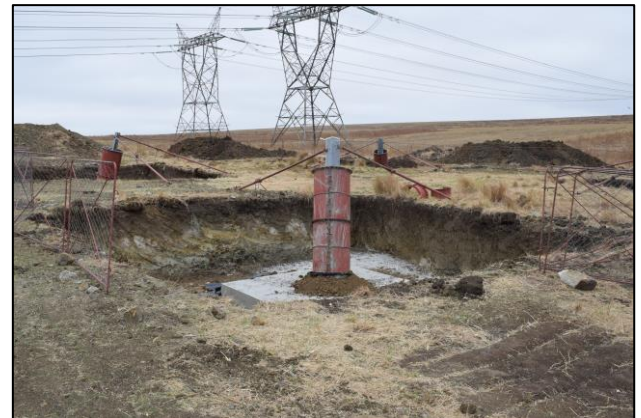
Figure 7: Shattering completed on V-blocks
