SITE CLOSURE REPORT

EXTENSION OF A CAR PARK AT KOEBERG NUCLEAR
POWER STATION ON CAPE FARM 1552,
DUYNEFONTYN, CAPE TOWN.

DATE: November 2021

REPORT NO: ECO/Koe/CLOSURE/11/2021

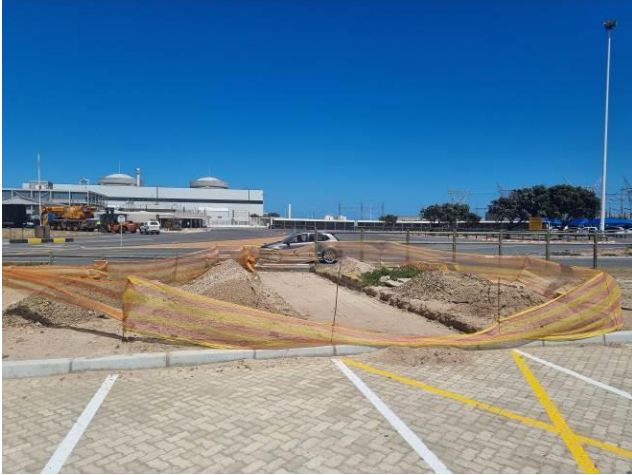
Image 1: Construction of pathway

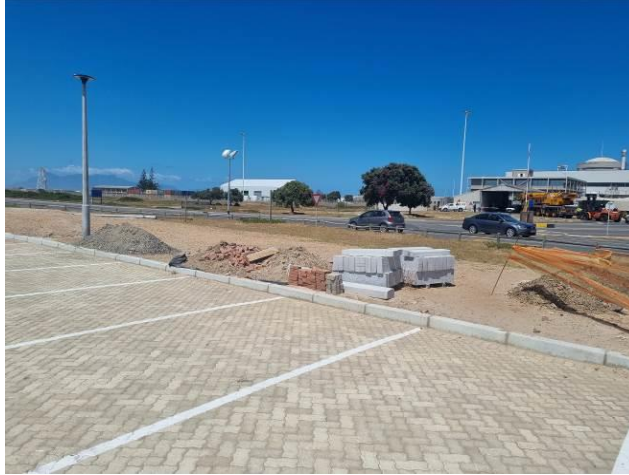
Image 2: Construction materials for the construction of the pathway

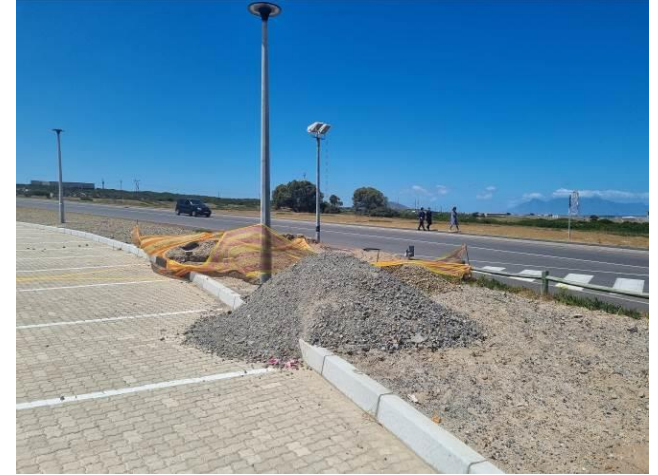
Image 3: Construction materials for the construction of the pathway

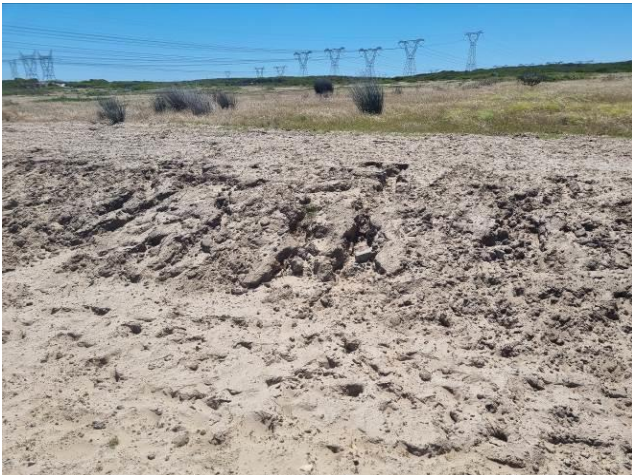
November 2021	COMPLIANCE WITH THE EMPR, METHOD STATEMENTS AND EA		
	Compliance Full/Part/Non	Comments/ Observations	Action to be taken
Areas which remain cleared are to be top soiled and re-vegetated.	Non-compliant	On the 19 th of November 2021, the ECO noted various areas along the parking lot and the V-drain had not been revegetated. As a result of this, erosion gullies have started to form on the V-drain.	The contractor is to ensure that provisions are made for the gullies to be backfilled with an appropriate topsoil. Furthermore, the contractor is to ensure that provisions are made for cleared areas to be appropriately revegetated. Alternatively, it falls on the Applicant (Eskom) to perform these duties.
All inert waste and rubble, including surplus rock, foundations and discarded concrete aggregates must be removed from site.	Full		
All domestic waste removed from site.	Full		
All construction related materials (barricade netting, wire, perimeter fence ect) must be removed from site.	Full

Image 4: Unvegetated V-drain

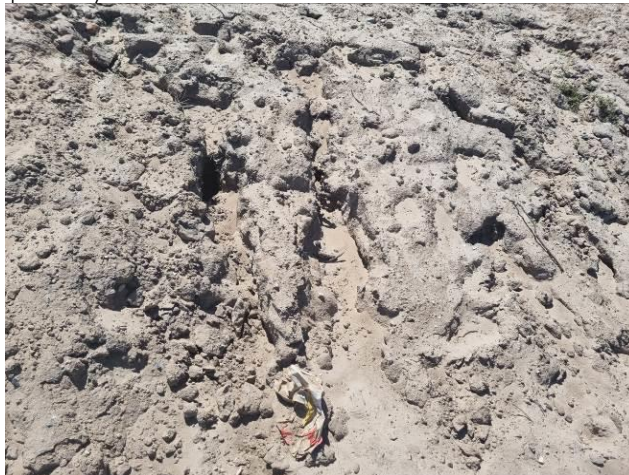
SES has compiled this Site Closure Report to detail compliance with the EA and EMPr for the closure of the Car park expansion site at KNPS. During the final site visit conducted by the ECO on the 19th of November 2021, evidence of hazardous waste, and the presence of gullies, formed as a result of exposed surfaces remaining unvegetated, was noted on site.

Image 5: Erosion gullies on V-drain

registered hazardous waste facility.		ECO noted the presence of a used concrete bag partly buried on site	that provisions are made for hazardous waste found on site to be removed from site and disposed of at a licenced landfill facility.
All excavations must be backfilled with <i>in situ</i> material.	Full		
All erosion gullies and runnels must be backfilled with <i>in situ</i> material.	Non-compliant	On the 19 th of November 2021, the ECO noted the presence of gullies formed on the V-drain by water erosion, due to soil be exposed without an appropriate cover crop.	In the short-term, the contractor is to ensure that provisions are made for the gullies formed on site to be backfilled with appropriate topsoil. However the contractor must ensure that an appropriate cover crop is planted on the V-drain to avoid future gullies from forming. Alternatively, it falls on the Applicant (Eskom) to perform these duties.

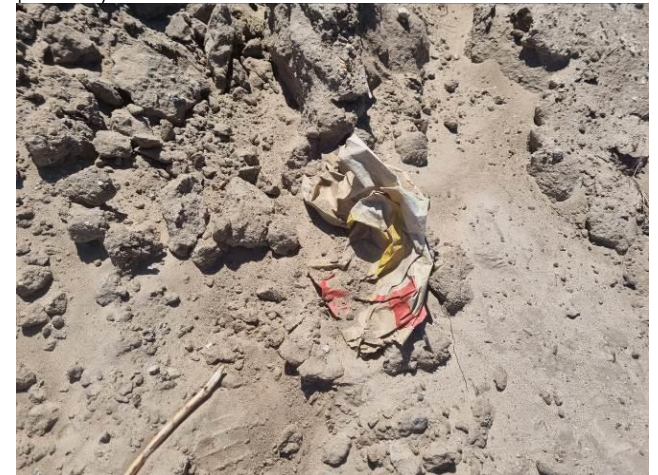
Image 6: Used concrete bag found on site

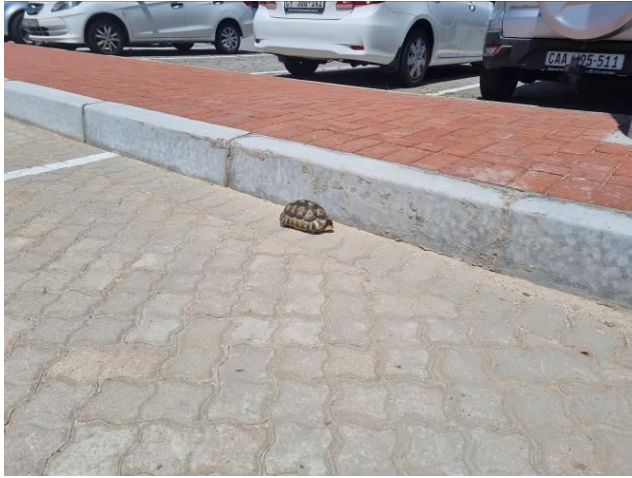
A local tortoise was found to be trapped within the parking lot. It must be noted that no routes for trapped tortoises to escape the parking lot has been incorporated into the final design of the parking lot. If trapped, the tortoise will not be able to leave, or have access to water and it is advised that a solution is found for this, such as an exit ramp.

Image 7: Trapped tortoise on site

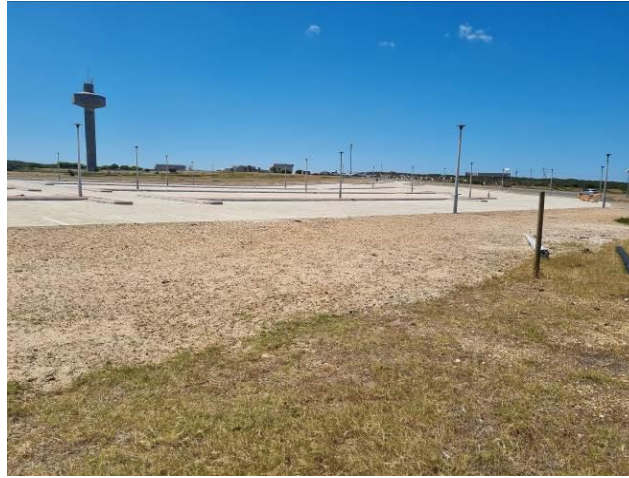
Image 8: Cleared areas remain unvegetated
