## EXPANSION OF THE KOMSBERG MAIN TRANSMISSION SUBSTATION AND ASSOCIATED INFRASTRUCTURE NEAR SUTHERLAND, WITH THE KAROO HOOGLAND LOCAL MUNICIPALITY IN THE NORTHERN CAPE

### MONTHLY MONITORING REPORT

DATED: 28 MAY 2019

DEA REF: 14/12/16/3/3/1/1482

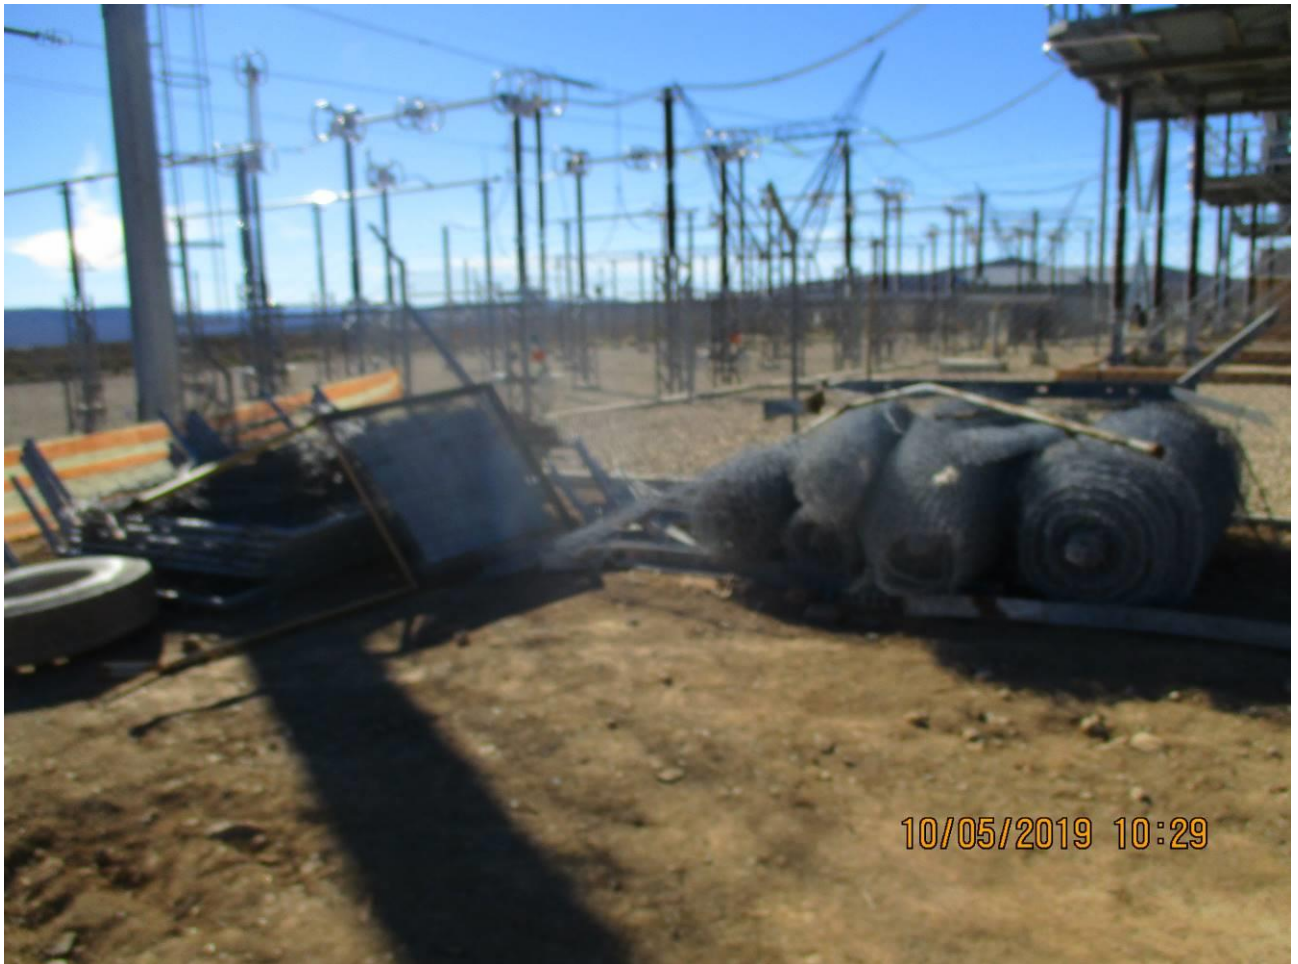
It was observed that all material used for construction are neatly stacked and stored at the laydown area.

Photo 1: Good practice of stacking and storage of material.

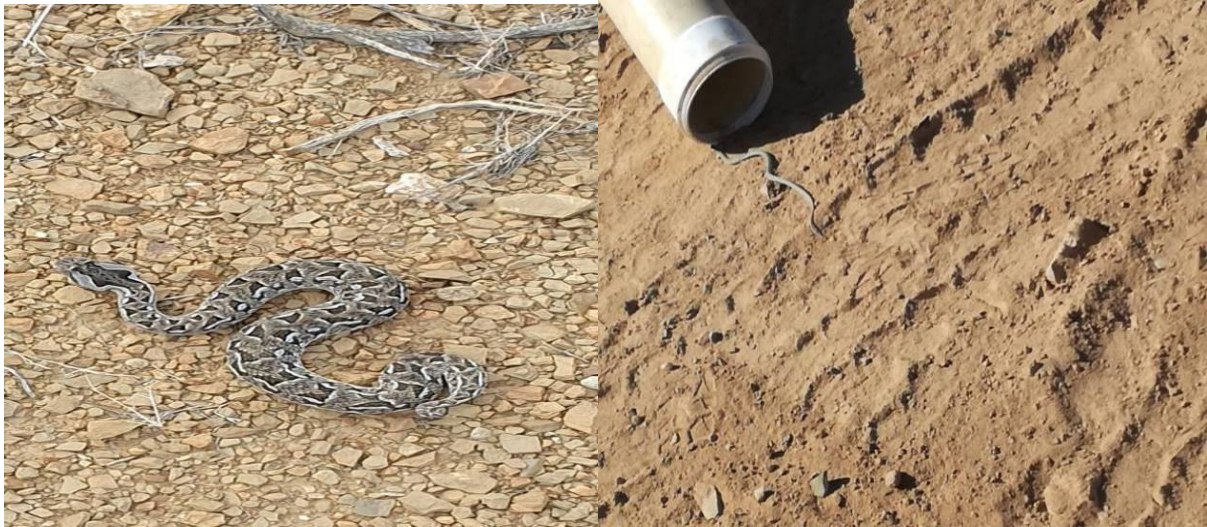
Two snake Berg adder (*Burke's adder*) and Karoo Whip snake were sighted on site and they were all removed to the nearest safe environment.

Photo: Berg adder (*Bitis atropos*) relocated. Photo: Karoo Whip snake.

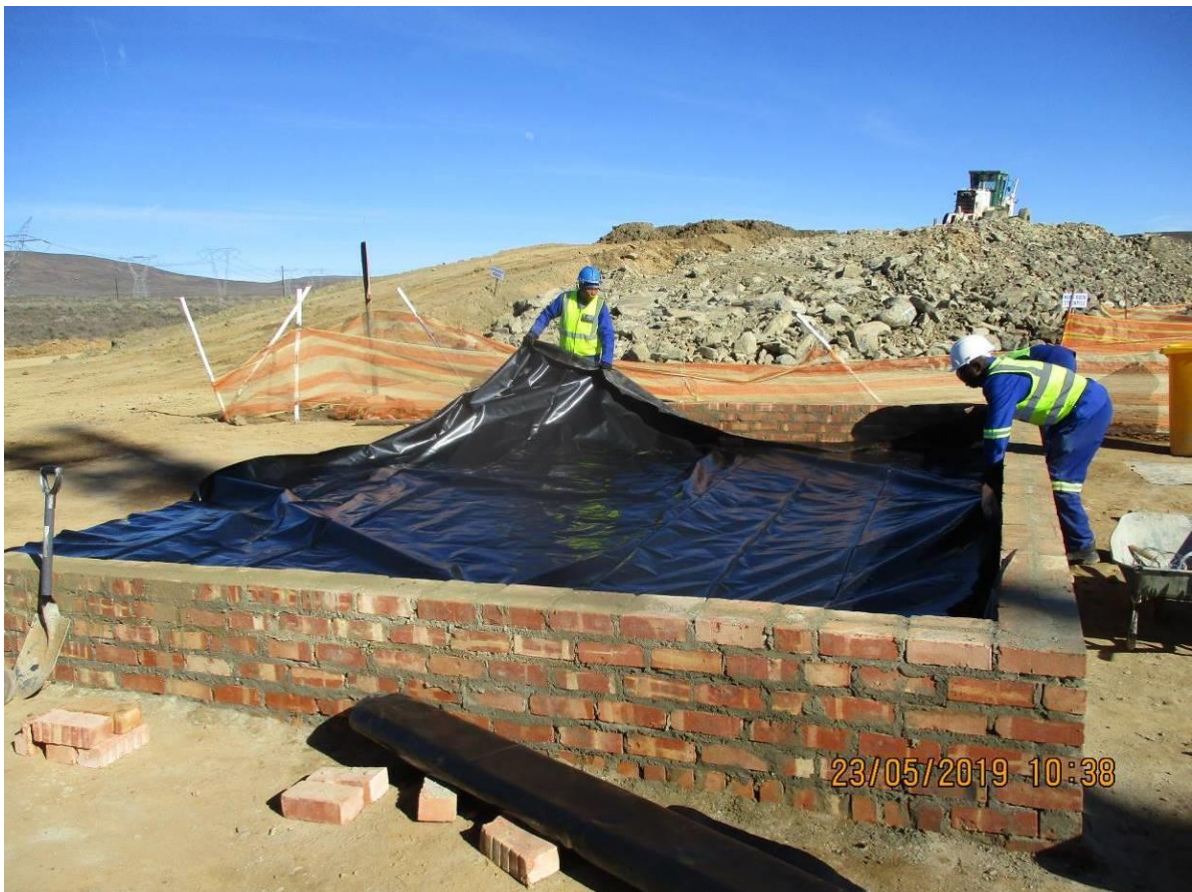
The construction of bund for servicing or repair of construction vehicle area is in progress.

Photo: Bund area for repair of servicing of vehicle.

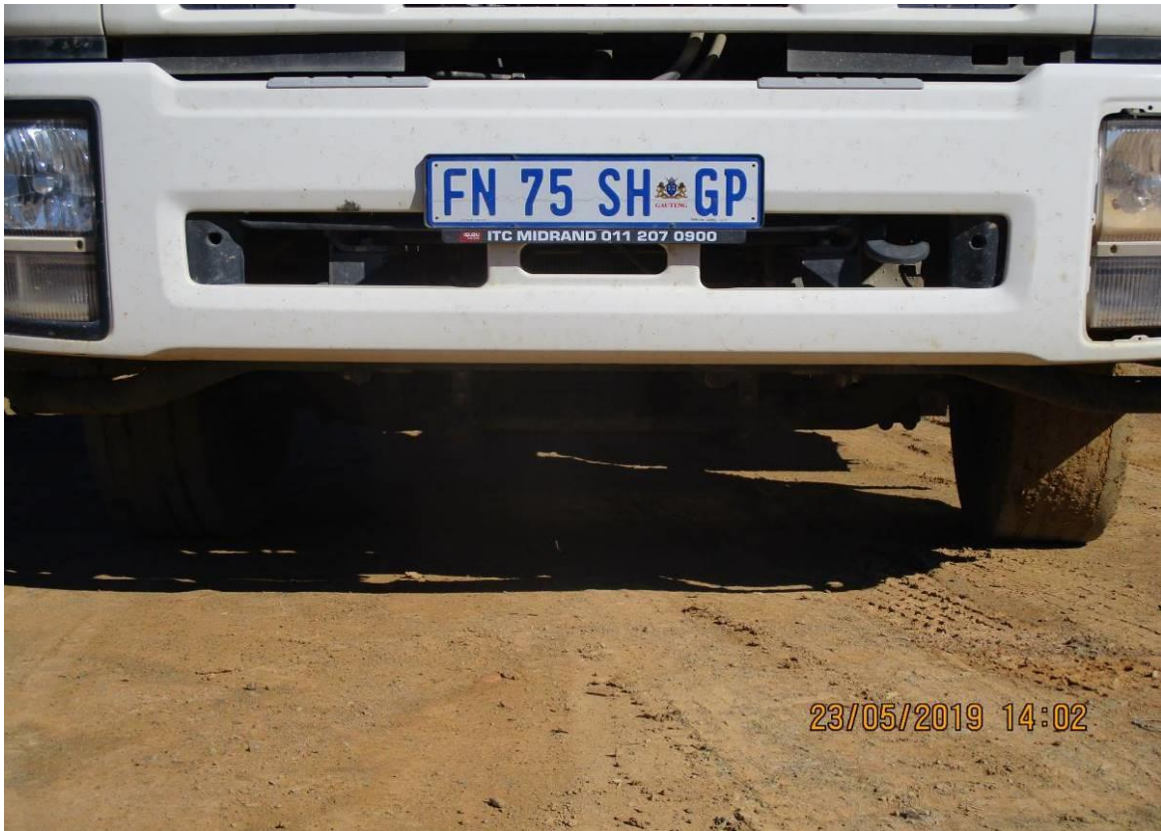
1. No designated waste bins for storing oil rags, oil rags are found all over the laydown area.
2. Minor oil spills at the refuelling area.
3. Development foot print are not demarcated.
4. Stationary truck parked without drip tray.

Photo: Stationary truck parked without drip tray.

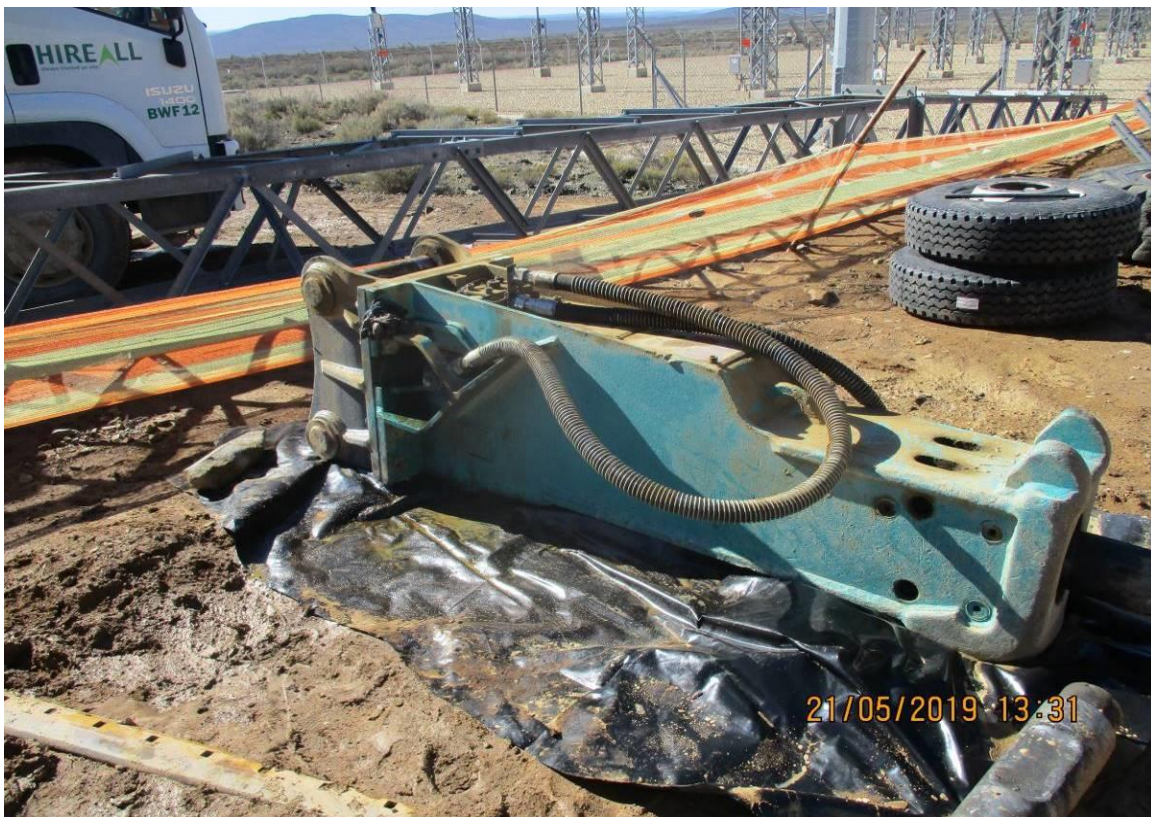
<b>EMPr Section</b>	<b>Findings</b>	<b>Suggested Corrective Action and Actual Corrective Action.</b>
Objective 3 and 6	No sufficient Fire-fighting equipments such as fire beaters to fight fire.	Sufficient Fire-fighting equipments such as fire extinguisher, fire beaters must be available and easily accessible.
Objective 16	No specific areas designated for the temporary management of various waste streams, i.e. general refuse, construction waste (wood and metal scrap) and contaminated waste.	A designated and banded area must be designated for management of all waste stream on site.
Objective 16	Hazardous chemical and fuels stored are not within the banded area and sealed surface.	All hazardous chemical substance must be stored within the bund and on sealed surface area.
Objective 16	Excavator packer is placed	Construction machinery must be

on the bare ground without measure in place to prevent soil contamination.	stored within a bunded area and on a sealed surface. Bund or sealed surface must be provided for the placement of such
Observe 16.	No copy of the permit for landfill facility used to disposed general and of permit for treatment water works used to sewage waste.	Disposal of waste must be in accordance with relevant legislative requirements, including the use of licensed contractors and licensed waste disposal sites. A copy of license must be available of site.
Objective 17	Construction vehicle was found parked on site without drip tray.	Drip trays must be placed under stationery machineries in sensitive areas. A toolbox talk must be conducted to all Operators/Drivers

Photo: Excavator packer is placed on the bare ground without effort/measure in place to prevent soil contamination

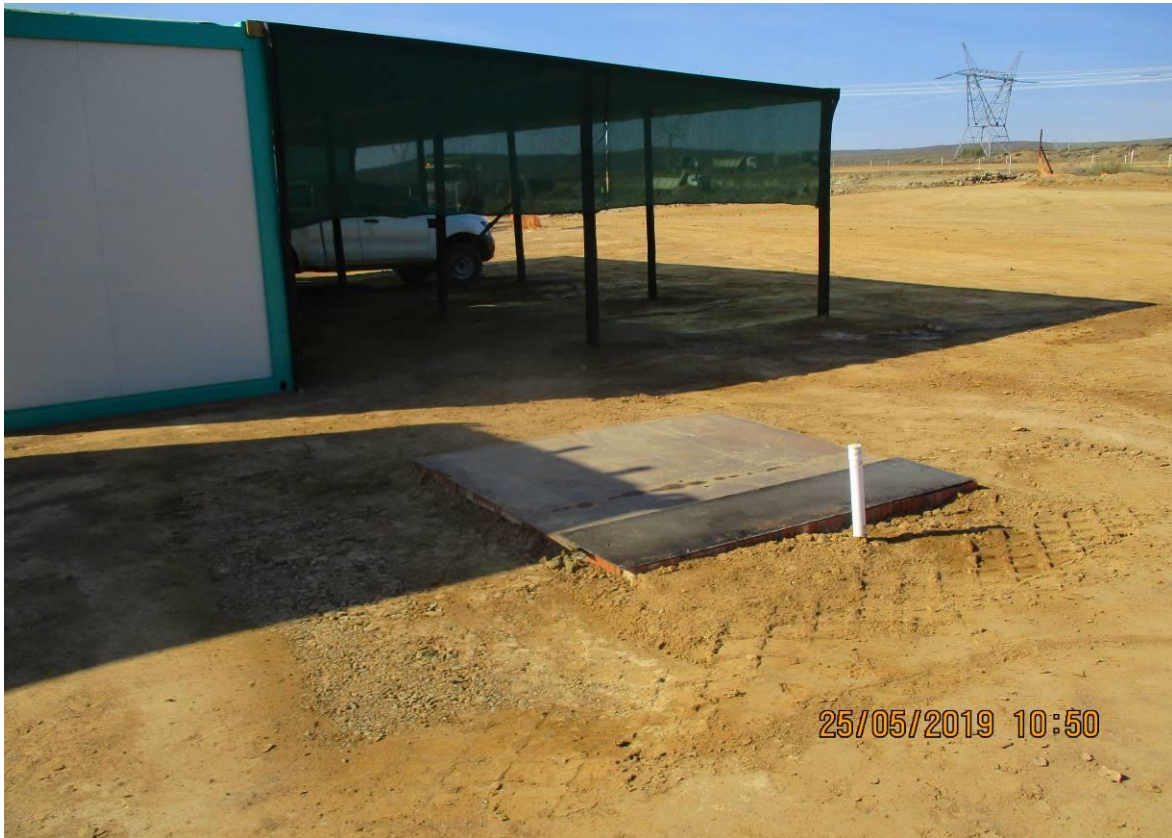
Photo: Constructed bund for underground septic tank.

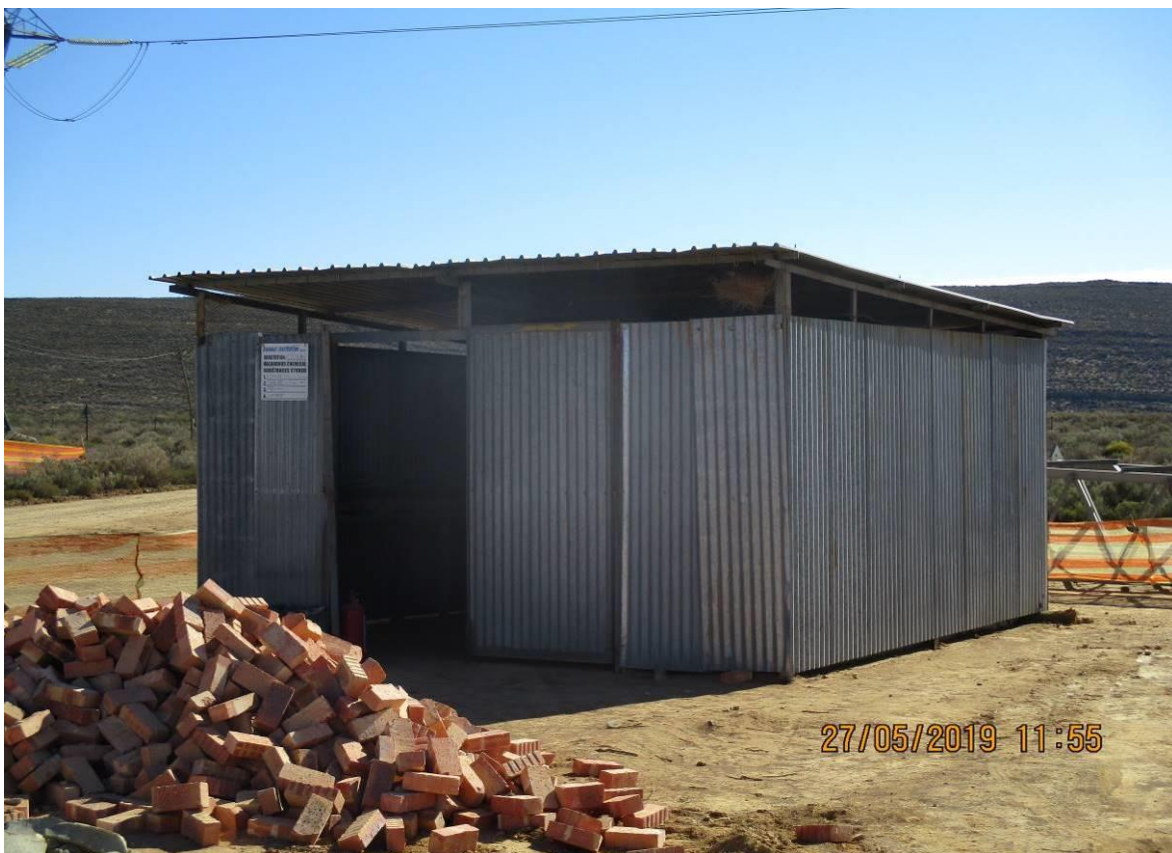
During the inspection it was observed that no dedicated store controller, controlled access and necessary signage at the temporary hazardous store.

Photo: Hazardous store that does not meet the minimum requirements.

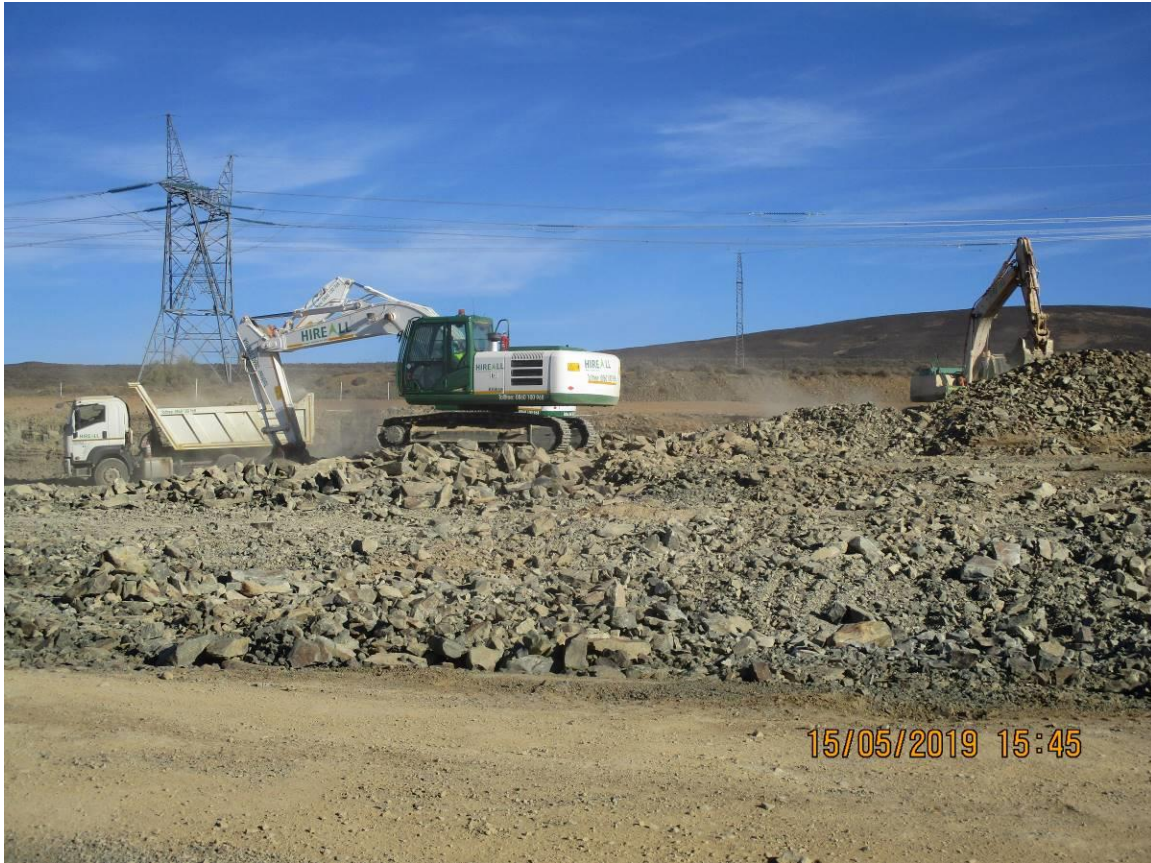
Photo: Bulk earthworks at Section B of 132kV terrace.

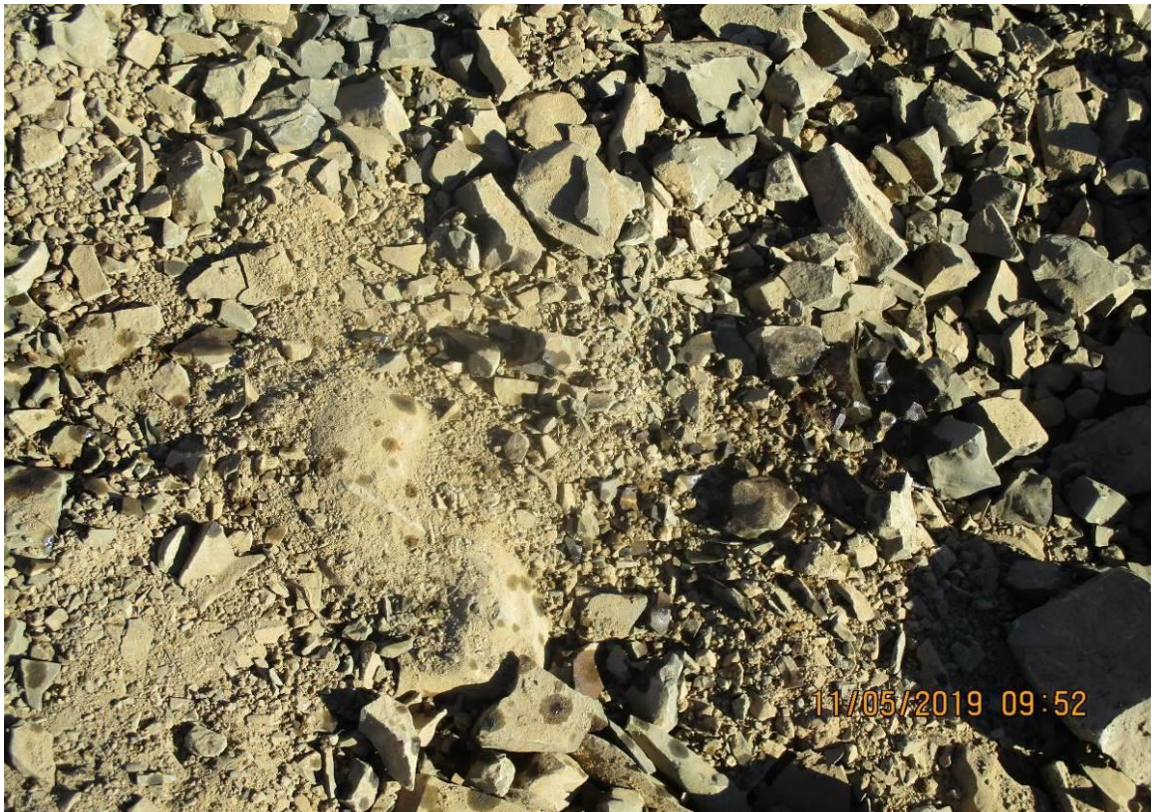
The contractor is strongly advised to make every effort to prevent spills and leakages on site. Regular maintenance of construction vehicle is essential to prevent unnecessary oil spills. During the reporting period **they** were three (3) **minor** spillages observed and one (1) chemical spills. All oil spills minor or major must be cleaned immediately and reported to the ECO. All spill were cleaned up and contaminated soil were temporarily stored into hazardous waste bins.

Photo: Minor oil spill at Section B of 132kV terrace.

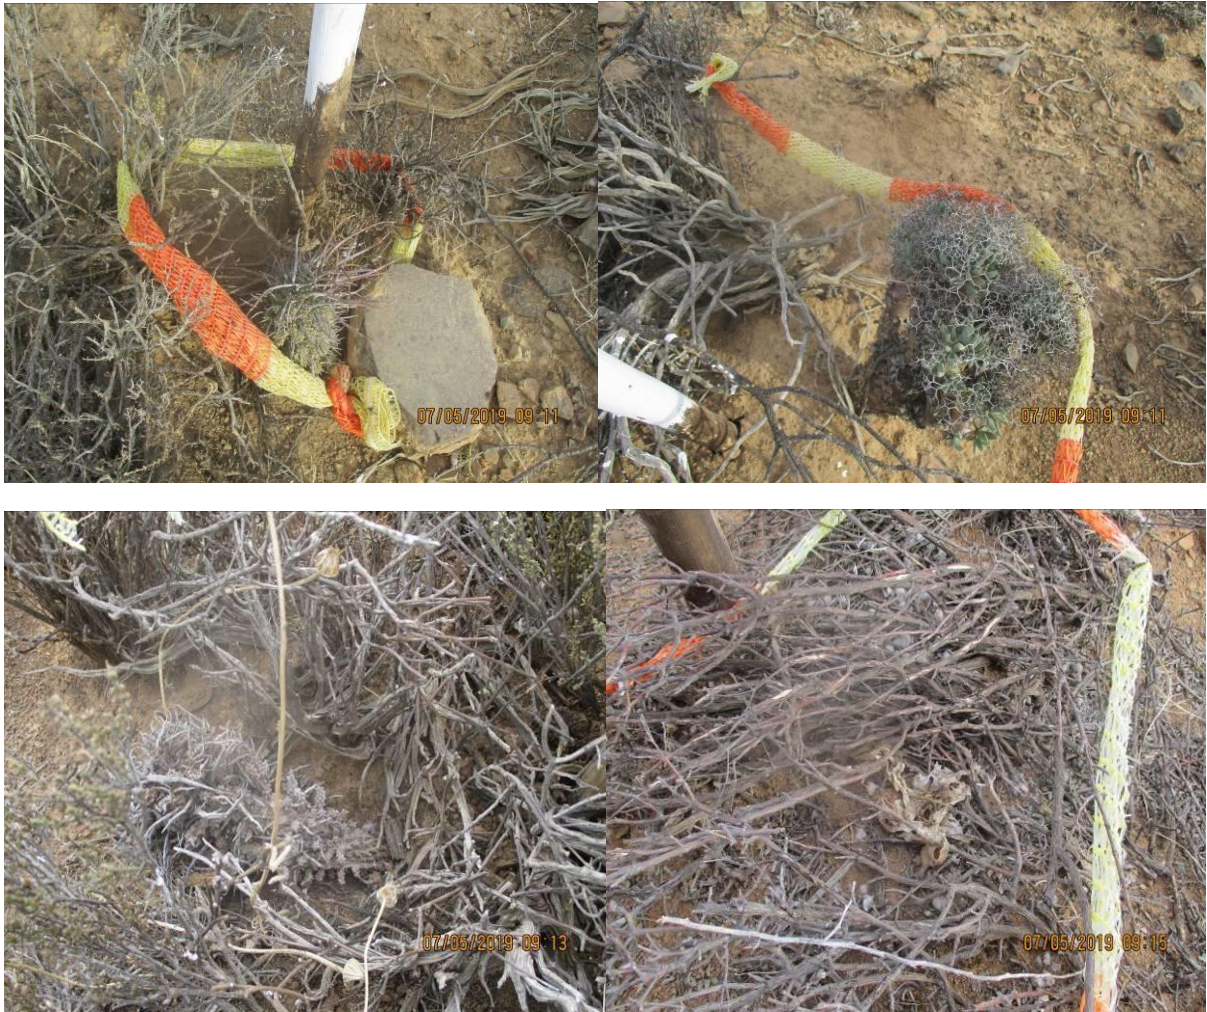
During the inspection it was observed that not all endangered/ protected/ threatened species that are on the development foot print are identified and marked during the walk down for search and rescue of threatened/ protected species. Most of those species are Protected according to Schedule 2 of the Northern Cape Nature Conservation Act, 2009 (Act No. 9 of 2009). Permits will be required from Northern Cape Department of Environment and nature Conservation (NC DENC) to remove or translocate protected plant species.

Photo: Identified endangered/ protected and threatened plant species that need to be rescued.

It is recommended that all areas of development must be clearly marked on-site to eliminate the potential for unnecessary clearing in order to minimise impacts on flora, fauna and ecological processes.
