EXPANSION OF THE KOMSBERG MAIN TRANSMISSION SUBSTATION AND ASSOCIATED INFRASTRUCTURE NEAR SUTHERLAND, WITH THE KAROO HOOGLAND LOCAL MUNICIPALITY IN THE NORTHERN CAPE

MONTHLY MONITORING REPORT

DATED: 29 AUGUST 2019

DEA REF: 14/12/16/3/3/1/1482

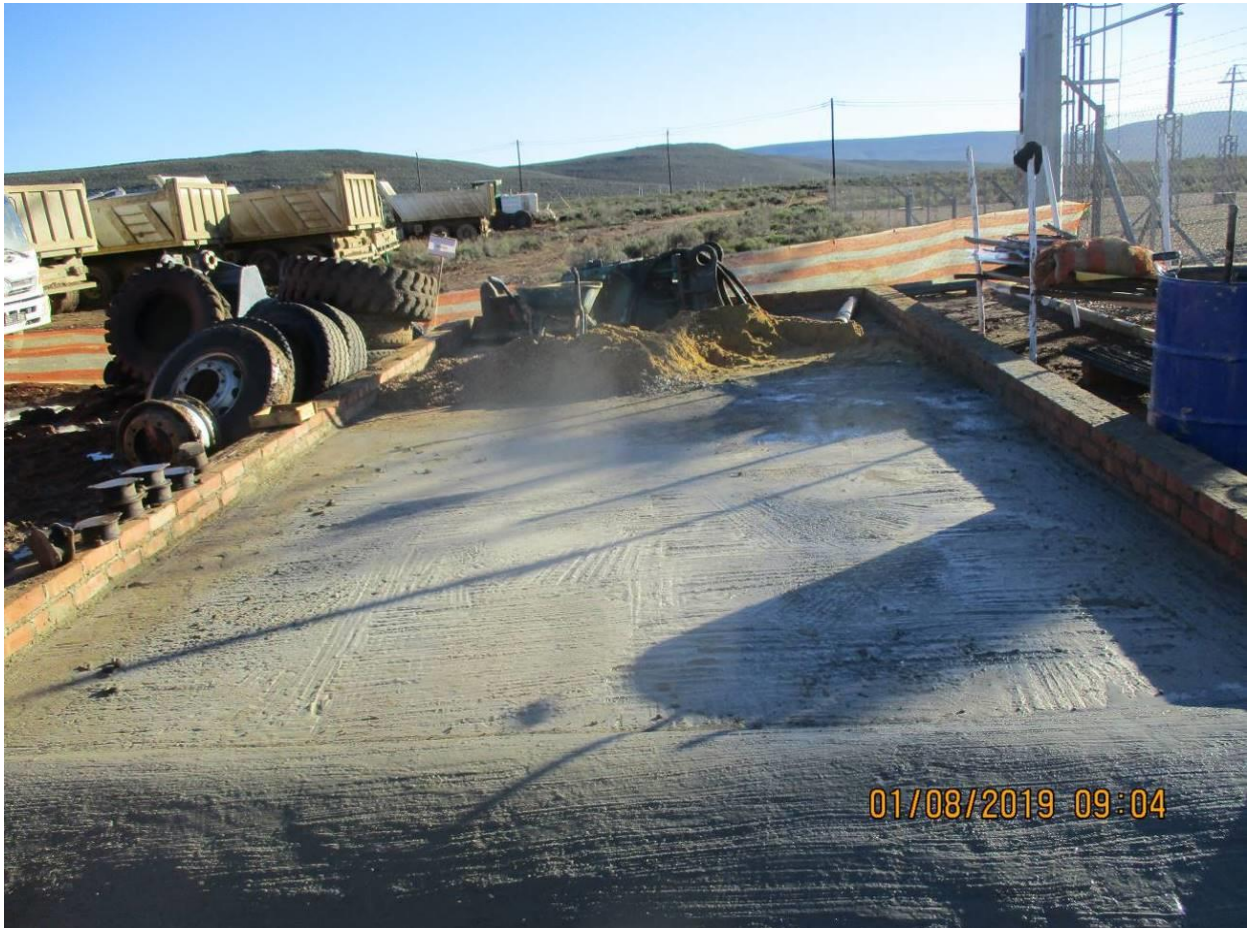
The construction of bund for servicing or repair of construction vehicle area is in place. However there is no measure in place to prevent pollutants reaching the surround environment (oil/water separator).

Photo: Vehicle servicing area.

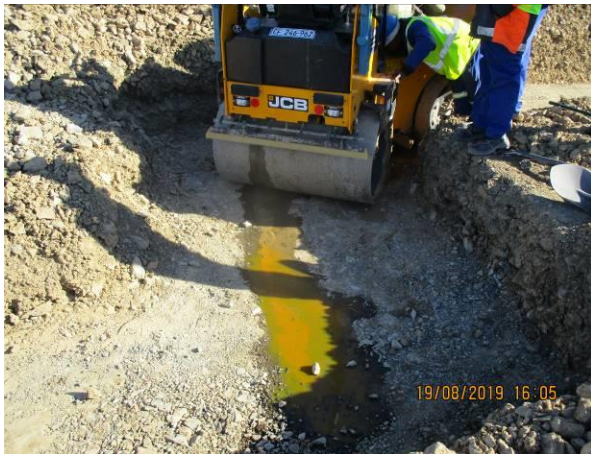
Photo: Hydraulic pipe burst from bomag roller. Photo: cleaning in progress.

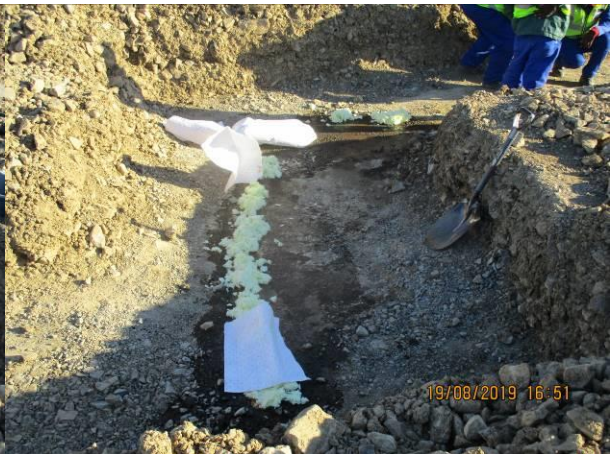
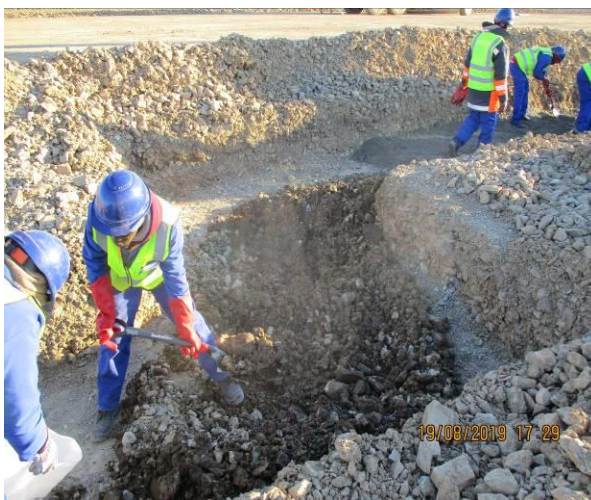
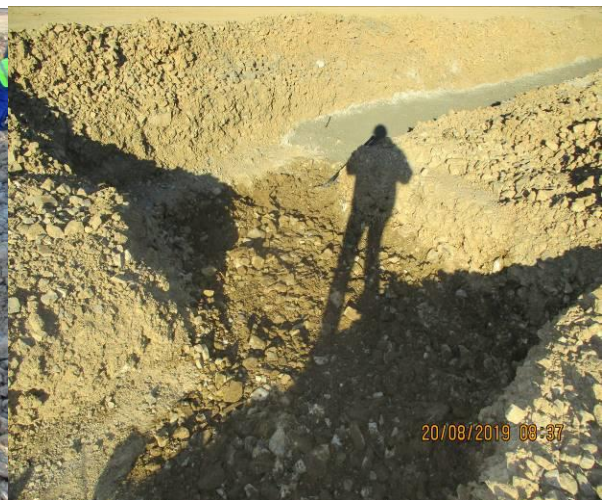
Photo: Cleaning in progress.

Photo: final clean up.

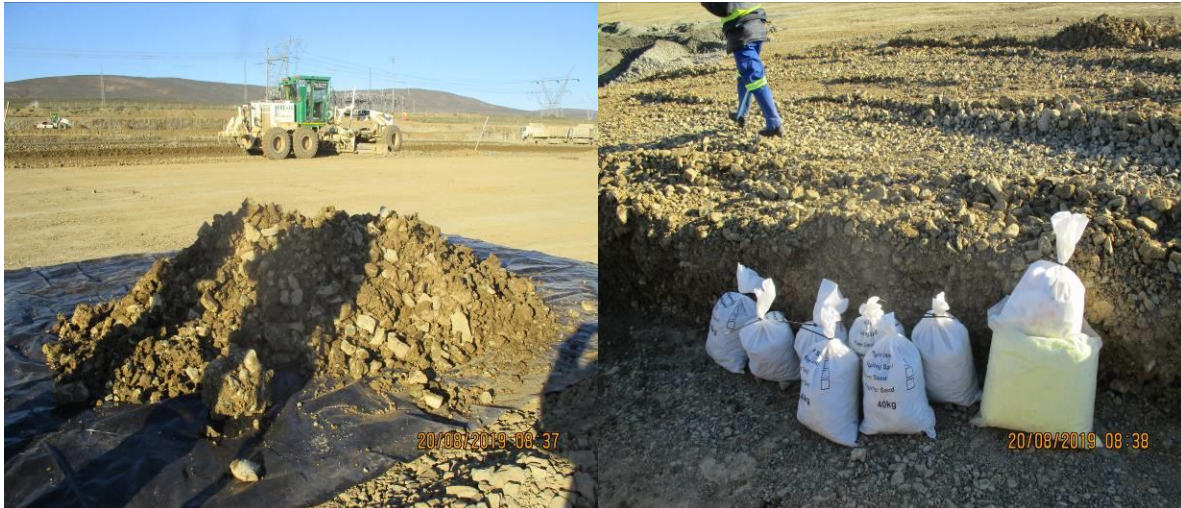
Photos: Contaminated soil from the incident (hydraulic pipe burst from bomag roller: date 19/08/2019)

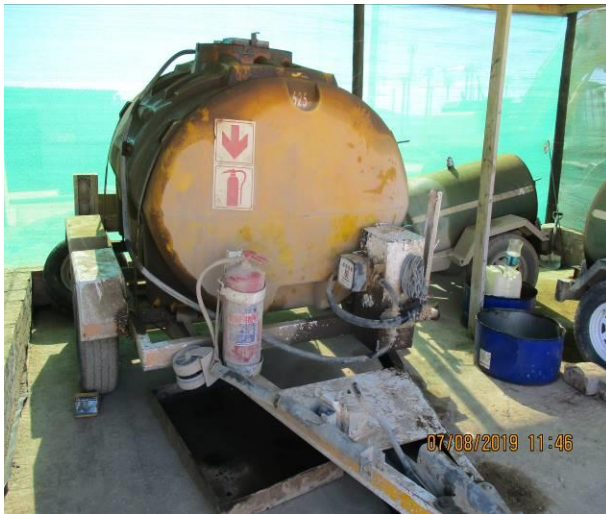
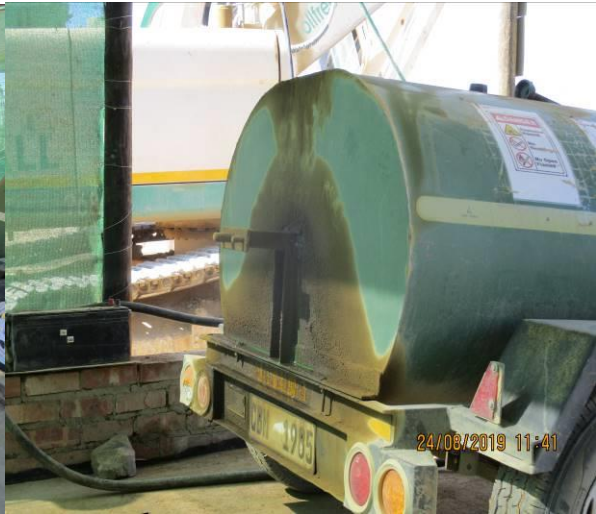
Photos: Leaking diesel bowsers.

Objective 6	Damaged fence at the adjacent property by the excavator delivery trucks. The damage must be reported to the affected landowner ASAP and the fence to be fixed immediately to his satisfaction.	Should there be any damage to private property and/or loss of livestock, game and/or other fauna that can be linked to the Contractor, or any subcontractor, the landowner shall be compensated accordingly upon sufficient proof thereof.	Partially Closed
Objective 16	Multiple hydrocarbon spills at section D of 400kV terrace.	Any spills must be reported, accessed and receive the necessary clean-up action immediately.	Closed
Objective 16	Waste skip not labelled.	Hazardous and non-hazardous waste must be separated at source. Separate waste collection bins must be provided for this purpose. These bins must be clearly marked and appropriately covered.	Open
Objective 17	Diesel bowser leaking.	All leaks must be fixed immediately.	Open

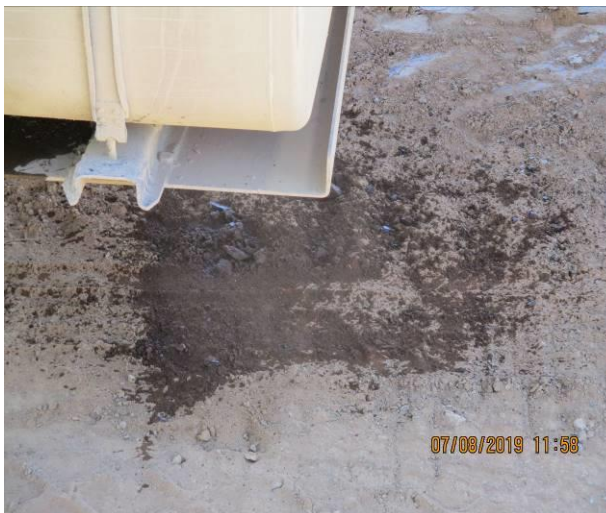
Photo: Diesel spill at refuelling area.

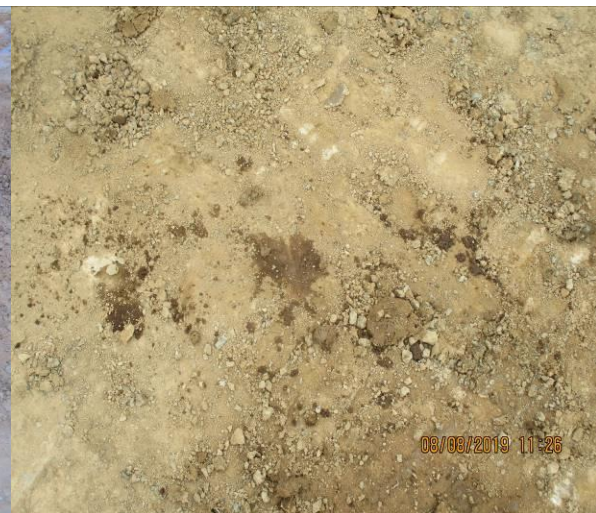
Photo: Oil spill at the laydown area.

EMPr Section	Findings	Suggested Corrective Action and Actual Corrective Action.	status
Objective 16	Unattended multiple oil spill at the laydown area.	Any spills must be reported, accessed and receive the necessary clean-up action immediately.	Closed
Objective 16	Unattended diesel spills from front end loader at the crushing area.	Any spills must be reported, accessed and receive the necessary clean-up action immediately.	Closed
Objective 17	Tipper truck (BDT 48) parked on site without a drip tray.	Drip trays must be placed under stationery machineries in sensitive areas.	Closed
Objective 17	Multiple oil and diesel leaks from bulldozer. All the leaks must be properly fixed before it can continue working.	Corrective action must be undertaken immediately if a complaint is made, or potential/actual leak or spill of polluting substance identified. All leaking machinery must be taken for service area for repairs.	Closed

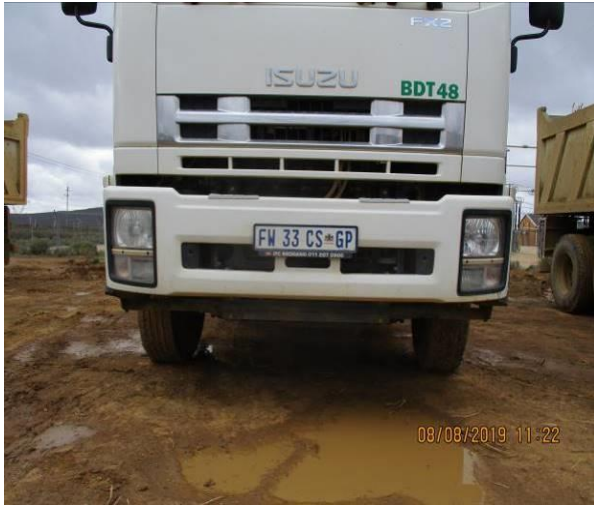
Photo: Tipper truck parked without a drip tray. Photo: Leaking bulldozer that need repair.

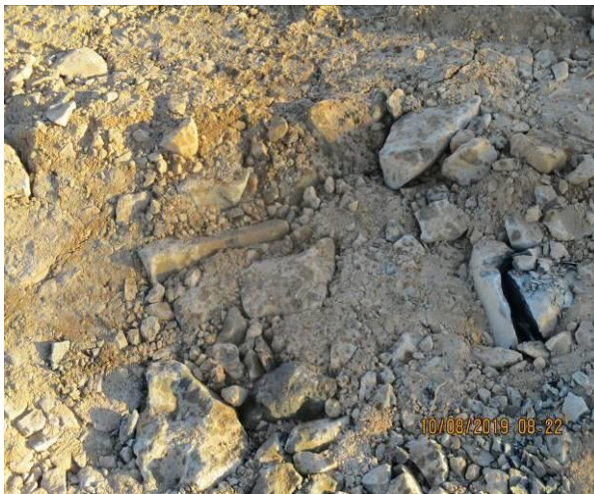
Photo: Oil spill at section D of 132kV terrace. Photo: Oil spill at the laydown area.

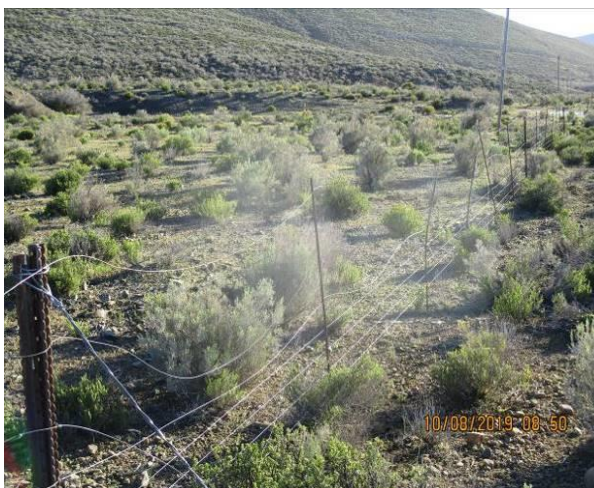
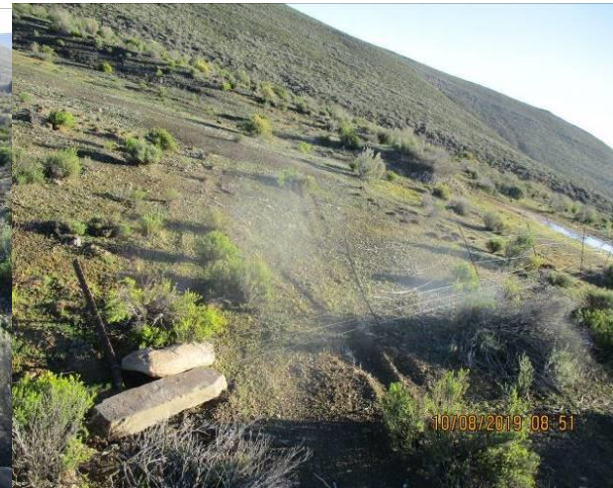
Damage of fence at the adjacent property by the excavator delivery trucks was observed during site walk. The damage was later reported to the affected landowner and the fence was temporarily fixed and it was agreed with the landowner that the fence will be properly fixed towards the end of the earthworks project.

Photo: Damaged fence at the adjacent property by the excavator delivery trucks.

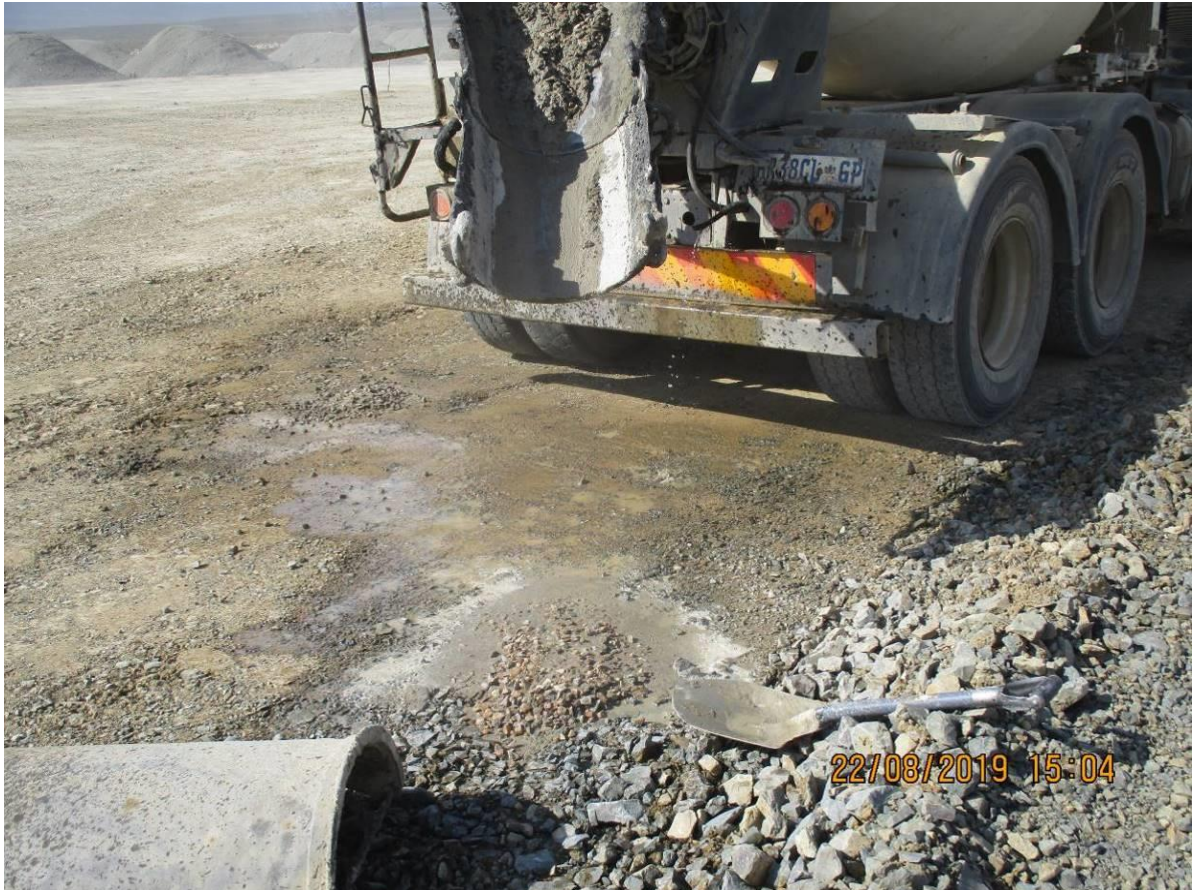
Photo: Concrete spill from mixer truck (Operator washed access concrete on the terrace).

Objective 17	Concrete spill	Spilled cement and concrete must be cleaned up as soon as possible and	Open

disposed of at a suitably licensed waste disposal site. All operator/drivers from external ready mix concrete supplier must be made aware that no washing of access concrete chute on site during visitors induction.	
Objective 16	Unattended oil spill at the designated parking area.	Any spills must be reported, accessed and receive the necessary clean-up action immediately.	Open

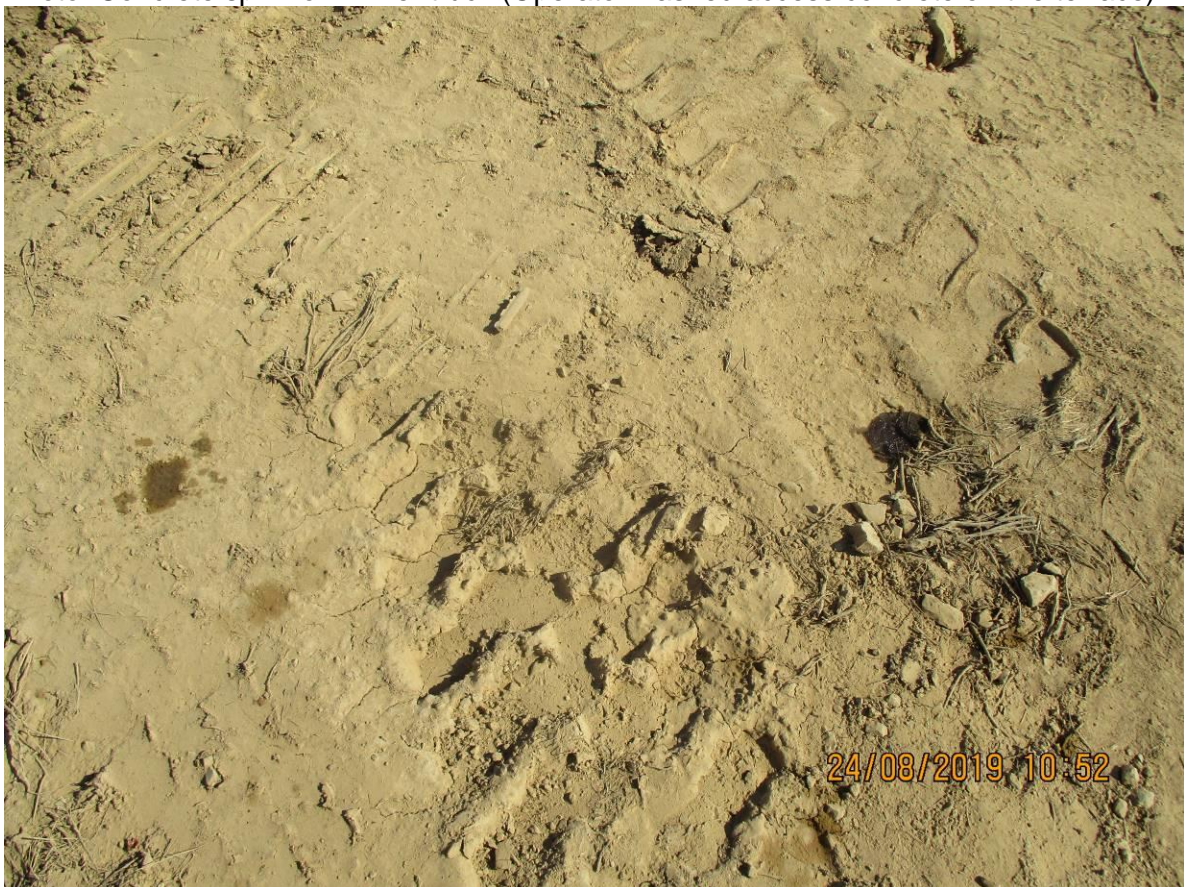
Photo: Unattended oil spill at the parking area.

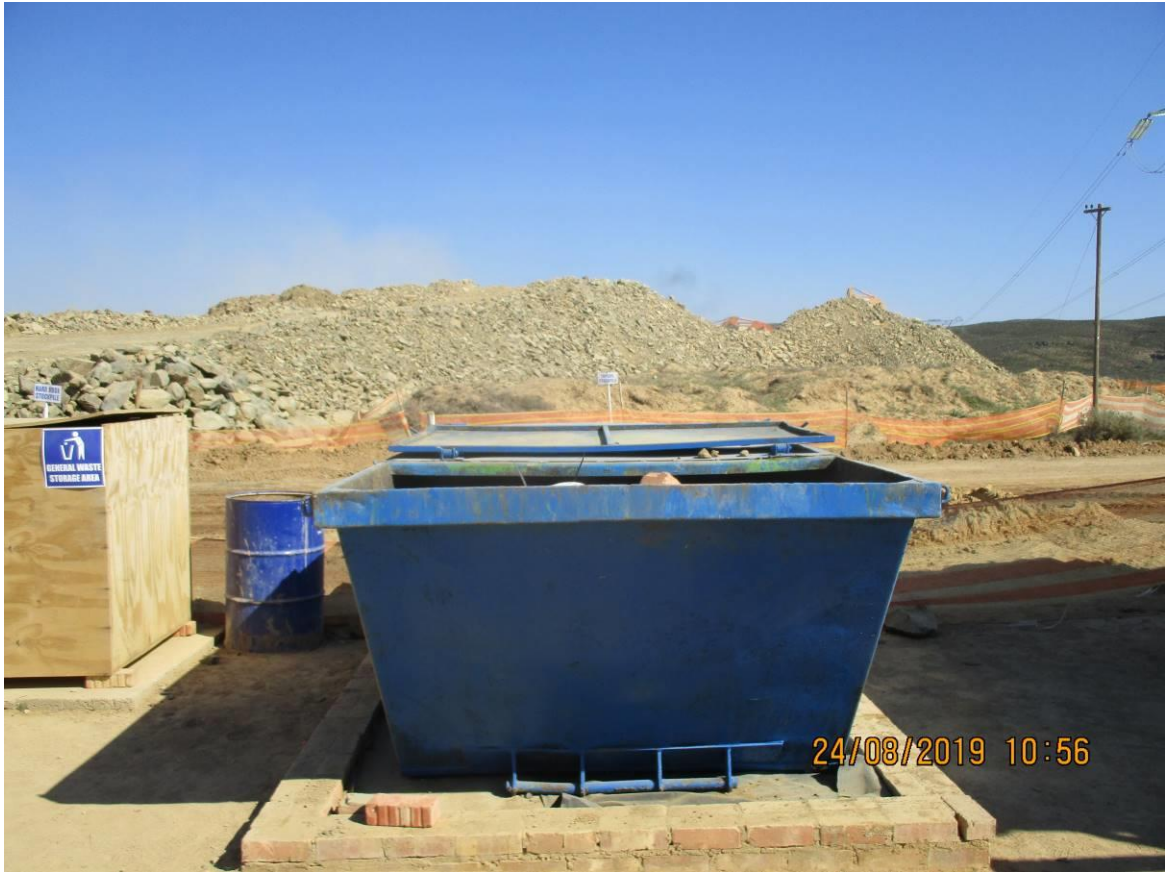
Photo: Waste kip not labelled.
