## EXPANSION OF THE KOMSBERG MAIN TRANSMISSION SUBSTATION AND ASSOCIATED INFRASTRUCTURE NEAR SUTHERLAND, WITH THE KAROO HOOGLAND LOCAL MUNICIPALITY IN THE NORTHERN CAPE

### MONTHLY MONITORING REPORT

DATED: 30 SEPTEMBER 2019

DEA REF: 14/12/16/3/3/1/1482

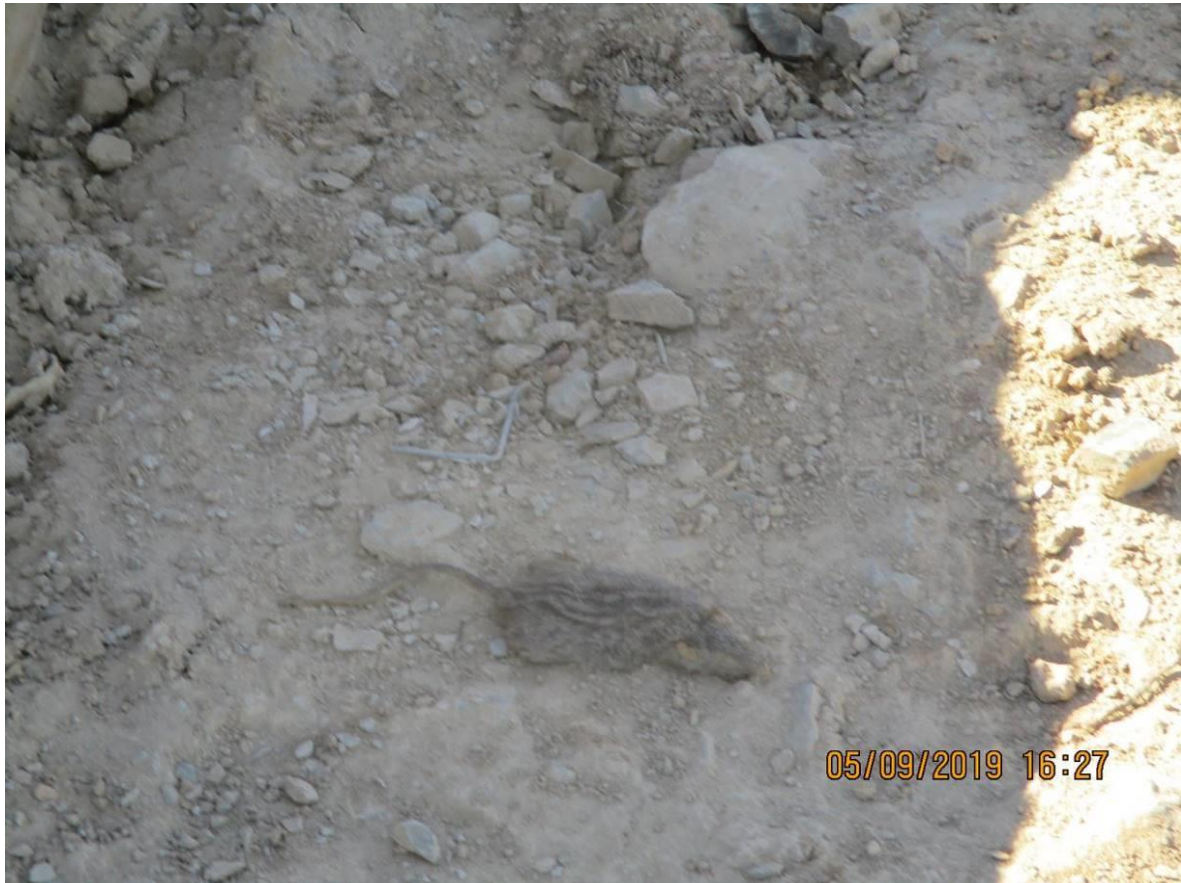
Four-striped grass mouse (*Rhabdomys pumilio*) was observed dead next to the servicing area that might have been died or killed due to human negligent. Employees, visitors and/or subcontractors should be made well aware of the consequences of any damage to private property and/or loss of livestock, game and/or killing of other fauna.

Photo: Dead four-striped grass mouse (*Rhabdomys pumilio*) observed next to the servicing area.

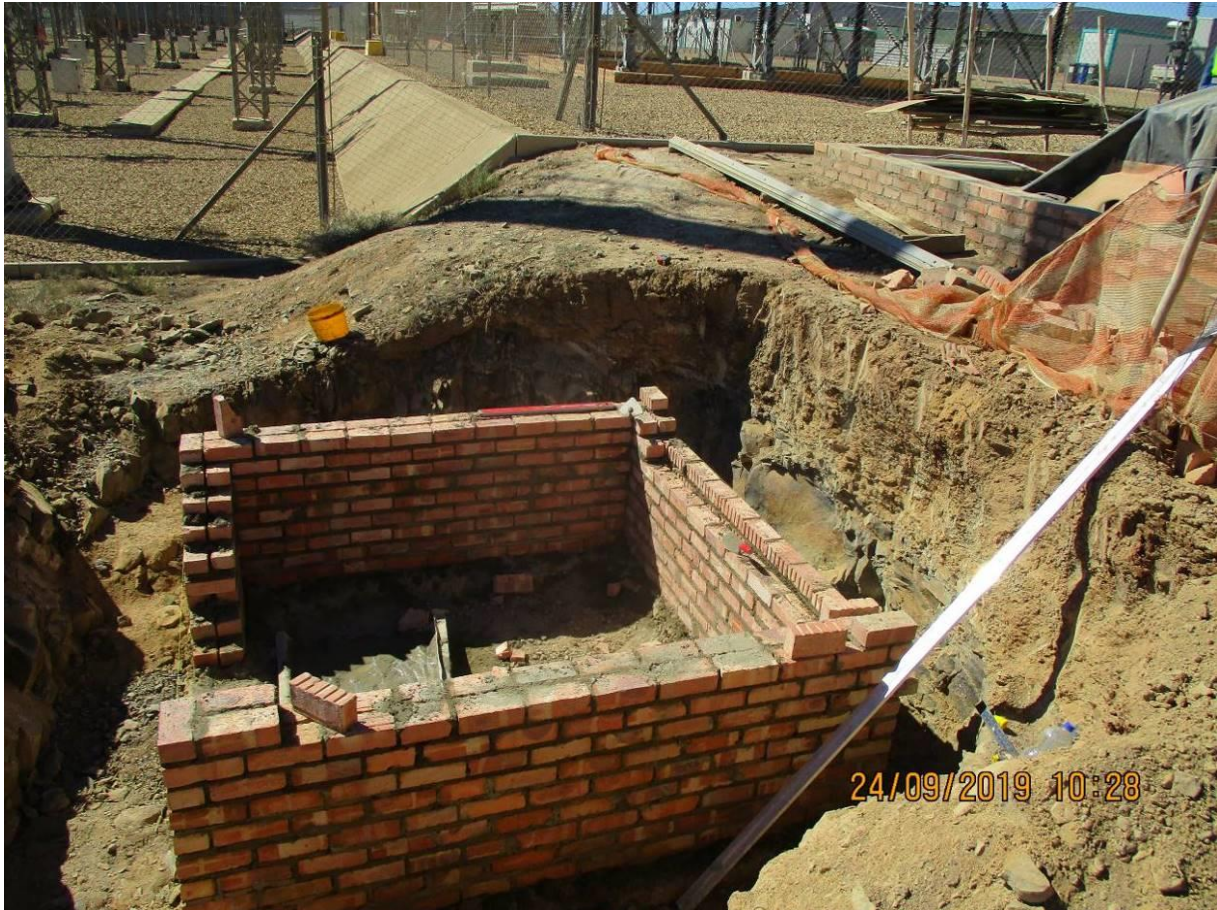
The construction of bund for servicing or repair of construction vehicle area is in place. Construction of bund for oil water separator to collect all contaminant in the servicing from reaching the surrounding environment is in progress.

Photo: Construction of bund for oil water separator at the servicing area.

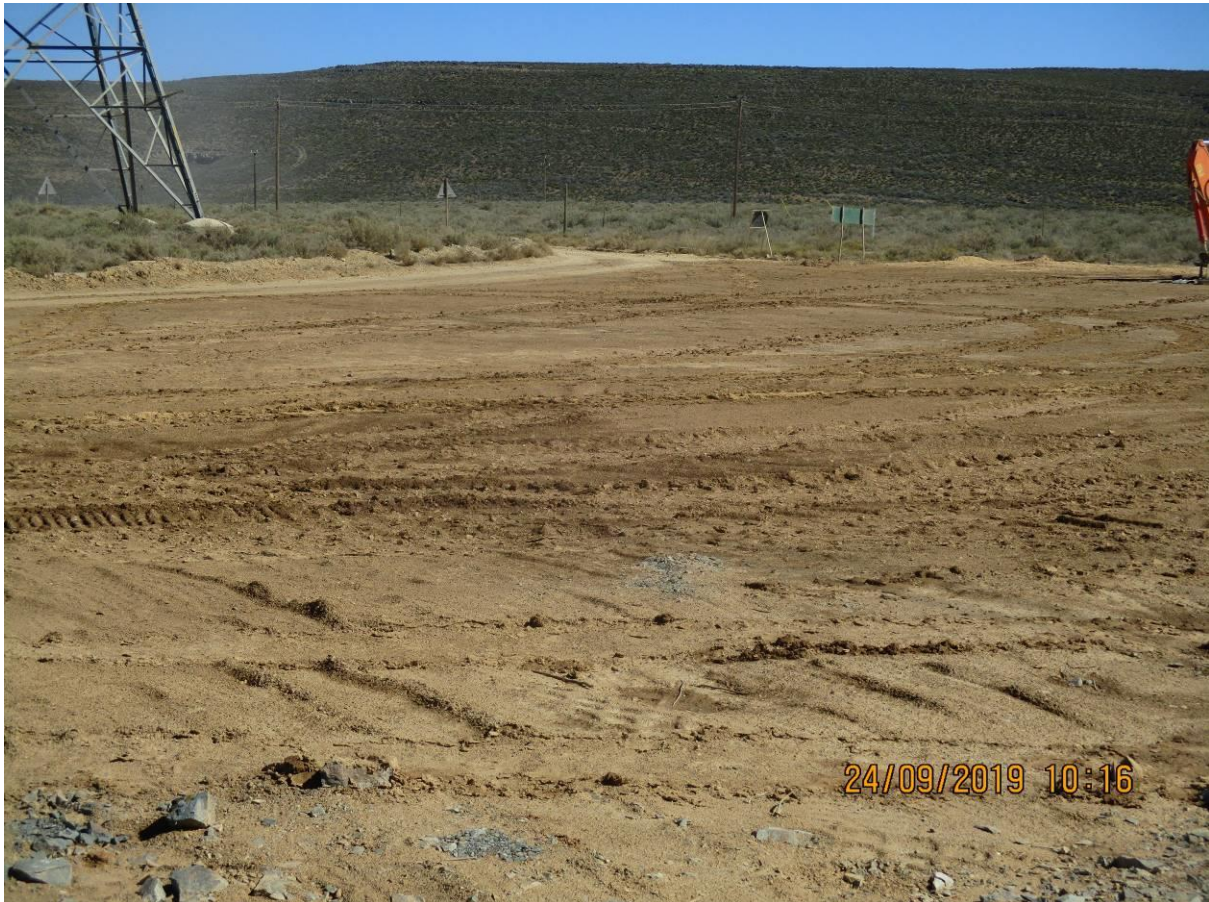
During inspection it was observed that more dust is generated during crushing of stones at the crusher areas. During construction there must be a measure for control of dust in specified places or areas, either in general or by specified machinery or in specified instances as well as steps that must be taken to prevent nuisance by dust or other measures aimed at the control of dust as per the National Environmental Management: Air Quality Act (Act No. 39 of 2004).

Photo: Dust suppression implemented at the heavy machinery parking area.

It is also recommended that dust-generating activities or earthworks as well as crushing areas may need to be rescheduled or the frequency of application of dust control/suppressant increased especially during periods of high winds and if excessive visible dust is blowing towards where other employees are working or to the nearby residences outside the site in order to achieve the objective of the EMPr.

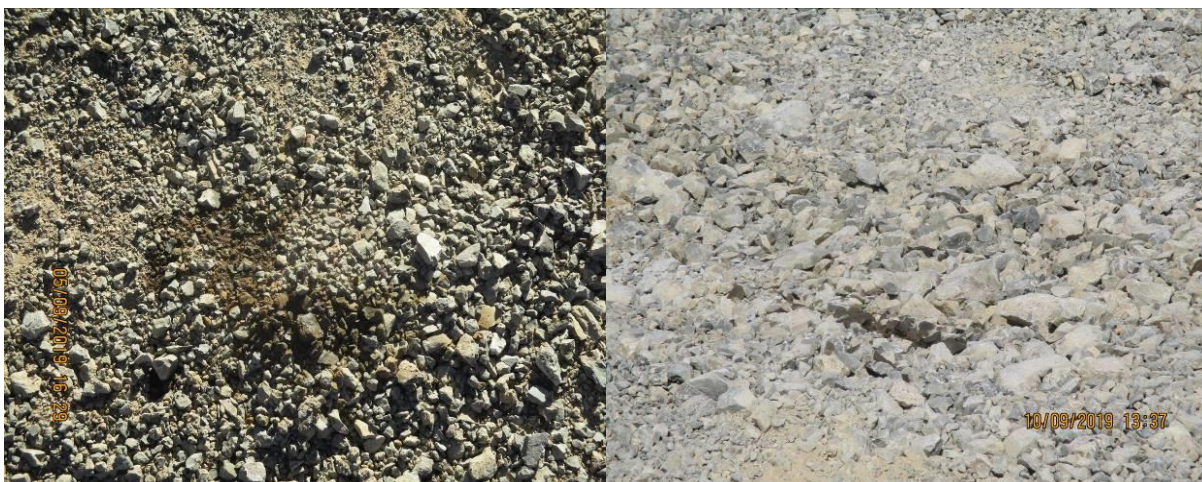
Photo: Oil spill (laydown area).

Photo: Oil spill at 132kV terrace (section A).

The contractor shall be strongly advised to make every effort to prevent spills and leakages on site. Regular maintenance and inspections of construction vehicle is essential to prevent unnecessary oil spills. Seven (7) minor hydrocarbon spills and two (2) moderate. Moderate hydrocarbon spills was flashed to Eskom, three (3) concrete spill from concrete works. Total of twelve (12) chemical spills were reported for the reporting month. All spills were clean up. It is recommended that all spills must be assessed to determine the significance of the spill, reported to ECO and cleaned immediately.

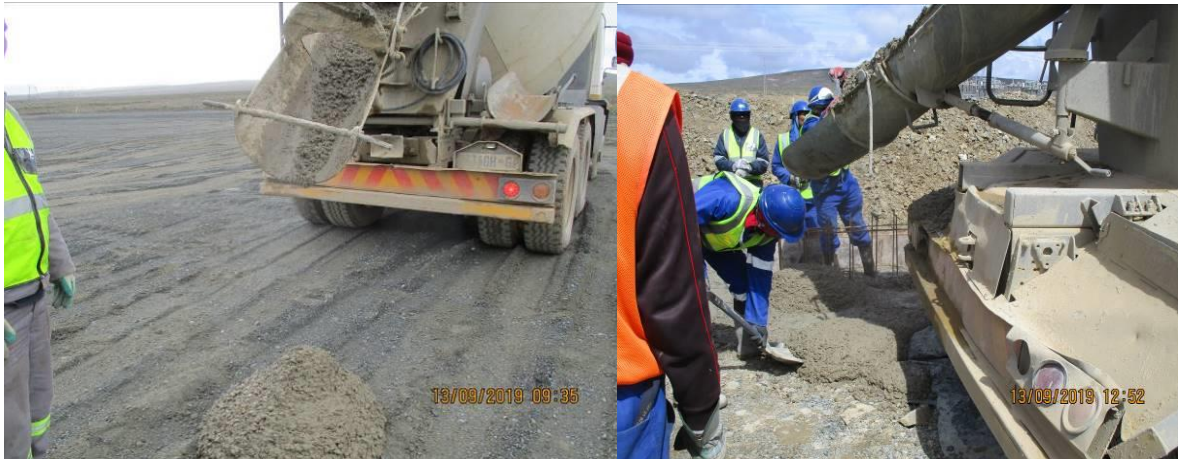
Photo: Concrete spill at 132kV terrace (section A) during concrete works at the retaining wall

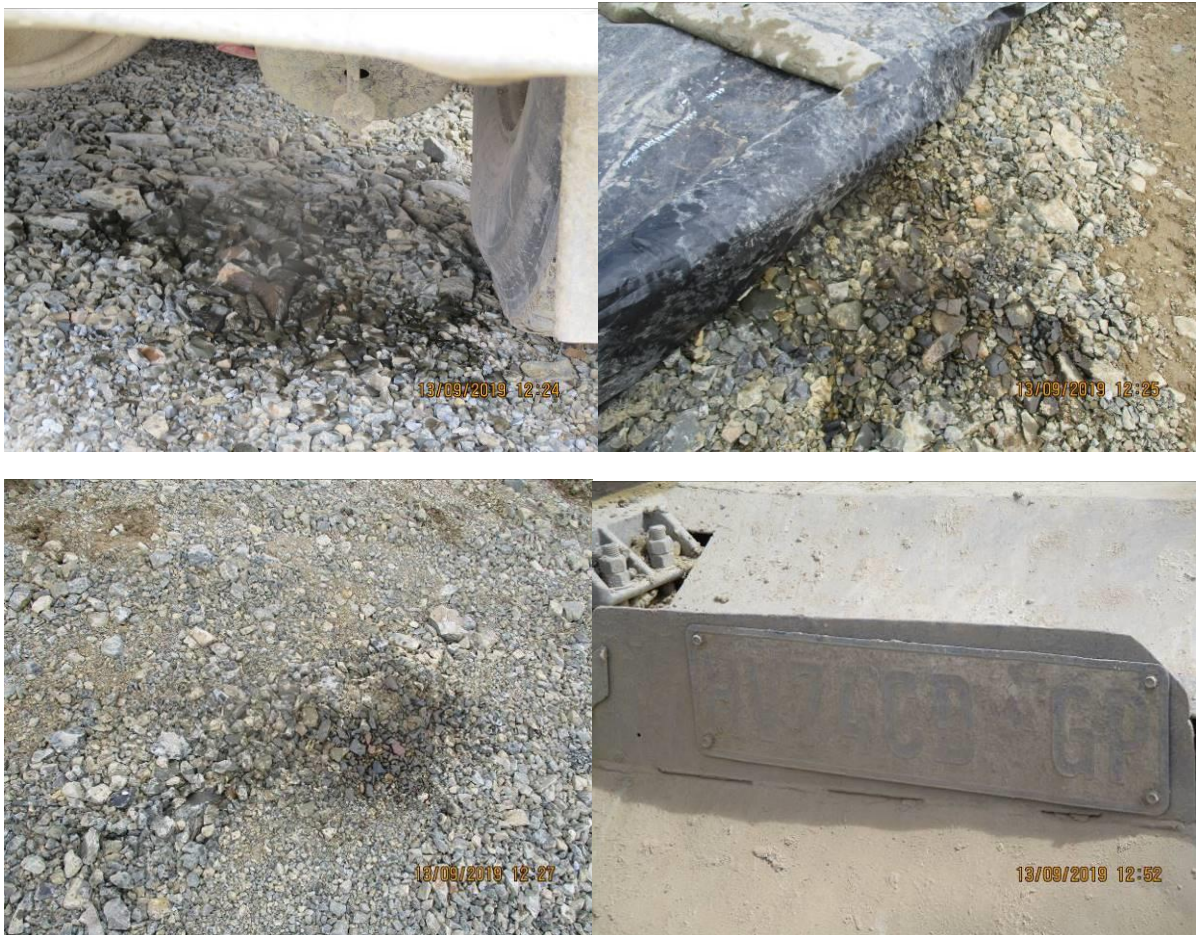
Photo: Multiple diesel spill from ready mix concrete truck (HV74CDGP)

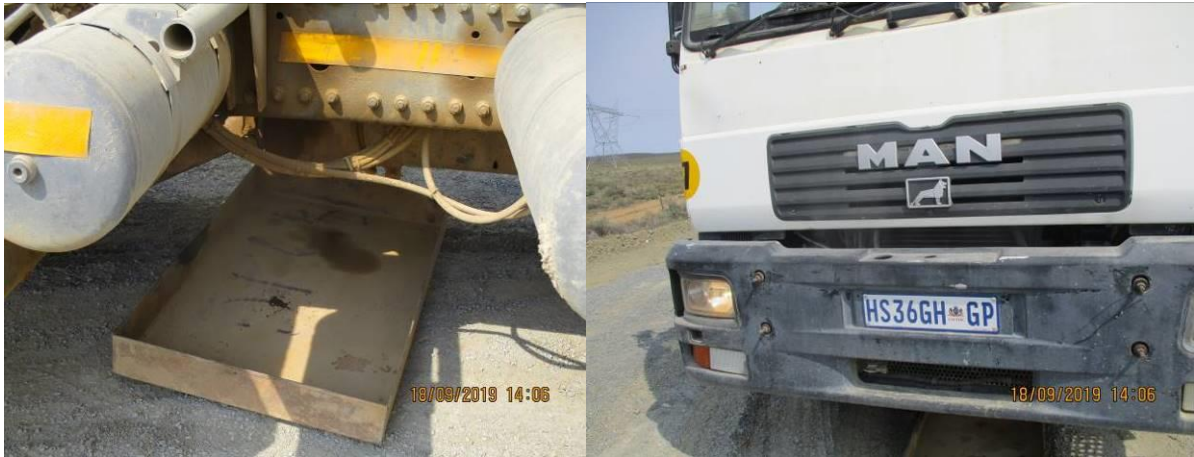
Photo: Leaking ready mix concrete truck (HS36GHGP).

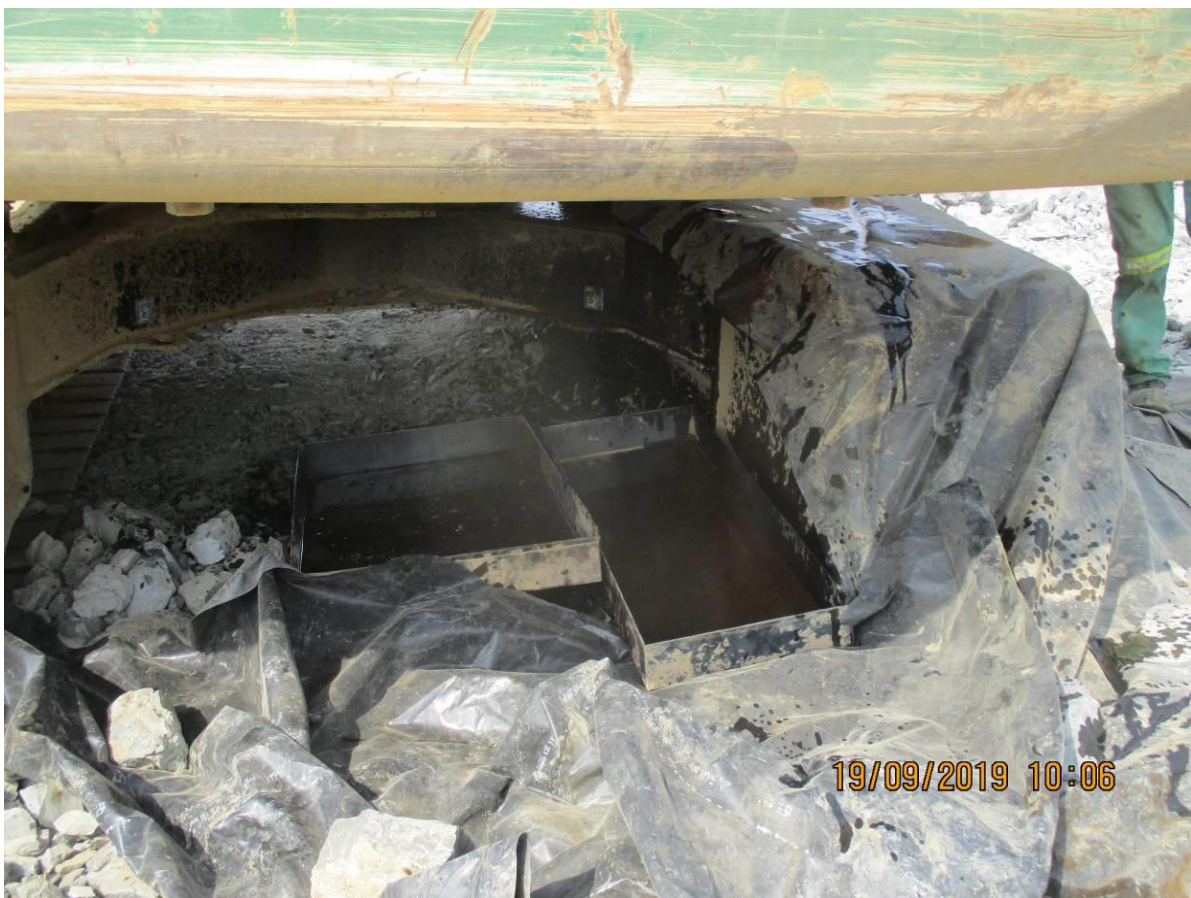
Photo: Moderate oil spill due to hydraulic pipe burst from excavator (BWX 13).

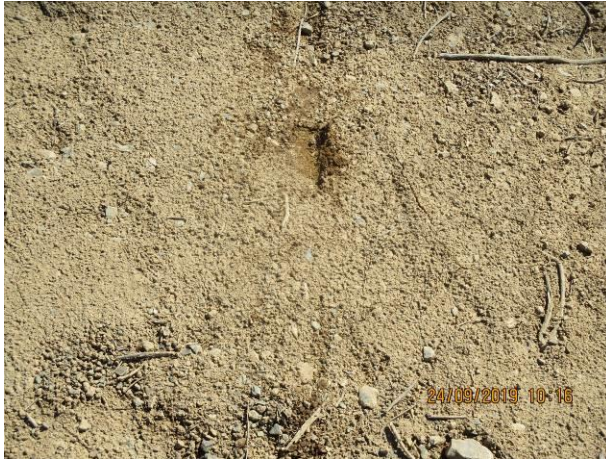
Photo: Oil spill at the parking area.

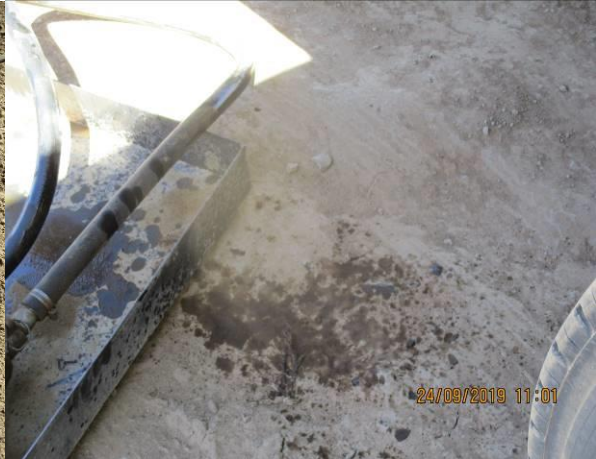
Photo: Diesel spill at the refuelling area.

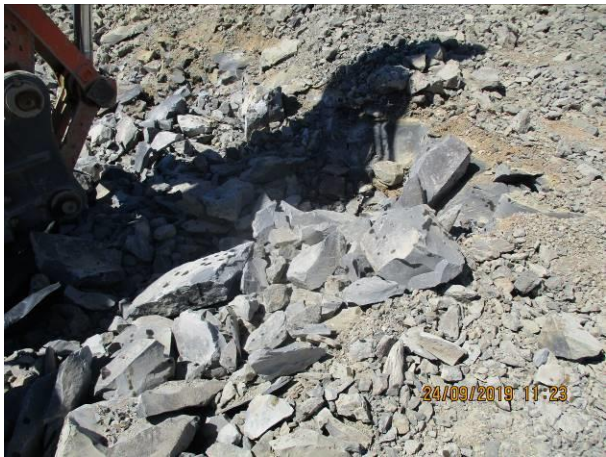
Photo: Hydraulic oil spill from packer attached to excavator number (80).

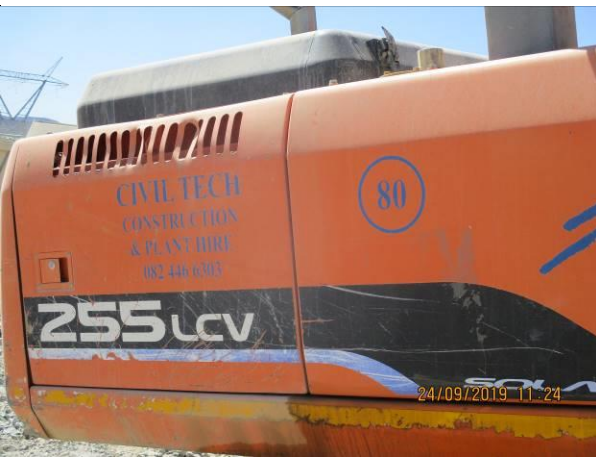
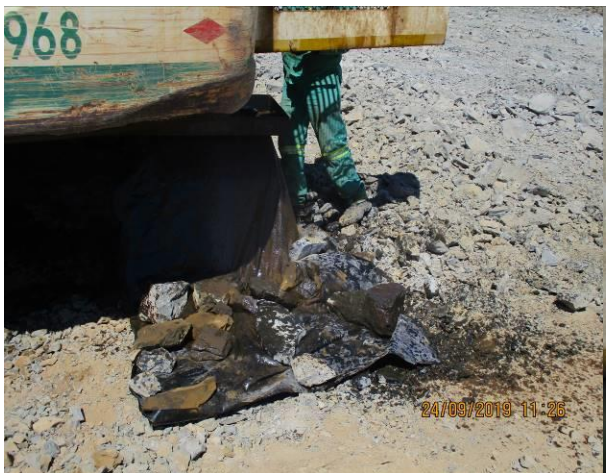
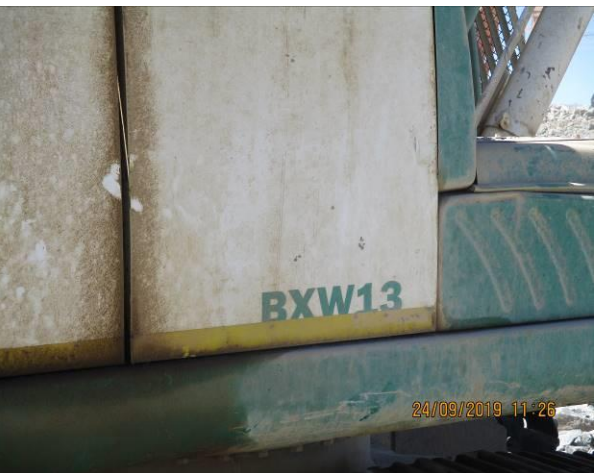
Photo: Another hydraulic oil spill from excavator (BXW 13).

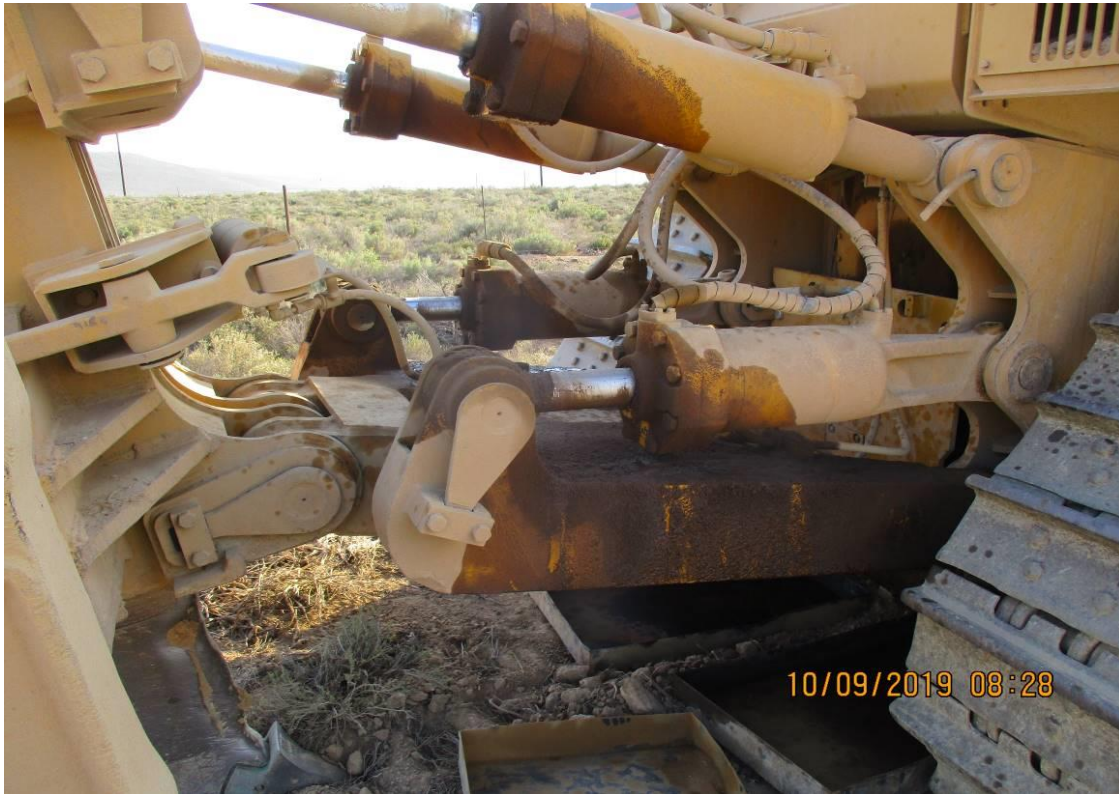
Photo: Multiple hydraulic oil leaks from the bulldozer.

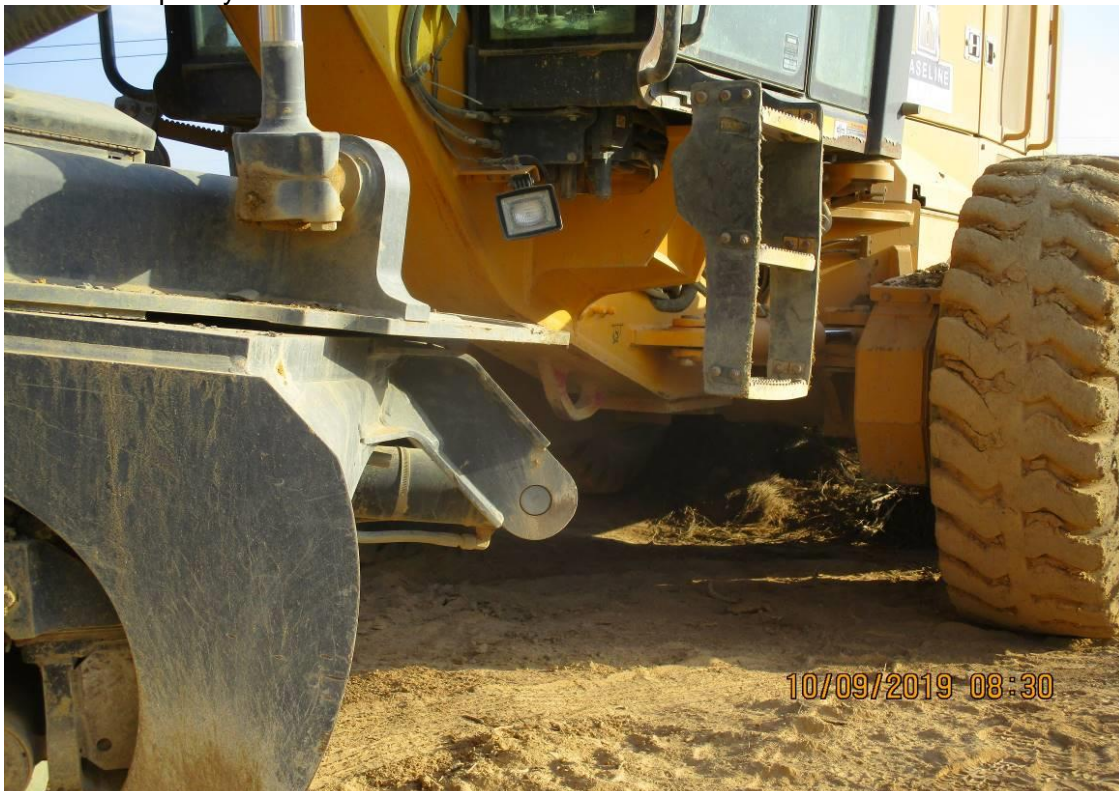
Photo: Komatsu grader (stationary) parked without drip tray.

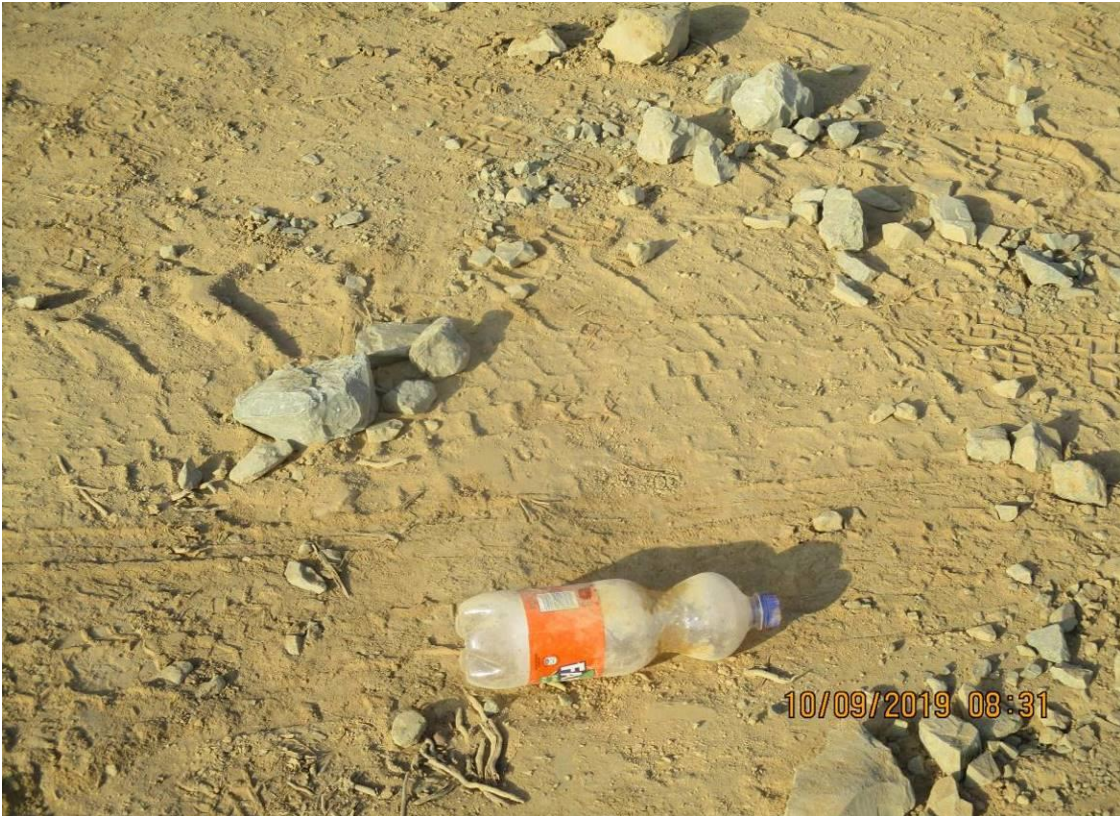
Photo: Littering of waste at the parking area.

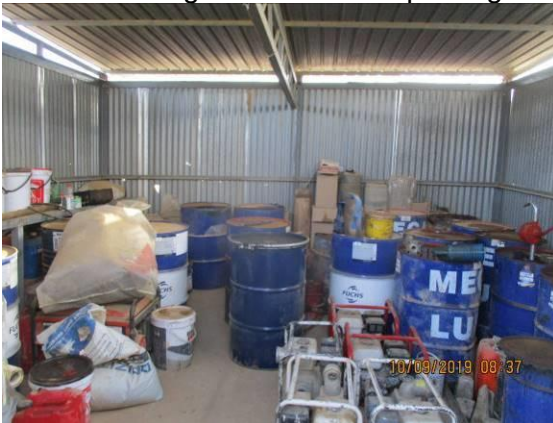
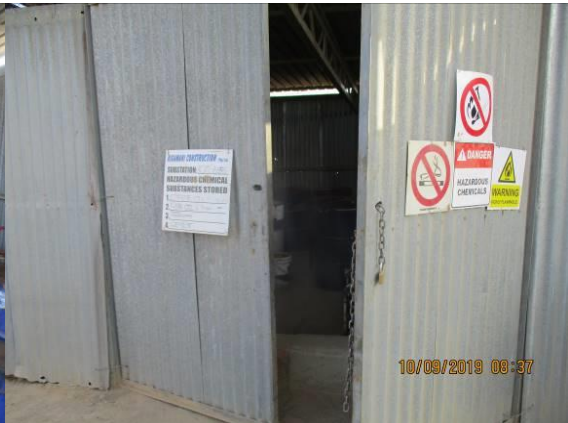
Lack of control access, chemical inventory not updated were observed during different site inspection.

Photo: Poor housekeeping and uncontrolled access at the HCS storage.

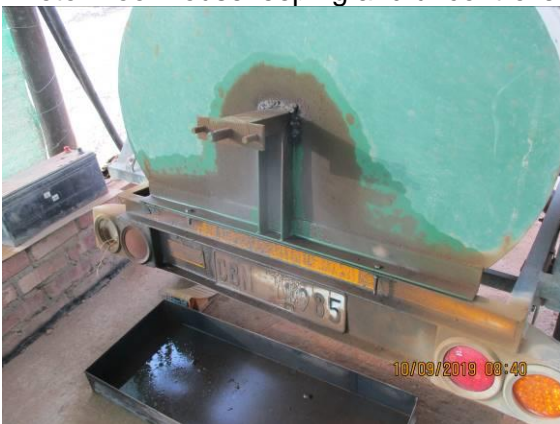
Photo: Leaking diesel bowser.

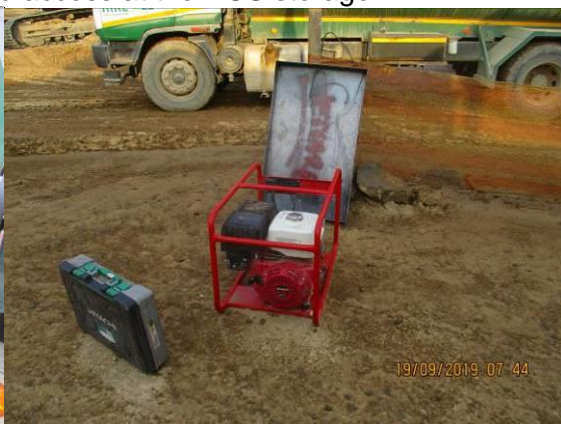
Photo: generator on the ground with drip tray

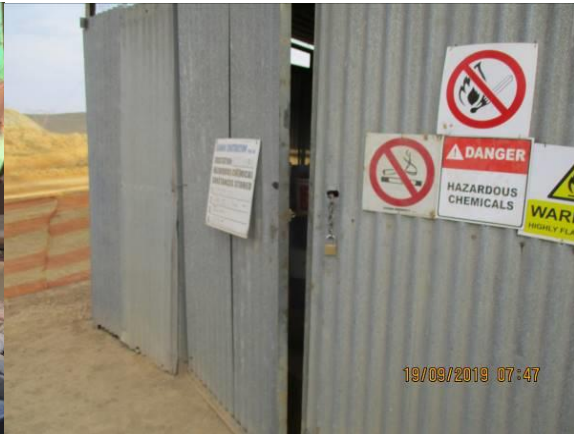
Photo: Uncontrolled access at the HCS storage

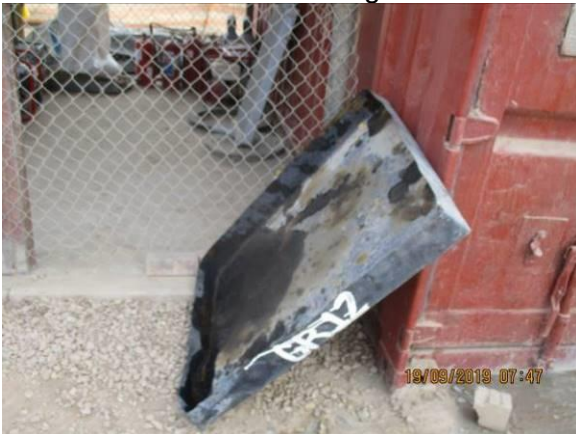
Photo: Poor housekeeping and oil spill management.

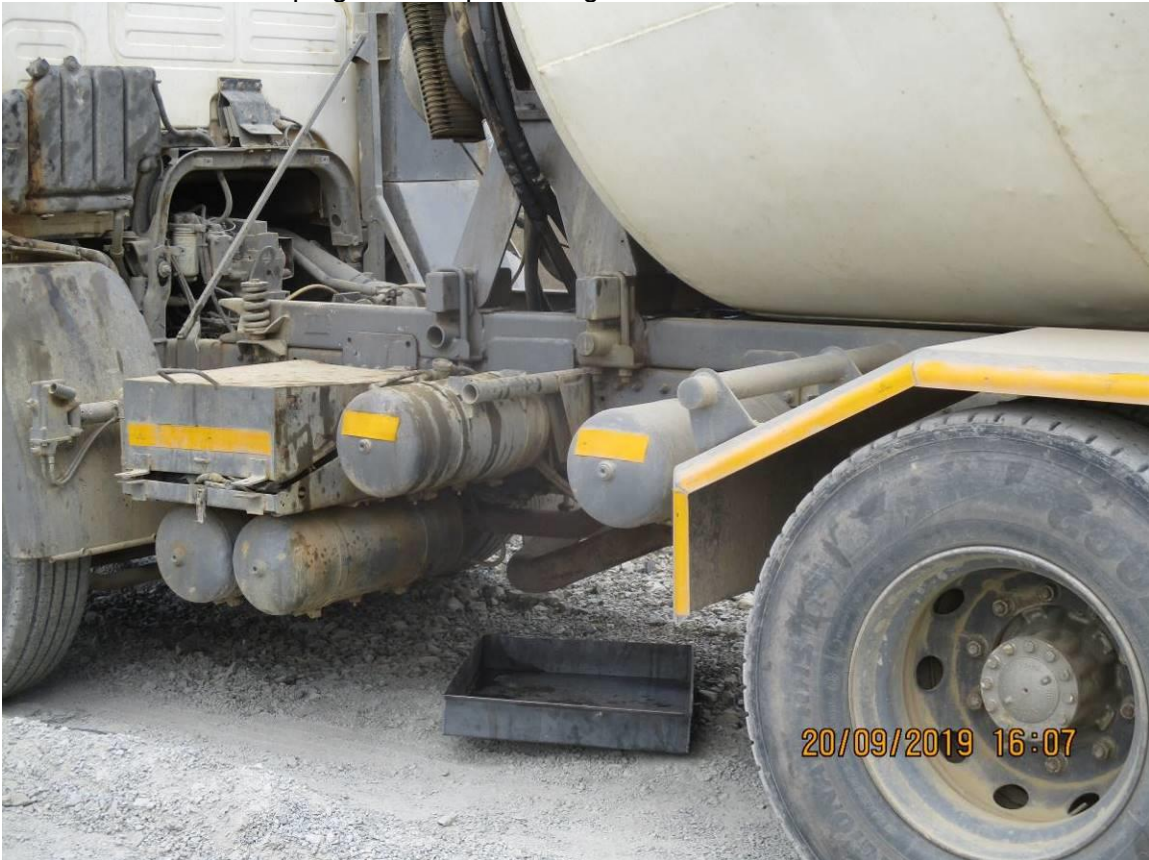
Photo: Leaking ready mix concrete truck (HS36GHGP).
