EXPANSION OF THE KOMSBERG MAIN TRANSMISSION SUBSTATION AND ASSOCIATED INFRASTRUCTURE NEAR SUTHERLAND, WITH THE KAROO HOOGLAND LOCAL MUNICIPALITY IN THE NORTHERN CAPE

MONTHLY MONITORING REPORT

DATED: 29 OCTOBER 2019

DEA REF: 14/12/16/3/3/1/1482

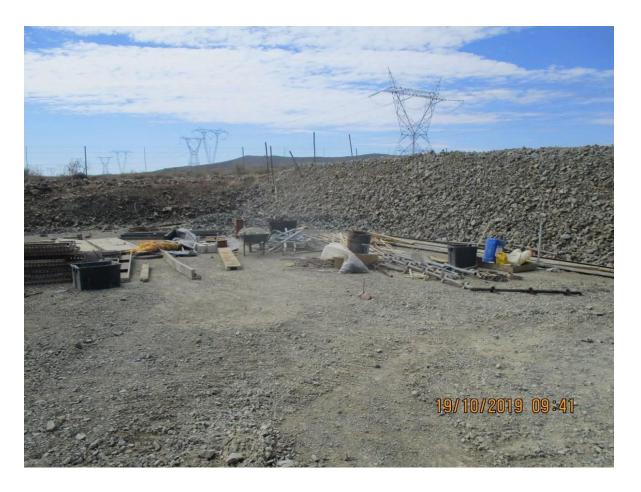
- 1. Poor house keepings within the working area.
- 2. Evidence of cigarette buds in different working areas that is outside the designated smoking area.

Photo: Poor housekeeping.

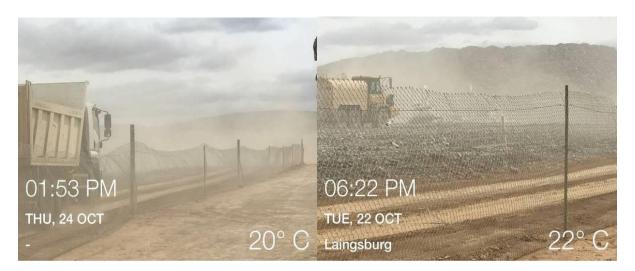
During inspection it was observed that more dust is generated during crushing of stones at the crushing areas, on the haul or access road as well as the heavy plant parking area. During construction there must be a measure for control of dust in specified places or areas, either in general or by specified machinery or in specified instances as well as steps that must be taken to prevent nuisance by dust or other measures aimed at the control of dust as per the National Environmental Management: Air Quality Act (Act No. 39 of 2004).

Photo: Dust generated as a result of construction activities.

No evidence of schedule or regular dust suppression conducted on site. It is also recommended that dust-generating activities or earthworks as well as crushing areas need to be rescheduled or the frequency of application of dust control/suppressant increased

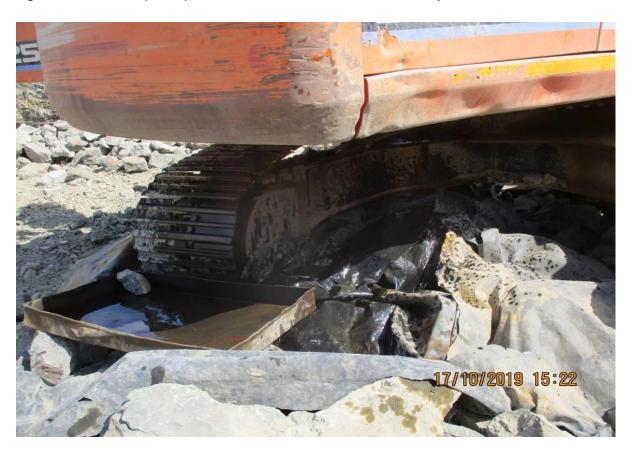
Photo: Hydraulic pipe bust from excavator (119).

The contractor shall be strongly advised to make every effort to prevent spills and leakages on site. Regular maintenance and inspections of construction vehicle is essential to prevent unnecessary oil spills. Two (2) minor hydrocarbon spills, and one (1) moderate hydrocarbon spill were reported during October reporting period. Total of 3 chemical spills were reported. All spills were clean up. It is recommended that all spills must be assessed to determine the significance of the spill, reported to ECO and cleaned immediately.

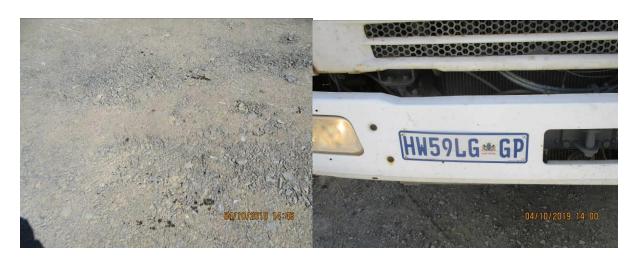
Photo: Multiple oil spill from concrete truck (HW 59 LG GP).

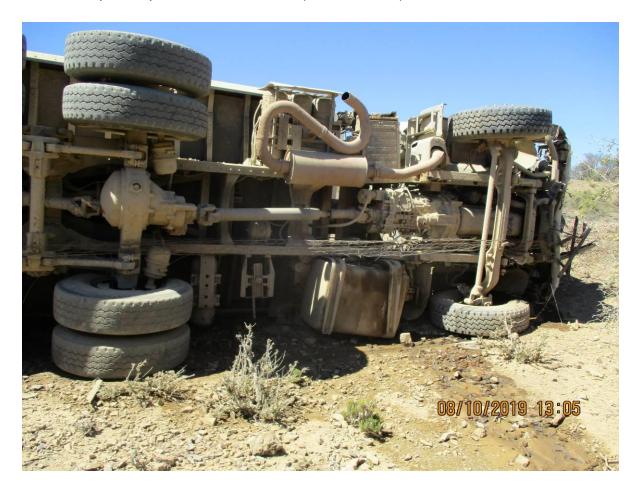
Photo: Diesel/oil spill as a result of motor vehicle accident.

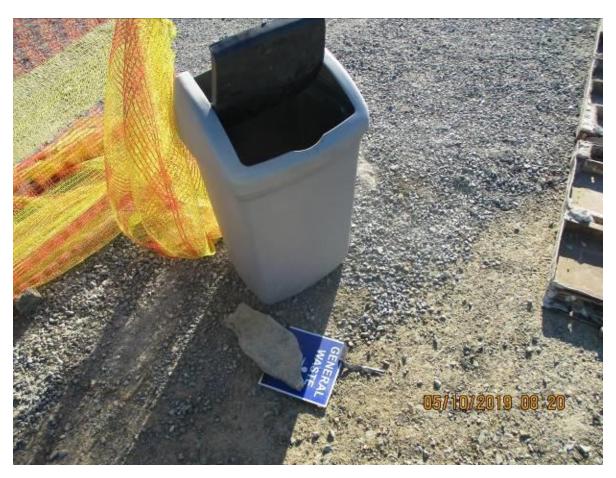
Photo: Waste bin not marked/labelled.

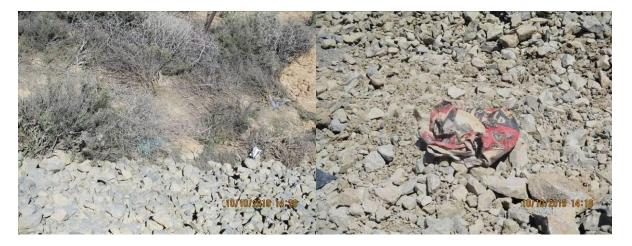
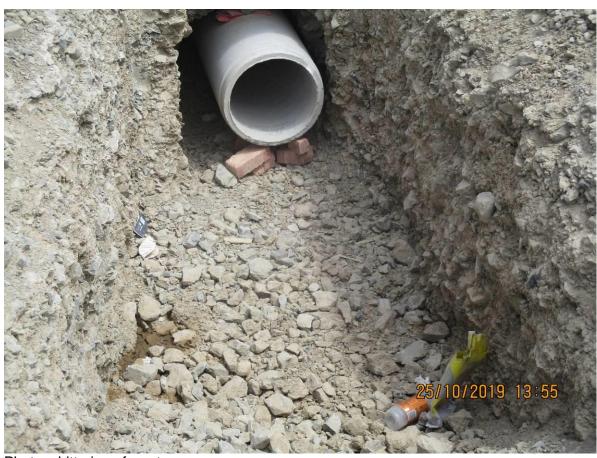
Photos: Littering of waste.

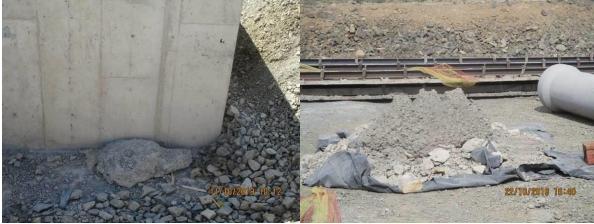
Objective 17	Unattended concrete waste (not cleaned or properly disposed).	Concrete or spill cement must be cleaned up as soon as possible and disposed of at a suitably licensed waste disposal site.	Open
Objective 2	The number of people on site does not meet the toilet ratio as required by the EMPr.		Open
Objective 16	Hydraulic pipe burst from the excavator (119).	Routine maintenance and servicing of plant must be conducted to minimize incidents.	Open
Objective 17	Drive unit was placed without drip tray underneath.	Drip trays must be used to all small plant. A tool box talk must be conducted to all employees.	Open

Photos: Unattended concrete waste (not properly cleaned or disposed).

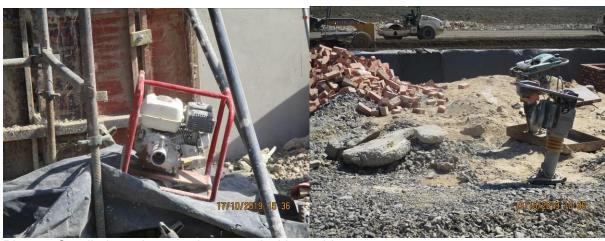
Photos: Small plant place on the ground without drip tray.

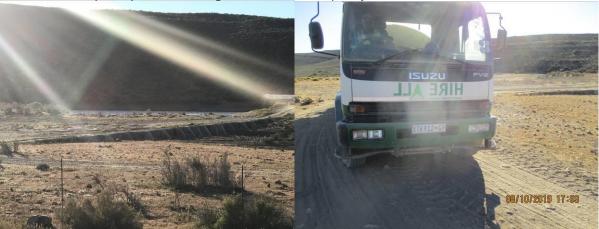
There was one (1) NCR's issued by Eskom to the contractor for contravening "water use registration and authorisation in terms of the national water act, 1998 (Act 36 of 1998): For taking of water from groundwater – Farm Standvastigheid 210/RE, Sutherland road, in quaternary catchment J11D, Western Cape" by abstracting water from unauthorised source (dam).or opened during the reporting month. No pre-warning was issued for the reporting month, however the findings on the report form part of the daily inspections for the reporting month. All findings on the report should be properly addressed to avoid reoccurrence as it will lead to Non-Compliance.

Photos: Construction water abstracted from unauthorized source.
