APPENDIX D

ENVIRONMENTAL PERFORMANCE ASSESSMENT REPORT

**Tutuka Power Station Ash Disposal Facility
(ADF):
External Environmental Performance Assessment
as part of the Part 2 Exemption amendment application process to the
Exemption issued.
Audit Report**

26 July 2019

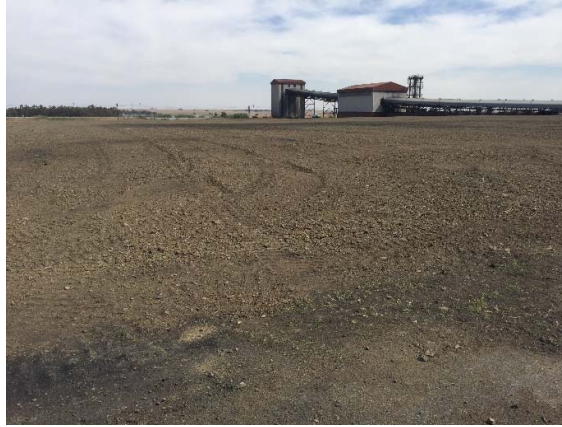
Photo 1. Temporary Coal Stockpile removed

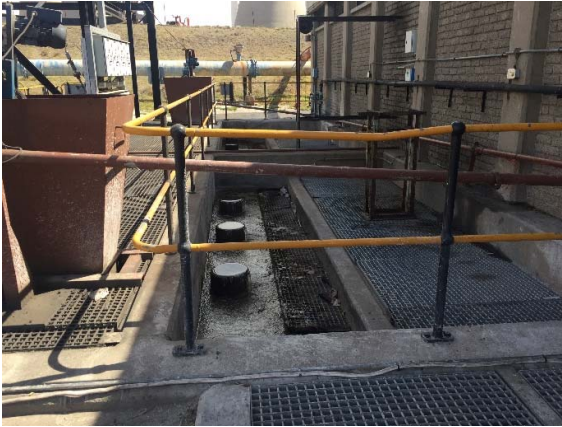
Photo 2. Oil skimmers

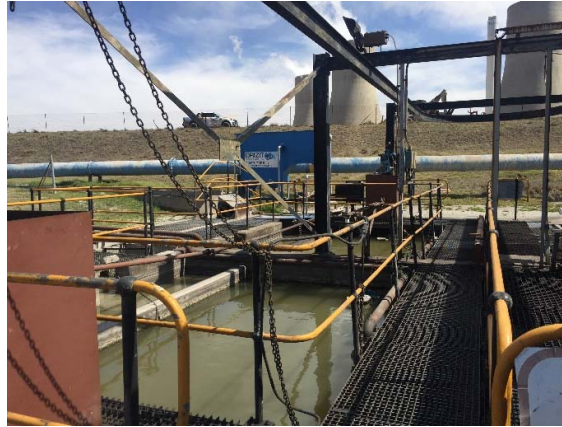
Photo 3. Oil Skimmers

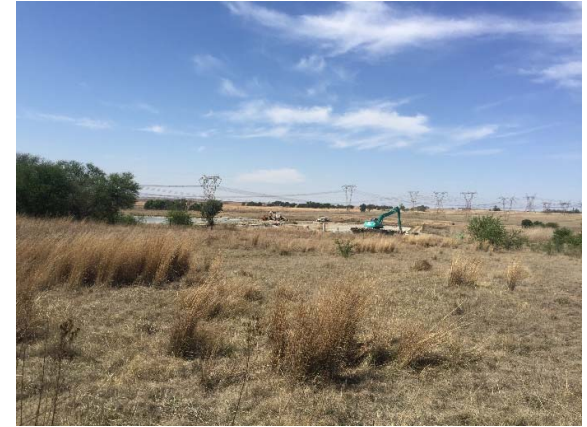
Photo 4. Cleaning in progress at PMD17

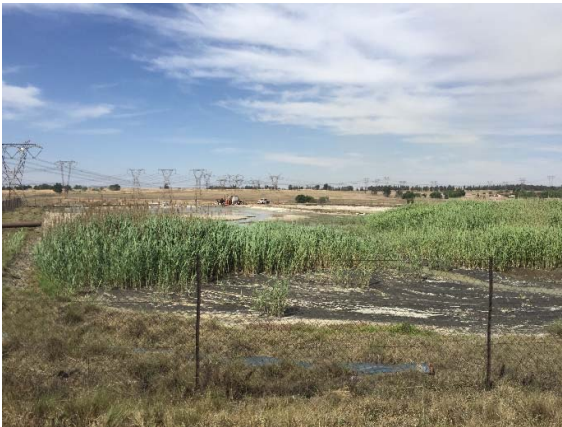
Photo 5. PMD19

PMD19	Small dam next to settling ponds, PMD17.	Small settling dam.	PMB07	11-Oct-16	14:50	Full	No Sample	P5	Overgrown.	Vegetation must be cleared on a regular basis.	
	PMD13	Dirty Water Dam in the north-east of the power station.	Dirty water dam.	PMB07, PMS23	11-Oct-16	14:13	Low	Y	P6	Oil visible on surface.	Remove excess oil where necessary.

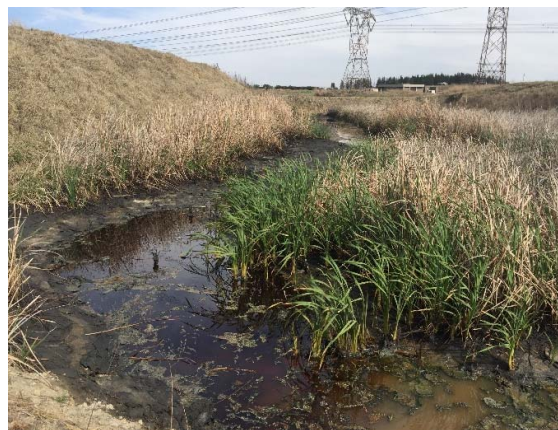
Photo 8. PMS34 - soil

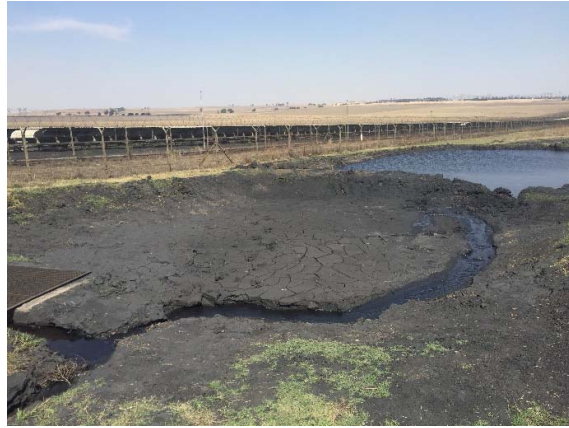
Photo 9. CMD23 – overflows from PMS22

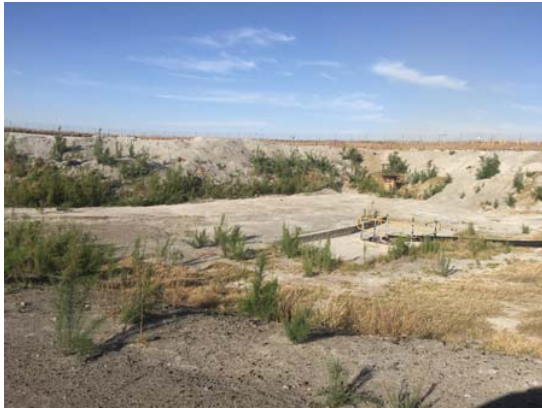
Photo 1 *General site conditions*

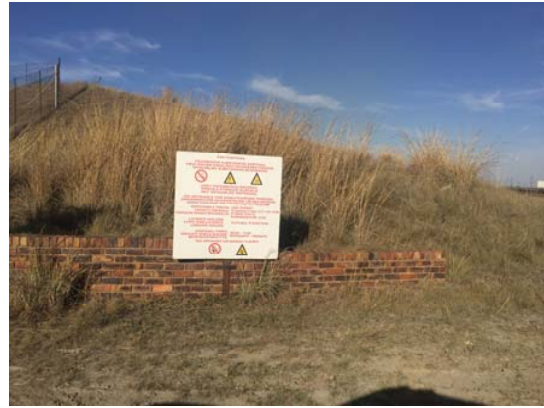
Photo 2 *Renewed signage.*

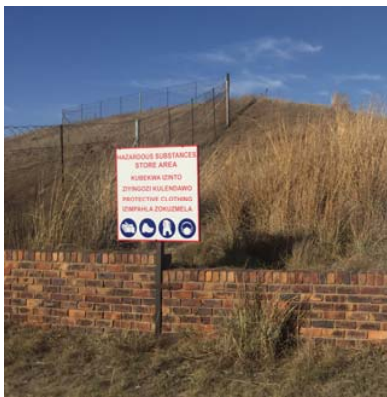
Photo 3 *Renewed signage.*

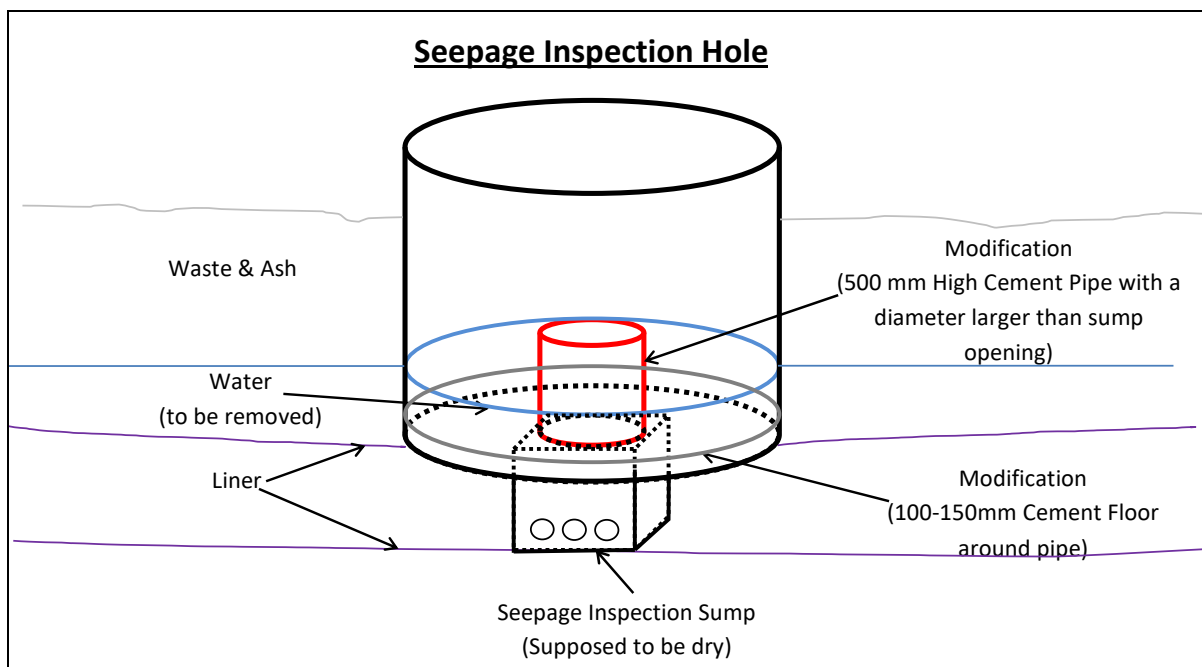
Figure 2. Proposed modification.

- **Leakage detection system (Manhole)** – The conditions at the bottom of the sump are unchanged with seepage from the top of the liner dripping into the seepage inspection sump at the bottom. The seal between the cement ring and the liner is an inherent design problem and is unlikely to be completely and permanently mendable. With the on-going problem of seepage between the cement ring and the liner, it is recommended that the system be revised with a protection ring as indicated in Figure 2. The water can then be scooped from the upper area. It should be handled as hazardous and handled accordingly when discarded at the current cell where waste is being dumped. It was further confirmed by Mr. Johan Venter that there is a liner still beneath the seepage inspection sump and that water seeping backwards into the seepage inspection pipes would therefore not leak into the groundwater below the sump.
