**Tutuka Power Station Ash Disposal Facility
(ADF):
External Environmental Performance Assessment
as part of the Part 2 Exemption amendment application process to the
Exemption issued.
Audit Report**

06 September 2019

Eskom (Pty) Ltd

GCS Project Number: - 19-0217

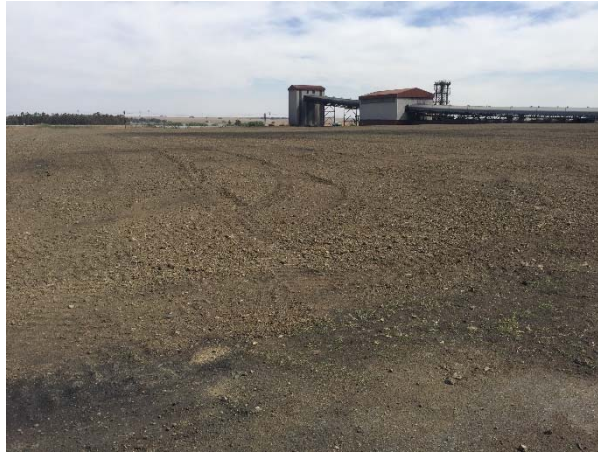
Photo 1. Temporary Coal Stockpile removed

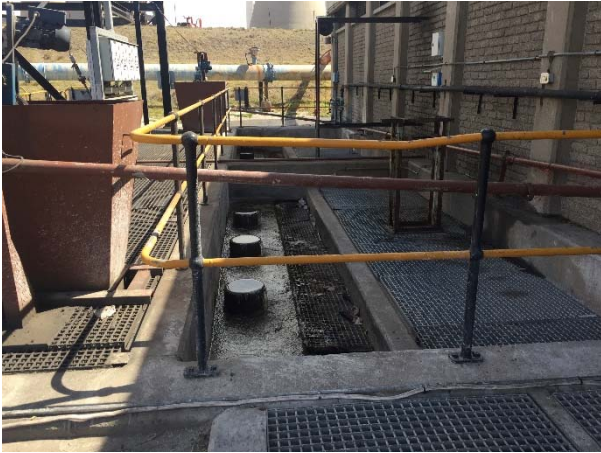
Photo 2. Oil skimmers

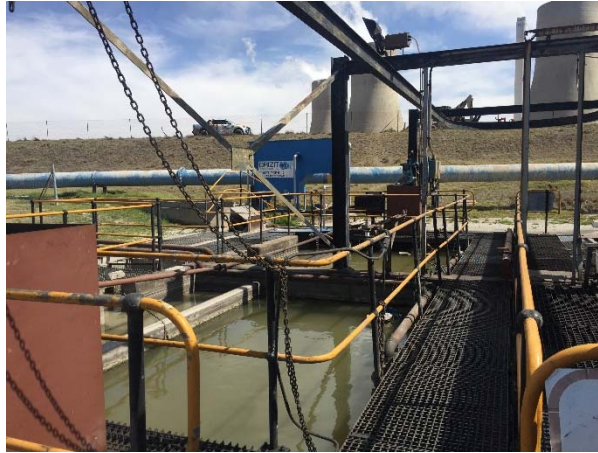
Photo 3. Oil Skimmers

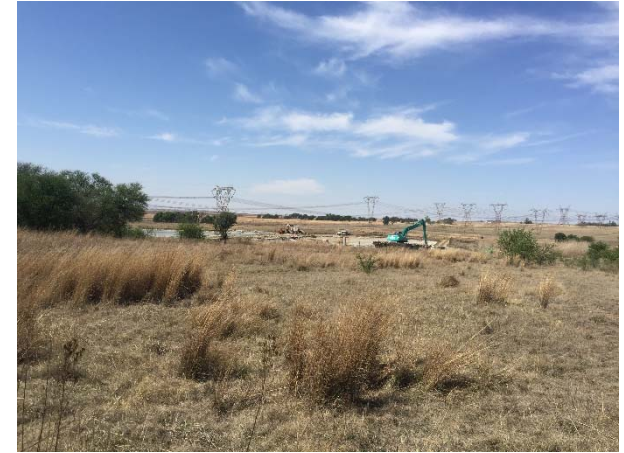
Photo 4. Cleaning in progress at PMD17

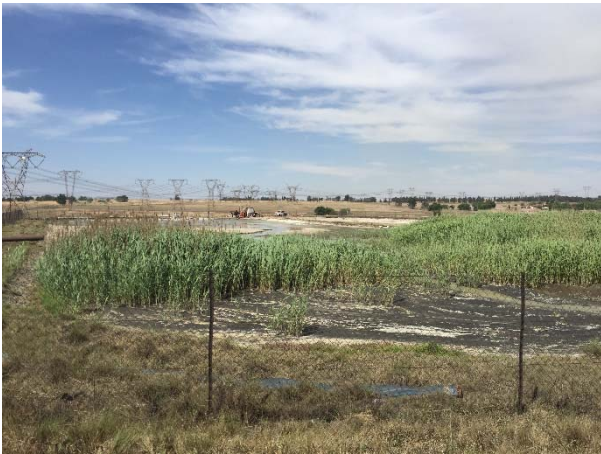
Photo 5. PMD19

PMD19	Small dam next to settling ponds, PMD17.	Small settling dam.	PMB07	11-Oct-16	14:50	Full	No Sample	P5	Overgrown.	Vegetation must be cleared on a regular basis.
	PMD13	Dirty Water Dam in the north-east of the power station.	Dirty water dam.	PMB07, PMS23	11-Oct-16	14:13	Low	Y	P6	Oil visible on surface.	Remove excess oil where necessary.

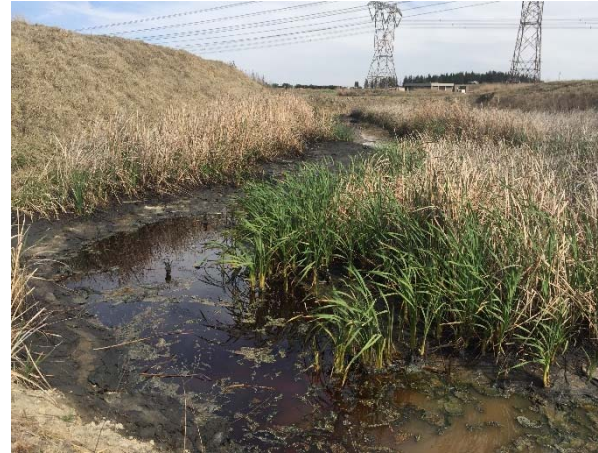
Photo 8. PMS34 - soil

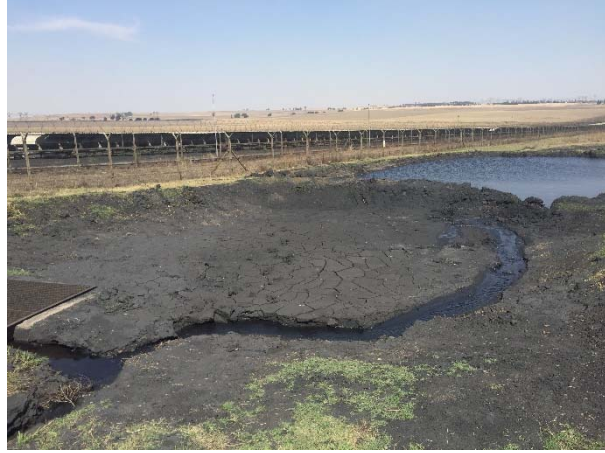
Photo 9. CMD23 – overflows from PMS22

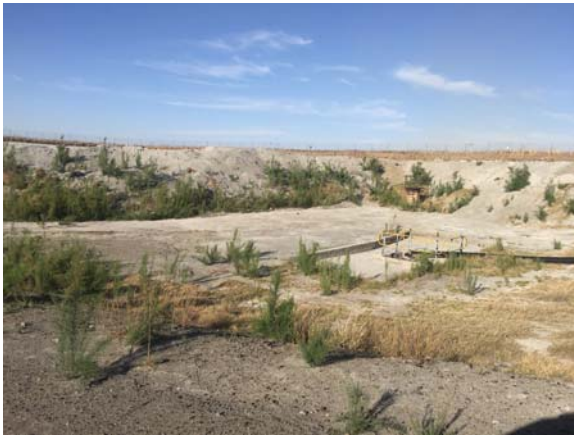
Photo 1 General site conditions

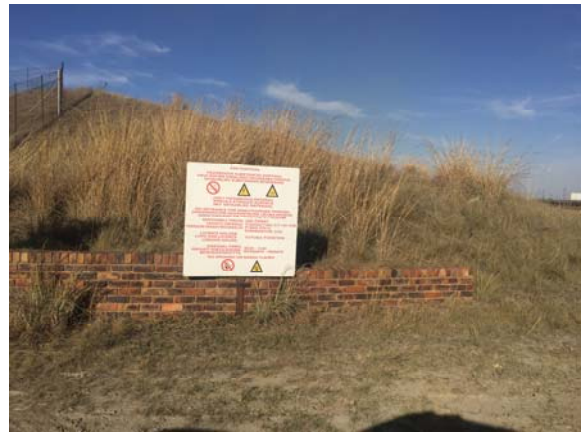
Photo 2 Renewed signage.

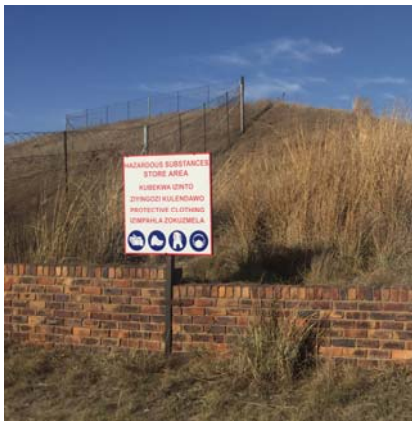
Photo 3 Renewed signage.

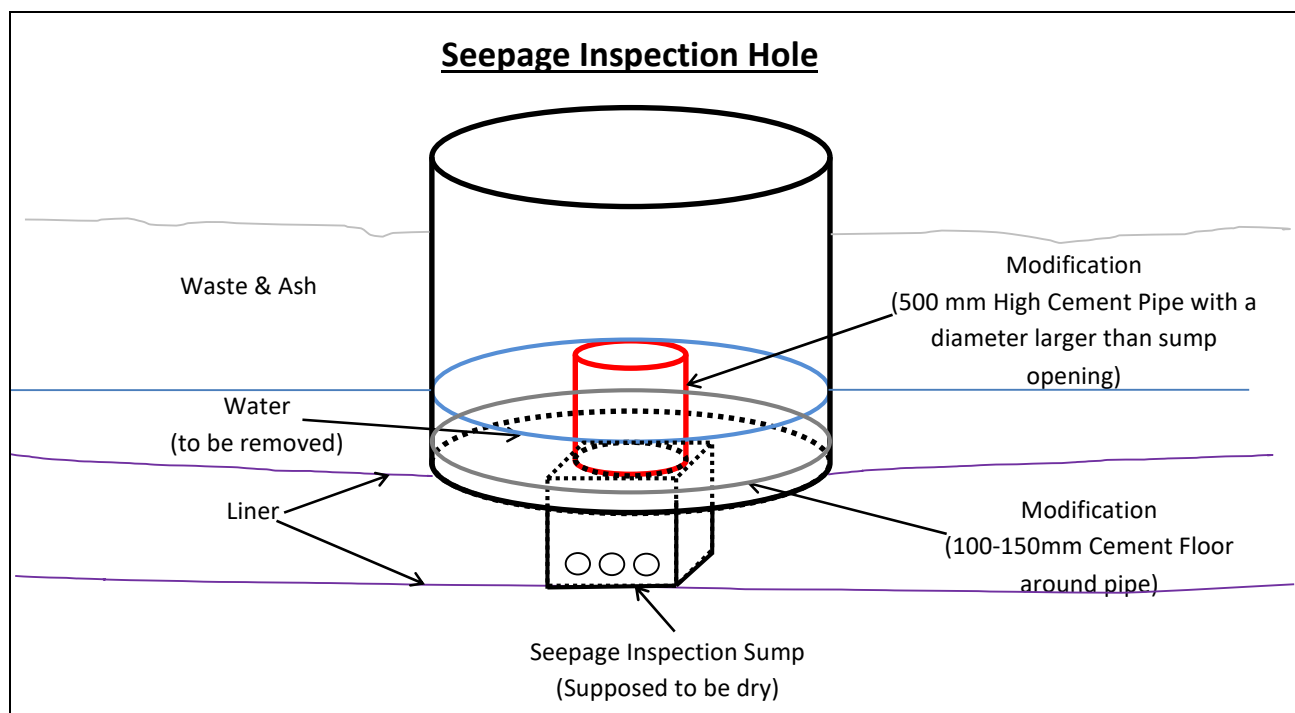
Figure 2. Proposed modification.

- **Leakage detection system (Manhole)** – The conditions at the bottom of the sump are unchanged with seepage from the top of the liner dripping into the seepage inspection sump at the bottom. The seal between the cement ring and the liner is an inherent design problem and is unlikely to be completely and permanently mendable. With the on-going problem of seepage between the cement ring and the liner, it is recommended that the system be revised with a protection ring as indicated in Figure 2. The water can then be scooped from the upper area. It should be handled as hazardous and handled accordingly when discarded at the current cell where waste is being dumped. It was further confirmed by Mr. Johan Venter that there is a liner still beneath the seepage inspection sump and that water seeping backwards into the seepage inspection pipes would therefore not leak into the groundwater below the sump.
