Ref: 08102/g

# REPORT ON A GEOTECHNICAL DESK STUDY AND RECONNAISSANCE SURVEY FOR CANDIDATE SITES FOR THE ESKOM LANDFILL AND HAZARDOUS WASTE HOLDING FACILITY

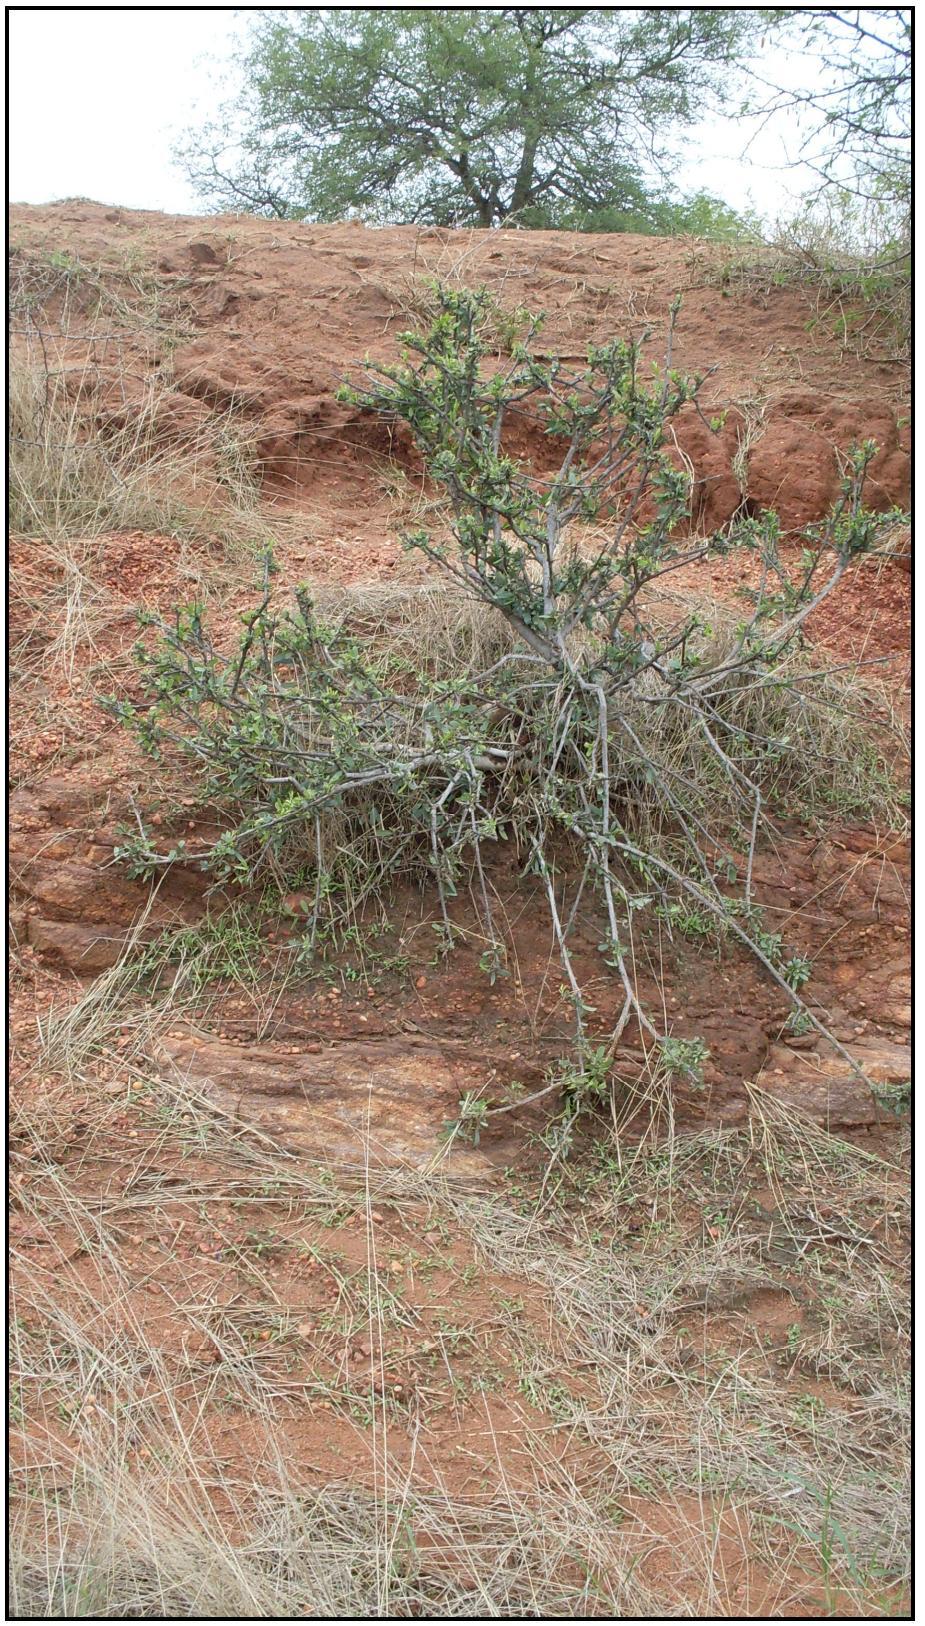
The nature of the host rock underlying sites 1 to 4, namely sandstone, together with the flat topography and Weinert's N value of about 4,5 together suggest that the soil profile developed from the host rock will be fairly shallow and comprise mainly a sand. It is nevertheless very likely that a transported soil layer covers the residual material and this is clearly illustrated in the railway cutting near to the sites.

Photograph: Exposure of railway cutting
