REPORT ON A GEOTECHNICAL INVESTIGATION FOR THE PROPOSED NEW ESKOM GENERAL LANDFILL AND HAZARDOUS WASTE FACILITY, LEPHALALE

Eskom Landfill & Hazardous Waste Storage Facility- Lephalale

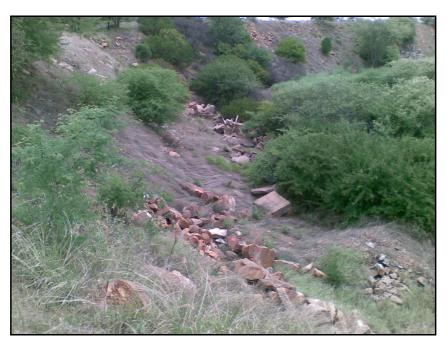
A disused waste facility occupies the central south western sector of the site. It covers an area of some 11 hectares and comprises a perimeter earth wall within which ash, rubble and other waste has been discarded.

Figure 7.1 Existing waste facility on the site

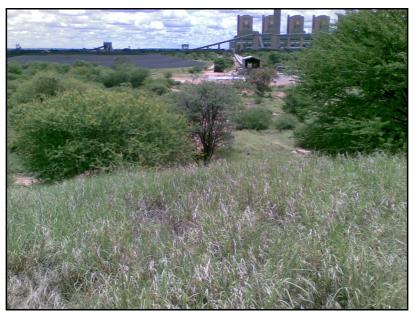
The site has been extensively disturbed and as a result in many places covered by alien vegetation and weeds. Dense groves of mature acacia and other trees are, however, present over parts of the site and illustrated below.

Figure 7.2: Typical vegetation covering the site

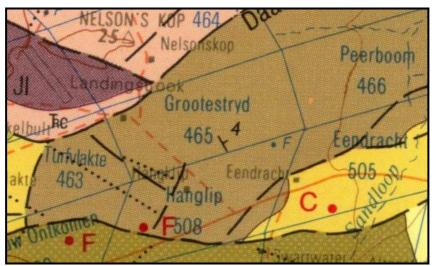
Figure 8.1

Based on the 1:250 000 geological map, an extract of which is attached below, the site located on the farm Grootestryd is underlain by rocks of the Karroo sequence comprising sandstones, gritstone, mudstones and coal.

Geological map of the farm Grootestryd underlain by rocks of the Karroo Supergroup: sandstone/gritstone/mudstone/coal
