Specialist Basic Assessment report:

Proposed Letaba/Makutswi project

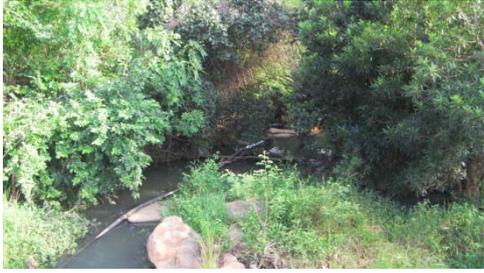
To the east of the cemetery, the corridor crosses a small stream (Figure 14). The pylons must be placed at least 50m from the edge of the outer edge of the riparian zone to prevent any damage to the stream banks. In this stream, some *Breonadia salicina*, a protected tree was observed. No crossing through the stream during construction or maintenance is allowed, unless at a proposer road or bridge. To the east the natural vegetation is modified due to town development, roads, railway lines and wood collection by inhabitants of the nearby residential area. The corridor follows a route to the north of the residential area (next to the railway line). The natural vegetation is modified due to small businesses, agricultural activities, town developments and wood collection (Figure 15 - 18).

Figure 14: View of the stream with *Breonadia salicina* present.

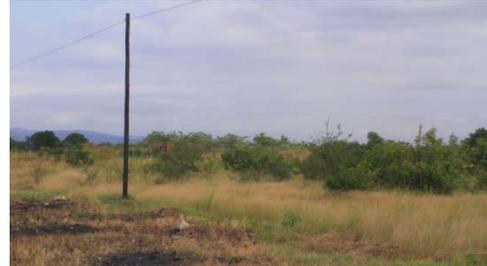
Figure 20: Natural vegetation severely modified.

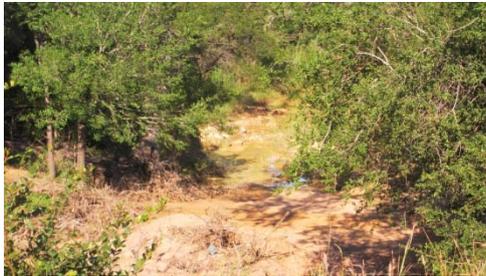
Figure 37: Stream crossings in the sector – sensitive areas act as migration corridors for biota.

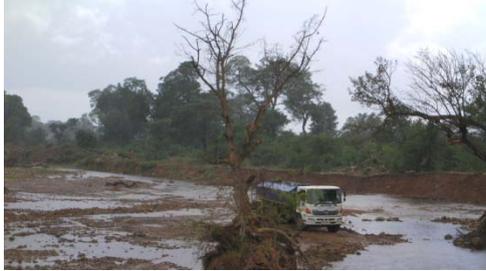
Figure 77: Water abstraction for road construction from the Mahlatsi River – a tributary of the Ga-Selati River.

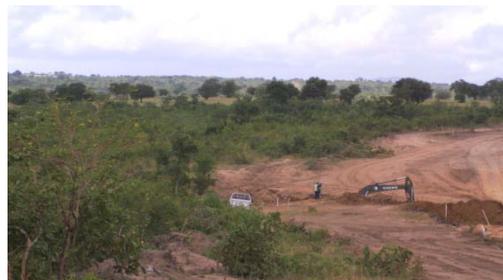
Figure 80: Construction having a negative impact on natural vegetation and streams – erosion severe.

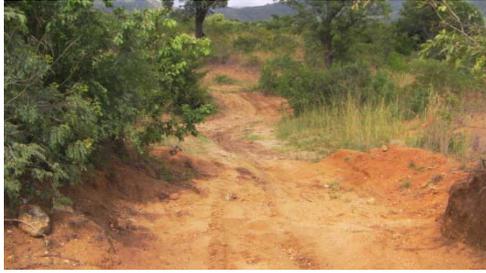
Figure 82: Poor infrastructure planning, development and maintenance contribute to degradation of the habitat and landscape.

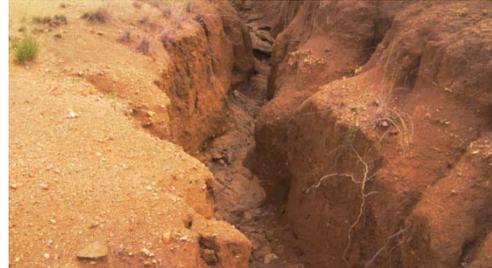
Figure 83: Erosion a result for poor land use practices and maintenance of infrastructure.

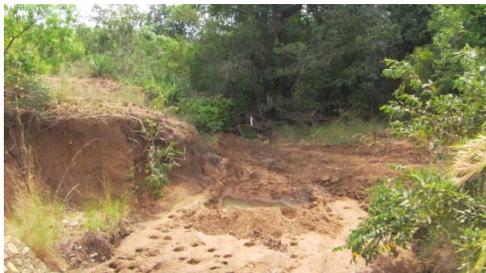
Figure 84: Illegal sand mining in all streams having a negative impact on the environment.

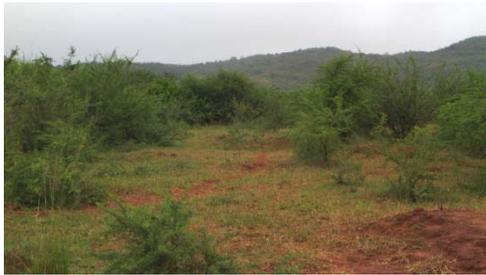
Figure 99: Impacts in valleys modify natural vegetation.

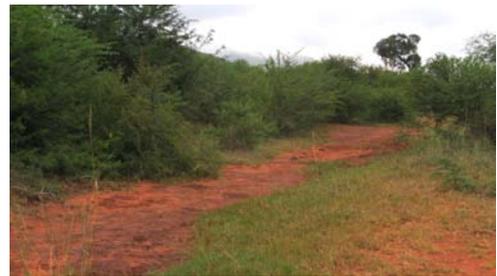
Figure 100: Erosion a high risk.

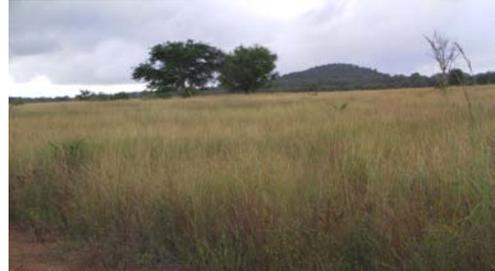
Figure 111: Outcrops are sensitive areas – refugia and migration corridors for biota.
