AQUATIC ECOLOGICAL STUDY PRIOR TO THE PROPOSED DEVELOPMENT OF THE INGULA BRIDGE

Prepared by: Scientific Aquatic Services
Report Authors: S. van Staden (Pr. Sci. Nat)
Project Reference: 28090
Date: August 2008

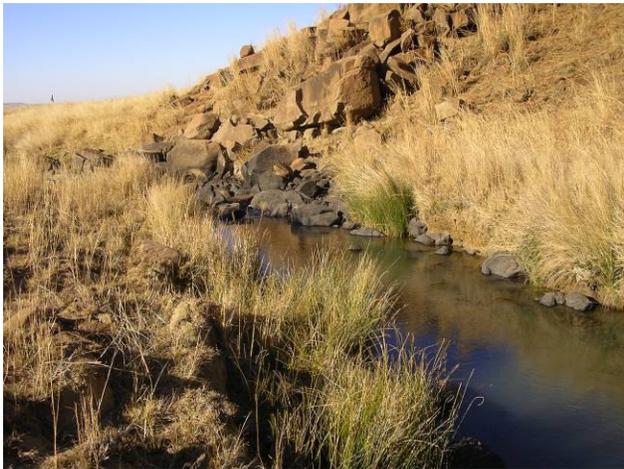
Figure 3: Downstream view of the IN1 site on the Braamhoekspruit showing the presence of pool habitats

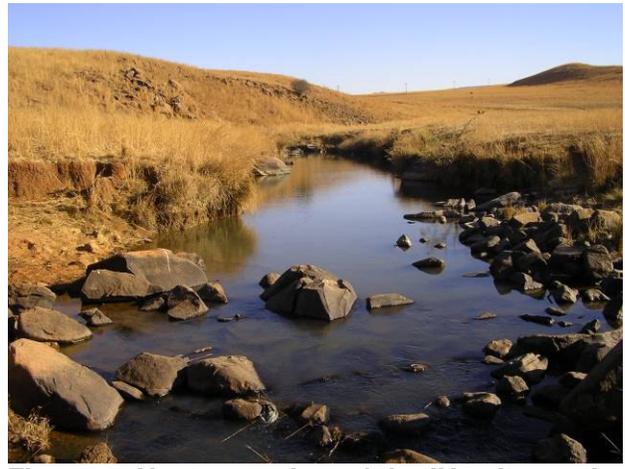
Figure 4: Upstream view of the IN1 site on the Braamhoekspruit showing lack of low in the system at the time of assessment

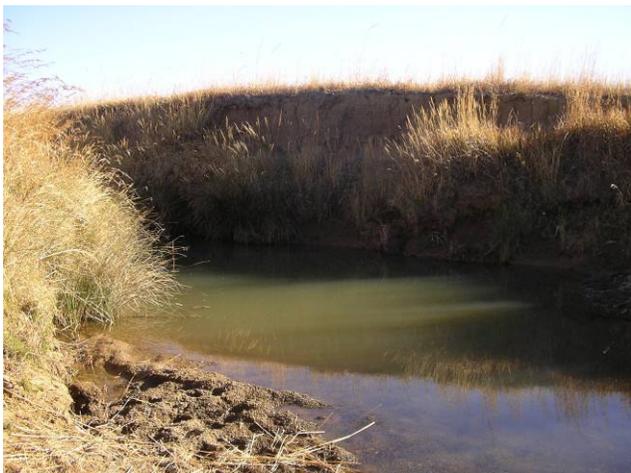
Figure 5: Local view of the IN2 site indicating the pools habitat and slow flowing water

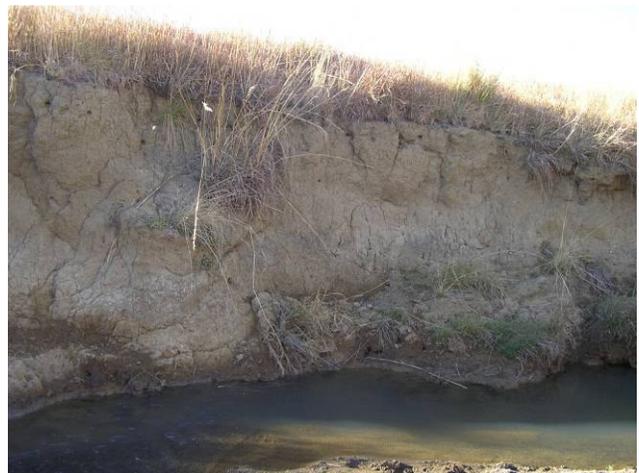
Figure 6: Local view of the IN2 site indicating the severe bank erosion at the site

Erosion potential	The banks have a significant potential for erosion due to the presence of very steep banks in some areas. Bank failure has already occurred in some areas. Other areas are protected from erosion by the presence of bedrock.	The banks have a significant potential for erosion due to the presence of very steep banks in some areas. Bank failure has already occurred in some areas.
Stream continuity	Limited impacts on stream continuity were observed; however, the gauging weir and existing road crossing may prevent some migration of more mobile species.	No impacts on stream continuity below the bridge were observed.

- Any areas where bank failure is observed, due to the effects of bridge crossing should be immediately repaired by reducing the gradient of the banks to a 1:3 slope.
- Bank vegetation cover should be monitored to ensure that sufficient vegetation is present to bind the bankside soils and prevent further bankside erosion.

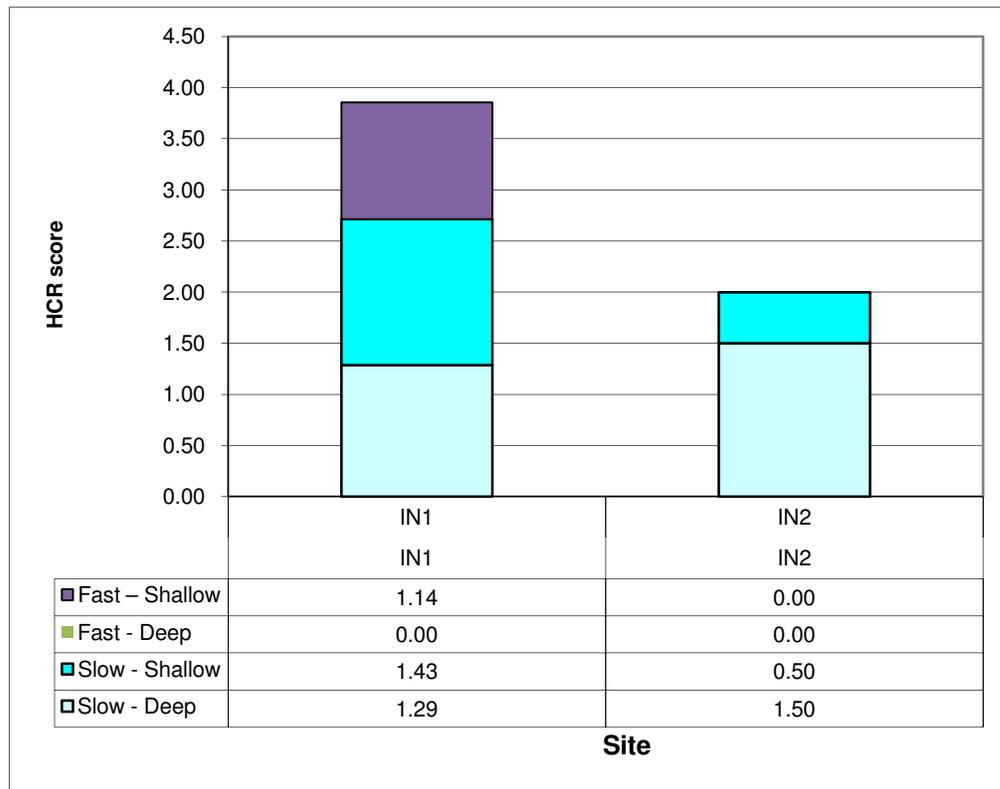
The riverine assessment site was sampled for fish for a period of one hour. Figure 8 below summarises the habitat and cover availability for fish in this reach of the Braamhoekspruit River. The table below serves to summarise the findings of the application of the FAIL index to the site.

Figure 8: Summary of the application of the HCR index to the study site
