# GEOTECHNICAL ASPECTS REGARDING FOUNDATION CONDITIONS AT GAMMA SUBSTATION'S TWO PROPOSED SITES

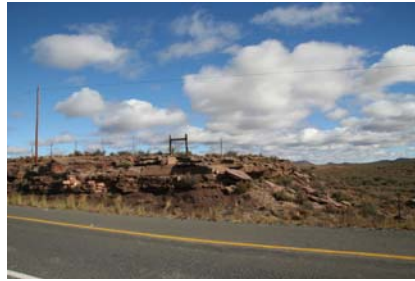
At the Kleinfontein site, the shale bedrock is blanketed by a layer of brown sandy colluvium with abundant flaky shale fragments, some 0.3m thick, sequentially underlain by highly weathered shale bedrock intercalated with dark grey to black carbonaceous lenses – see Plate 2 on the following page.

**Plate 2:** Shale exposed in N1 road cutting adjacent to proposed site

The shale bedrock exposed in the road cutting near the Kleinfontein site appears to be medium weathered and founding within the competent shale with a bearing capacity of 500KPa is expected at an average depth of 0.5m on this site. Consolidation settlement is expected to be < 5mm and only to occur during the construction period. No heave is expected as the materials are too gravelly. Good site drainage is required.

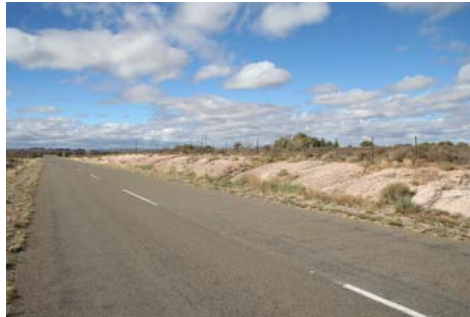
The Uitvlugtfontein site is blanketed by ivory coloured, partially to well cemented calcrete, some 1.0 to 1.5m thick, sequentially underlain by shale bedrock in various stages of weathering. As indicated by the local borrow pits, road cuttings, access roads and drainage courses, the immediate surroundings of the Uitvlugtfontein site are blanketed by calcrete – see Plate 3 below.

**PLATE 3:** Calcrete exposed in cutting in tarred road near Uitvlugtfontein.

The shale bedrock at the Uitvlugfontein site is blanketed by partially to well cemented calcrete, some 1.0m thick and more in places. The ivory coloured calcrete is partially to well cemented with an estimated bearing capacity of 150KPa and negligible consolidation settlement. However, where the profile is dominated by powdery, partially cemented calcerous soils, some densification will be required. Alternatively, the structures should found on competent shale bedrock below the calcrete. No heave is expected as the materials are too gravelly.
