**HERITAGE ASSESSMENT REPORT  
MERCURY SUBSTATION EXPANSION,  
ZAAIPLAATS 190/3, FEZILE DABI (DC20)  
DISTRICT, FREE STATE, SOUTH AFRICA**

**REPORT FOR PBA INTERNATIONAL**

**19 June 2007**

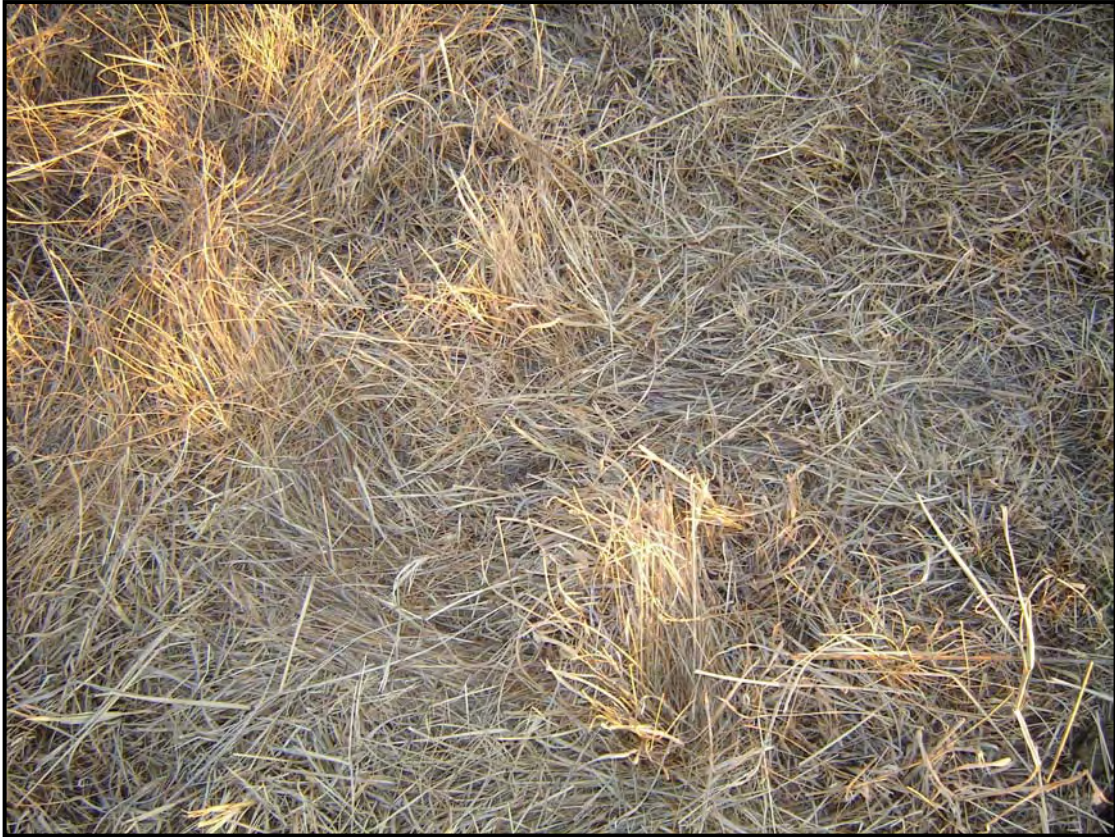
Visibility of the surface of the ground was reasonable for most of the surveyed area, apart from the area to the south-west of the road, where the grass was very thick, and it was impossible to see the ground surface beneath.

Photo 3: Thick grass cover SW of dirt road

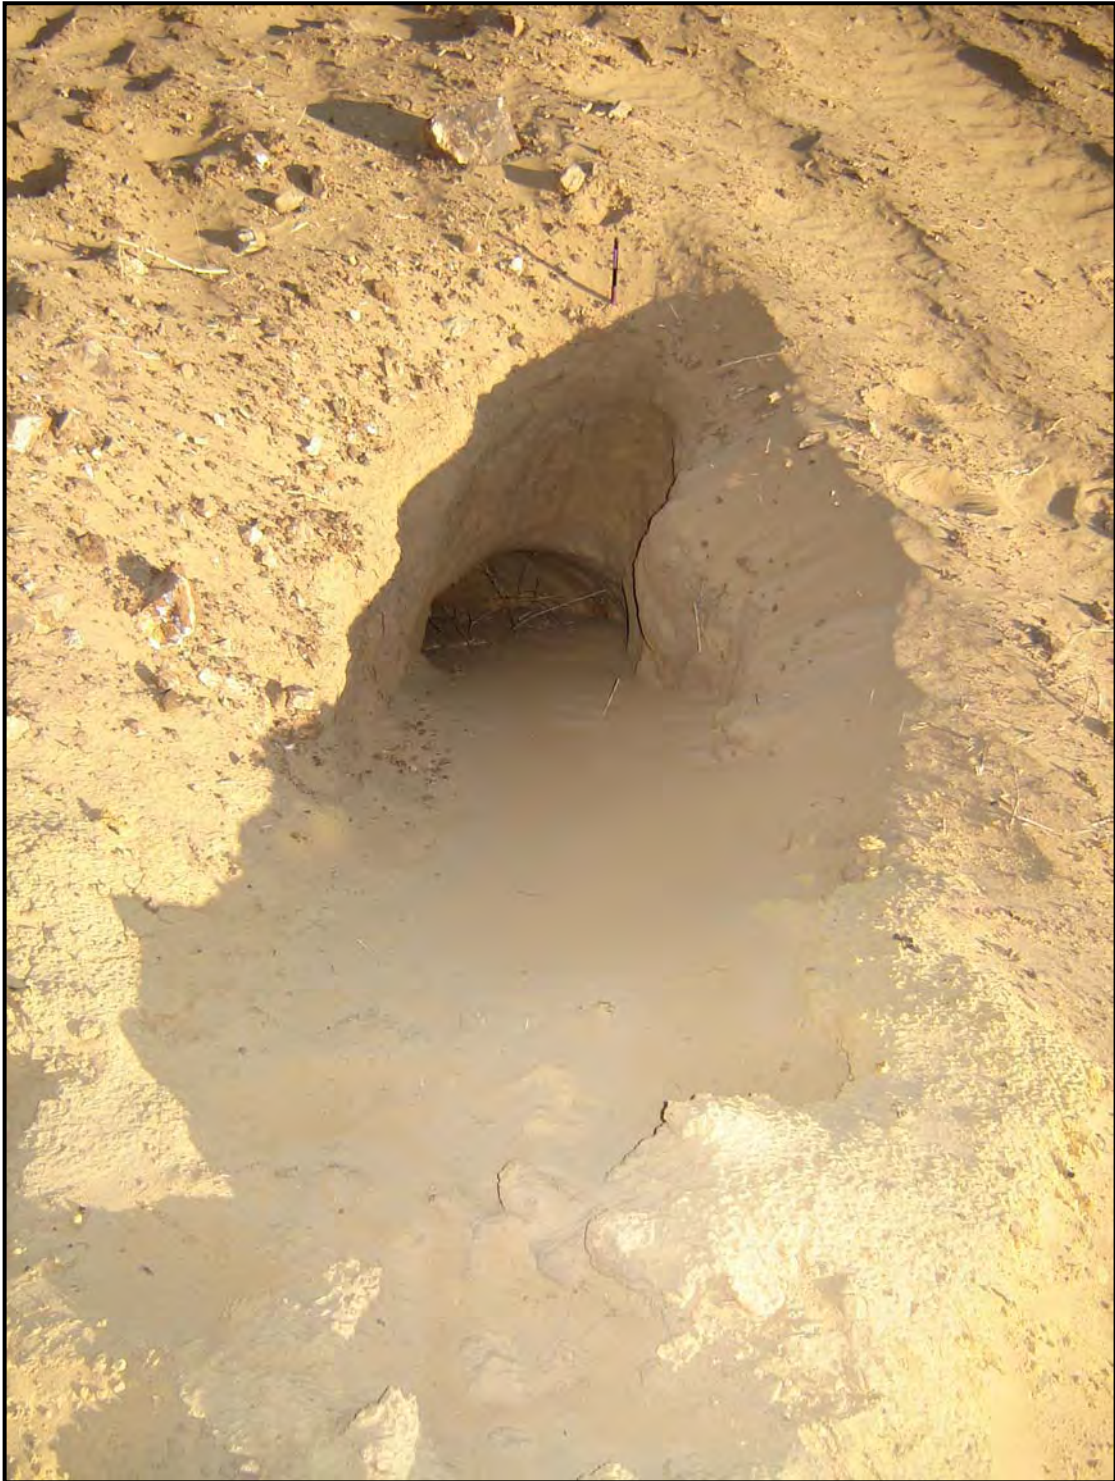
Photo 5: Animal burrow – no visible artefacts

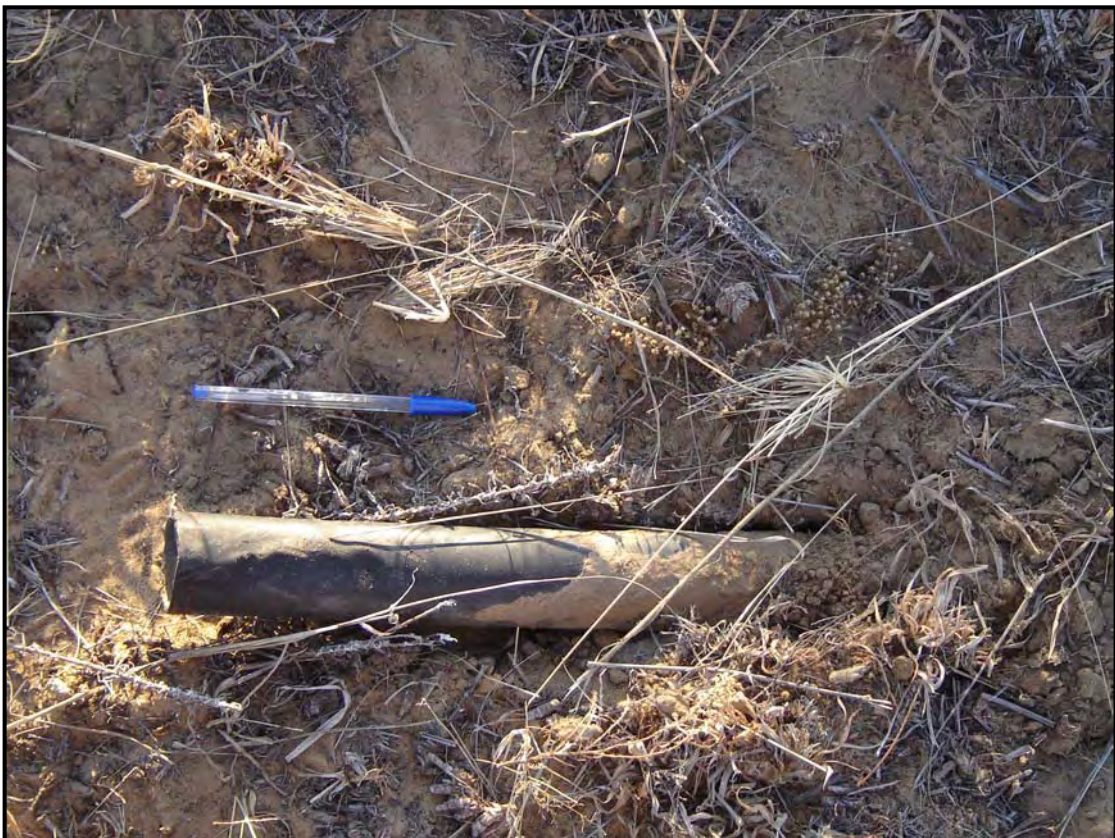
The area has been disturbed in the past, as is evidenced by a buried plastic pipe. Recent disturbance includes new roads in the south-western section of the surveyed area (see map), along the eastern and southern boundaries (the latter is against the northern fence of the current substation). Further disturbance in the form of various inspection pits was noted in the area. The inspection pits appeared to have been dug with a back-actor and then refilled. All of the disturbed areas were also surveyed for subsurface material which had possibly been brought up to the surface.

Photo 7: Buried pipe – indicating previous disturbance

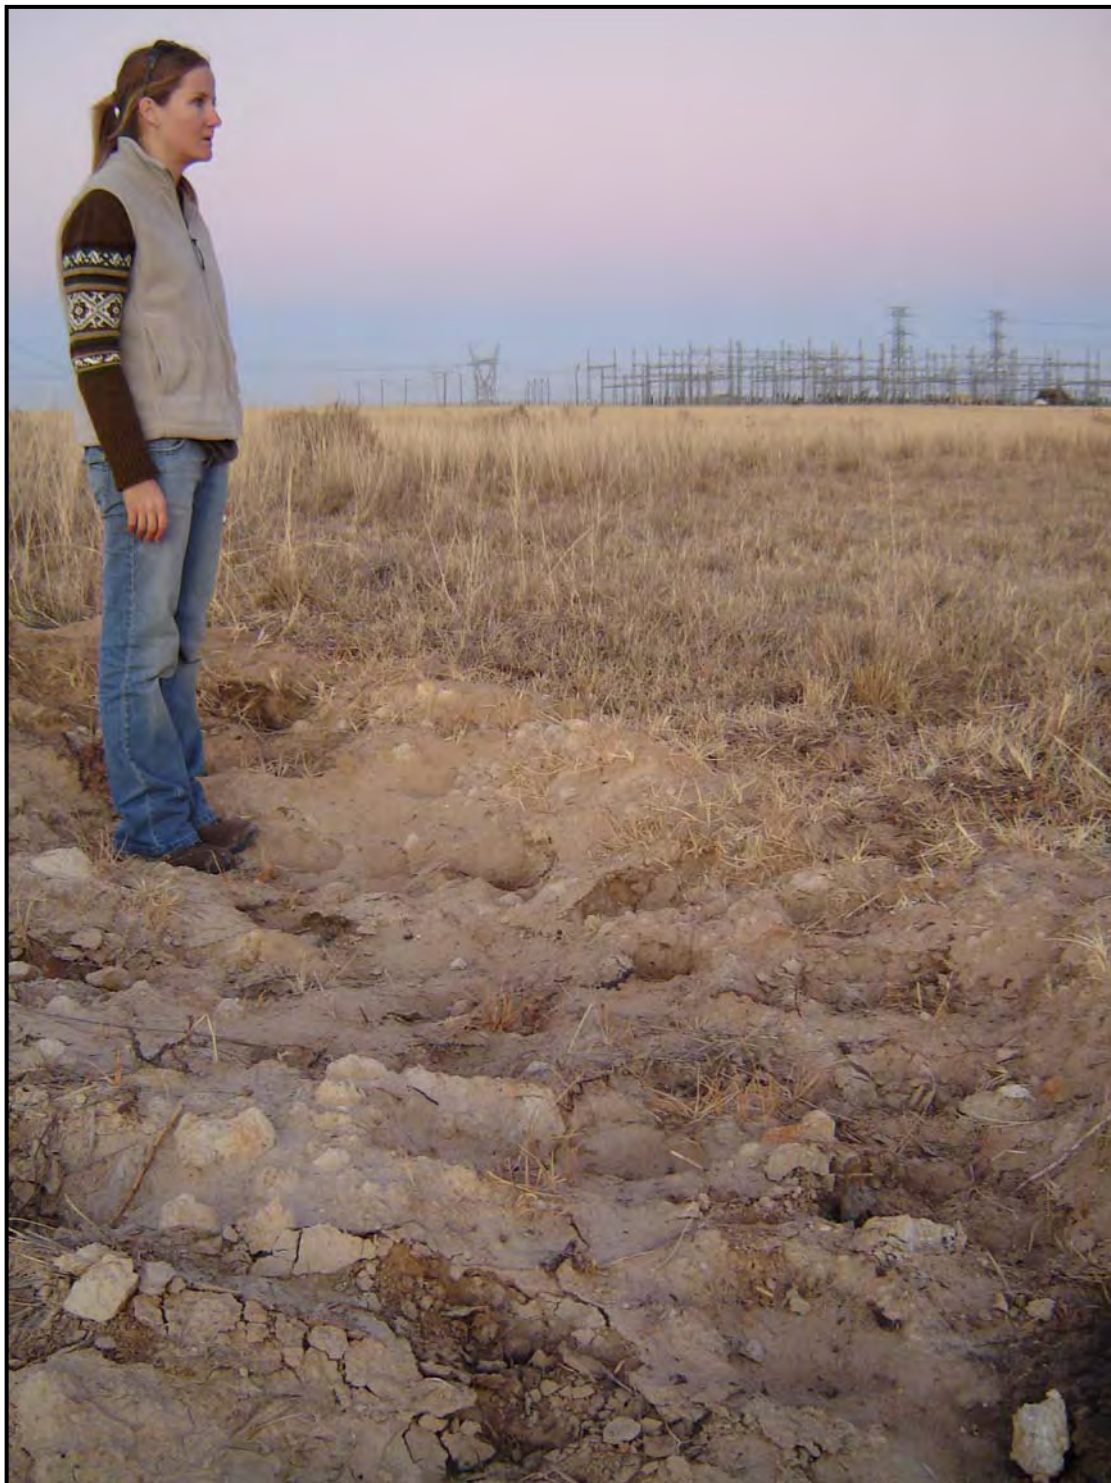
No sites were found in the area surveyed. However, although the inspection pits are now filled up, three of the pits examined yielded archaeological material in the form of stone artefacts.

The three inspection pits which yielded material are all in the southern part of the surveyed area (see map). The sandy soils of the area could be wind blown Kalahari sands, which would date to the last 10 000 years. The artefacts may or may not be in situ in the sands, as artefacts can move in sandy contexts through water action, trampling and other circumstances. The occurrence of the artefacts in sandy soils that yielded no other lithic material on the surface has to be investigated further.

Photo 13: Inspection pit containing artefacts (see photo 14)

That shovel testing (under permit from SAHRA) is carried out in the south-western side of the proposed substation area. On the basis of the shovel test pits, further mitigation, or not, will be recommended.

A small area of the inspection pit should be opened to reveal the profile of the pit, and the opened area can be extended slightly in order to understand the nature of the artefact occurrence.

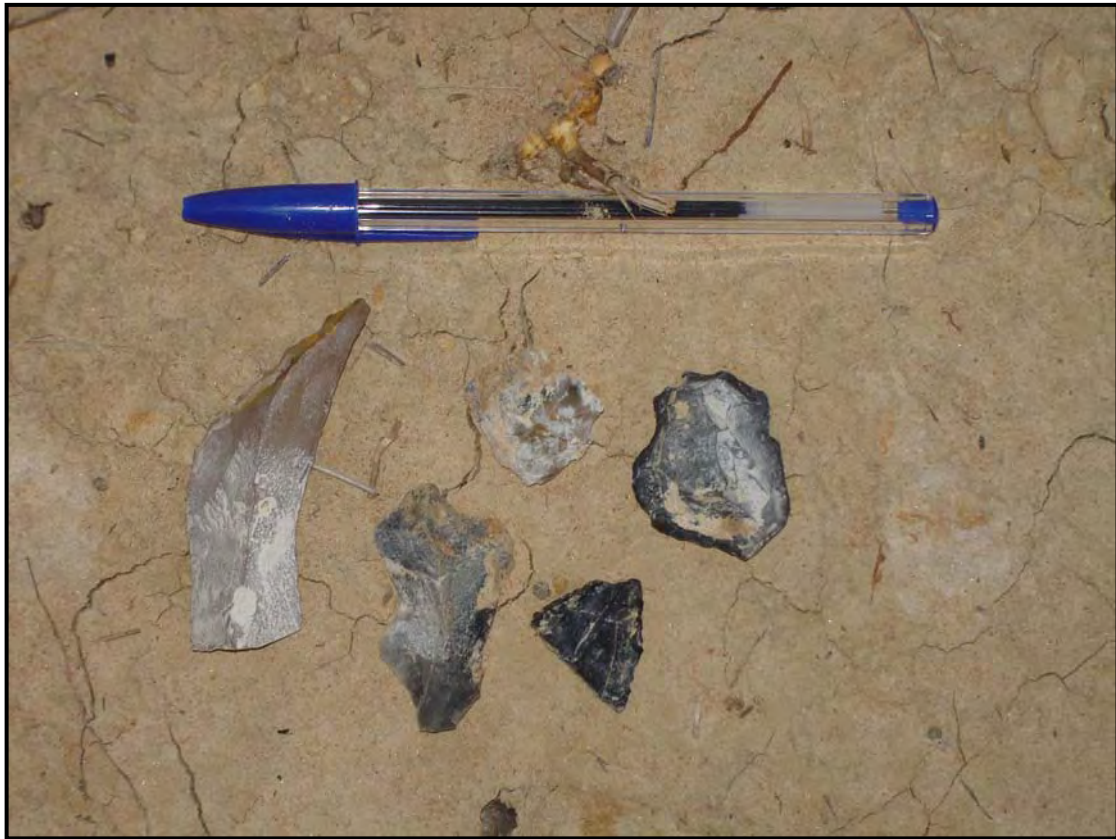
Three of the inspection pits yielded artefacts. One pit yielded five artefacts, another three and the third one. These artefacts had been brought up from an unknown depth (probably no more than a metre or two), and were mostly undiagnostic flakes with one blade-like flake which could be Middle Stone Age. Raw material included cryptocrystalline, chert and quartz.

Photo 14: Stone artefacts

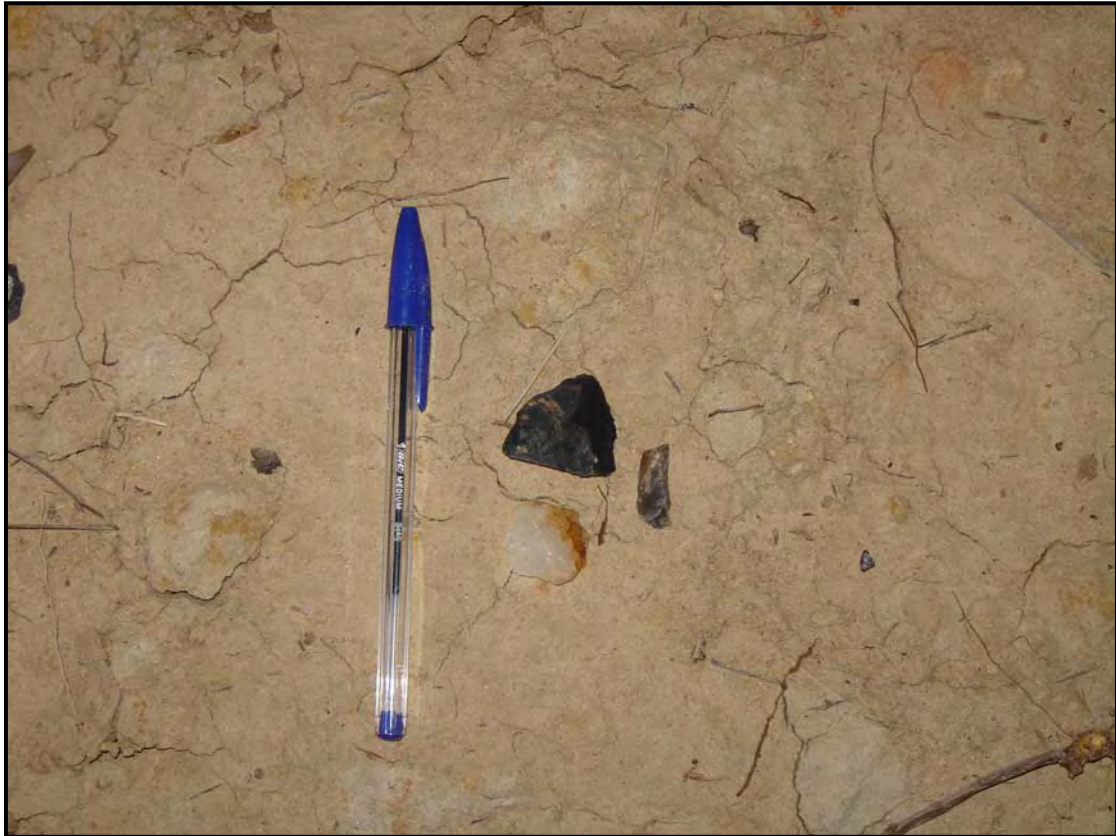
Photo 15: Stone artefacts
