## **Vegetation, Soil & Land Capability Assessment and Wetland Delineation for Ingula Bridge near Van Reenens in Kwa-Zulu Natal**

### **Draft Report**

This is a report compiled for Eskom  
Holdings (Pty) Ltd

ESC-245:0-Soil&Veg Assessment -BvA- v1-260808

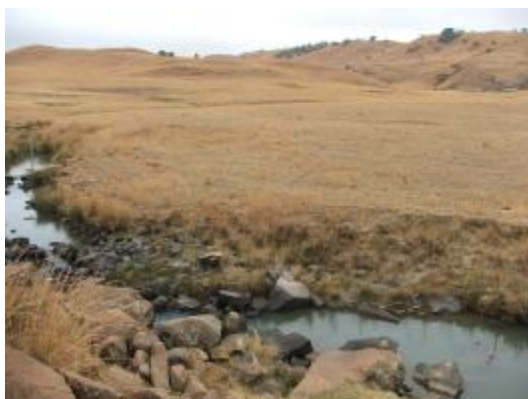
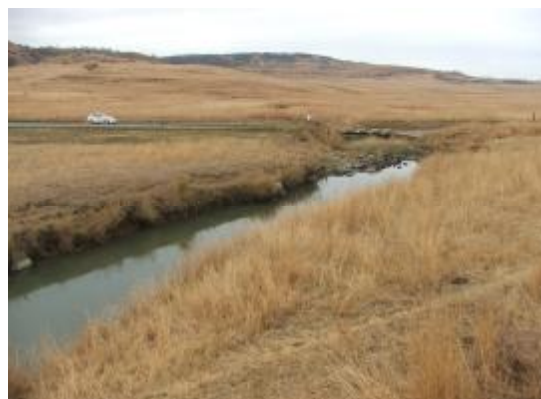
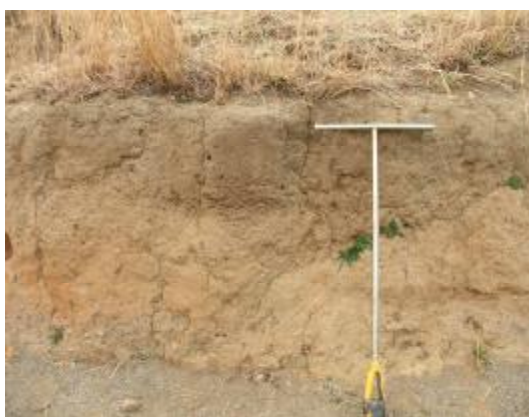
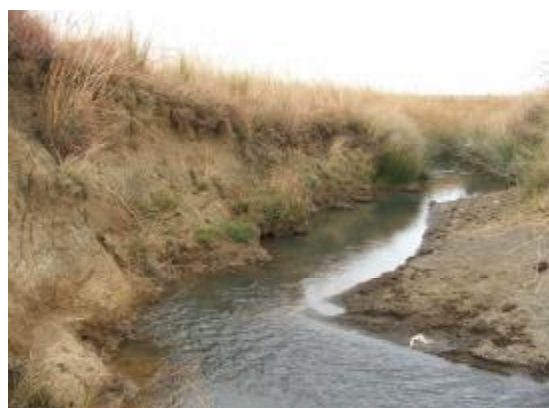
**Figure 2-2: Photos of the Braamhoekspruit**

Figure 2-3 shows the surface hydrology of the site. The site falls in the V12A quaternary catchment. The surrounding catchments are the V12B the V12E quaternary catments. The V12A quaternary catchment drains into the Braamhoekspruit, which will be crossed by the by the proposed bridge. The Braamhoekspruit is a highly meandering perennial river with extremely steep and high river banks (Figure 2-2).

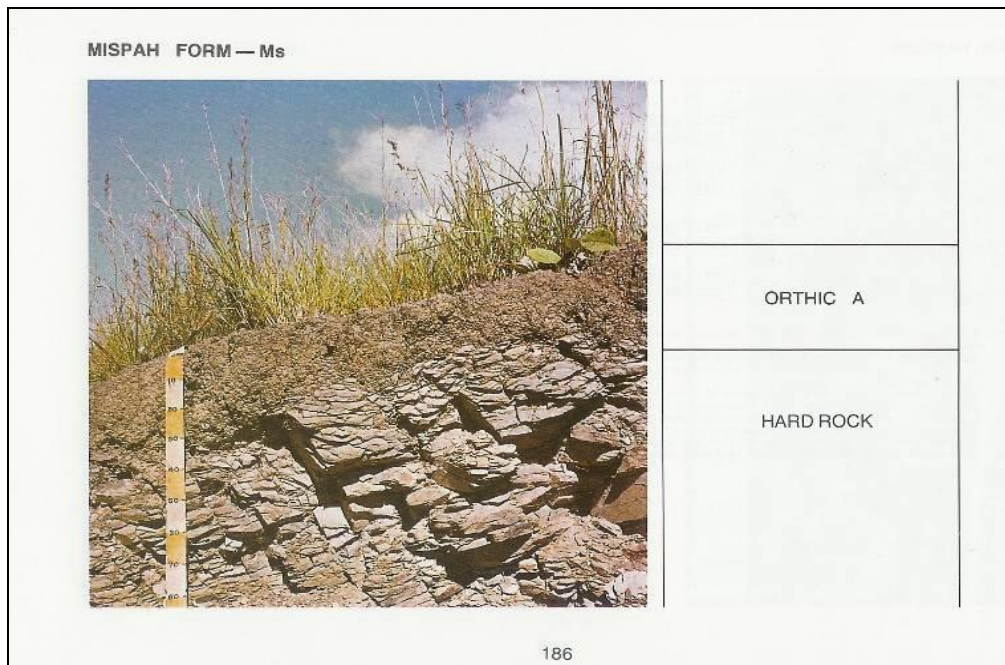
**Figure 2-5: Mispah soil form (Memoirs on the Natural Resources of South Africa, no. 15, 1991).**

The Mispah soil form is characterised by an Orthic A – horizon overlying hard rock. Mispah soil is horizontally orientated, hard, fractured sediments which do not have distinct vertical channels containing soil material. There is usually a red or yellow-brown apedal horizon with very low organic matter content. Please refer to Figure 2-5 for an illustration of a typical Mispah soil form.

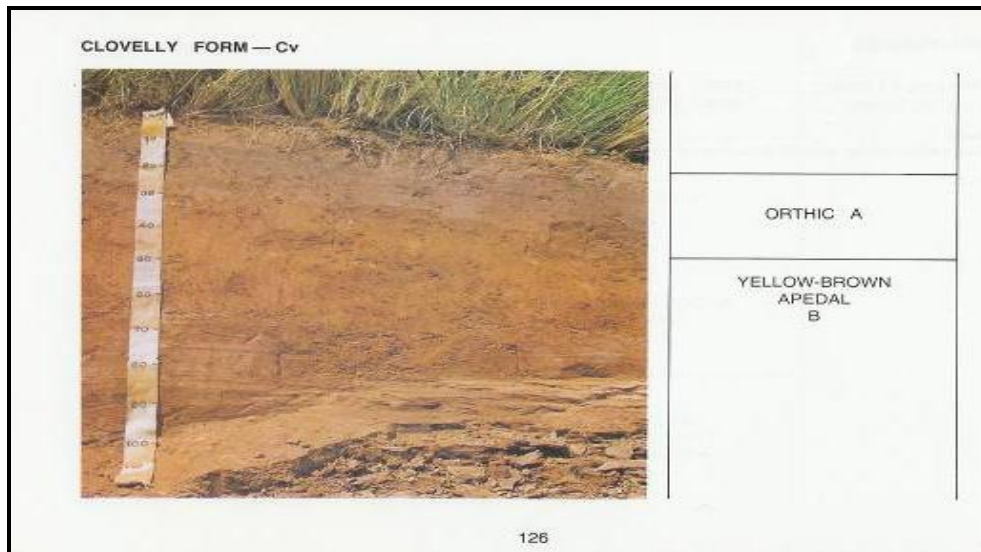
**Figure 2-6: Clovelly soil form (Soil Classification, 1991 & site visit auger hole)**

Clovelly soils can be identified as an apedal “yellow” B-horizon as indicated in Figure 2-6 below. These soils along with Hutton soils are the main agricultural soil found within South Africa, due to the deep, well-drained nature of these soils. The soils are found on the valley bottom which constitutes 83.1 % of the site.

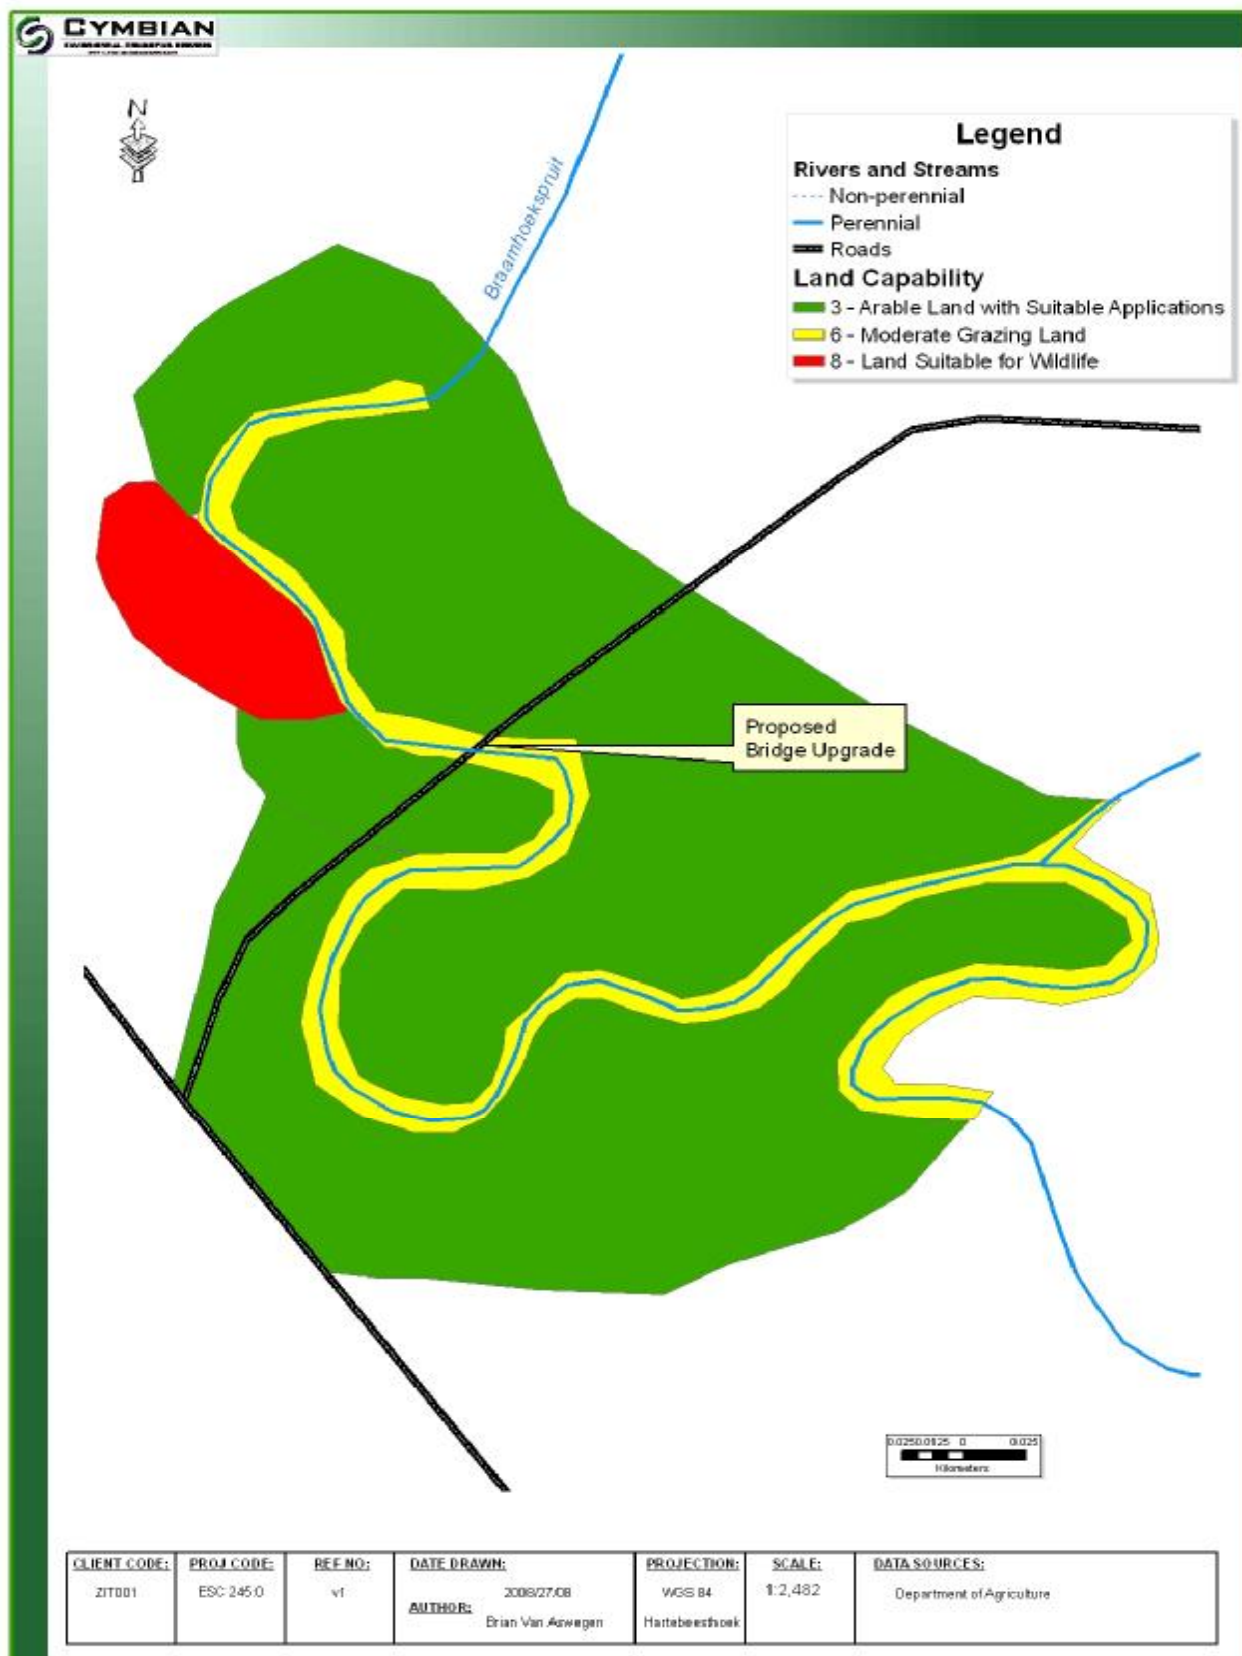
2.7 Figure 2-10: Land Capability Map

The site has a dominant land capability of class III. This indicated that the site is suitable for cultivation and can be used for a wide range of agricultural applications. Some soils are in class VII which has continuing limitations that cannot be corrected; in this case rock complexes, flood hazard, stoniness, and a shallow rooting zone constitute these limitations.

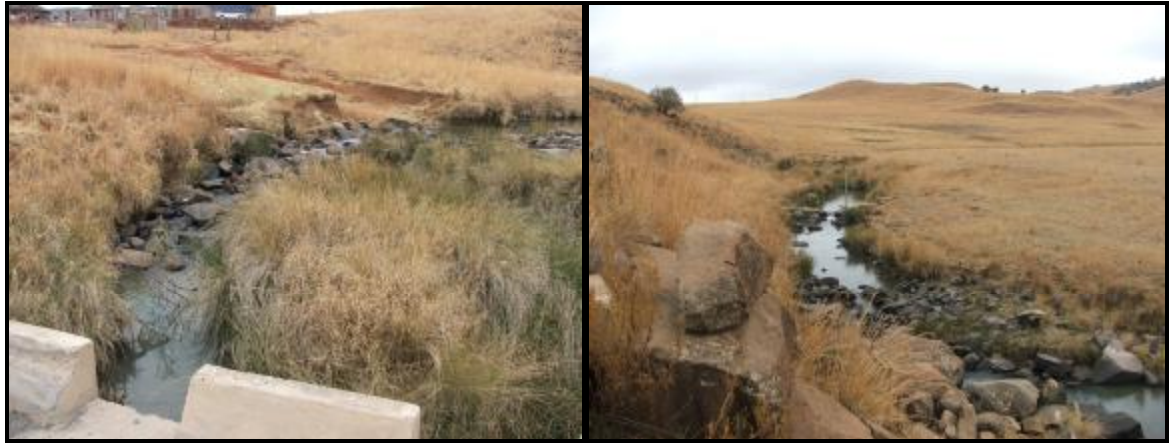
**Figure 2-12: Photographs showing the Riparian Vegetation Unit**

The riparian vegetation unit follows the Braamhoekspruit and is comprised mainly of water-loving grasses and *Leucosidea* trees. This unit is sensitive and according to the DWAF should be buffered in order to protect the essential ecological services within the unit. The vegetation unit are illustrated in Figure 2-13 below. This unit is approximately 2.4 ha in size and is buffered by a 50m buffer as prescribed by the DWAF. The buffer zone is also indicated on the figure. A list of the species that were found on site is also given in Table 2-5.

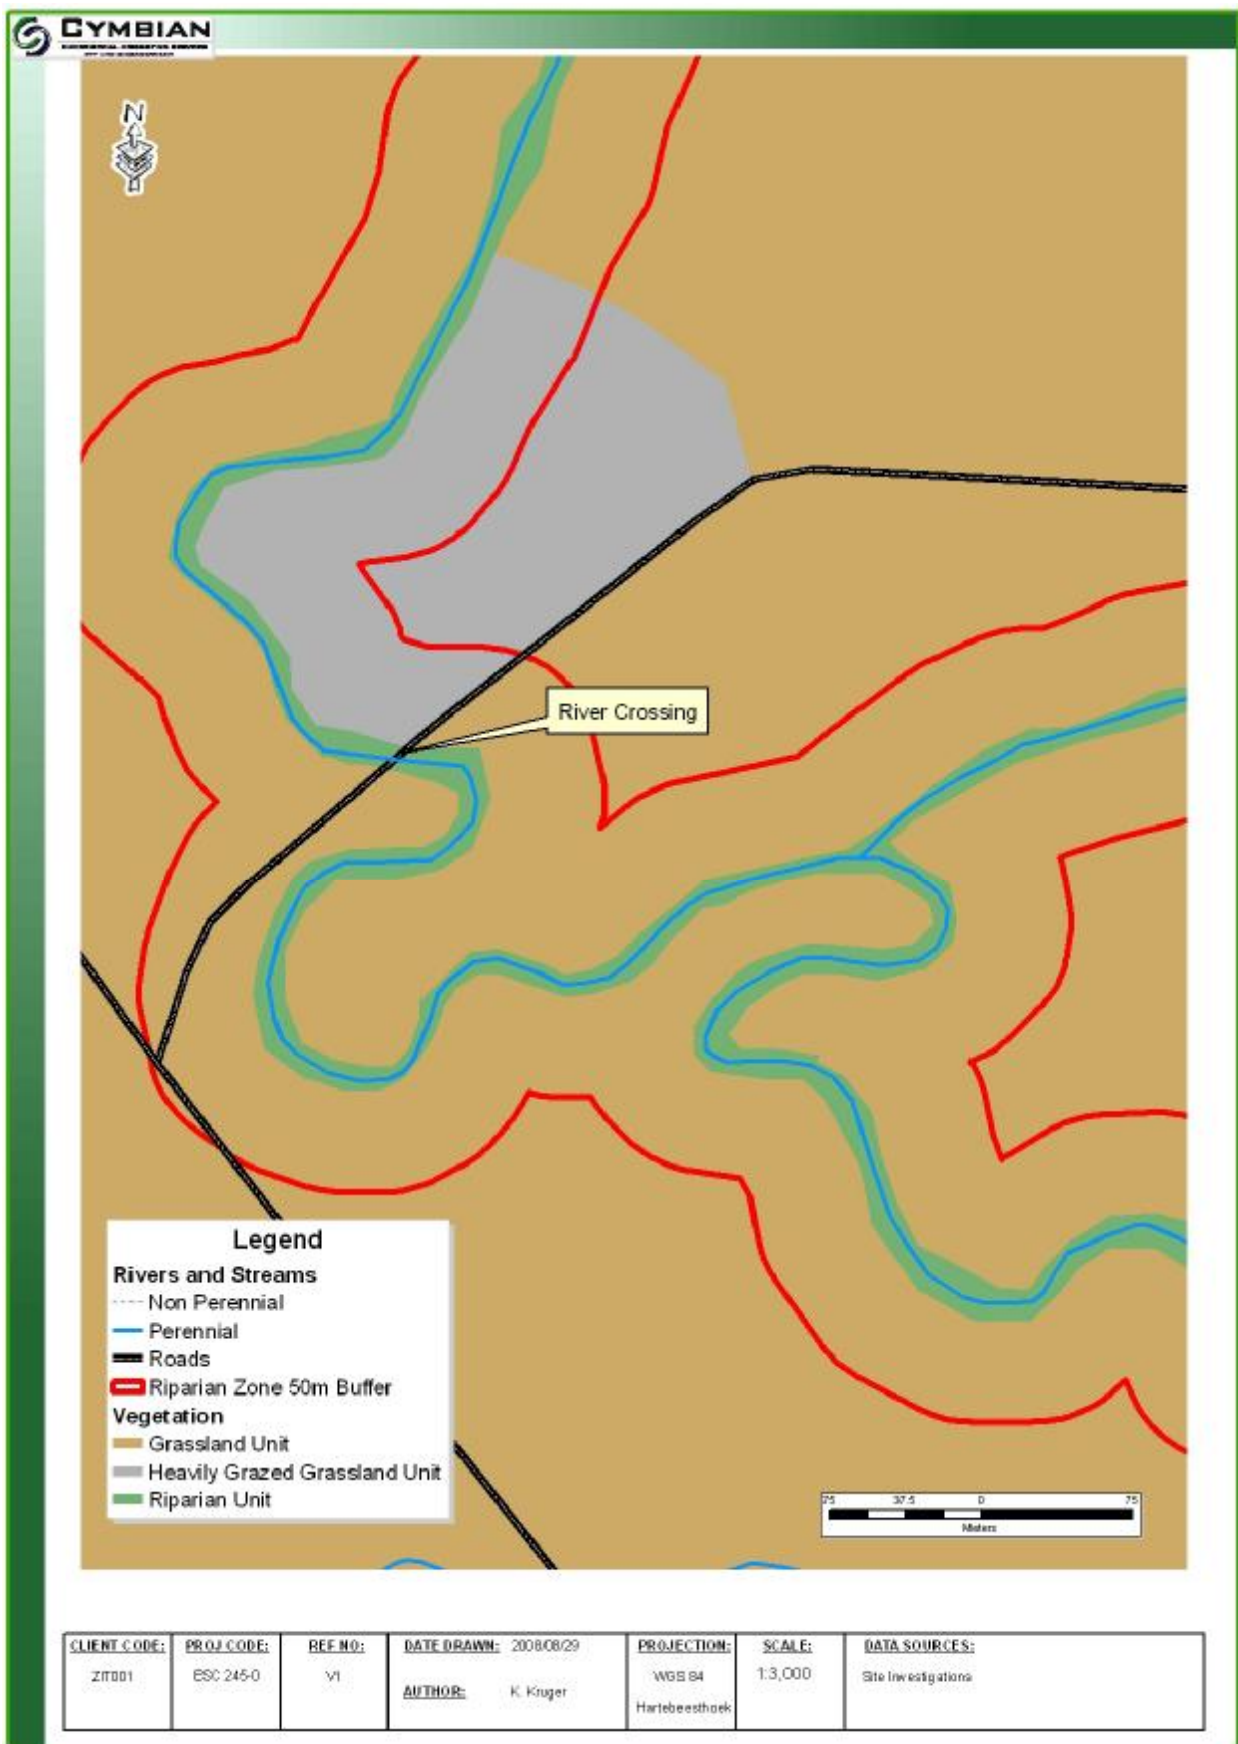
Figure 2-13: Vegetation units found on site

During the site assessment, it was noted that the site is comprised of two distinct vegetation units, namely the riparian unit and the grassland unit. The riparian unit, as the name suggests, is found along the Braamhoekspruit and is limited to the riparian zone. Each of the vegetation units is described in more detail below.

However, due to the Braamhoekspruit being a riparian zone it is necessary, as per legislation, to buffer the riparian zone. Inside an urban edge the required width of the buffer is 32 m while outside the urban edge a buffer of 50 m needs to surround the riparian zone. A 50 m buffer is proposed from the edge of the riparian zone in order to protect the ecological processes found within this system. During construction of the proposed bridge, management measures will be more stringent within the buffer of the riparian zone. Figure 2-13 shows the 50 m buffer around the riparian zone of the Braamhoekspruit.

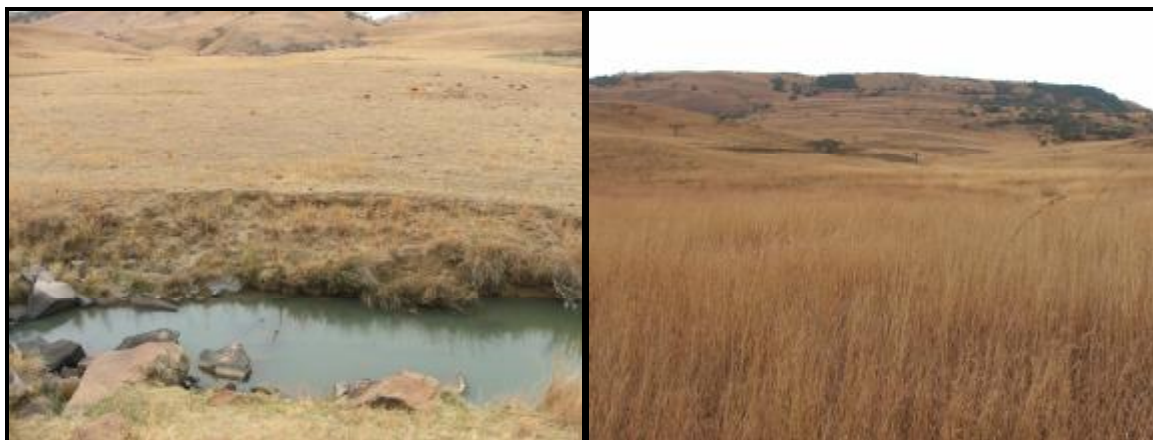
**Figure 2-14: Photographs of the Grassland vegetation unit**

The grassland vegetation unit is extensively used for grazing of cattle and the dominant species is *Hyparrhenia hirta*. The unit is divided by the gravel road at which the bridge upgrade will be located and the area to the north-west of the proposed bridge upgrade is heavily grazed. This is also the proposed site for the temporary by-pass road and it is suggested that all impacts be located within this area if possible. The grassland unit is a very common unit in KwaZulu Natal and rehabilitation should be easily affected. This unit comprises approximately 96 ha of the site of which 3 ha is heavily grazed. The unit is indicated on Figure 2-13 and the species list is tabled in Table 2-5. In addition photographs of the site are illustrated in Figure 2-14.
