Vegetation, Soil & Land Capability Assessment and Wetland Delineation for Ingula Bridge near Van Reenens in Kwa-Zulu Natal

Draft Report

This is a report compiled for Eskom
Holdings (Pty) Ltd

ESC-245:0-Soil&Veg Assessment -BvA- v1-260808

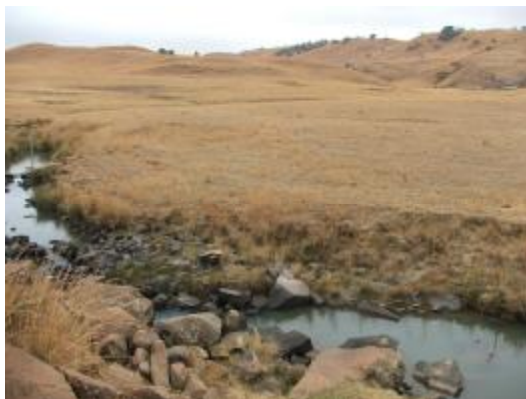
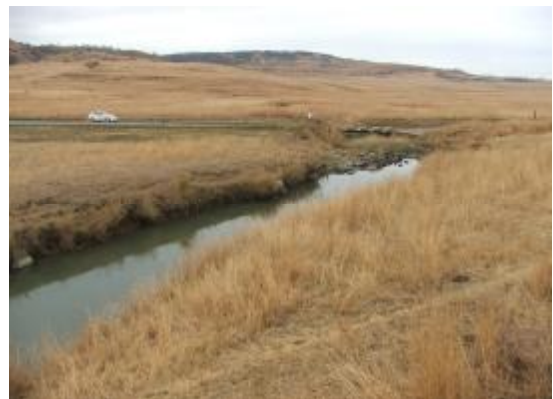
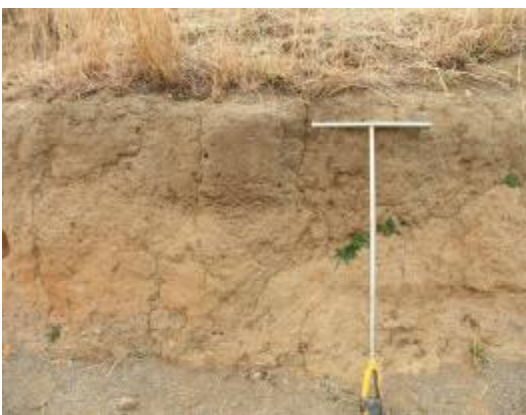
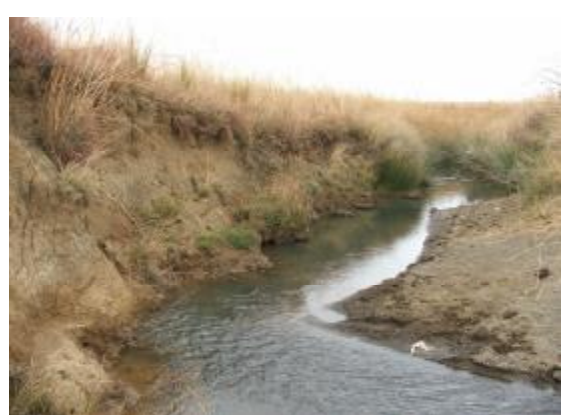
Figure 2-2: Photos of the Braamhoekspruit

Figure 2-3 shows the surface hydrology of the site. The site falls in the V12A quaternary catchment. The surrounding catchments are the V12B the V12E quaternary catments. The V12A quaternary catchment drains into the Braamhoekspruit, which will be crossed by the by the proposed bridge. The Braamhoekspruit is a highly meandering perennial river with extremely steep and high river banks (Figure 2-2).

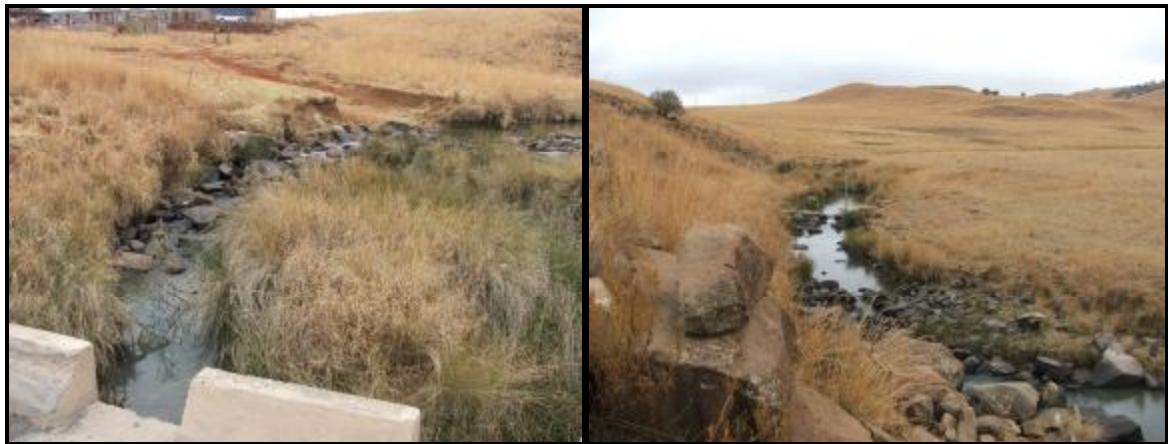
Figure 2-12: Photographs showing the Riparian Vegetation Unit

The riparian vegetation unit follows the Braamhoekspruit and is comprised mainly of water-loving grasses and *Leucosidea* trees. This unit is sensitive and according to the DWAF should be buffered in order to protect the essential ecological services within the unit. The vegetation unit are illustrated in Figure 2-13 below. This unit is approximately 2.4 ha in size and is buffered by a 50m buffer as prescribed by the DWAF. The buffer zone is also indicated on the figure. A list of the species that were found on site is also given in Table 2-5.

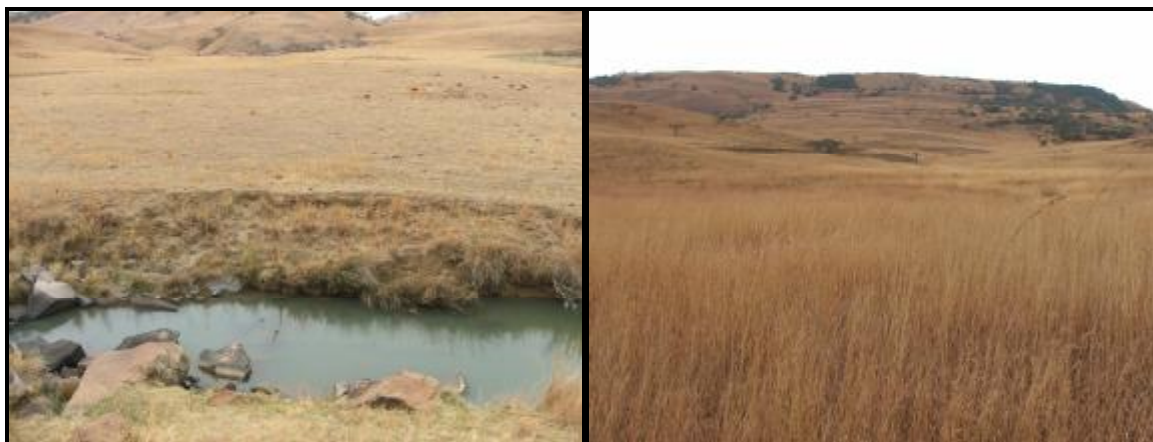
Figure 2-14: Photographs of the Grassland vegetation unit

The grassland vegetation unit is extensively used for grazing of cattle and the dominant species is *Hyparrhenia hirta*. The unit is divided by the gravel road at which the bridge upgrade will be located and the area to the north-west of the proposed bridge upgrade is heavily grazed. This is also the proposed site for the temporary by-pass road and it is suggested that all impacts be located within this area if possible. The grassland unit is a very common unit in KwaZulu Natal and rehabilitation should be easily affected. This unit comprises approximately 96 ha of the site of which 3 ha is heavily grazed. The unit is indicated on Figure 2-13 and the species list is tabled in Table 2-5. In addition photographs of the site are illustrated in Figure 2-14.
