## **Ecological Survey of the Proposed Site for Ash Dam Extension 3 and the Powerline Deviation Route**

### **Ash Dam Extension 3 Site**

### **Powerline Deviation Route**

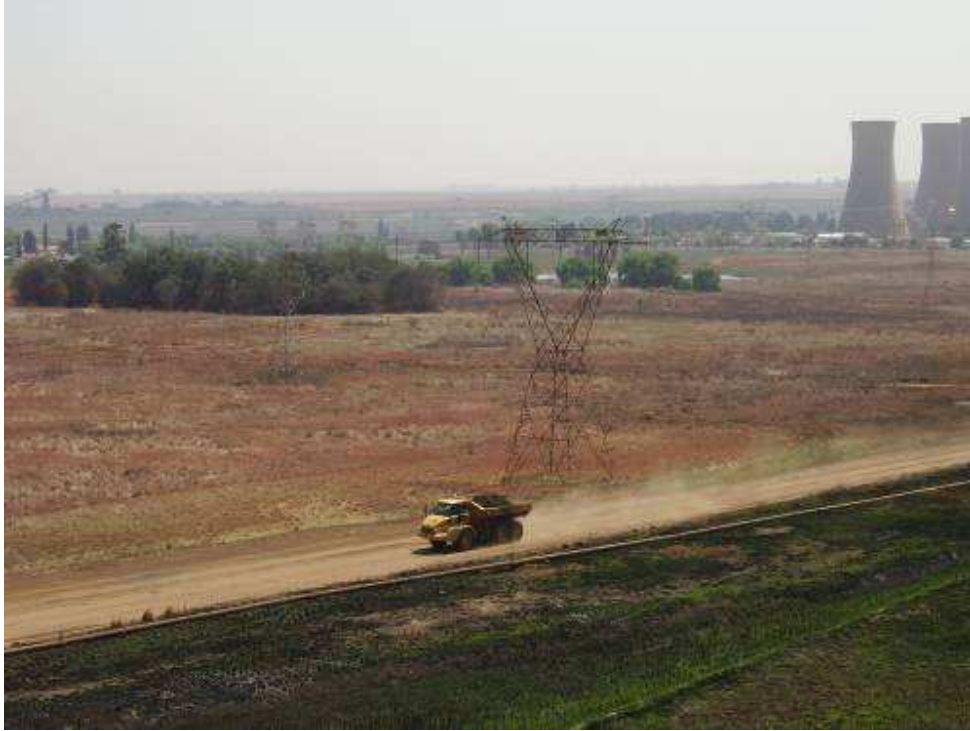
Plate 1: View of Ash dam Extension 3 Site from Ash Dam 1 showing the powerlines requiring deviation. Note the stands of exotic trees.

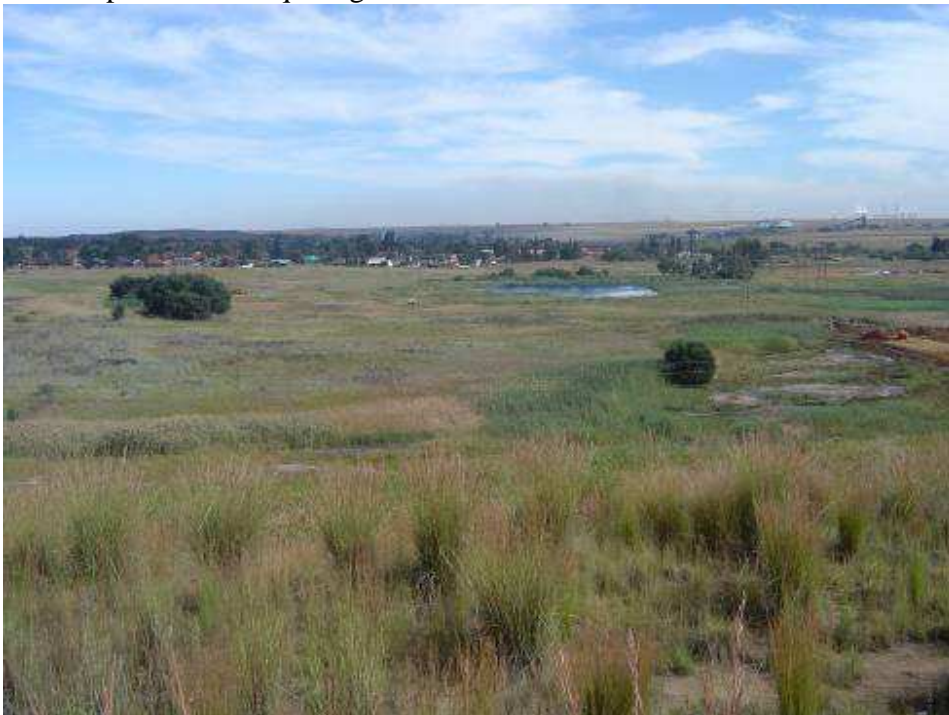
Plate 2: View of Ash dam Extension 3 Site from Ash Dam 1 showing the drainage line and Gras Dam. Note the Giant Reeds (*Arundo* spp) in the drainage lines.

The central drainage line, adjacent wet areas and dams have extensive reed (*Arundo* spp) and bulrush stands. In the areas with damp soils there are numerous sedge species and hydrophilic grasses as well as extensive stands of *Imperata cylindrical*, which was used to vegetate the ash dam walls.

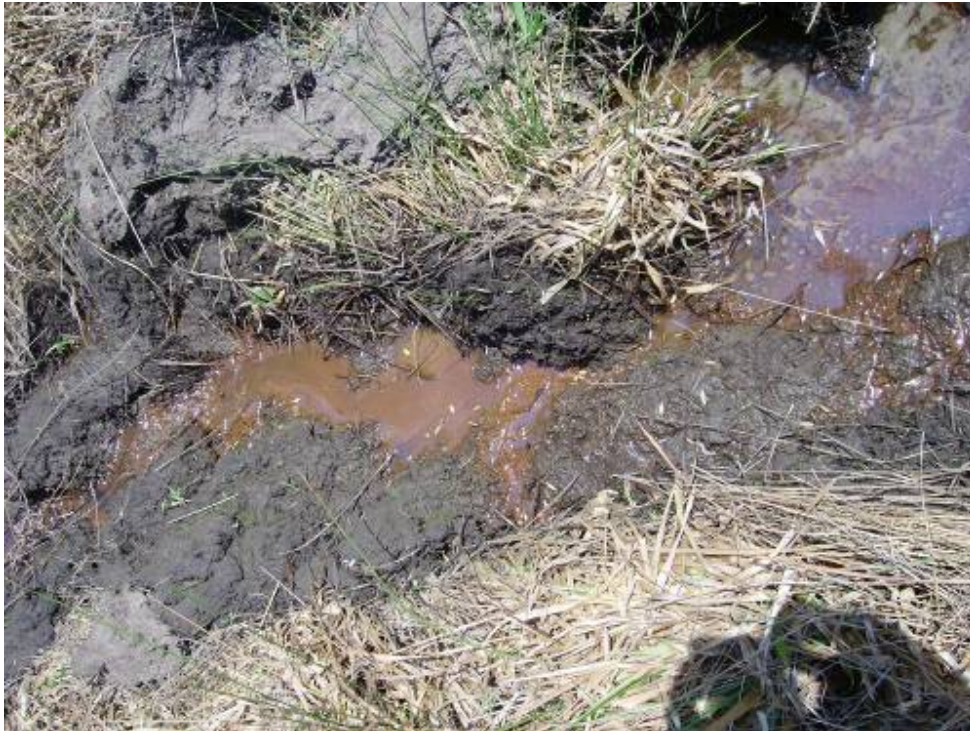
Plate 3: View of Ash dam Extension 3 Site showing extensive surface seepage.

The proposed site for ash dam extension 3 is located within the Komati Power Station Property, adjacent to the existing ash dam complex and is brownfields site. The area slopes gently to the north and is bisected by a small drainage line that drains to the Gras Dam. Extensive disturbances including roads and tracks; old buildings; seepage; sedimentation of ash; and various in-stream and off-stream impoundments have altered large portions of the site. Some of these disturbances are recent while others are historical. Soils in the drainage line and large portions of the lower lying areas across the site are damp to completely inundated, mostly from the seepage that comes from the ash dams.

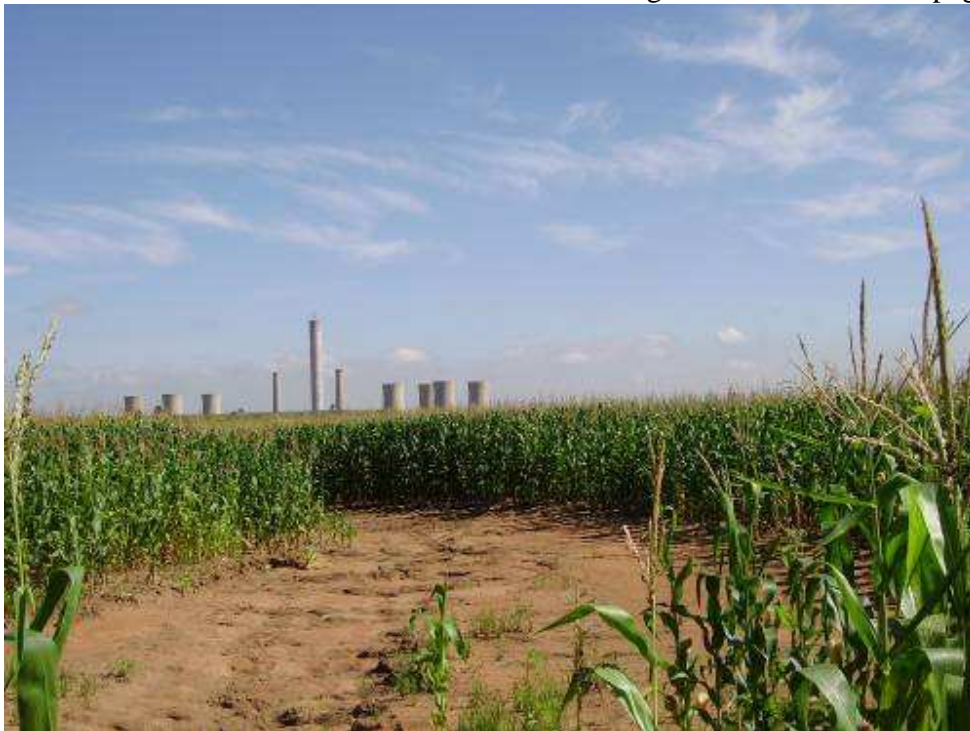
Plate 4: View of the powerline route in the maize fields at the southern end of the proposed deviation route.

The southern and central portions of the proposed powerline route are currently agricultural lands with a dryland maize crop. No ecological sensitivities were identified, although cognisance should be given to the residents of the houses adjacent to the route. The northern-central portion of the route, from the end of the maize fields to the point where the route dog-legs toward the Komati Power Station is vegetated with secondary grasslands. These grasslands appear to have established on old lands and are dominated by species such as *Hyparrhenia* and *Sporobolus* spp, typical of disturbed areas. These grasslands are also heavily infested with various weed species including *Sesbania* spp.

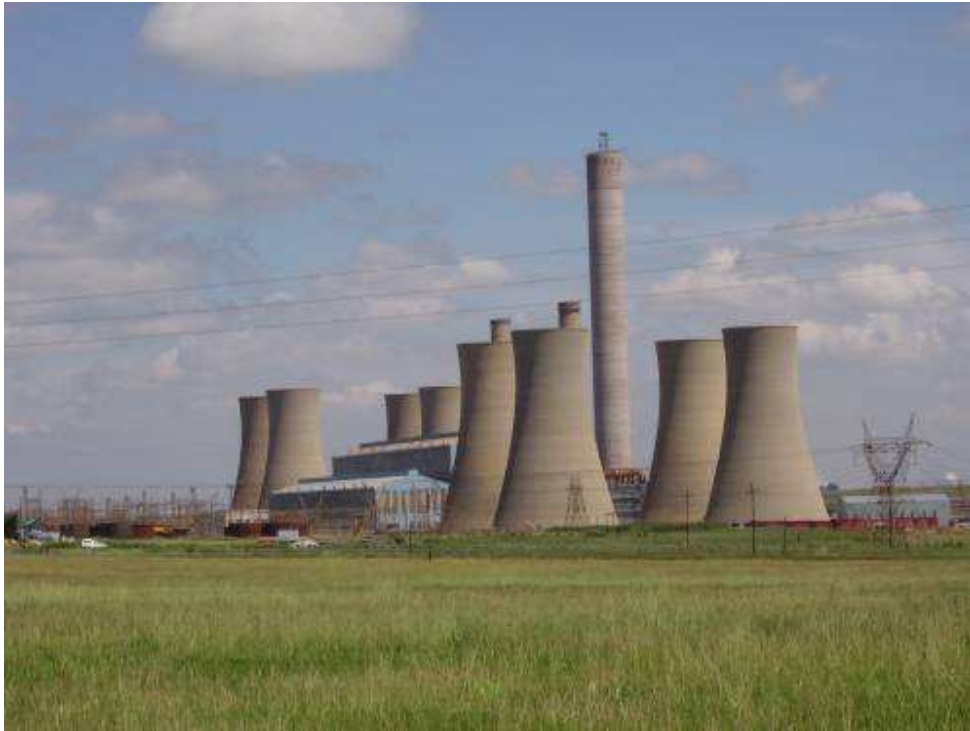
Plate 5: View of the powerline route from the northern corner toward the R35. The vegetation is a mixture of secondary grasslands on old lands with remnant patches of primary grassland.

The area between the powerline route dog-leg and the R35 provincial road has remnants of indigenous, primary vegetation. These patches are comprised of short grasslands interspersed with numerous forb and herb species. Once the powerline route crosses the provincial road it enters Komati Power Station property. This portion of the route has been influenced by regular disturbance and heavy grazing. Although indigenous grass species persist there are numerous weed species, including Thistle and Thorn Apple present. Some of these areas are devoid of vegetation as they have been cleared for roads or construction laydown.

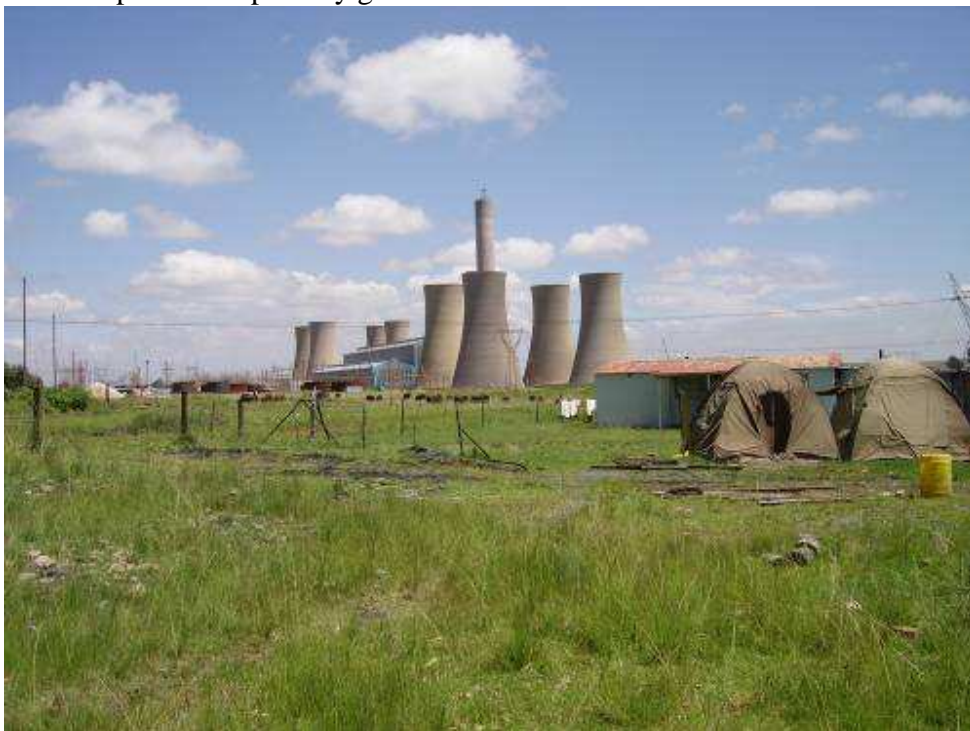
Plate 6: View along the powerline route from the R35 toward Komai Power Station. Note the residents and disturbance to the grass sward (dumping and overgrazing)
