Biophysical Specialist Study Report for the Bravo 3

Power Line Route Alternatives

Draft Report

228_Bravo3_Biophys_kkv7_21Jan09

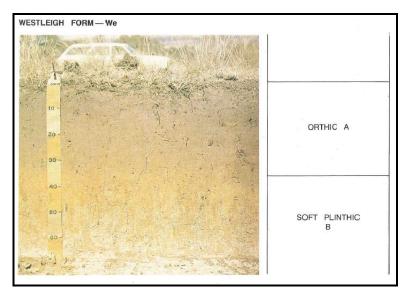
Figure 30: Westleigh Soil Form (Soil Classification 1991)

Westleigh soils are characterised by an orthic A-horizon over a soft plinthic B-horizon and is found in areas between good agricultural soils and clay soils and the movement of water determines the characteristics of the soil.

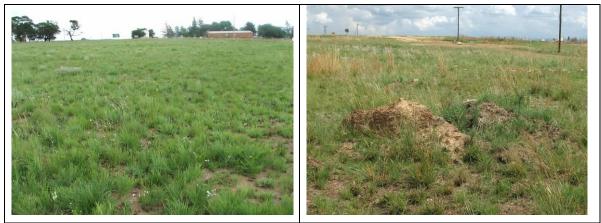
Figure 42 Photos of Egoli Granite Grassland vegetation along the corridors

The Egoli Granite Grassland vegetation type is found the Gauteng Province in the region between Johannesburg in the south, Muldersdrift in the west, Centurion in the north and Tembisa in the east. The moderately undulating plains and low hills support tall grassland, usually dominated by *Hyparrhenia hirta* with some woody species on rocky outcrops.

The vegetation type is listed as endangered as the vegetation type has a conservation target of 24 % conserved, while only 3 % is currently conserved. More than two thirds of the unit has already undergone transformation mostly by urbanisation, cultivation or by building of roads. Current rates of transformation threaten most of the remaining unconserved areas. There is no serious alien infestation in this unit, although species such as *Eucalyptus grandis*, *E. camaldulensis* and *E. sideroxylon* are commonly found. A species list with all the species identified for each vegetation type is attached in Appendix 1 and photos are given Figure 42 below. Approximately 25 % of the corridors fall within this vegetation unit.

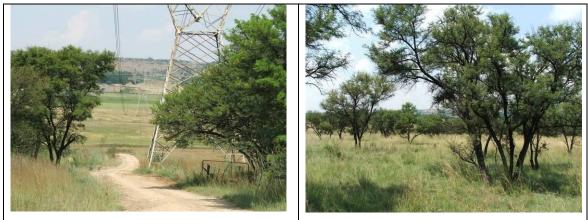
Figure 44: Marikana Thornveld encountered along the route

The Marikana Thornveld vegetation type occurs on plains from the Rustenburg area in the west, through Marikana and Brits to the Pretoria area in the east. The vegetation type is typified by open *Acacia karroo* woodland occurring in the valleys and undulating plains. Shrubs are denser along drainage lines and it is common for the drainage lines to be infested with aliens. Refer to Figure 44 for photos of the Marikana Thornveld encountered along the route.

Marikana Thornveld is considerably impacted, with 48 % of the vegetation type being transformed, mainly due to cultivated and urban or built-up areas. Most agricultural development of this unit is in the western regions towards Rustenburg, while in the east (near Pretoria) industrial development is a greater threat of land transformation. This vegetation type is rated as endangered as only 0.7 % of the unit is conserved. Approximately 2.5 % of the route is covered by Marikana Thornveld.

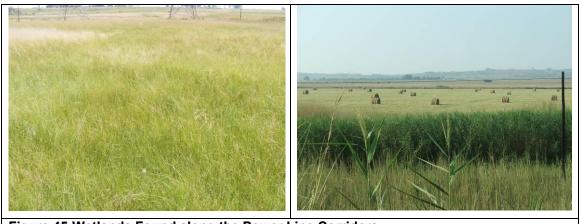
Figure 45:Wetlands Found along the Power Line Corridors

Due to the recent efforts of organisations such as Ramsar, this vegetation unit is now 4.6 % conserved and rated as least threatened. The following aliens are encountered in this type of wetland: *Bidens bidentata, Cirsium vulgare, Conyza bonariensis, Oenothera rosea, Physalis viscosa, Plantago lanceolata, Rumex crispus, Sesbania punicea, Schkuhria pinnata, Stenotaphrum secundatum* (native on South African coast, alien on Highveld), *Trifolium pratense, Verbena bonariensis, V. brasiliensis, and Xanthium strumarium.* Approximately 1 % of the route traverses through areas that could be classified as Wetlands (Refer Figure 45 below for photographs).

Areas around drainage lines/seepage areas were also added to this unit because of the similar vegetation that may occur in these areas. Seepage areas are seasonally wet areas that occur in sandy areas where water seeps into lowlying drainage lines after rains. These areas are usually covered by hygrophytes such as sedges and reeds. The dominant sedge in the study area is *Juncus rigidus*. Sometimes bulrush (*Typha capensis*) and reeds (*Phragmites australis*) also occurs.

Wetlands are of a more permanent nature and occur in low-lying areas such as tributaries of streams and rivers. Here hydrophytes can be found. Typical plants are the Orange River Lily (*Crinum bulbispermum*), bulrush (*Typha capensis*) and reeds (*Phragmites australis*), sedges of the *Cyperus, Fuirena and Scirpus* genera also occur. The site had many drainage and seepage lines running into large streams and into dams. Many of the site drainage and seepage lines had associated wetland and riparian flora. This made these areas have a high species diversity in terms of both plants and animals and makes them have a high conservation leve

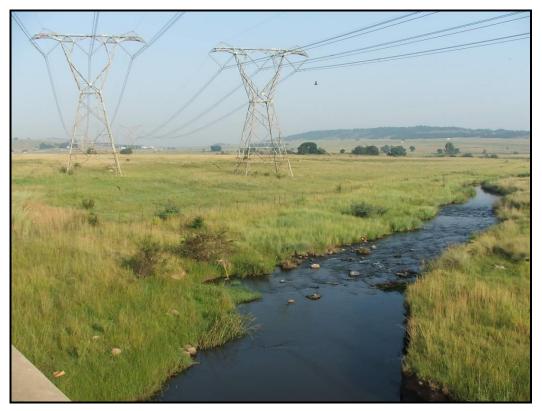
Figure 54: View of the existing power line on site

The landscape character is described in detail above under the Topography section. Figure 54 below illustrates some of the existing power lines on site.
