PRESENT ECOLOGICAL STATE ASSESSMENT OF THE AQUATIC RESOURCES IN THE VICINITY OF THE PROPOSED EXTENTION OF THE ASH DISPOSAL FACILITIES AT THE CAMDEN POWER STATION, MPUMALANGA

Zitholele Consulting (Pty) Ltd

Scientific Aquatic Services
Kieren Bremner
Stephen van Staden (Pr. Sci. Nat.)
SAS 211195
February 2012

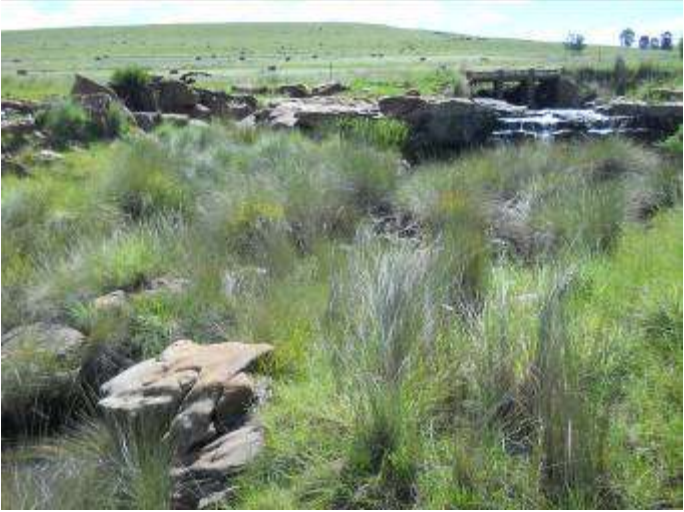
| Site CB1 | | | | | | | | | | | | | | | | | | | | | | | | | | | | | | | | | | | |

| Site description: Unknown tributary 1 of the Vaal River. Upstream of confluence with Unknown tributary 2. | | | | | | | | | | | | | | | | | | | | | | | | | | | | | | | | | | | |
| pH | 8.72 | | | | | | | | | | | | | | | | | | | | | | | | | | | | | | | | | | |
| Conductivity | 33.6 mS/m | | | | | | | | | | | | | | | | | | | | | | | | | | | | | | | | | | |
| IHAS Score | 60 Inadequate | | | | | | | | | | | | | | | | | | | | | | | | | | | | | | | | | | |
| Erosion | | | | | | | | | | | | | | | | | | | | | | | | | | | | | | | | | | | |

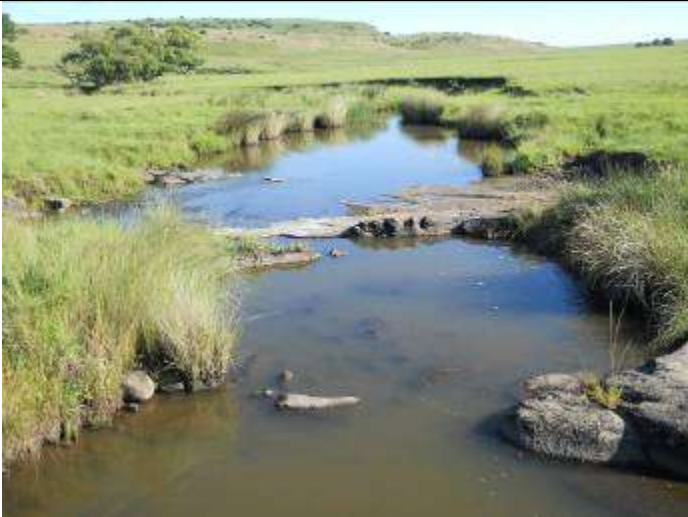
| <p>Site CB2</p> | |

| <p>Site description: Unknown tributary 1 of the Vaal River. Downstream of confluence with the Unknown tributary 2.</p> | |
| <p>Water quality: pH 8.80 Conductivity 37.0 mS/m Temperature 26.3 °C</p> | |
| <p>SASS5 Index: Dickens and Graham 2001 Class D Dallas 2007 Class E/F SASS5 Score 68 No. of Taxa 14 ASPT Score 4.9</p> | |
| <p>Impacts and Threats Sedimentation and inundation</p> | |

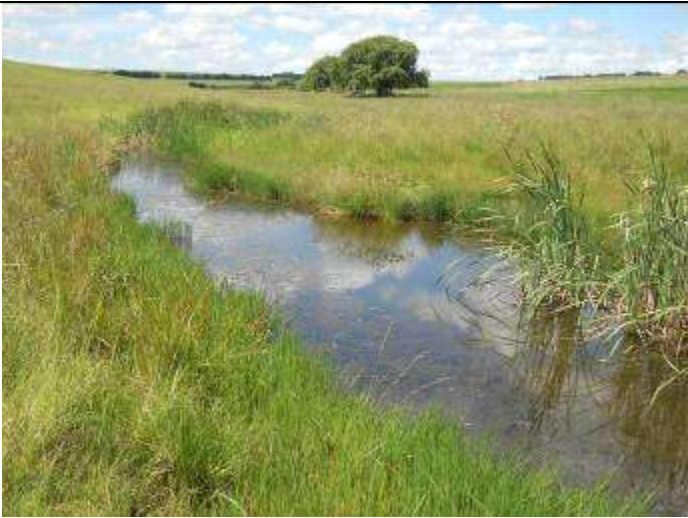
| <p>Site CB3</p> | |

| <p>Site description: Unknown tributary 2 confluencing with Unknown tributary 1 of the Vaal River.</p> | |
| <p>Water quality: pH 9.99 Conductivity 34.4 mS/m Temperature 31.5 °C</p> | |
| <p>Habitat suitability: IHAS Score 49 Inadequate IHIA Score 94.6% Class A</p> | |
| <p>Impacts and Threats Inundation. High pH</p> | |

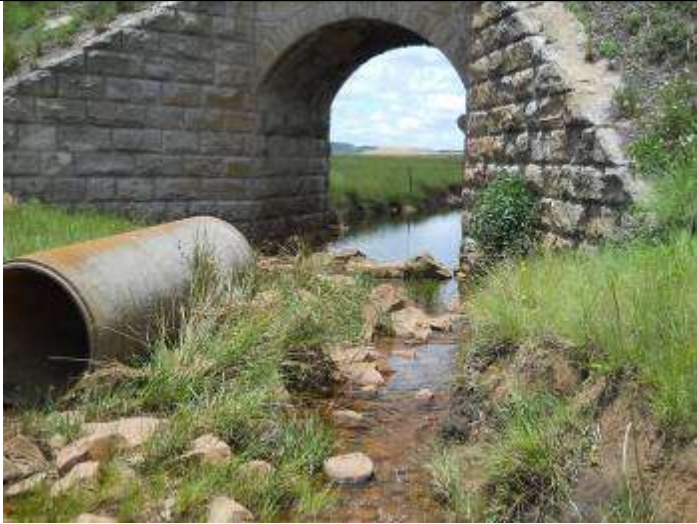
| Site CB4 | | |

| Site description: Downstream on the Humanspruit | | |
| Low pH | | |
| High dissolved salt concentration | | |

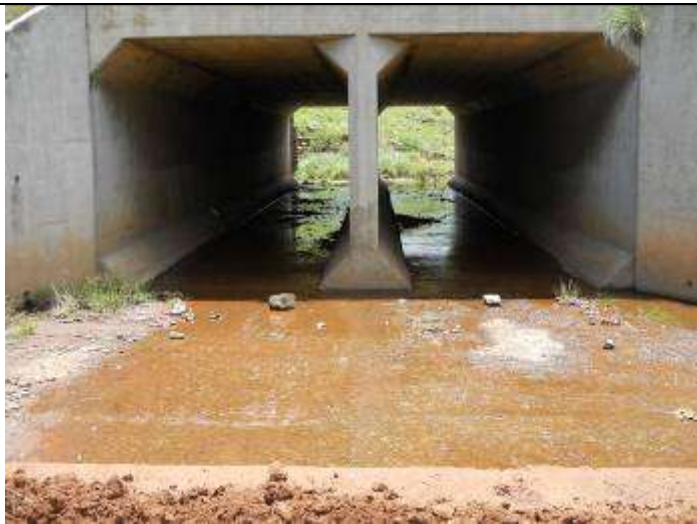
| Site CB5 | | |

| Site description: Upstream on the Humanspruit | | |
| IHAS Score | 60 Inadequate | |
| Some reduction in pH and some elevation in salts observed | | |

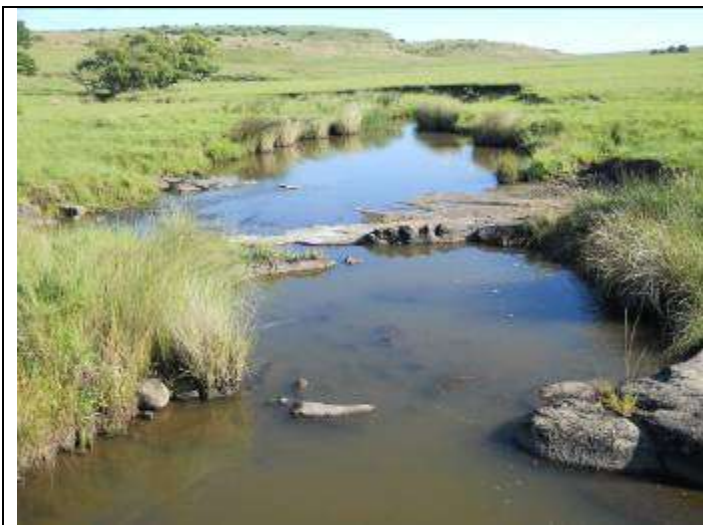
Figure 5: Downstream view of the CB2 site, indicating the bedrock and pool-like nature of this Unknown tributary 1 of the Vaal River.

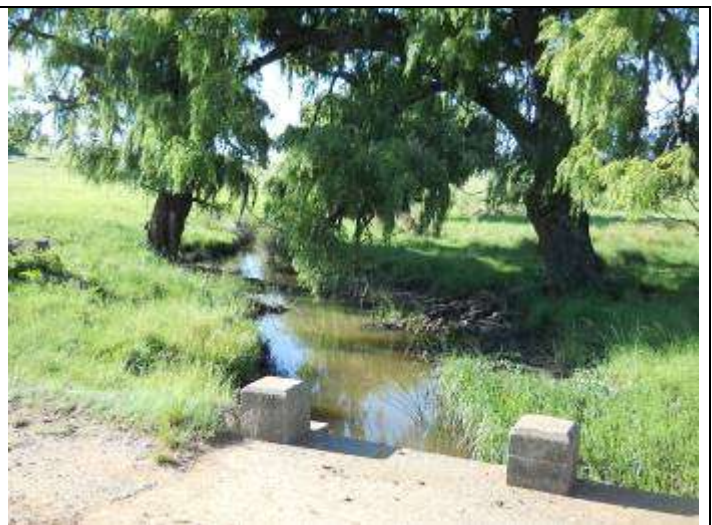
Figure 6: Upstream view of the CB2 site indicating the grasses dominating the riparian zone at this point.

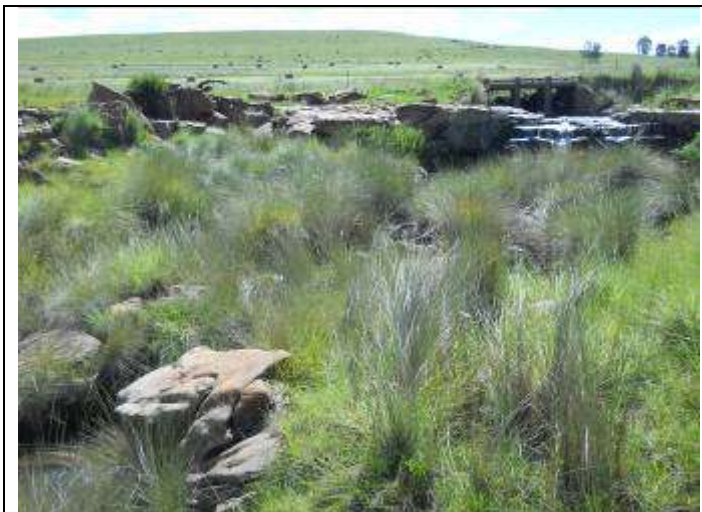
Figure 7: Upstream view of the CB1 site, indicating the rocky nature of the substrate on this Unknown tributary 1 of the Vaal River at this point.

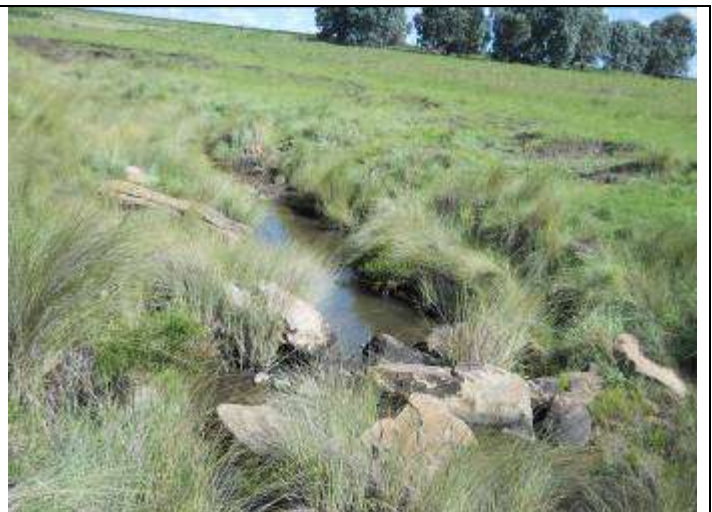
Figure 8: Downstream view of the CB1 site indicating the grasses that dominate the riparian zone at this point.

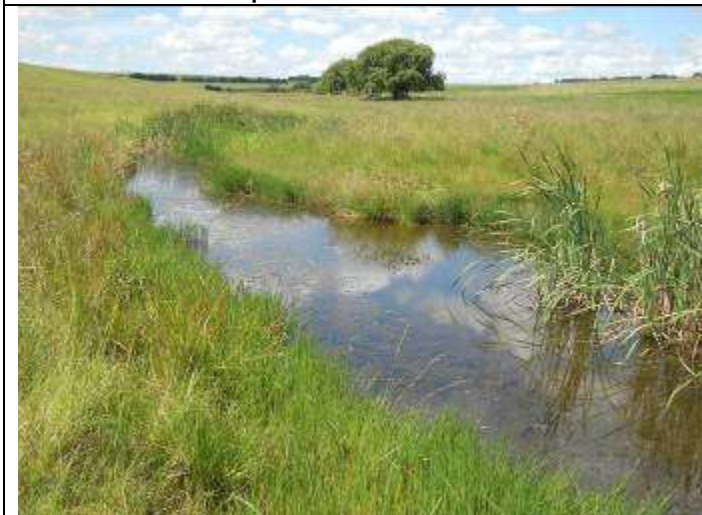
Figure 9: Upstream view of the CB3 site, indicating the marginal and aquatic vegetation on this Unknown tributary 2 of the Vaal River.

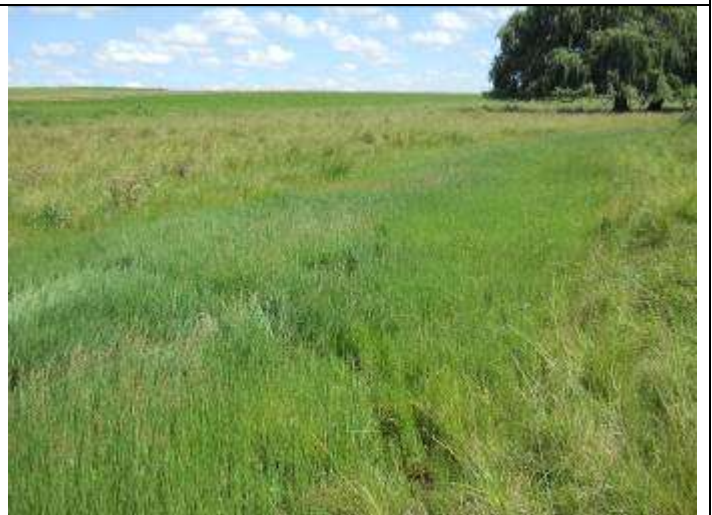
Figure 10: Downstream view of the CB3 site indicating the nature of the stream at this point which has no active channel.

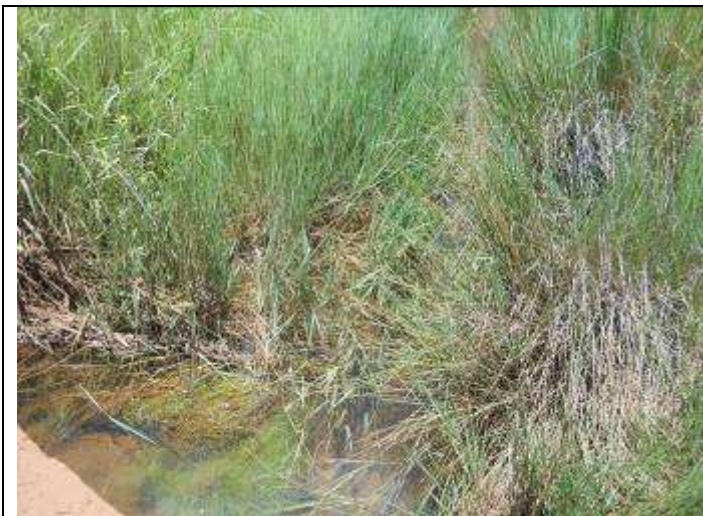
Figure 11: Local view of the CB5 site, indicating the abundant aquatic vegetation at this point.

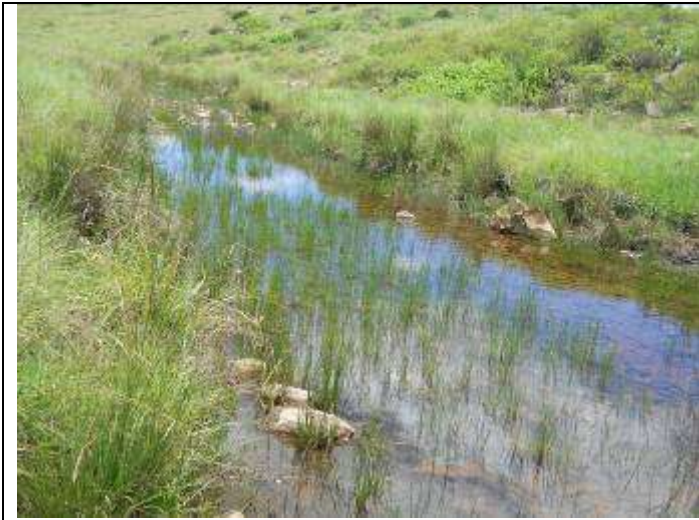
Figure 13: Upstream view of the CB4 site, indicating the marginal vegetation and stones at this point.

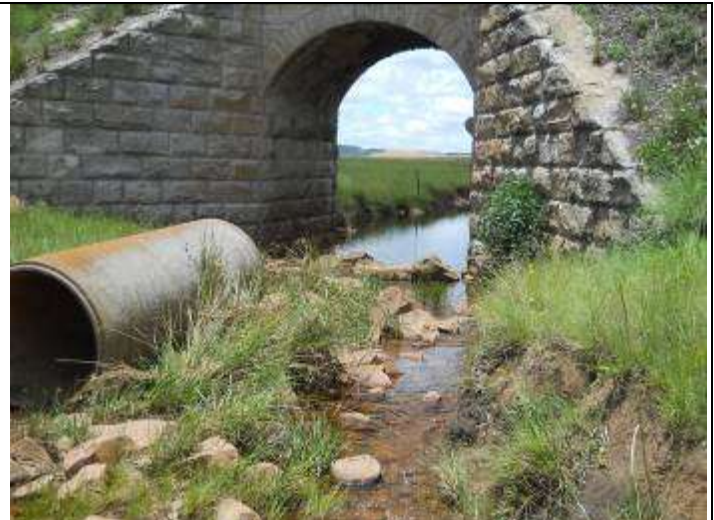
Figure 14: Downstream view of the K2 site indicating the slow flowing shallow nature of the stream at this point.

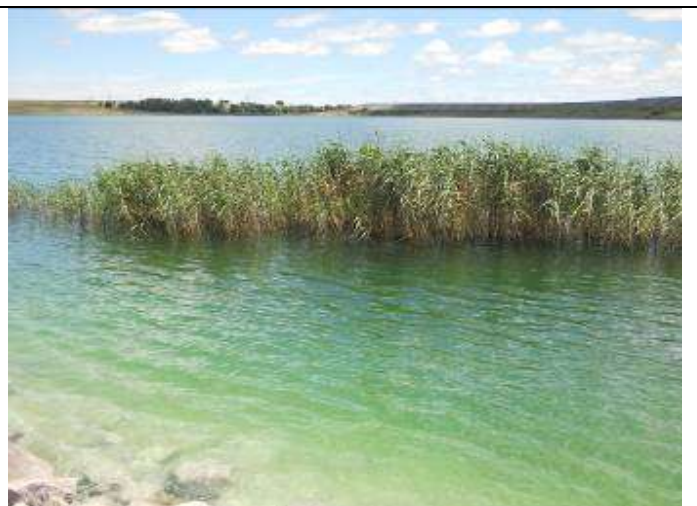
Figure 16: General view of the CT1 site, indicating the proximity of the ash dump from the water body.

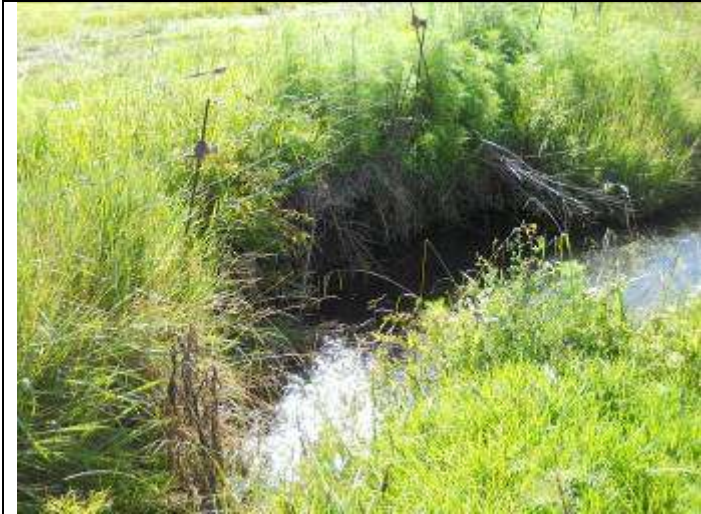
Figure 17: Local view of the CT2 site, indicating the abundant marginal vegetation at this point.

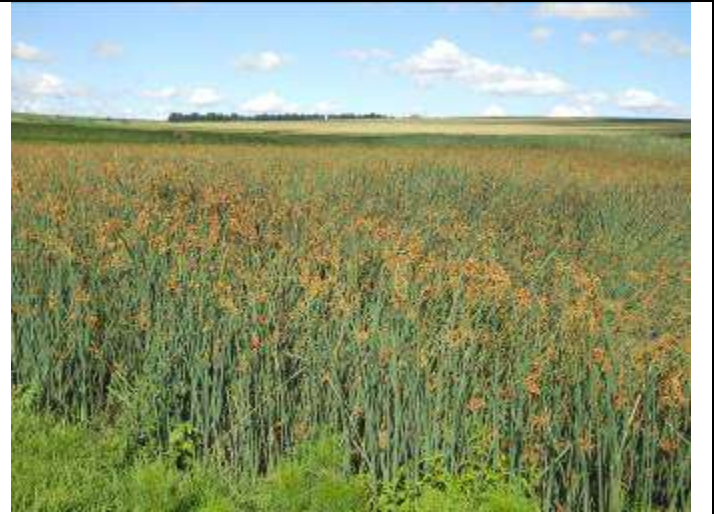
Figure 18: General view of the CT2 site indicating the prolific instream vegetation at this point.
