ZITHOLELE CONSULTING (PTY) LTD.

# Camden Power Station Ash Disposal Facility - Wetland and Aquatic Assessment

**Report Number:** 1407683-13024-1

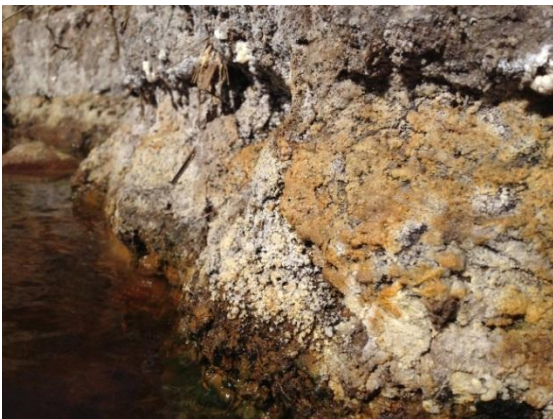
Figure 5: Crystalline deposits along river banks

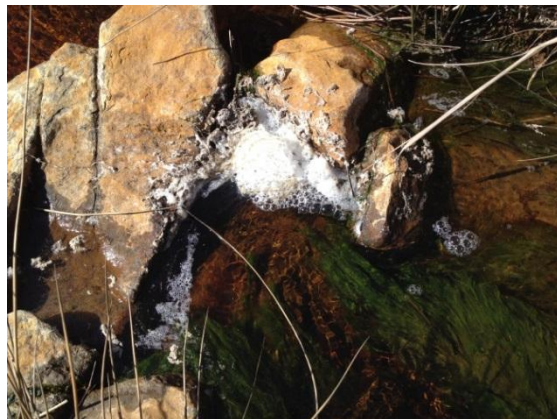
During the July 2014 site visit, salt precipitation and uncharacteristic bubbles/foam were observed in the Humanspruit (Figure 6). Additionally, there were large quantities of algae and the water was discoloured (Figure 8). These are further indications that there are substantial upstream impacts. Potential upstream impacts include Ermelo Town and the Ermelo Yard associated with the Heavy-haul Coal Line. In addition to this there are extensive opencast mining operations within the area, with likely occurrences of sinkholes and decant.

Figure 6: Bubbles and foaming

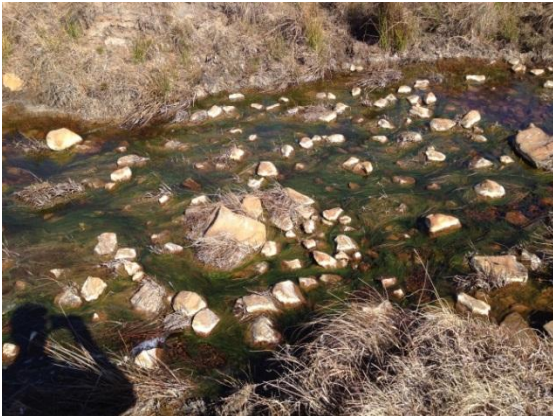
Figure 7: Excessive algal build-up

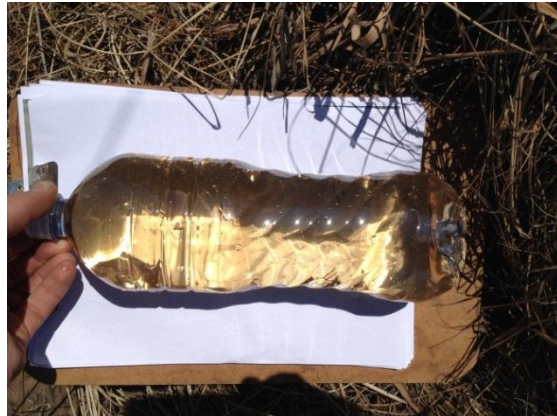
Figure 8: Discoloured water

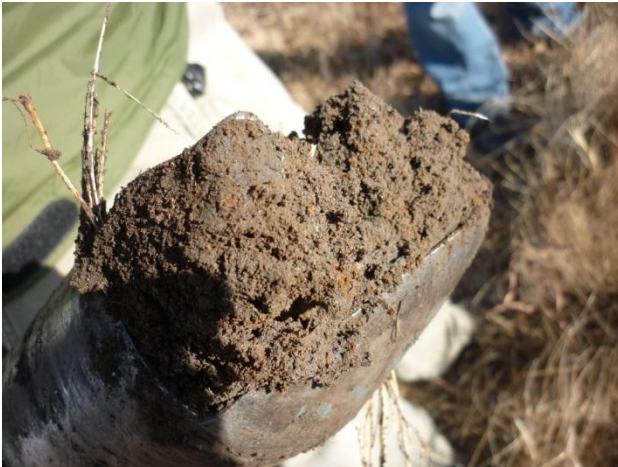
Figure 11: Seasonal wetland soil

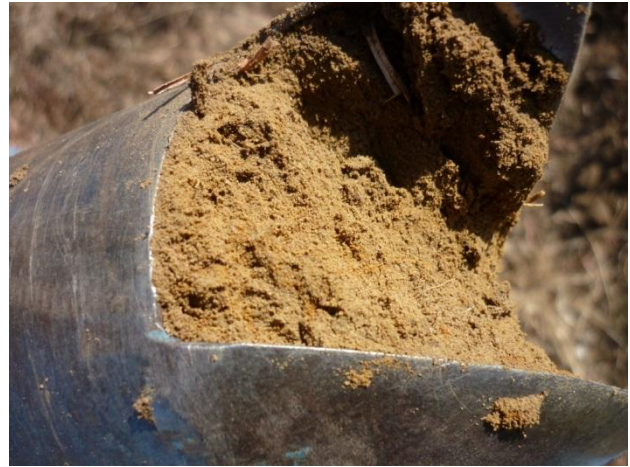
Figure 12: Temporary wetland soil

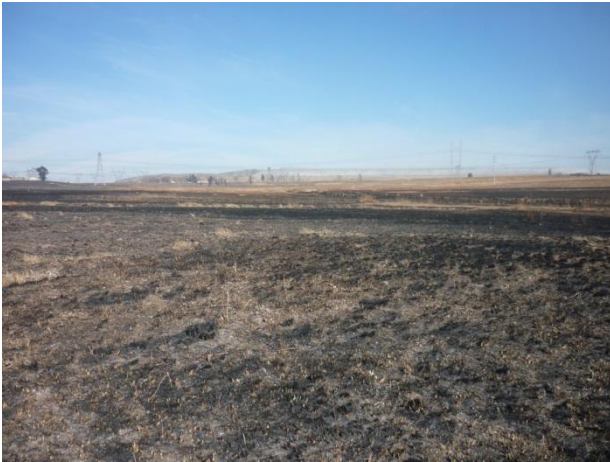
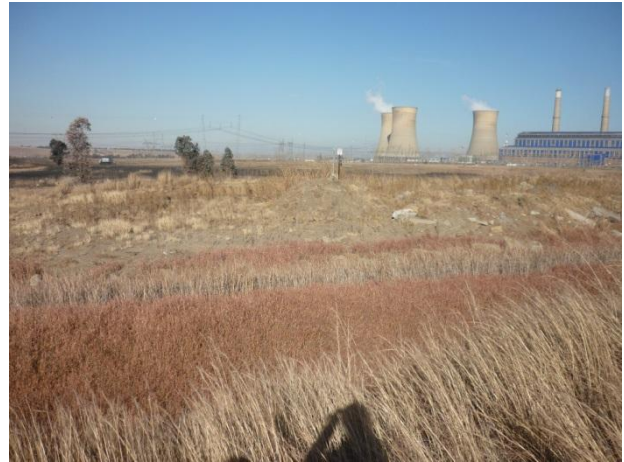
Figure 13: Heavily modified wetland area

Originally, this system was likely a hillslope seep without channelled outflow and fed by seepage from De Jager's Pan (Figure 10). The system is now almost completely modified by the presence of the existing ash disposal facility, and site roads that intersect the former wetland area at a number of junctures (Figure 10), channelling surface run-off through culverts. At the time of survey, the area was completely burnt and could not be accurately delineated in the field; however patches of *Imperata* grass are prevalent throughout, and *Phragmites* was evident adjacent to the channelled outflow from this area. Delineation of this system presented in this report is consequently derived from aerial imagery.

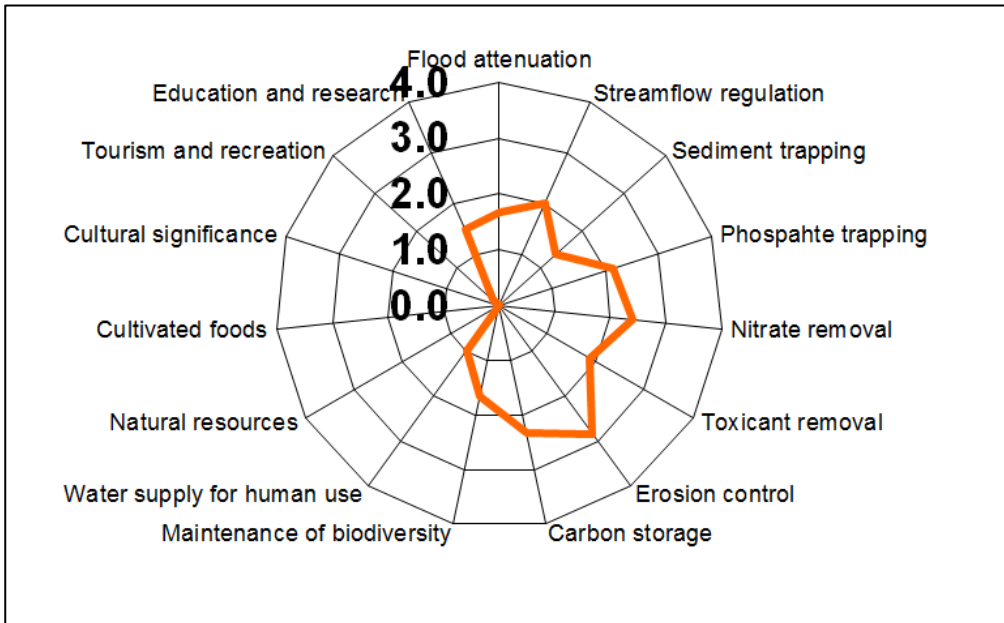
The findings of the assessment of VBA (channelled valley bottom wetland) adjacent to the infrastructure of preferred Site 1 (Figure 9) indicate that it principally controls exacerbation of erosion that could potentially arise as a result of tilled agricultural fields in its catchment (Figure 1), and increased levels of surface water runoff. Phosphate trapping and stream flow regulation are regulated in tandem with erosion control. The wetland has a more limited role in flood attenuation and maintenance of biodiversity, as a function of its size and apparently limited biological diversity.

Figure 14: Spider diagram showing scores for ecosystem services supplied by channelled valley bottom wetland (VBA)

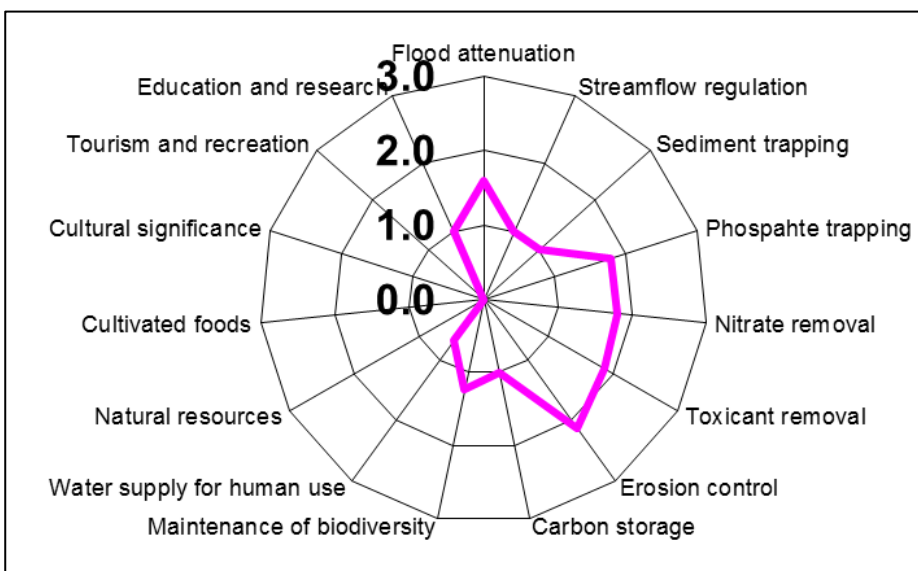
Although the unchannelled valley bottom (VBB) northeast of the infrastructure of preferred Site 1 (Figure 1) provides a number of ecosystem services, the value of these services is low, due to the impacted extent and ecological integrity of this wetland. It contributes to regulation of soil nutrients and may have an influence on toxicant removal; such toxicants may enter the wetland in the form of contaminants and sediments transported in surface water run-off from the adjacent roadway, or from dust blown off the ash disposal facility.

Figure 15: Spider diagram showing scores for ecosystem services supplied by unchannelled valley bottom wetland (VBB)
