CAMDEN POWER STATION
GEOHYDROLOGICAL IMPACT ASSESSMENT:
PROPOSED ASH DAM EXTENTION AT
ESKOM CAMDEN POWER STATION
JUNE 2012
REPORT

Project no.: 274-20-ghd.631
Report no.: RVN 631.1/1304

GEOHYDROLOGICAL IMPACT ASSESSMENT:
PROPOSED ASH DAM EXTENTION AT ESKOM CAMDEN POWER STATION
MARCH 2012 - REPORT

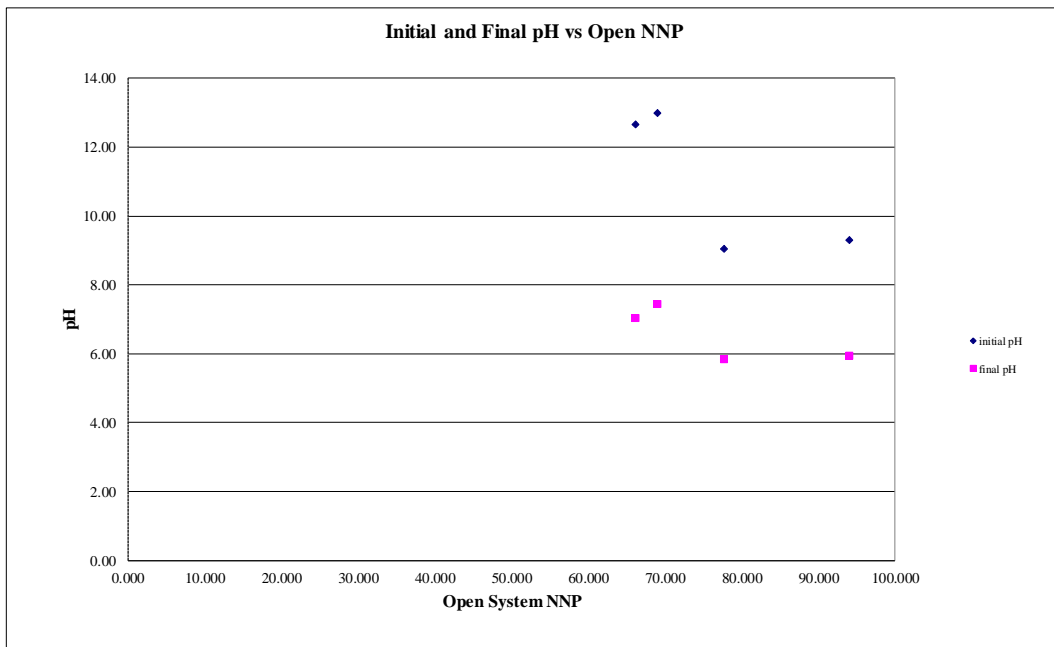
Figure 9. Initial and final pH values plotted versus NNP values (open system) for the samples from the Ashing Area.

Table 4 and Figure 9 and Figure 10 are graphs of the initial and final pH values of the ash samples from the Ashing Area plotted against the NNP values calculated for an open and closed system, respectively. It can be seen that all the final pH values are greater than 5 indicating no acid potential in both the open and closed systems. All the samples have positive NNP values (probably excess neutralising materials) and are not acid generating.

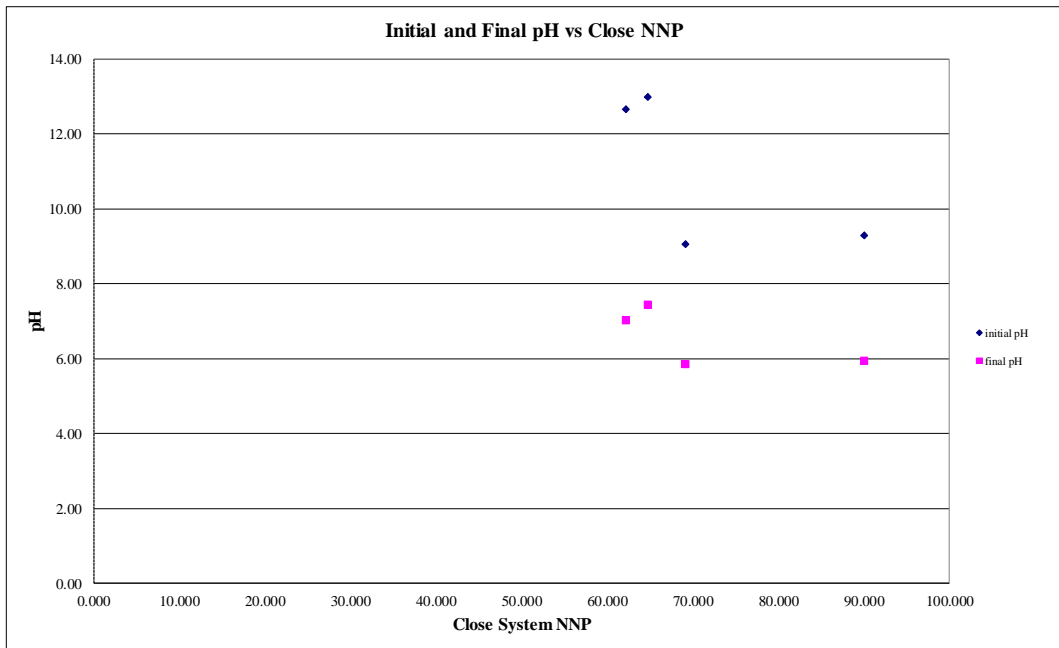
Figure 10. Initial and final pH values plotted versus NNP values (close system) for the samples from the Ashing Area.

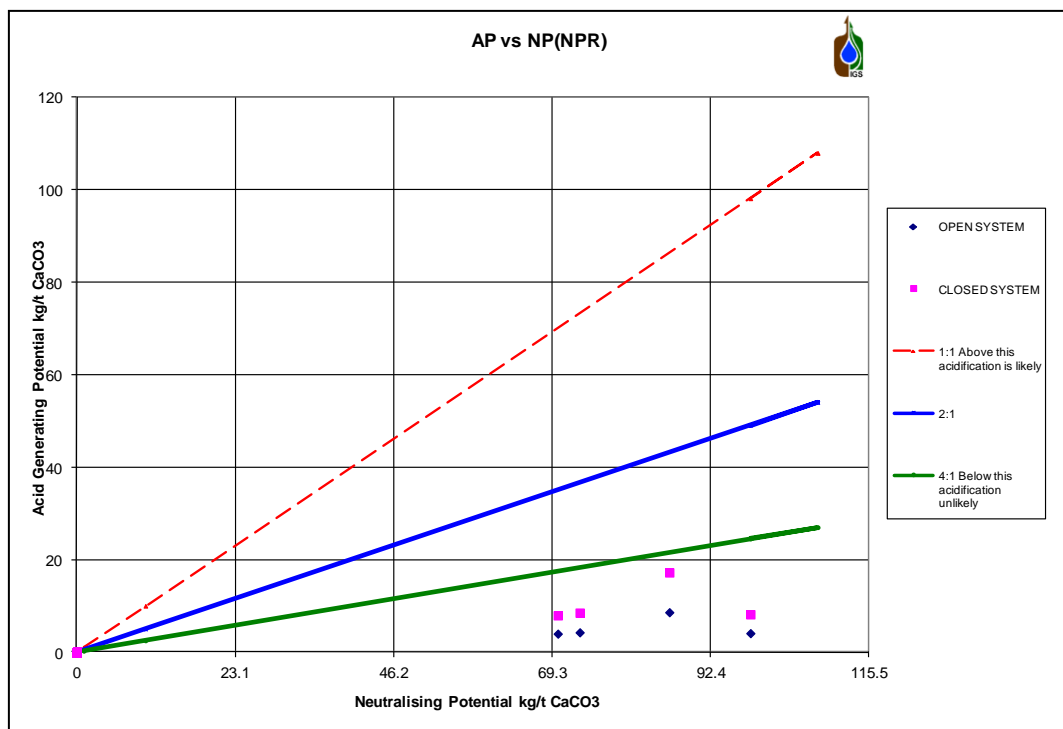
Figure 11. Acid potential (AP) plotted versus neutralising potential (NP) for the samples from the Ashing Area.

Figure 11 is a graph of the acid potential (AP) plotted against neutralising potential (NP) for samples for both open and closed systems. Both the samples plot Below the 4:1 line (Green solid line) and are therefore unlikely to be acid generating. This observation holds true for both the open and closed systems.

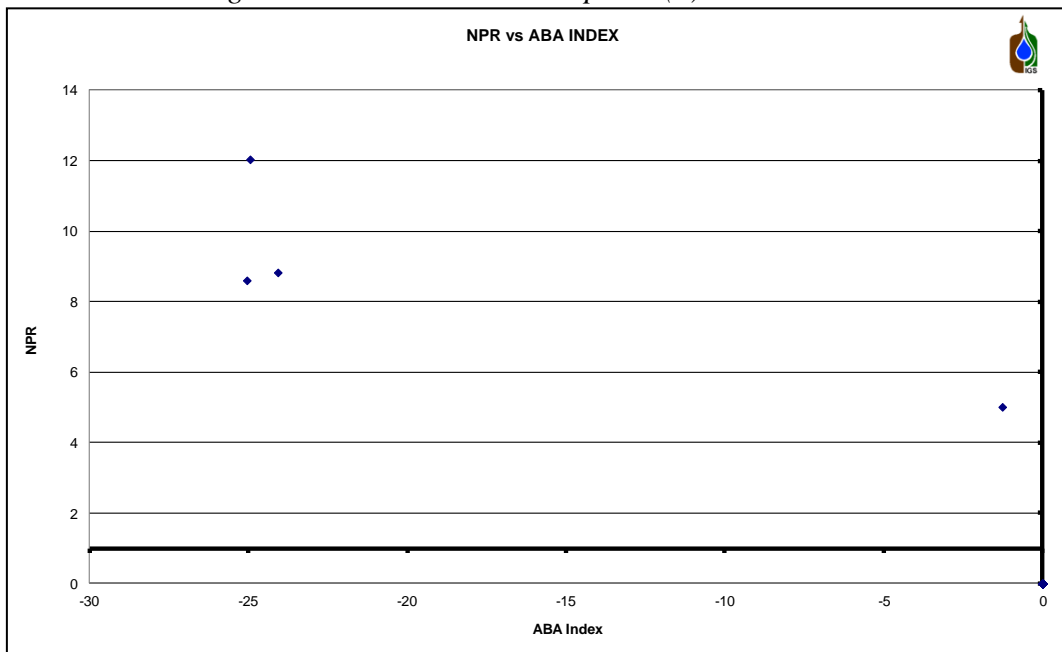
Figure 13. Neutralising Potential Ratio versus Acid/Base Accounting Index

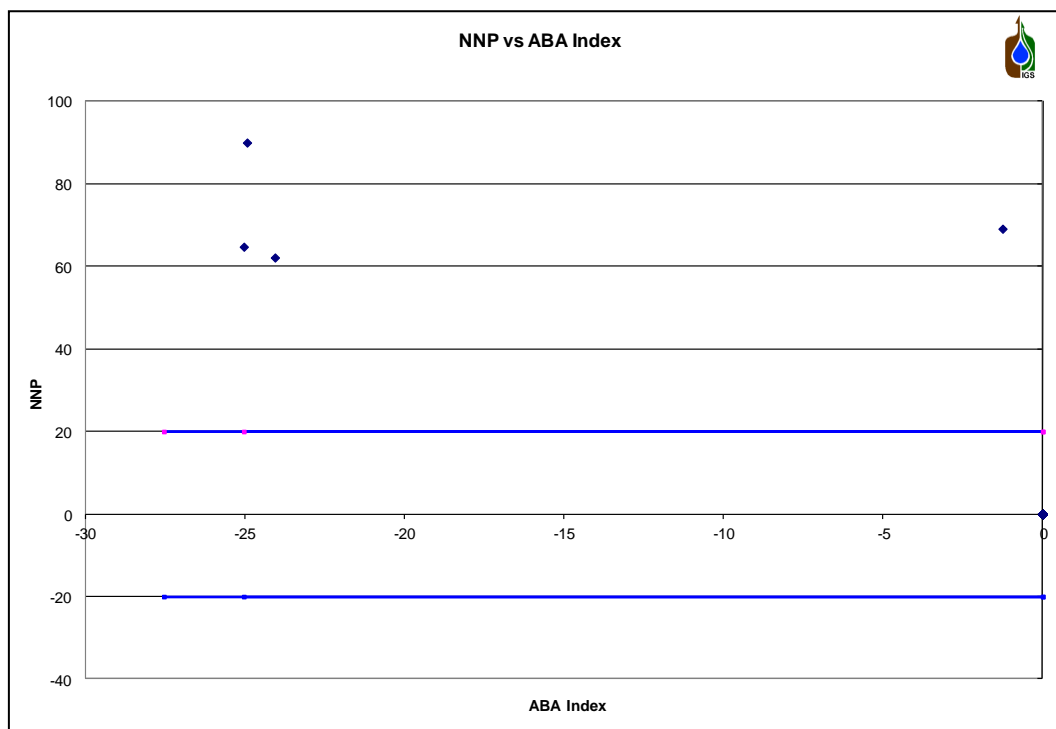
Figure 14. Net Neutralising Potential versus Acid/Base Accounting Index

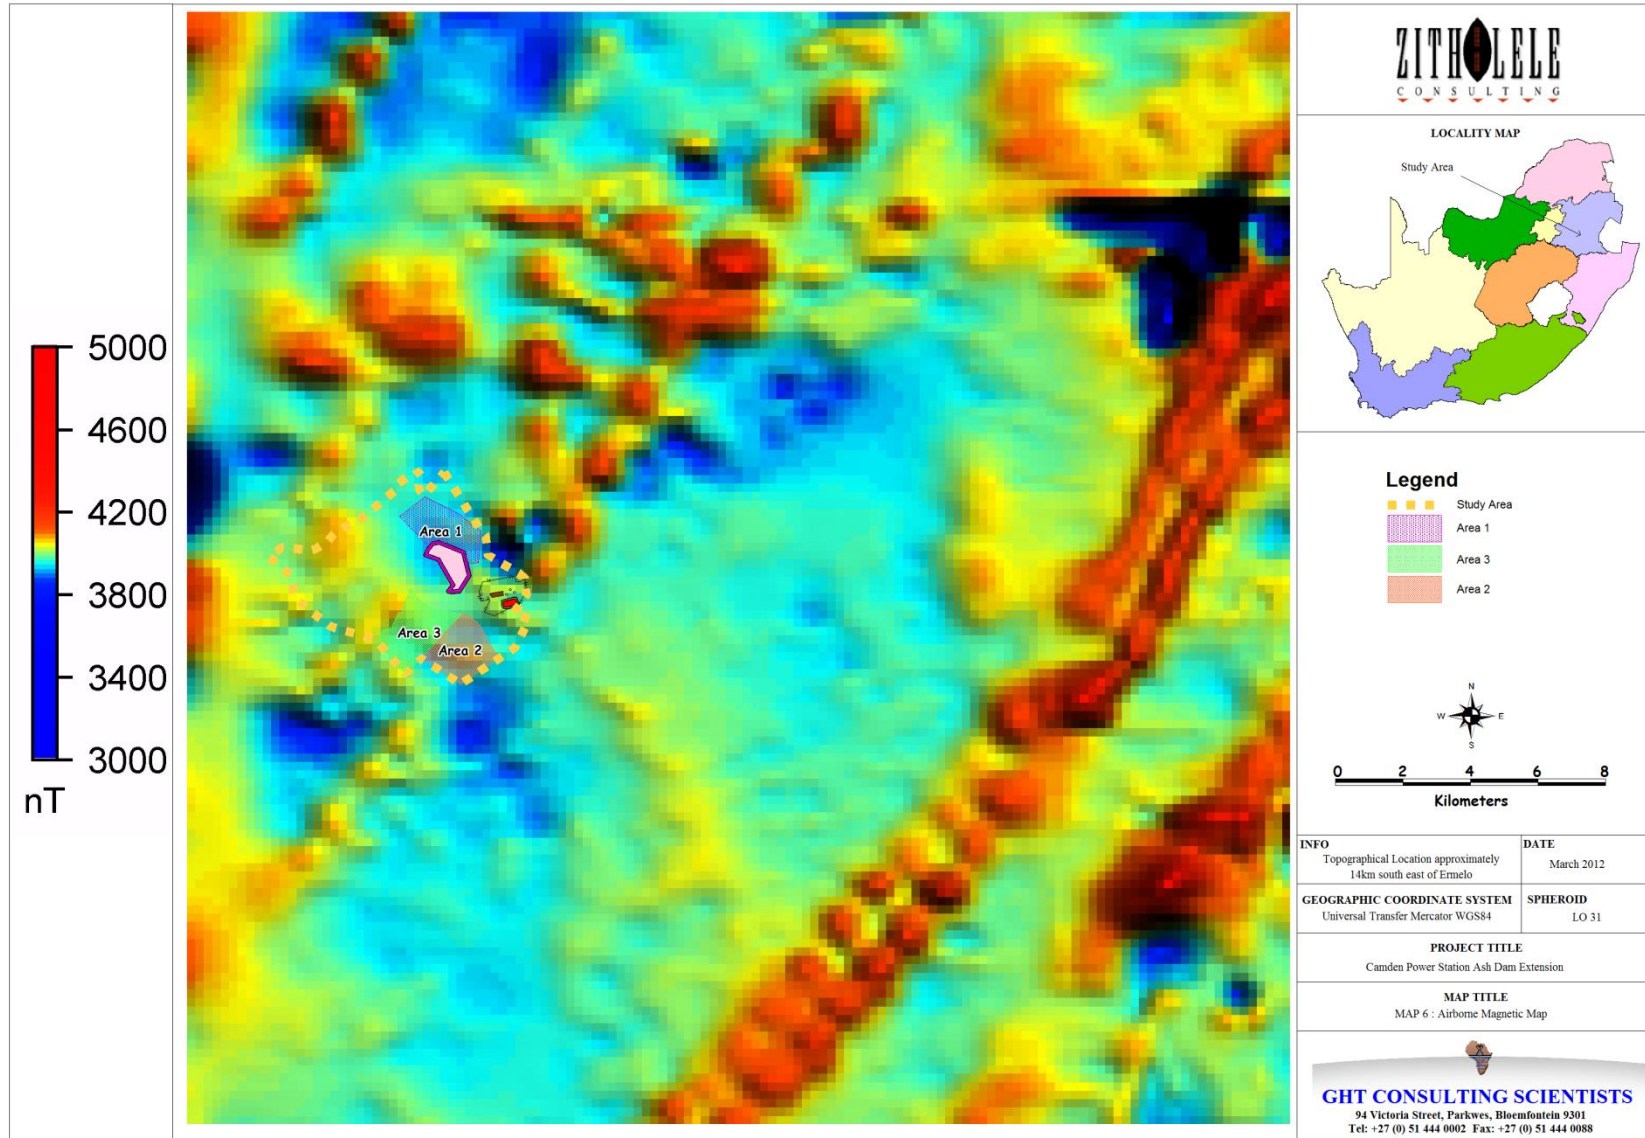
Figure 18. Airborne Magnetic Map

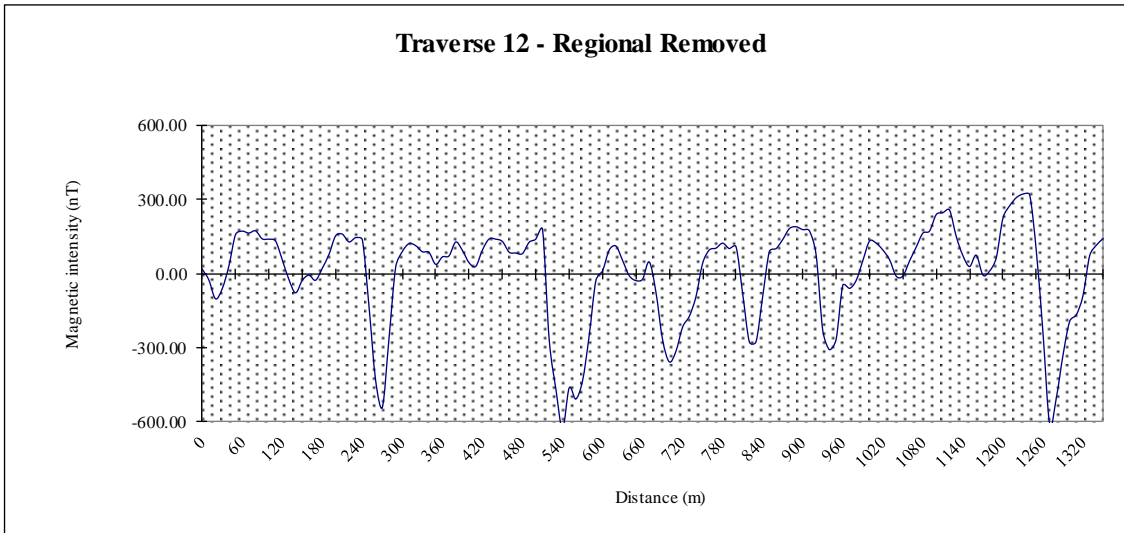
Figure 19. Magnetic profile along traverse T12.

Profile plots of the ground magnetic data are presented in **Figure 19** to **Figure 21**. Large magnetic anomalies with amplitudes more than 700 nT were recorded along traverses T12 and T14, these anomalies appear due to intrusive dolerite bodies. These anomalies are likely to be a large dolerite sill.

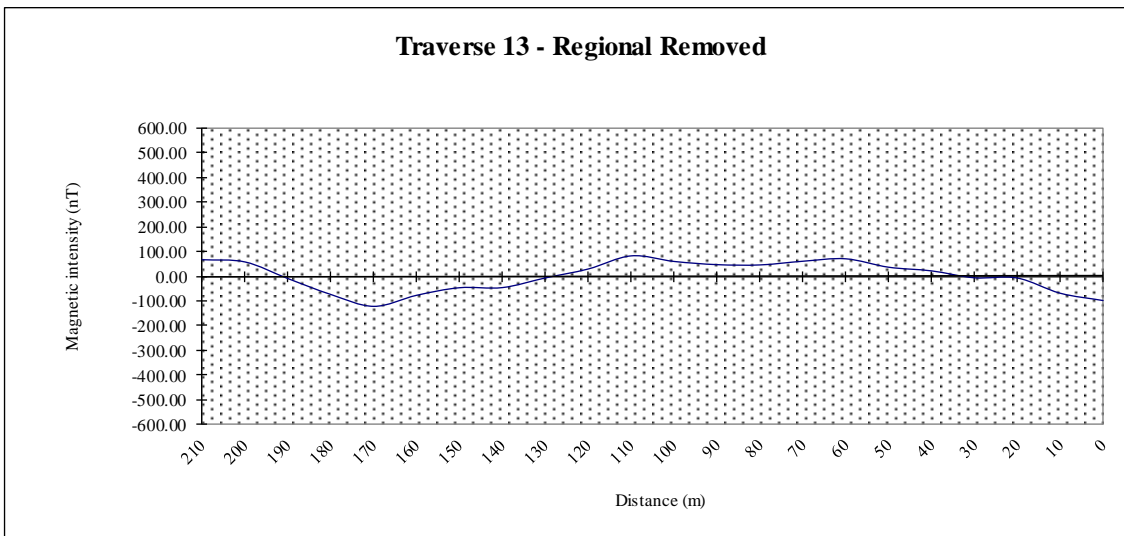
Figure 20. Magnetic profile along traverse T13.

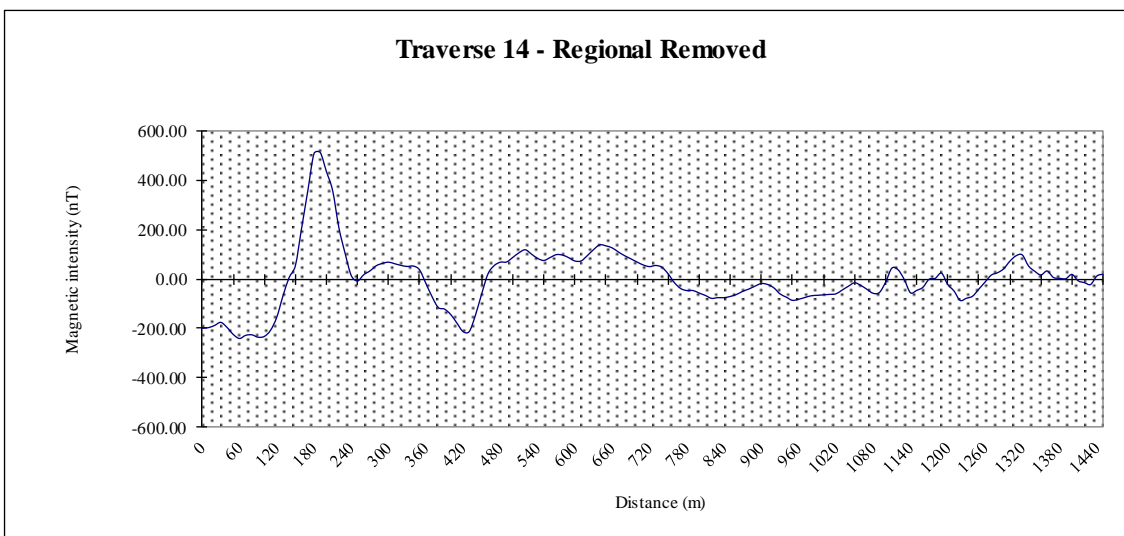
Figure 21. Magnetic profile along traverse T14.

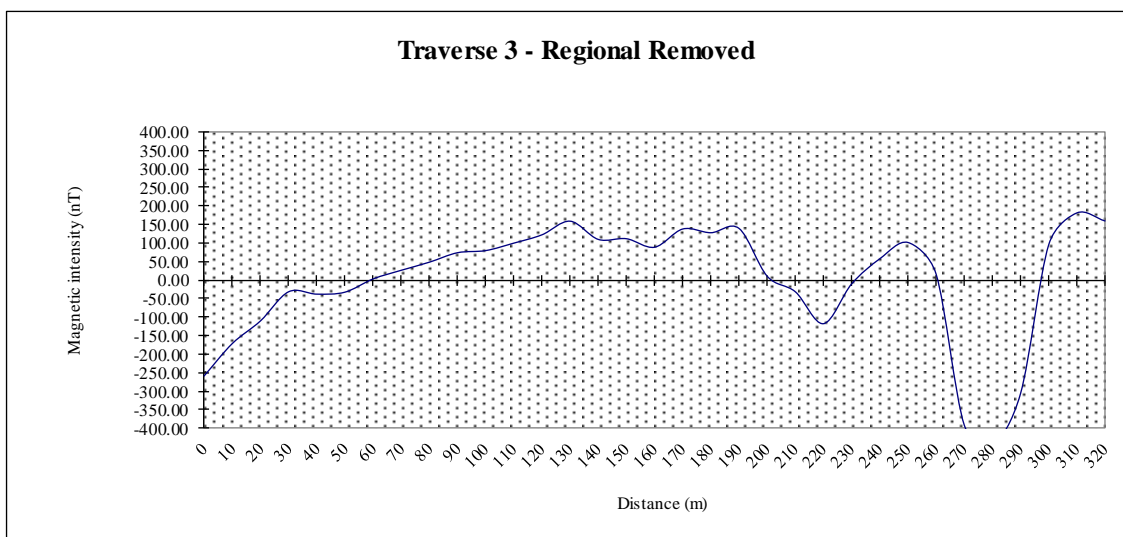
Figure 22. Magnetic profile along traverse T03.

The positions of the four ground magnetic traverses relative to the candidate site are shown in **Figure 16**. Profile plots of the ground magnetic data are presented in **Figure 22** to **Figure 25**.

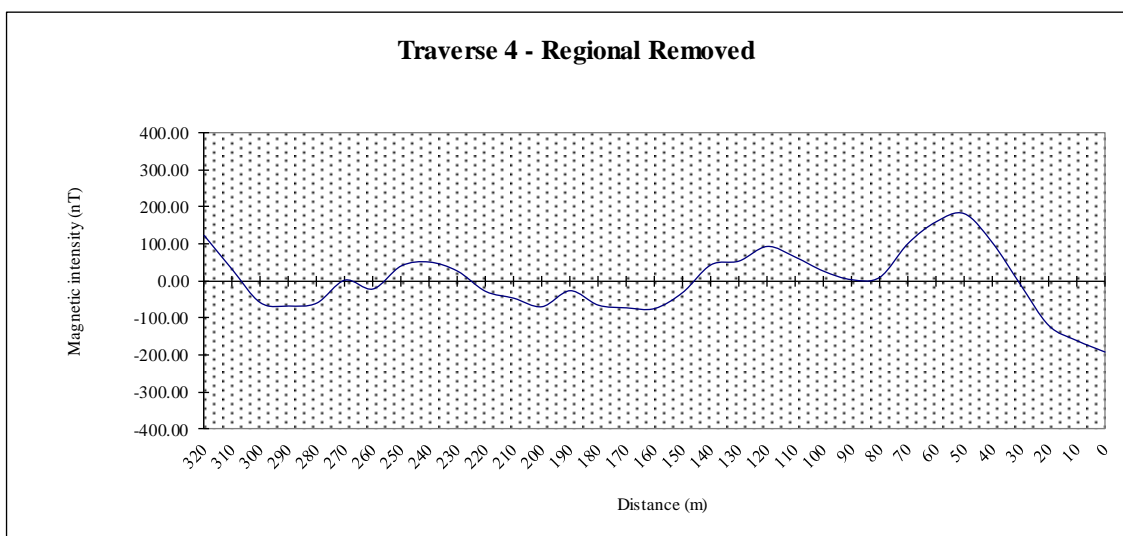
Figure 23. Magnetic profile along traverse T04.

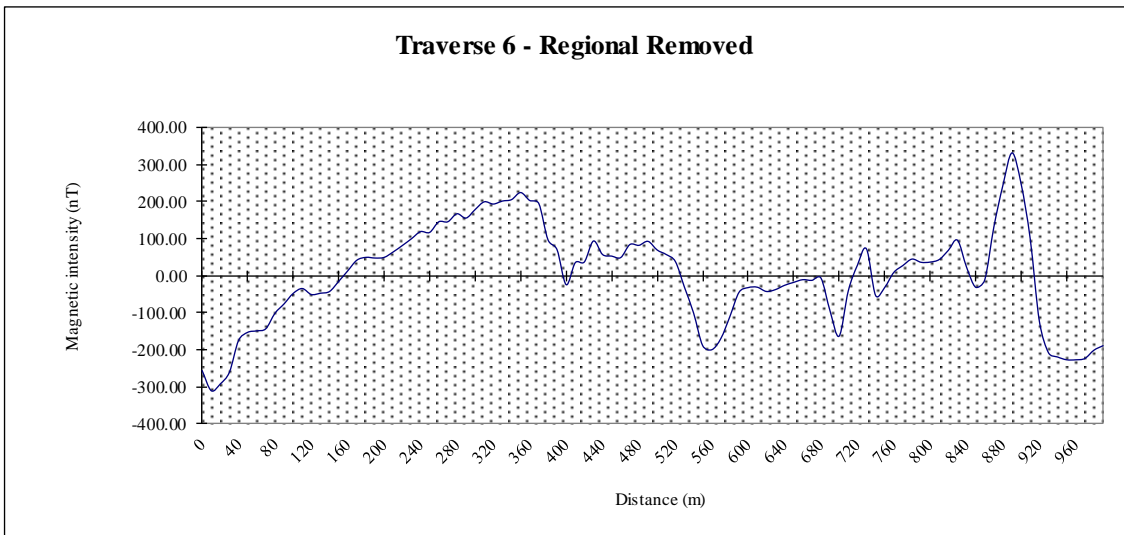
Figure 24. Magnetic profile along traverse T06.

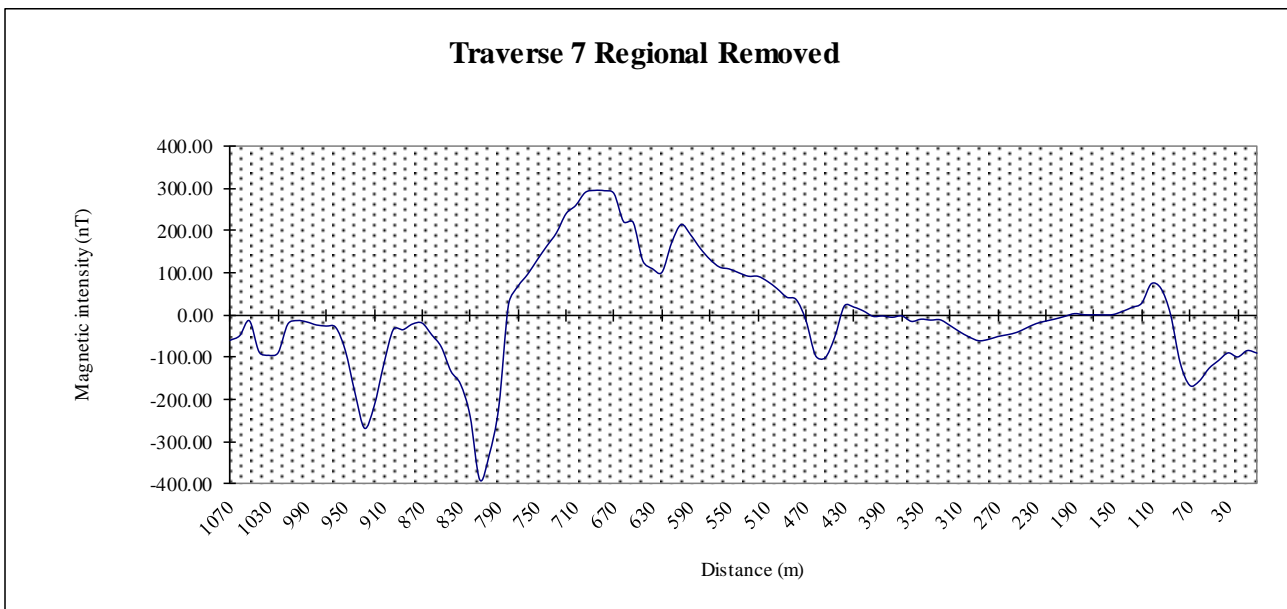
Figure 25. Magnetic profile along traverse T07.

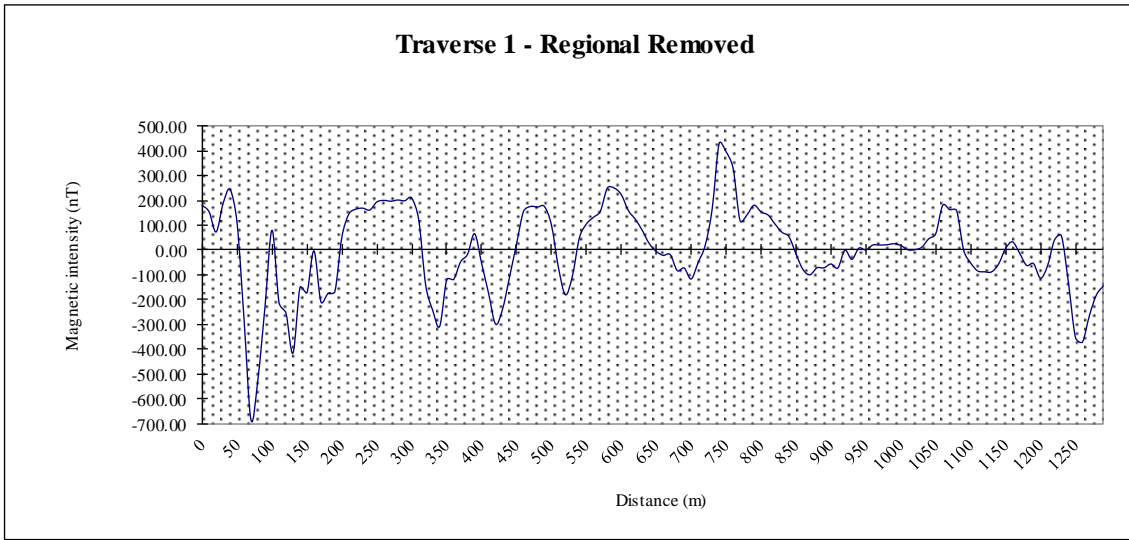
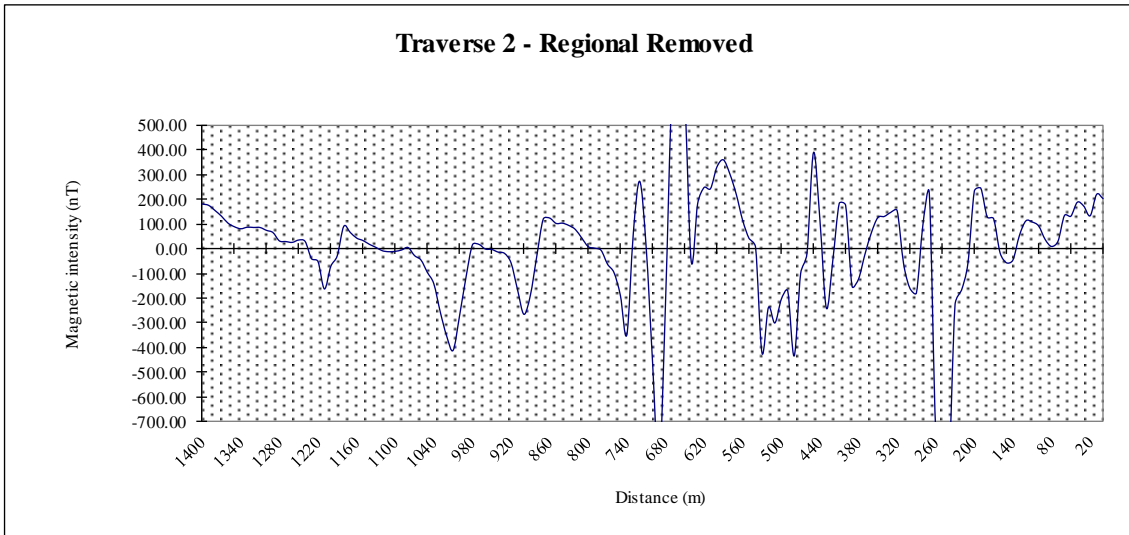
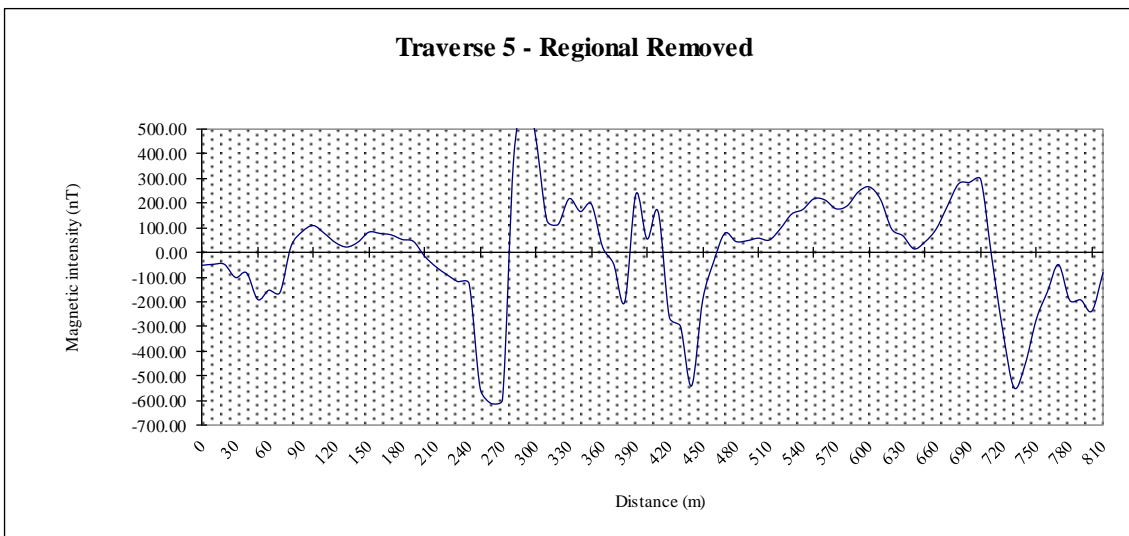
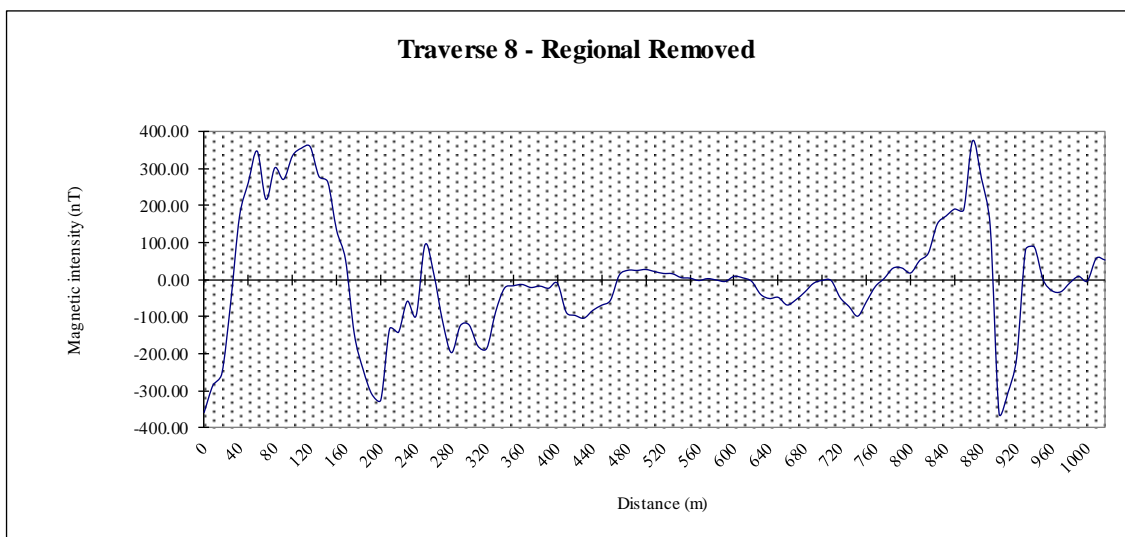
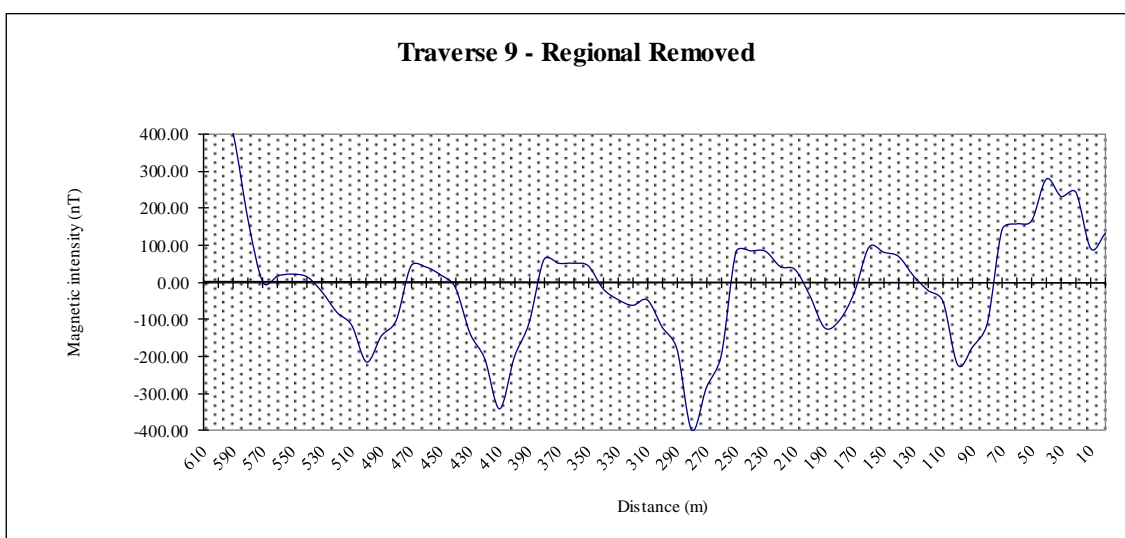
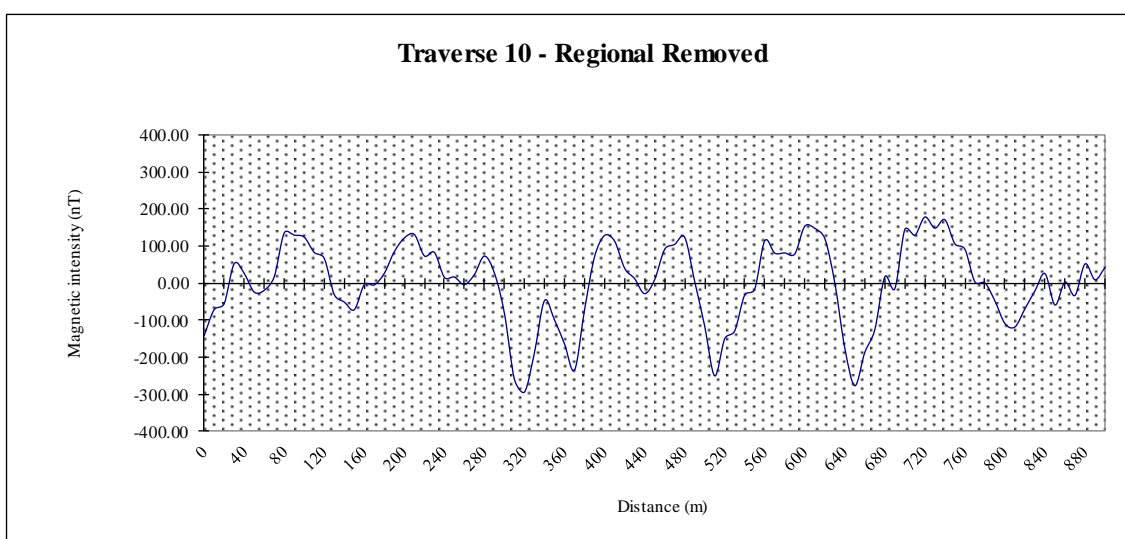
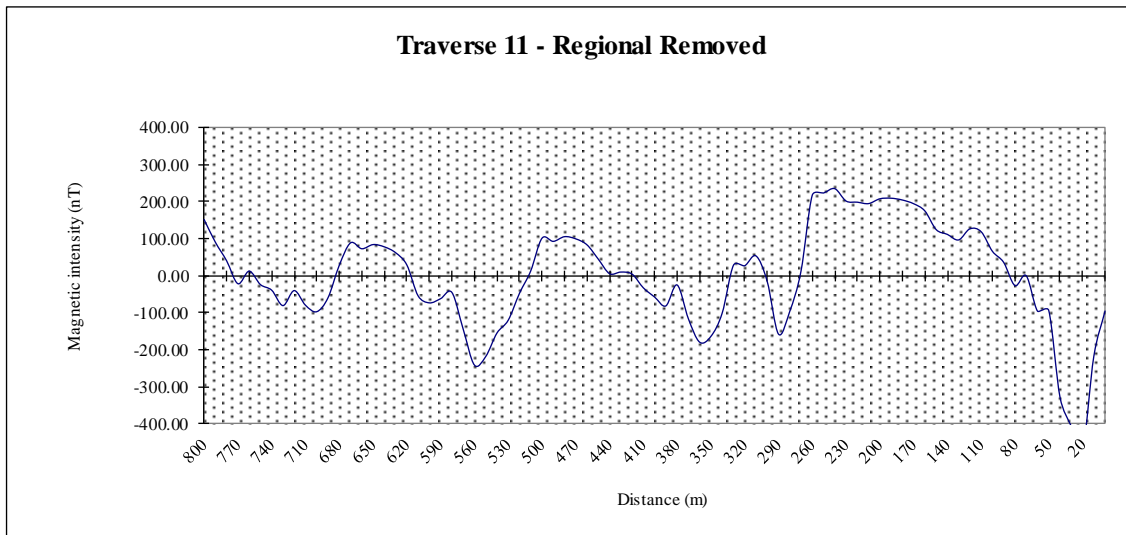
Large magnetic anomalies with amplitudes more than 700 nT were recorded along all the traverses, these anomalies appear due to intrusive dolerite bodies. These anomalies are likely to be a large dolerite sill.

Figure 26. Magnetic profile along traverse T01.

Figure 27. Magnetic profile along traverse T02.

Figure 28. Magnetic profile along traverse T05.

Figure 29. Magnetic profile along traverse T08.

Figure 30. Magnetic profile along traverse T09.

Figure 31. Magnetic profile along traverse T10.

Figure 32. Magnetic profile along traverse T11.

From the geophysical survey conducted it can be concluded that large dolerite sills of low permeability are encountered at all three candidate sites. Based on the results of the magnetic survey all three candidate sites investigated appear to be the suitable for the ash dam extension.

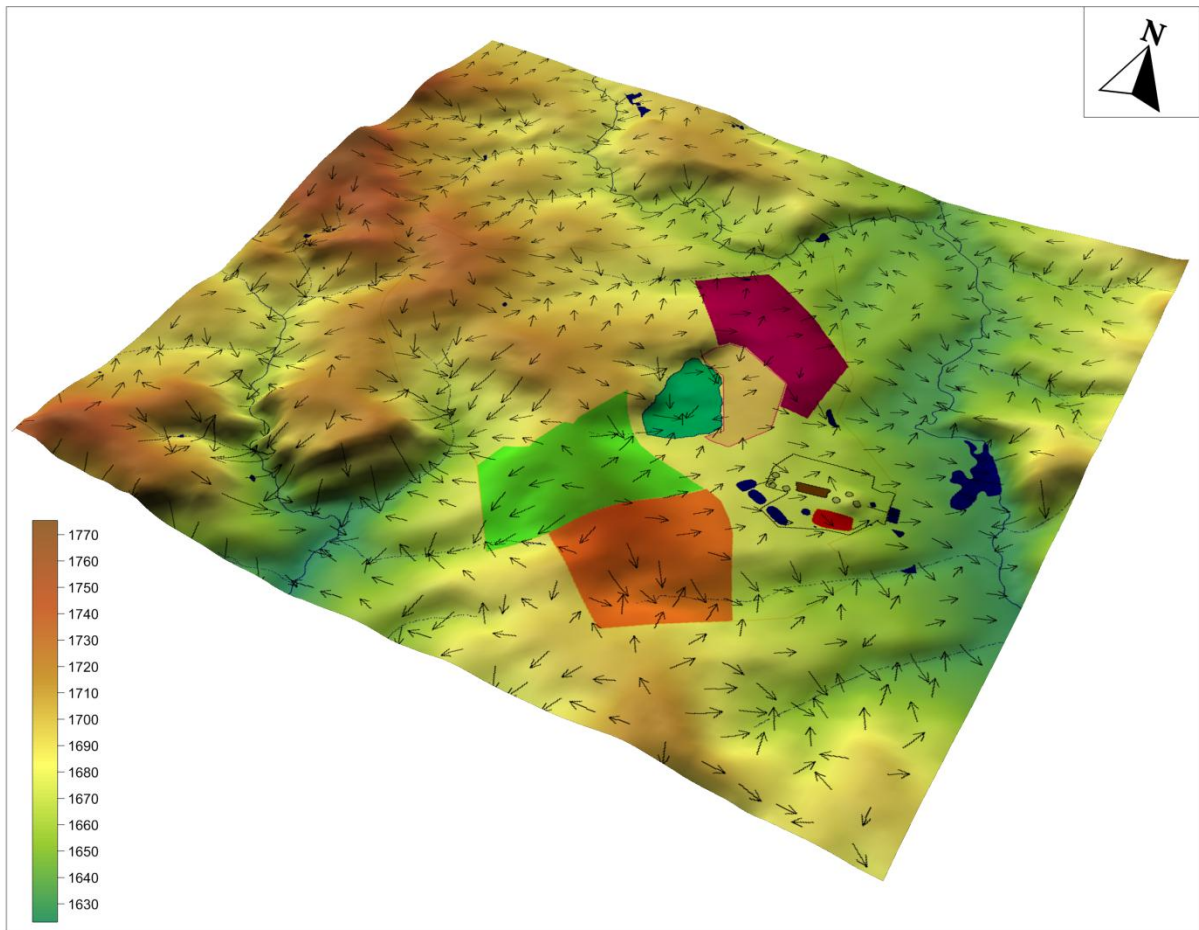
Figure 33. Direction of ground water flow.

Normally the groundwater table mimics the above topography if not disturbed by artificial recharge from manmade activities. Therefore, due to the lack of other groundwater level data it was decided

to use the topographical elevation data to estimate the direction of groundwater flow as indicated in **Figure 33**.

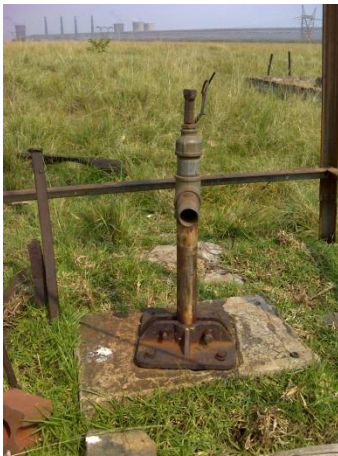
Photo 4. – Broken wind pump at FBB23.

It should be noted that two of the boreholes that have been located, FBB23 and FBB26 are situated in two of the candidate sites. These boreholes must be plugged, according to the standards set by the Department of Water Affairs, before ashing commence. When a pollution source is placed over an uncapped borehole the borehole creates an artificial preferred pathway to the deeper aquifers in which the pollutants can move more freely. The first of these (FBB23) is located in candidate site 1 approximately 400m north of the current Camden Power Station ash dam. This Borehole is currently is not in use and fitted with a wind pump which is not operational and severely neglected. The second borehole (FBB26) is located 100m north of the farm workers dwellings in the northern area of candidate site 2. This borehole is for domestic use and is fitted with a hand pump that is in a good working condition.
