Heritage Walkthrough

FOR THE THIRD 40 KM OF THE MASA NGWEDI TRANSMISSION POWERLINE PROJECT (120 KM) FROM LEPHALALE PAST THABAZIMBI IN LIMPOPO PROVINCE

VERSION 1.0

10 MARCH 2014

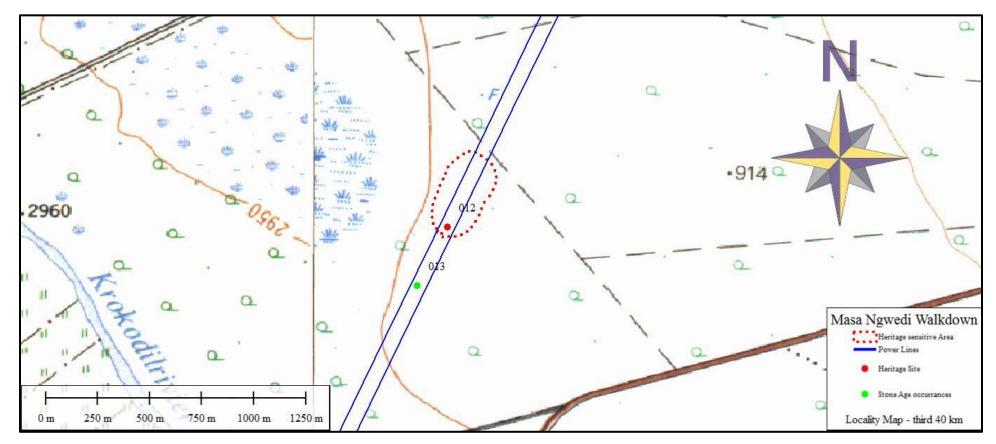
Figure 12: Site 1 (field nr 012) and Site 2 (field nr 013) on the farm Stratford.

Way-point Number	012
	-
Type of site	Open scatter
Geographical Setting	Plain
Geographical Setting - Closest Water source	Crocodile river to the south
Site components	Single component
	Below surface - Surface evidence has been obliterated,
	however, there is likely to be subsurface material present.
Current condition of the site	Note that this is different from a destroyed site
Describe any disturbance to the site	Sheet erosion
Description of artefacts, approximate age	
and significant features of the site	Slag, undecorated ceramics, tuyere fragments
Estimation or measurement of site extent	360 x 230 meters
Depth and stratification of the site	Non visible
Figure 1	14: Undecorated ceramics, slag and tuyere fragments
Statement of Significance	Low - Medium Significance
Field Rating (Recommended grading or field	Generally Protected B (GP.B), Medium significance-
significance) of the site:	Recording before destruction

Man Data (Name Lan	040
Way Point Number	013
Type of Site	Find Spot/ Occurrence
Geographical Setting	Plain
Closest Water Source	Crocodile River
Site Components	Unknown
Current Condition of site	Ex situ material (e.g transported, deflated or exposed by natural
	agents with no stratigraphy)
Describe any disturbance	The site is located on the floodplain of the Crocodile river and has
to the site	repeatedly been flooded over the years.
Threats or sources of risk	Sheet erosion
on the site	
Description and type of	Raw material from hornfells and quartzite, artefacts consisting of
artefacts, approximate age	triangular flakes, end scrapers and miscellaneous flakes. Found all
and significant features of	over turf plain. Ex situ and rolled. High degree of weathering. 1 artifact
the site (Raw material,	every 5 square meters
source of raw material,	
density).	
Estimation or	Scattered over an area of almost 300 meters.
measurement of site

The lack of decorated ceramics from the site hampers the positive identification of the site. The sites are buried underneath the red Kalahari windblown sand that hampers archaeological visibility and the site are marked by scatters of undecorated pottery, the possibility exist of founding archaeological deposits covered by soil. It is therefore recommended that the wider area around the recorded site is monitored by an archaeologist during construction to document and mitigate accidental finds.

Site 2 consists of individual occurrences of highly weathered MSA flakes that are found widely scattered on the northern floodplain of the Crocodile River, no one concentration of artefacts were identified and these isolated finds does not constitute a site per se. The artefacts have faceted striking platforms characteristic of MSA but are highly weathered and have a rolled appearance possibly the result of water related post-depositional processes .Artefacts are scattered over a large area (300 meters). Due to the low artefact density and the large area the site covers with the very small physical footprint (relative to the extent of the site) – and therefore adverse effects –the 765 and 400 kV power lines would have on the occurrence as a whole, the site is given a low heritage significance rating and no mitigation is necessary prior to construction.

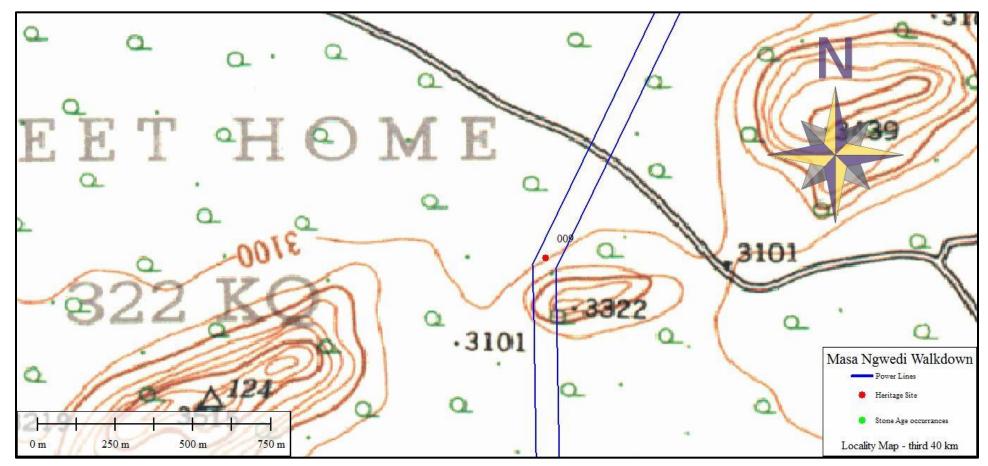
Figure 13: Site 3 (field nr 009) on the farm Sweet Home.

Type of site	Open Air Site
Geographical Setting	Hill Top
Geographical Setting - Closest Water source	Crocodile river to the north
Site components	Single component
	Fair = significant disturbance, some remains
Current condition of the site	in-situ
	Walls are collapsing as part of erosion
Describe any disturbance to the site	activities
Threats or sources of risk on the site	Erosion
	The site consists of two stone cairns. Of
	unknown purpose. That might have been
	part of a wall. The cairn are overgrown and
	covered with moss. The cairns are located
	on the northern face of a small hill. The
	cairns are located two meter apart and
	measures approximately 2x1.They are not
	aligned east to west like one would expect
	from graves and could be associated with
Description of artefacts, approximate age and	the historic mining activities on the farm
significant features of the site	(Pistorius 2009).
Estimation or measurement of site extent	4x4 meter

<image/> <caption></caption>	<image/>
Figure 19: General site conditions	
	If graves – high social significance
Statement of Significance	If mining heritage – low to medium
Field Rating (Recommended grading or field	Based on worst case scenario of graves:
significance) of the site:	Generally Protected a (GP.A)
	Secondary as construction activities might
Impact Evaluation of development on site	expose stratified deposits.
Recommendations including	Demarcate area during construction phase

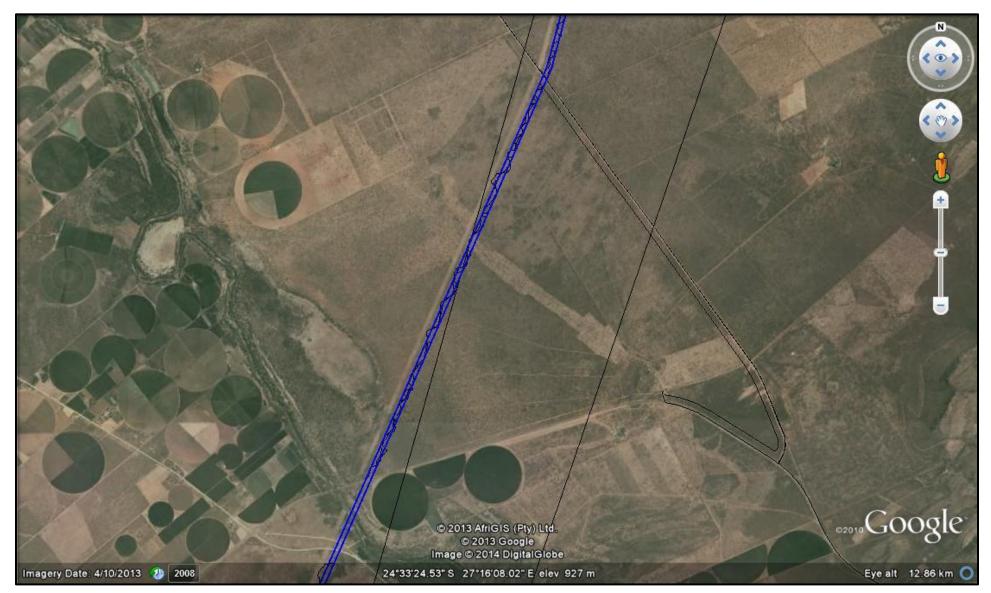
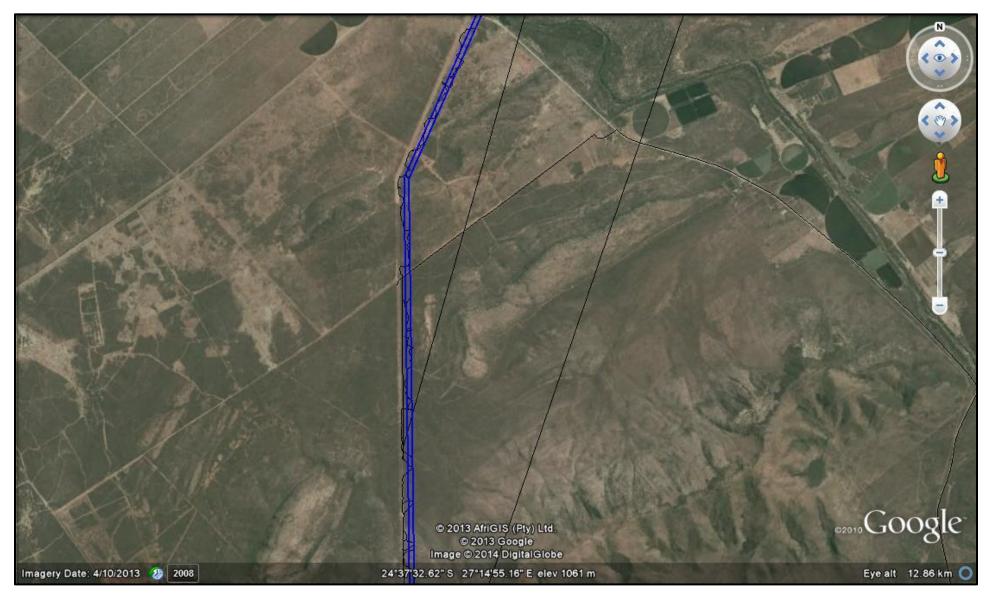
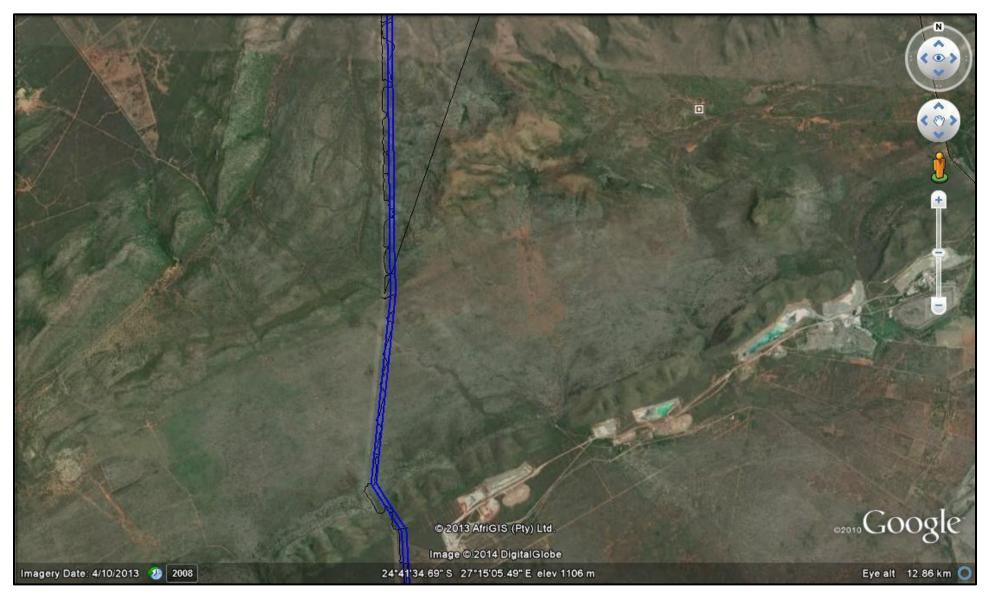
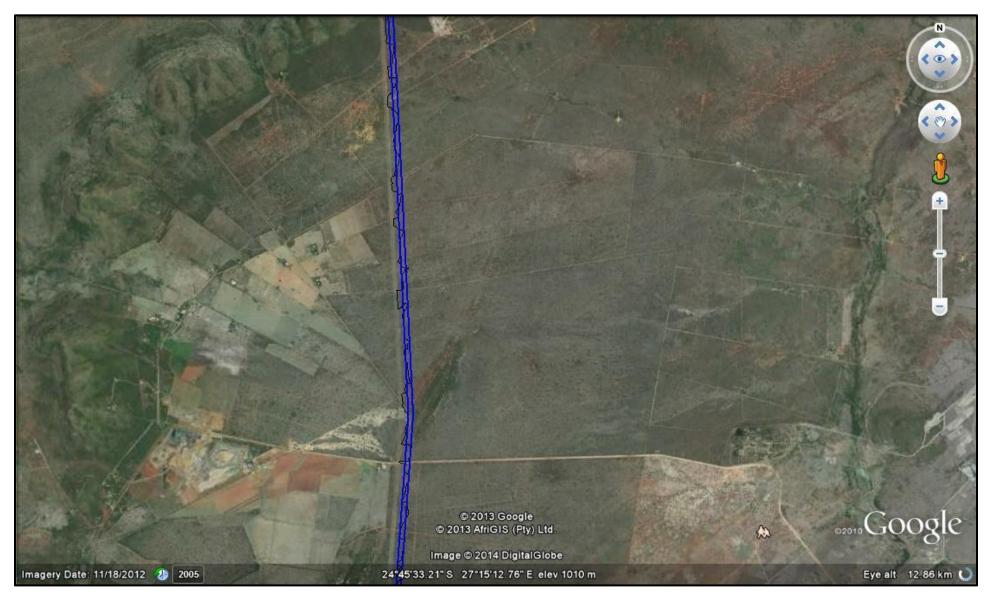
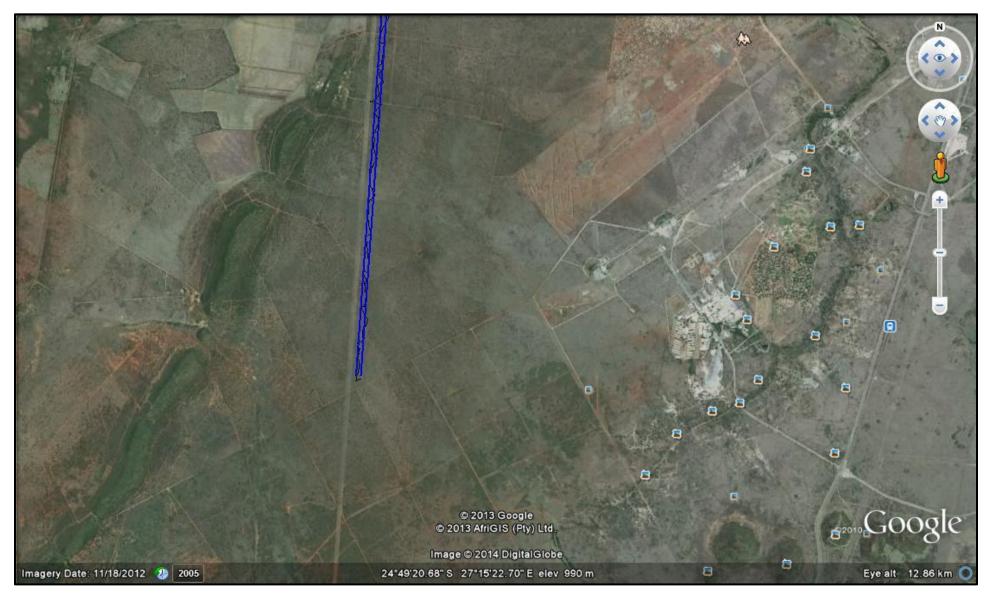
Track log of areas covered – power lines in blue and track logs in black

This report deals with the heritage walk through of the third section of the proposed Masa Ngwedi power line. A track log of the areas covered is included in Annexure C. This report focuses on Section 3 of the proposed alignment that starts from the farm Mecklenburg to Vlakpoort (approx. 35km). The end tower for section 3 for the 765kV power line is tower No. 258; the end tower of the 400kV power line is tower 252. Although the vegetation is very thick on some portions of this section, other portions have better visibility (Figure 6 - 11) it was possible to visit all the towers physically or to get close enough to assess the towers visually. The northern portion of this section is characterised by sandy soil, mountains and hills while the southern section is flat and marked by deep turf. The main drainage system in this area is the Crodile River in the northern portion of the study area.
