# HERITAGE SCOPING STUDY OF THE FARM GROOT OLIPHANTSKOP (FARM 81) FOR THE PROPOSED OMEGA SUBSTATION, WESTERN CAPE.

**Eyethu Engineers**

August 2004

**Archaeology Contracts Office**

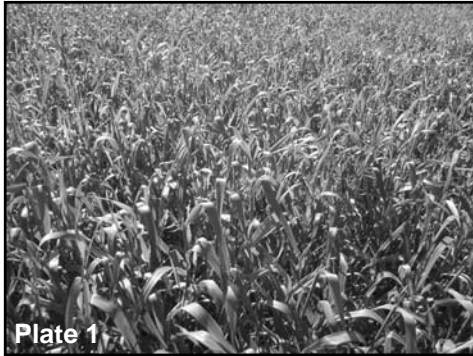
Currently almost all of the land at Alternative A and much of the area at C is under wheat and oats, while the land at Alternative B is used for grazing. Consequently ground visibility at Alternative A was poor (Plate 1), while the sand at Alternative B was plainly visible (Plate 2). At Alternative C some parts were under crops while other parts were open sand. With most of the area having been ploughed in the past, little *in situ* archaeological material was

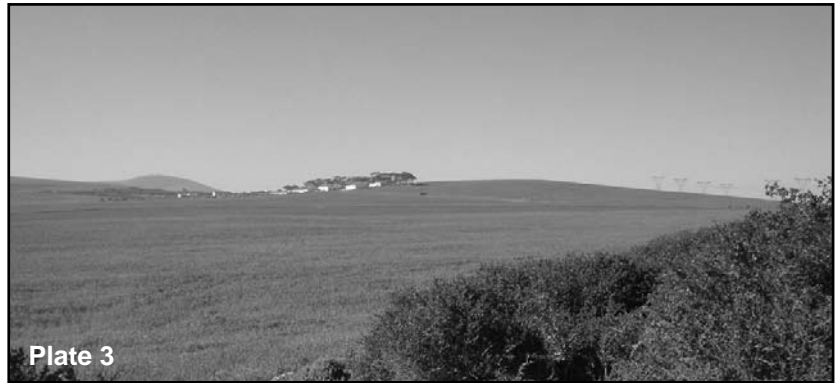
The area in which Groot Oliphantskop is located consists of gently rolling hills and open plains devoted primarily to wheat farming (Plate 3). Besides farmhouses and their associated outbuildings, few built structures exist. A road (R307), a railway line and power cables from Koeberg power station pass through the property. Occasional lines of blue gum trees occur, predominantly along roads, but most land is open space. From the Groot Oliphantskop farm buildings commanding views exist, both to the west and north (Plate 4).

Given the proposed footprints of the three alternatives, none is particularly suitable from a heritage point of view. Alternative A (foreground in Plate 3) would clearly have the greatest impact on the farm complex (GO1)(A2). While Alternative B (Plate 25 & 26) would impact the small graveyard, it might be seen as having the least overall impact on all heritage present on the farm. Graves, however, are difficult to mitigate. Alternative C (Plate 24), will impact directly on site GO3(C1). The best alternative in terms of heritage would be to reshape the footprint so as to allow heritage sites to remain intact. If this were possible, then Alternative B is viewed as the most suitable of the three.

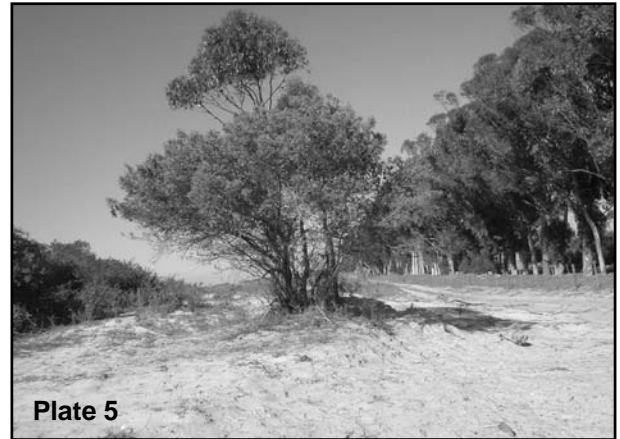
This site is located on the edge of the field identified as Alternative A (S 33° 42' 13.2" E 18° 30' 24.4"; Plate 5). It consists of a low bushy rise and sandy area (Plate 5) that have escaped ploughing and farming, and on which was found a very small selection of stone artefacts. These artefacts are made on silcrete and probably date to the Middle Stone Age (MSA), although a single ESA core in quartzite was also seen. This site has very low importance and could be assigned a provisional grading of 3b.

Site GO7(A1) is not seen as significant in any way, and its destruction will not result in any important loss of archaeological material. As such, no mitigation is recommended for this site.

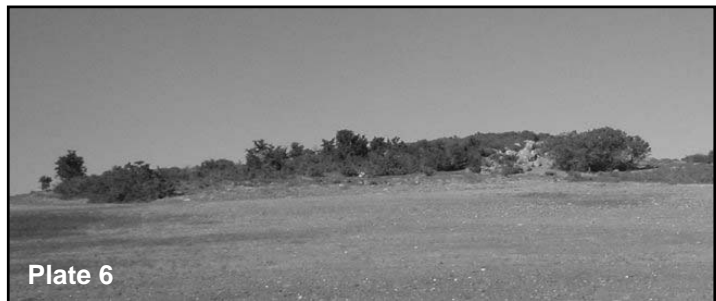
This site is located just within the southernmost part of the area earmarked as Alternative C (S 33° 42' 49.7" E 18° 29' 43.6"; Plate 6). Should this alternative be chosen the site would be directly impacted. The site is located on a small hill (Plate 6) capped with a layer of silcrete (Plate 7) from which Stone Age people have obtained raw material for the manufacture of stone artefacts.

Due to its nature, the prehistoric quarry site, GO3(C1), could not be suitably mitigated. As such, this site should receive full protection. However, it is quite feasible for the substation to be located very close to this site. If it were possible to reshape the footprint of the substation and avoid destruction of the quarry site, then this would make Alternative C the best option from a heritage point of view. During the construction phase of any of the alternatives, it should be ensured that no soil or rock is removed from the site or the surrounding area at any time. Site GO2(C2) no longer seems to be particularly conservation worthy. However, should the site be impacted by construction work, it should be explored archaeologically to ensure that all possible information has been obtained prior to its destruction. If the site will not be directly impacted, then it is recommended that it receive full protection during construction.

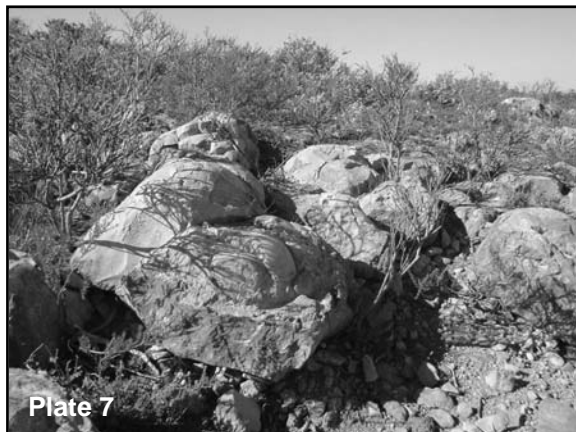
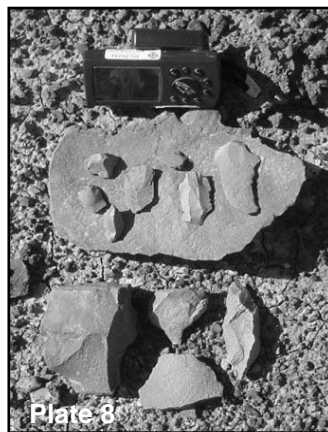
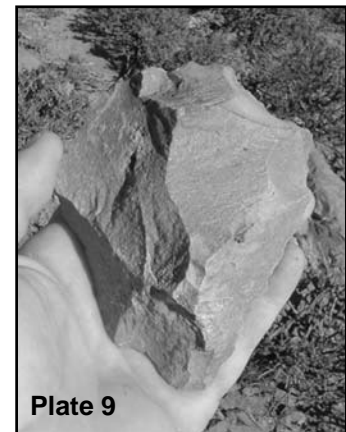
Numerous flakes, blades, cores and other débitage items are present lying on and around the hill (Plate 8), signifying frequent use of the outcrop as a stone source. Artefacts dating to the MSA and LSA (Later Stone Age) are common, although the former probably dominates. The vast majority of artefacts are on silcrete collected directly from the outcrop, although some quartz pieces are also present. A few silcrete artefacts attributable to the ESA, including one hand-axe (Plate 9), also occur. The deflated area to the northwest of the hill also contains numerous artefacts. This site could be assigned a grade of 3a.

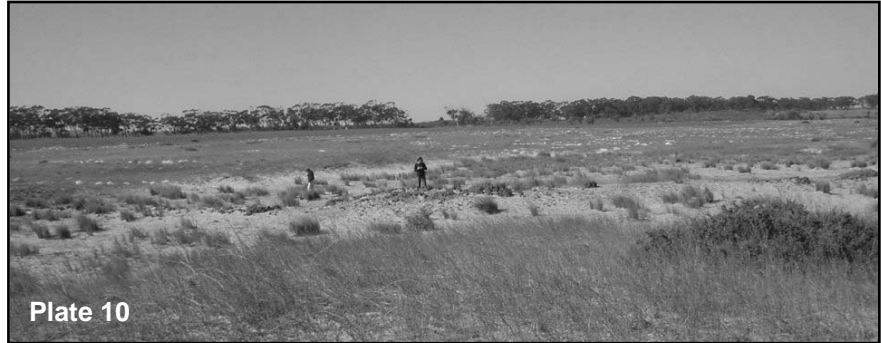
This site lies just outside the southeastern margin of Alternative C and should not be directly impacted by the erection of the substation here. The site should, however, be incorporated into the management plan for the farm as a whole, both

during and after the construction phase. It is located immediately east of GO3(C1) (S 33° 42' 49.5" E 18° 29' 59.1"; Plate 10) and consists of a sandy deflation containing a scatter of stone artefacts. These seem to be a mixture of MSA and LSA artefacts. Among the latter are three fragments of cobbles, each of which had been used as both a hammerstone and an upper grindstone (e.g. Plate 11), and one larger cobble that had been used as a lower grindstone and anvil (Plate 12). Plate 13 shows a single platform core, possibly of MSA origin. Kaplan (1996) reports that Mr D. Drury of the South African Museum excavated two human skeletons from this site, described as "a large sand dune" (Kaplan 1996:3), sometime in the mid-20<sup>th</sup> century. It is interesting to note that the artefacts occur in a deflation which appears to be a relatively recent phenomenon as shown by the blue circles on Figures 4 and 5 (aerial photographs from 1938 and 2001 respectively). The hill (foreground in Plate 10) is currently entirely vegetated and has no archaeological material present on it at all. We are uncertain as to how to reconcile these facts with the site having been recorded as a sand dune in the past. With the current deflation of the site, it is

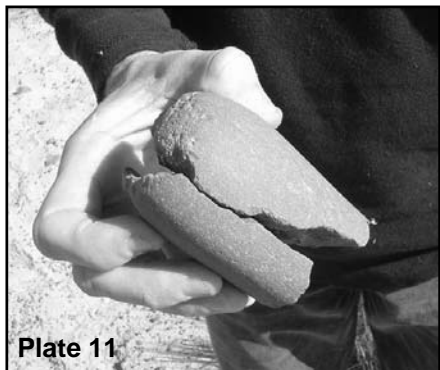
thought that its integrity has been substantially altered by souvenir hunters, with many artefacts probably having been removed over the years. As such, the site could provisionally be graded 3b.

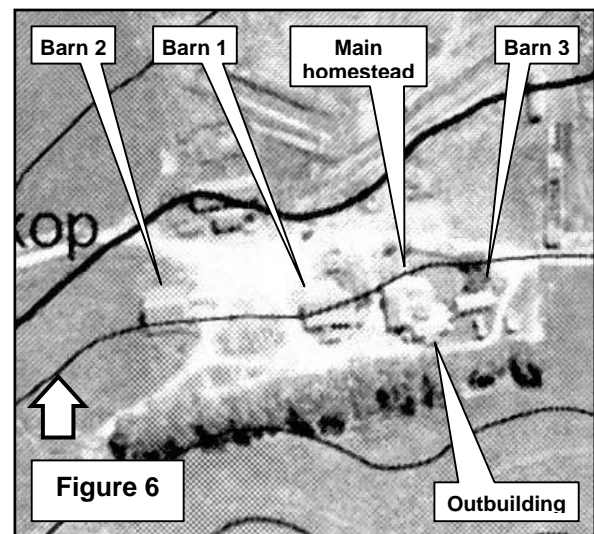
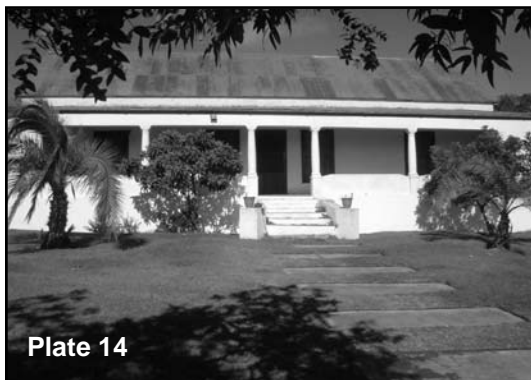
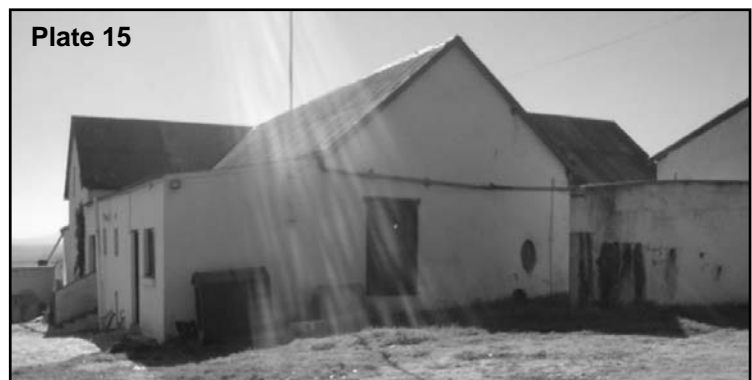
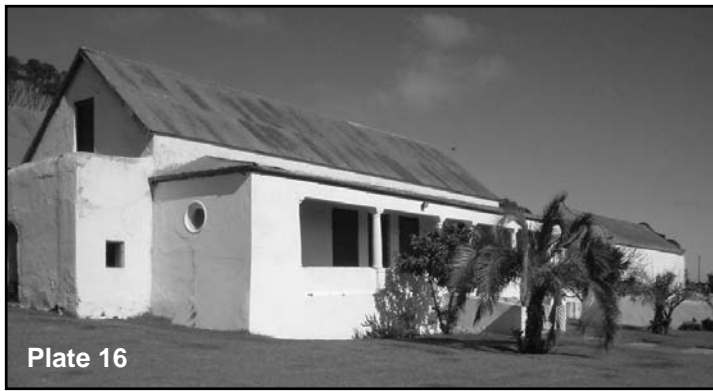
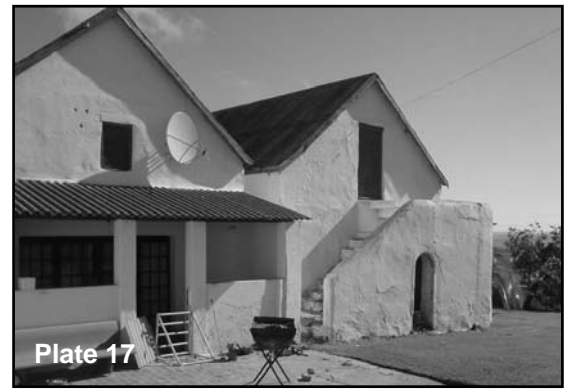
The main dwelling house (Plate 14) is architecturally very interesting. The previous report by Kaplan (1996) identified the building as late 18<sup>th</sup> or early 19<sup>th</sup> century, an estimate with which we agree. The essential form of the building is T-shaped indicating that it had its origins in the Dutch occupation period styles of the 18<sup>th</sup> century. The seemingly organic growth of this building suggests that it may even have originally started out as a longhouse, in the form of the current front portion. Although various additions were made to the building in later years (e.g. small room on the left in Plate 15 and second wing and later *stoep* on the left in Plate 17), the T-shaped core still exists. The front *stoep* (Plates 14 & 16) was probably added in the early 20<sup>th</sup> century and it is quite likely that the original thatched roof was replaced with corrugated iron at the same time. If the building ever had a front gable, it may well have been removed at this time. There is a *solder* in the roof space which is accessed by an outside staircase built in stone against the eastern end gable (Plates 17 & 18). Most of the openings in the building have 19<sup>th</sup> century fenestration ranging from Victorian to Georgian apart from the modern additions to the "T" form which contain contemporary joinery. The farm house has a neat garden bounded by a vernacular style yard wall.

This farmhouse is a significant structure protected by section 34 of the National Heritage Resources Act and is rendered additionally interesting by the fact that its historical layering is intact and it has not been “restored”. It is probably very old by South African standards and could be provisionally assigned grade 3a or even grade 2 status. The building is certainly worthy of conservation.

Various indirect impacts will also be felt and these would occur for any of the three proposed alternatives. Primary among these is the concern, especially with respect to the main house, that historic buildings will be treated inappropriately, when in fact they warrant active conservation. If the main dwelling house loses its status as a residence it may be demolished, abandoned or simply neglected. If used as a temporary site office during and after the construction phase there is a danger that illegal ad hoc changes will be made, and building fabric may be removed or stolen. The effect of accumulative small changes to a structure can be profound and have the effect of destroying the significance of an interesting historic place.

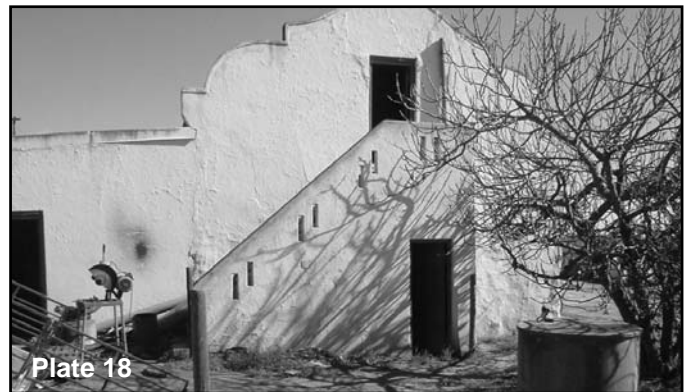
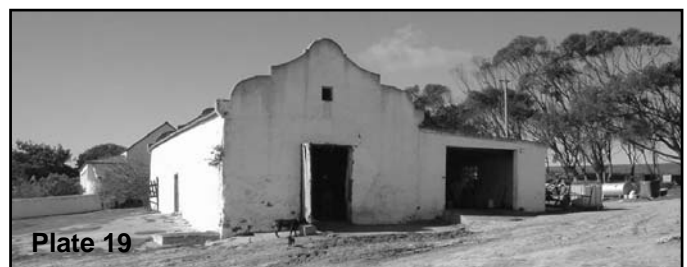
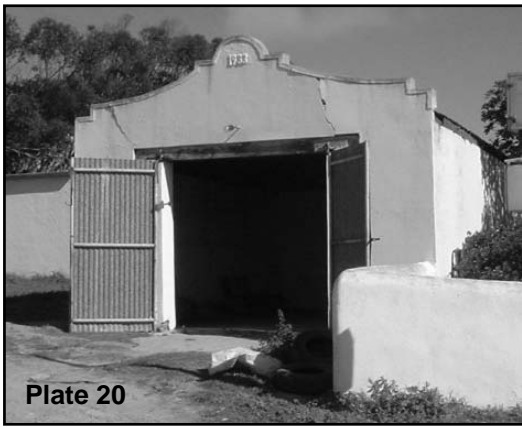
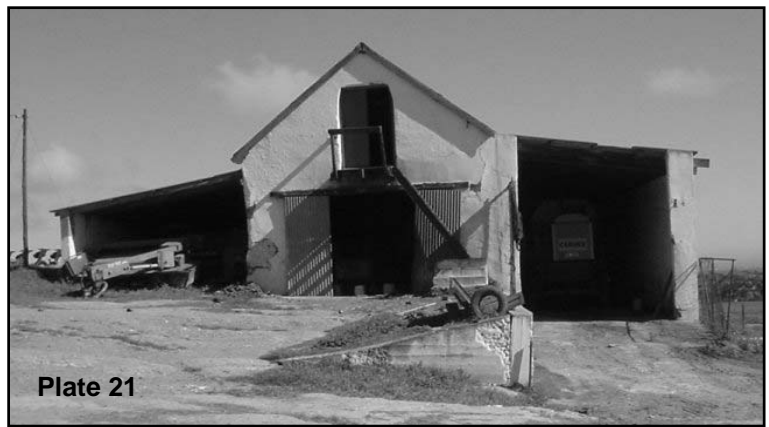
At least four of the outbuildings are old. The dates of 1937 on the barn immediately west of the main homestead (Barn 1; Plate 18 & 19) and 1933 on the barn to the southeast of the main dwelling (Barn 3; Plate 20) do not reflect the true age of the buildings. Rather they date the addition of the Cape Dutch revivalist gables to the already existing structures. Some of the joinery and fabric in the barns certainly predates the end of the 19<sup>th</sup> century and in all likelihood is earlier. Both the original structures were re-roofed when the gables were added resulting in loss of the original roof joinery. The barn dated 1937 has a modern shed added to its southern side. The last and westernmost barn (Barn 2; Plate 21) probably also dates to at least the mid- to late 19<sup>th</sup> century. Its straight gables are quite likely older than the curved gables of the other barns. This barn has had modern sheds attached to either side.

The outbuildings are protected by section 34 of the National Heritage Resources Act as applied by Heritage Western Cape. A permit must be applied for and issued for their alteration or destruction.

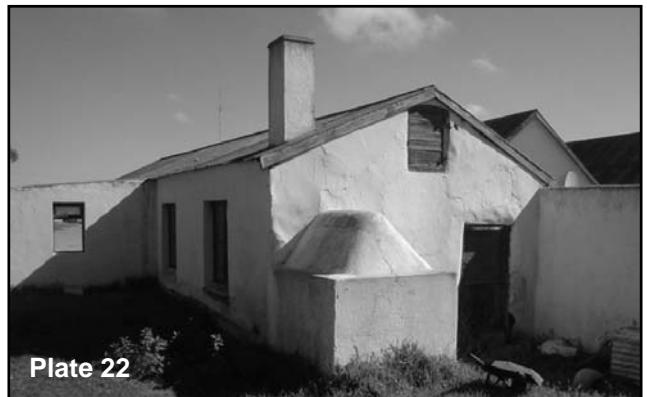
Plate 22

Immediately south-east of the main house is a small outbuilding with an oven attached to it (Plate 22). This building is also old and is “reputed to be older than the main house” (Kaplan 1996:4). Prior to the installation of a kitchen in the main homestead, this outbuilding may well have functioned as the farm kitchen.

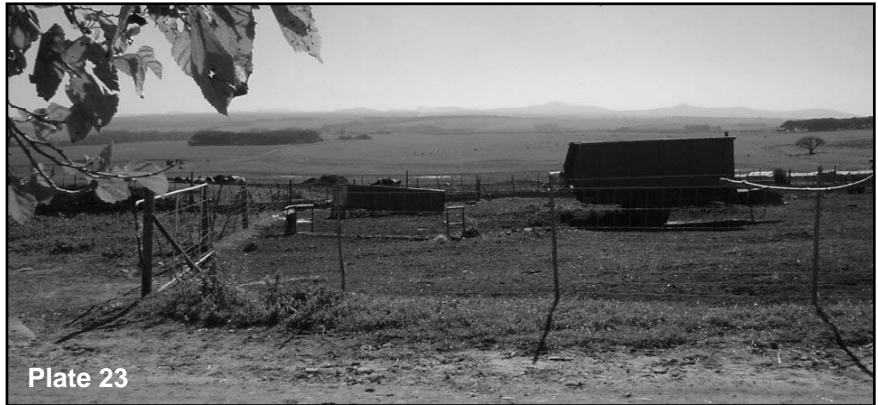
Cultural landscape relates to the historical form and use of the farm and surrounding land. The farm itself is over 200 years old and continues to function commercially to this day (Plate 23). The present farm boundary essentially dates to 1832, with a final deduction made in 1959. The surrounding landscape

is predominantly under crops and is punctuated only by the occasional line of blue gum trees. Both the historical and present cultural landscapes are therefore landscapes of agriculture.
