EXTENDED STUDY PROJECT: SOILS, VEGETATION AND MAMMALS

October 2007

by
Francois de Wet

**ESKOM ZEUS-MERCURY (VREDEFORT DOME AREA) 400kV
TRANSMISSION LINE ENVIRONMENTAL IMPACT ASSESSMENT –
ECOLOGICAL REPORT**

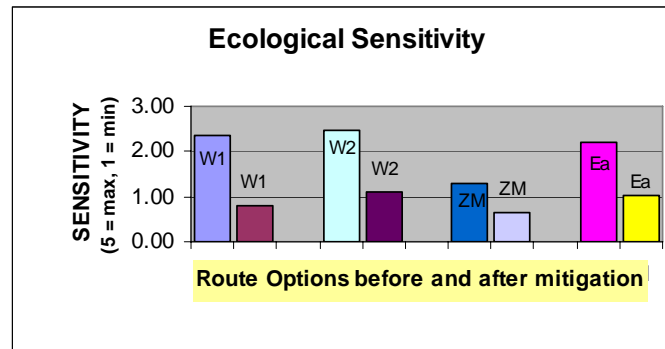
W1 = Western alignment 1
W2 = Western alignment 2
ZM = Zeus – Mercury alignment = Central route
Ea = Eastern alignment

Paired data sets for each of the above show the envisaged impact before (left) and after (right) mitigations if all the factors affecting ecological sensitivity are considered. From the figure above the following is noted:

- First: ZM (Central Alignment)
- Second: F2 (Ecological Alternative alignment 2)
- Third: F1 (Ecological alternative alignment 1)
- Fourth: W1 (Western alignment 1).

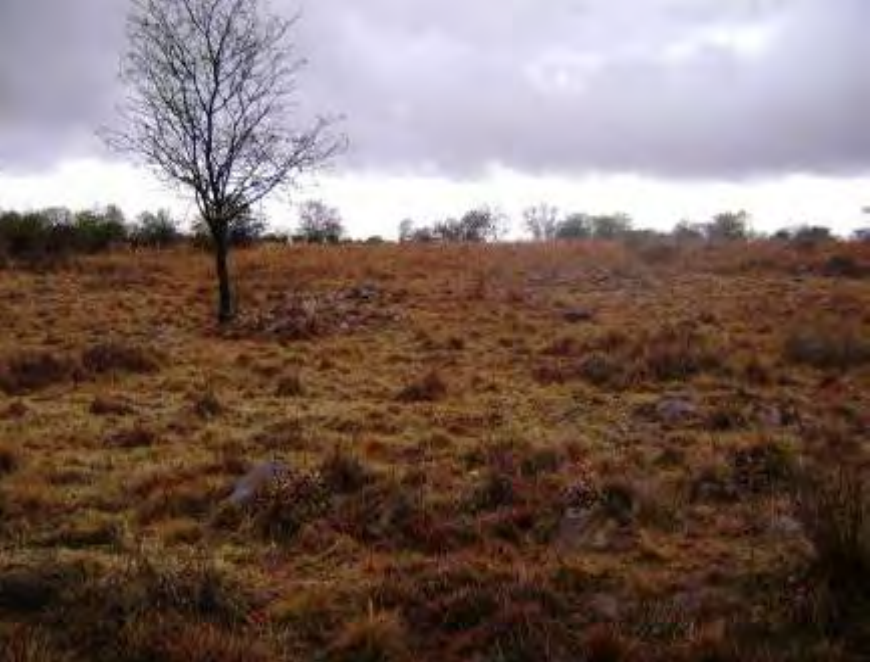
Site number	Site 5

Date visited	27-28/09/2007		
Land terrain Unit	Crest		
Geology / Soils	Andesite / Glenrosa- Mispah		
Soil description	Orthic A on Lithocutanic – Orthic A on Hard Rock		
Soil texture A- horizon	Sandy Loam		
Soil texture B- horizon	Not assessed		
Soil depth A- horizon	100 mm		
Subsoil depth	100+ mm		
Soil erodability	Low	Veld Condition	Selectively grazed
Dominant Species	Forbs and woody species = <i>Acacia karroo</i> Grasses = <i>Elionurus muticus</i>		
Notes	<ul style="list-style-type: none"> • Biodiversity expectation = Good to Very Good • Natural grazing area • Site at power line 		
Red Data Plant Species Recorded	None recorded	Recommendation	<ul style="list-style-type: none"> • See main report

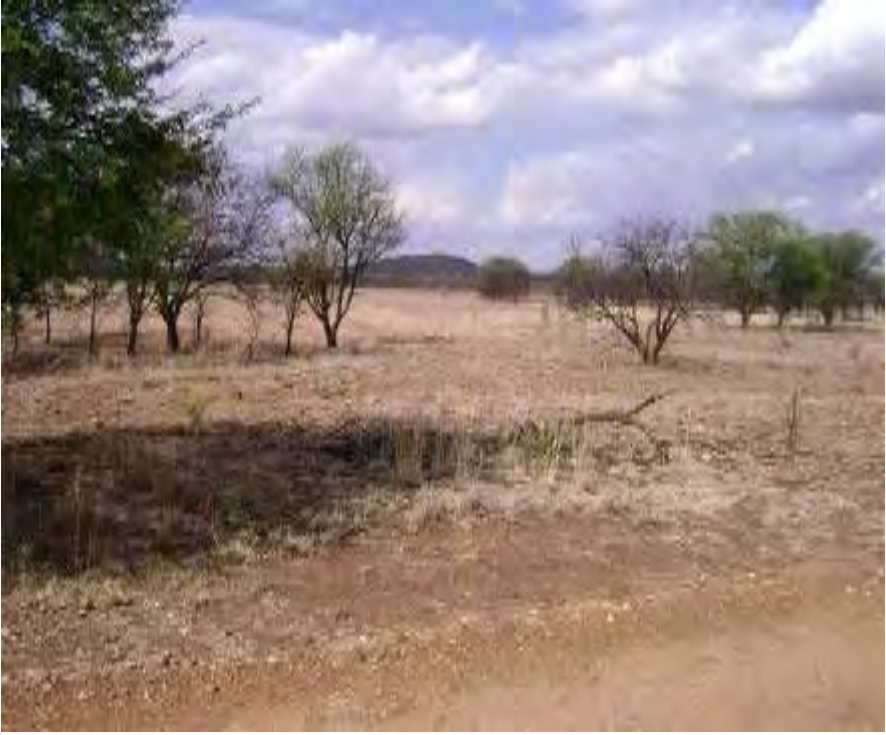
Site number	Site 8

Date visited	27-28/09/2007		
Land terrain Unit	Midslope		
Geology / Soils	Andesite / Sterkspruit		
Soil description	Orthic A on Prisma-cutanic B		
Soil texture A-horizon	Sandy Clay Loam		
Soil texture B-horizon	Sandy Clay		
Soil depth A-horizon	200 mm		
Subsoil depth	200+ mm		
Soil erodability	Very High	Veld Condition	Heavily grazed
Dominant Species	Forbs and woody species = <i>Acacia karroo</i> Grasses = <i>Themeda triandra</i>		
Notes	<ul style="list-style-type: none"> • Biodiversity expectation = Moderate to Good • Game Farm • Site near power line 		
Red Data Plant Species Recorded	None recorded	Recommendation	<ul style="list-style-type: none"> • See main report

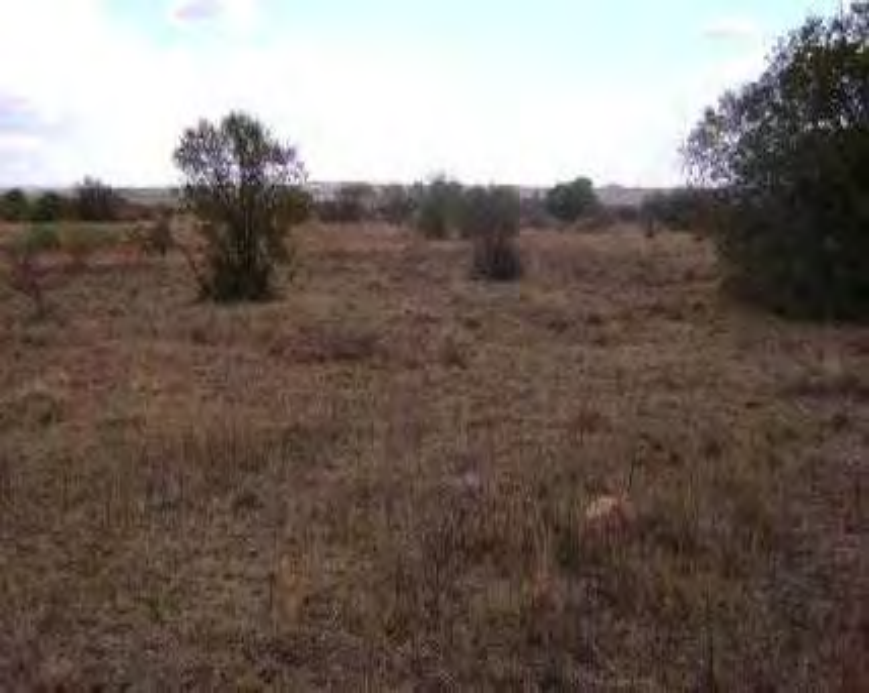
Site number	Site 9

Date visited	27-28/09/2007		
Land terrain Unit	Crest		
Geology / Soils	Quartzite (Sedimentary on geological map) / Hutton		
Soil description	Orthic A on Red Apedal B on Unspecified		
Soil texture A-horizon	Sandy Clay Loam		
Soil texture B-horizon	Sandy Clay Loam		
Soil depth A-horizon	200 mm		
Subsoil depth	400 mm		
Soil erodability	Moderate	Veld Condition	Slightly degraded
Dominant Species	Forbs and woody species = <i>Acacia caffra</i> , <i>Rhus lancea</i> Grasses = <i>Cynodon dactylon</i> Alien invaders and weeds = <i>Opuntia ficus-indica</i> , <i>Melia azedarach</i>		
Notes	<ul style="list-style-type: none"> • Biodiversity expectation = Good • Grazing area • Site near powerline 		
Red Data Plant Species Recorded	None recorded	Recommendation	<ul style="list-style-type: none"> • See main report

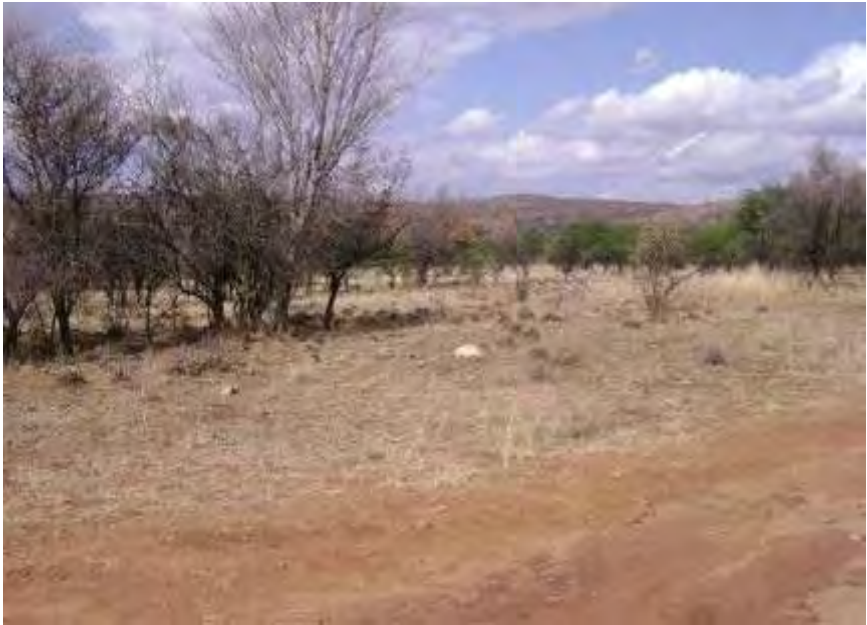
Site number	Site 41

Date visited	27-28/09/2007		
Land terrain Unit	Midslope		
Geology / Soils	Quartzite (Shale on geological map) / Mispah		
Soil description	Orthic A on Hard Rock		
Soil texture A-horizon	Loamy sand		
Soil texture subsoil horizon	N/a (hard rock)		
Soil depth A-horizon	200 mm		
Subsoil depth	200+ mm (Hard Rock)		
Soil erodability	Low	Veld Condition	Overgrazed
Dominant Species	Forbs and woody species = <i>Acacia karroo</i> Grasses = <i>Cynodon dactylon</i> , <i>Hyparrhenia hirta</i>		
Notes	<ul style="list-style-type: none"> • Biodiversity expectation = Good • Game Farm 		
Red Data Plant Species Recorded	None recorded	Recommendation	<ul style="list-style-type: none"> • See main report

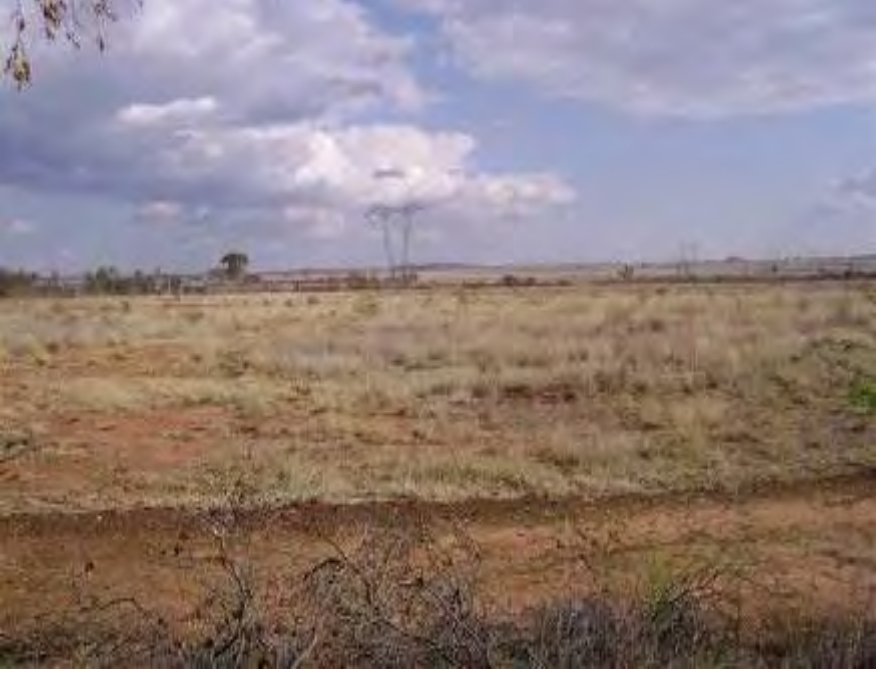
Site number	Site 45

Date visited	27-28/09/2007		
Land terrain Unit	Crest/Plain		
Geology / Soils	Sedimentary / Hutton		
Soil description	Orthic A on Red Apedal B on Unspecified		
Soil texture A-horizon	Sandy Clay Loam		
Soil texture B-horizon	Sandy Clay Loam		
Soil depth A-horizon	250		
Subsoil depth	410+		
Soil erodability	Moderate	Veld Condition	Disturbed
Dominant Species	Forbs and woody species = <i>Acacia karroo</i> Grasses = <i>Cynodon dactylon</i> Alien invaders and weeds = <i>Opuntia ficus-indica</i>		
Notes	<ul style="list-style-type: none"> • Biodiversity expectation = Poor • Grazing area • Site near power line 		
Red Data Plant Species Recorded	None recorded	Recommendation	<ul style="list-style-type: none"> • See main report

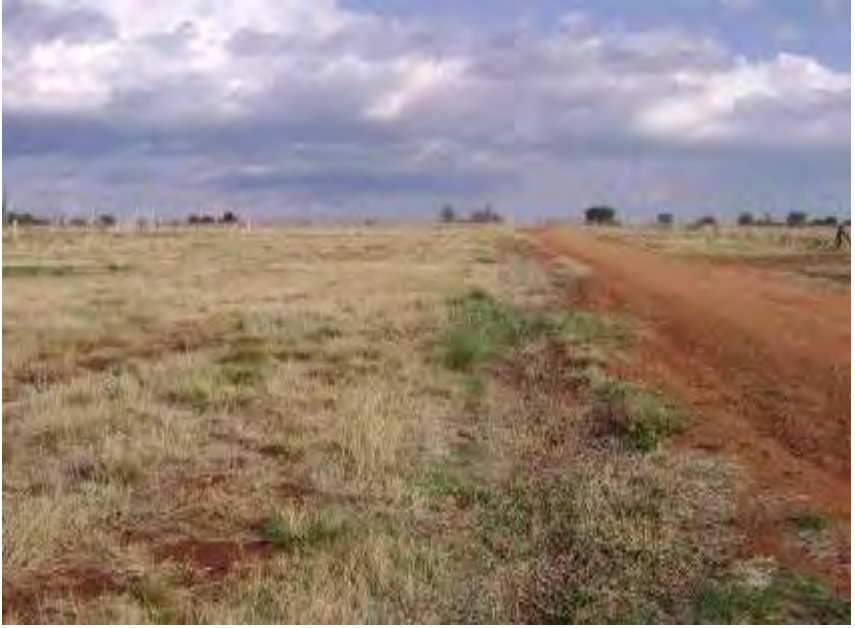
Site number	Site 48					
Date visited	27-28/09/2007					
Land terrain Unit	Crest					
Geology / Soils	Dolerite / Hutton					
Soil description	Orthic A on Red Apedal B on Unspecified					
Soil texture A-horizon	Sandy Clay Loam					
Soil texture B-horizon	Sandy Clay Loam					
Soil depth A-horizon	250 mm					
Subsoil depth	1500+ mm

Soil erodability				Moderate	Veld Condition	Disturbed
Dominant Species				Grasses = <i>Cynodon dactylon</i> , <i>Sorghum bicolor</i>		
Notes				<ul style="list-style-type: none"> • Biodiversity expectation = Very Poor • Site near chicken pens 		
Red Data Plant Species Recorded				None recorded	Recommendation	<ul style="list-style-type: none"> • See main report

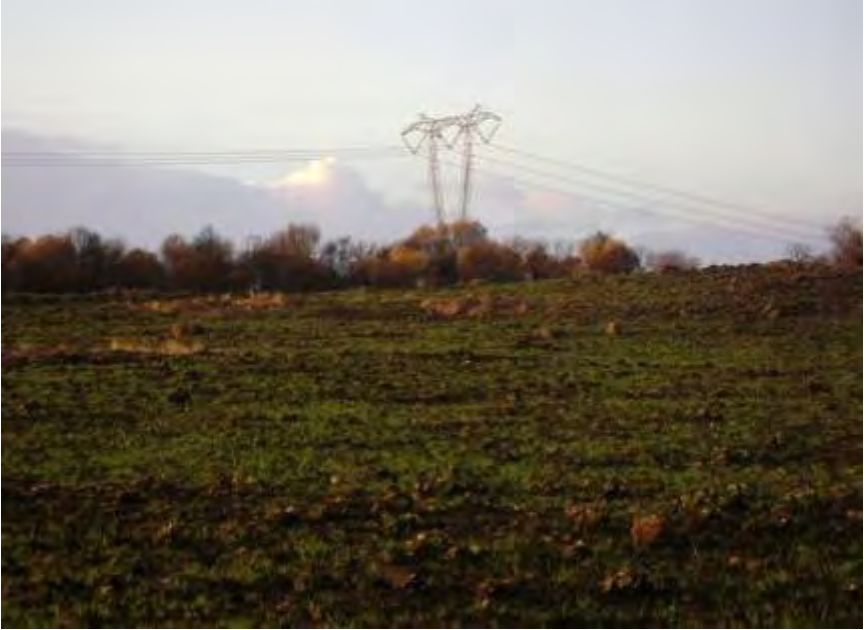
Site number	Site 69

Date visited	27-28/09/2007		
Land terrain Unit	Midslope		
Geology / Soils	/ Mispah		
Soil description	Orthic A on Hard Rock		
Soil texture A-horizon	Loamy Sand		
Soil texture subsoil-horizon	N/a (hard rock)		
Soil depth A-horizon	50 mm		
Subsoil depth	50+ mm (Hard Rock)		
Soil erodability	Slightly erodible	Veld Condition	(Grassland burnt)
Dominant Species	Forbs and woody species = <i>Rhus pyroides</i> Grasses = <i>Digitaria eriantha</i> , <i>Melinis repens</i> Alien invaders and weeds = <i>Opuntia ficus-indica</i>		
Notes	<ul style="list-style-type: none"> • Biodiversity expectation = Very Good • Site at Rossouw Koppie • Grassland burnt 		
Red Data Plant Species Recorded	None recorded	Recommendation	<ul style="list-style-type: none"> • See main report

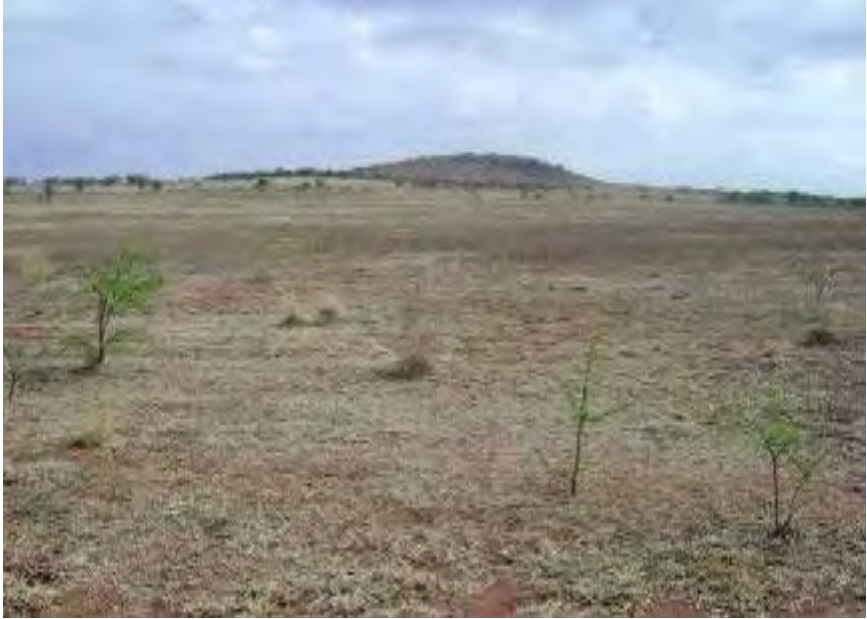
Site number	Site 70

Date visited	27-28/09/2007		
Land terrain Unit	Crest		
Geology / Soils	/ Hutton		
Soil description	Orthic A on Red Apedal B on Unspecified		
Soil texture A-horizon	Sandy Clay Loam		
Soil texture B-horizon	Sandy Clay Loam		
Soil depth A-horizon	250		
Subsoil depth	400+		
Soil erodability	Moderate	Veld Condition	Disturbed (Old land)
Dominant Species	Forbs and woody species = <i>Acacia karroo</i> Grasses = <i>Cynodon dactylon</i>		
Notes	<ul style="list-style-type: none"> • Biodiversity expectation = Very poor (Old land) and Very good (adjacent area) • Old land • Red data reptile species (<i>Cordylus</i> sp.) found in area adjacent to the site 		
Red Data Plant Species Recorded	None recorded	Recommendation	<ul style="list-style-type: none"> • See main report

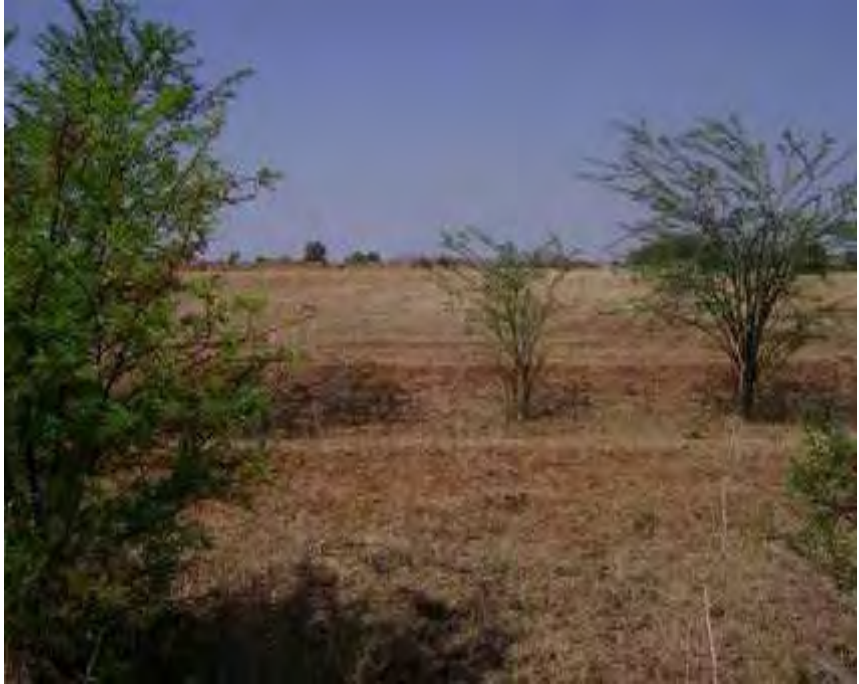
Site number	Site 71		
Date visited	27-28/09/2007		
Land terrain Unit	Midslope		
Geology / Soils	Hutton		
Soil description	Orthic A on Red Apedal B on Unspecified		
Soil texture A-horizon	Sandy Clay Loam		
Soil texture B-horizon	Sandy Clay Loam		
Soil depth A-horizon	Not assessed		
Subsoil depth	Not assessed

Soil erodability	Moderate	Veld Condition	Disturbed (old land and ploughed land)
Dominant Species	Forbs and woody species = <i>Acacia karroo</i> Grasses = <i>Cynodon dactylon</i> Alien invaders and weeds = <i>Tagetes minuta</i>		
Notes	Biodiversity expectation = Very poor in old land near compound and in ploughed land on western side of R53		
Red Data Plant Species Recorded	None recorded	Recommendation	<ul style="list-style-type: none"> • See main report
