APPENDIX 8 – ECOLOGY REPORT

ZEUS - MERCURY - VREDEFORT DOME

**ESKOM ZEUS-MERCURY (VREDEFORT DOME AREA) 400kV
TRANSMISSION LINE ENVIRONMENTAL IMPACT ASSESSMENT –
ECOLOGICAL REPORT**

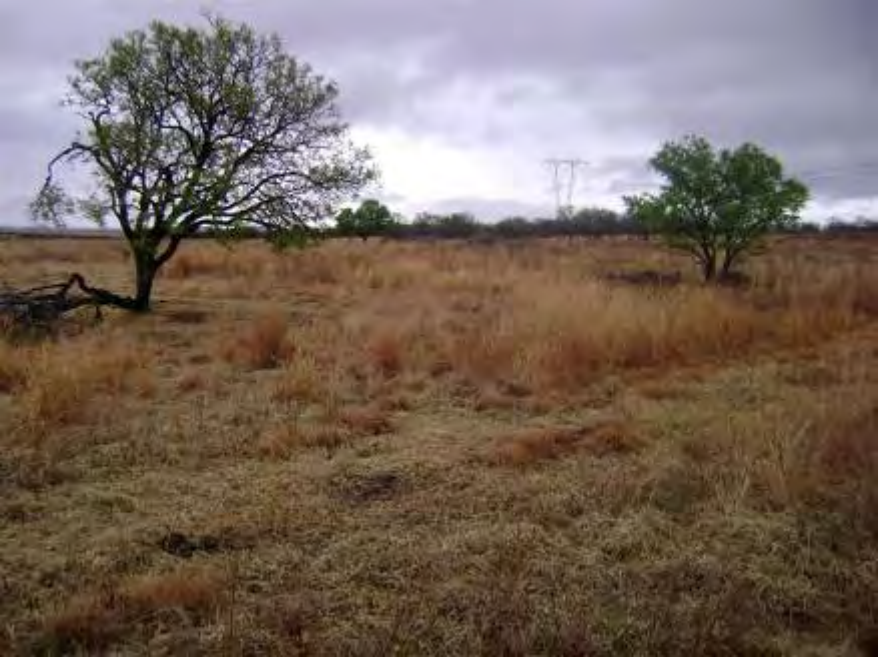
Site number	Site 4

Date visited	27-28/09/2007		
Land terrain Unit	Crest		
Geology / Soils	Andesite / Hutton		
Soil description	Orthic A on Red Apedal B on Unspecified		
Soil texture A-horizon	Sandy Clay Loam		
Soil texture B-horizon	Sandy Clay Loam		
Soil depth A-horizon	250 mm		
Subsoil depth	450 mm		
Soil erodability	Moderate	Veld Condition	Partially disturbed
Dominant Species	Forbs and woody species = <i>Acacia caffra</i> Grasses = <i>Themeda triandra</i> Alien invaders and weeds = <i>Tagetes minuta</i>		
Notes	<ul style="list-style-type: none"> • Biodiversity expectation = Moderate to Good • Ploughed below koppie • Site at R53 road crossing 		
Red Data Plant Species Recorded	None recorded	Recommendation	<ul style="list-style-type: none"> • See main report

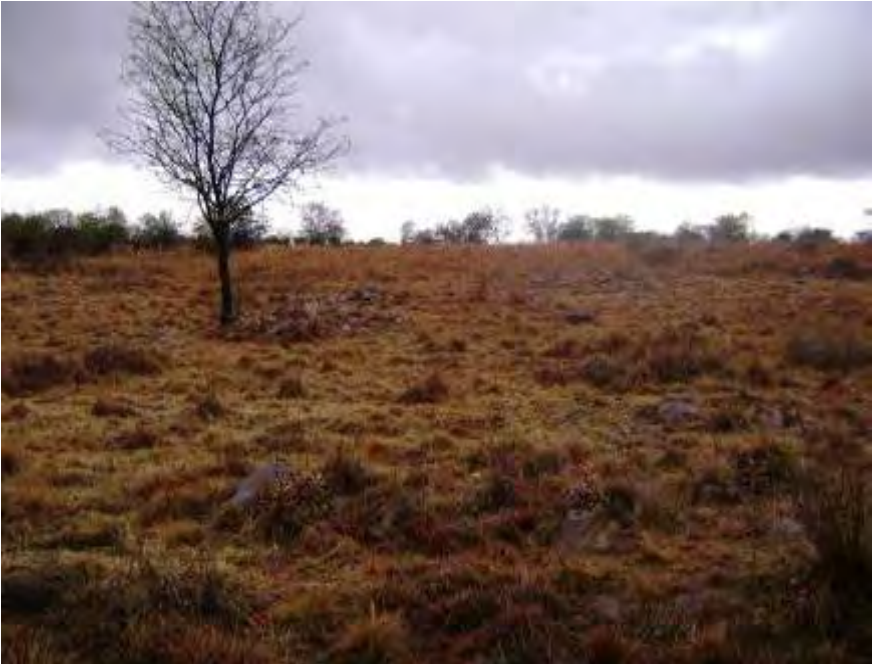
Site number	Site 5

Date visited	27-28/09/2007		
Land terrain Unit	Crest		
Geology / Soils	Andesite / Glenrosa- Mispah		
Soil description	Orthic A on Lithocutanic – Orthic A on Hard Rock		
Soil texture A- horizon	Sandy Loam		
Soil texture B- horizon	Not assessed		
Soil depth A- horizon	100 mm		
Subsoil depth	100+ mm		
Soil erodability	Low	Veld Condition	Selectively grazed
Dominant Species	Forbs and woody species = <i>Acacia karroo</i> Grasses = <i>Elionurus muticus</i>		
Notes	<ul style="list-style-type: none"> • Biodiversity expectation = Good to Very Good • Natural grazing area • Site at power line 		
Red Data Plant Species Recorded	None recorded	Recommendation	<ul style="list-style-type: none"> • See main report

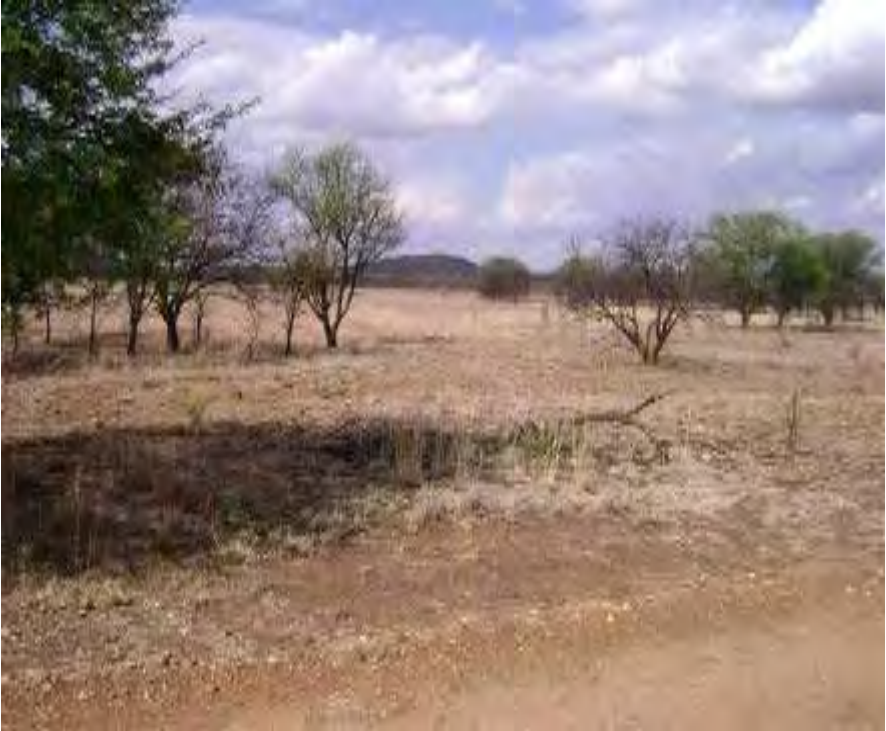
Site number	Site 8

Date visited	27-28/09/2007		
Land terrain Unit	Midslope		
Geology / Soils	Andesite / Sterkspruit		
Soil description	Orthic A on Prisma-cutanic B		
Soil texture A-horizon	Sandy Clay Loam		
Soil texture B-horizon	Sandy Clay		
Soil depth A-horizon	200 mm		
Subsoil depth	200+ mm		
Soil erodability	Very High	Veld Condition	Heavily grazed
Dominant Species	Forbs and woody species = <i>Acacia karroo</i> Grasses = <i>Themeda triandra</i>		
Notes	<ul style="list-style-type: none"> • Biodiversity expectation = Moderate to Good • Game Farm • Site near power line 		
Red Data Plant Species Recorded	None recorded	Recommendation	<ul style="list-style-type: none"> • See main report

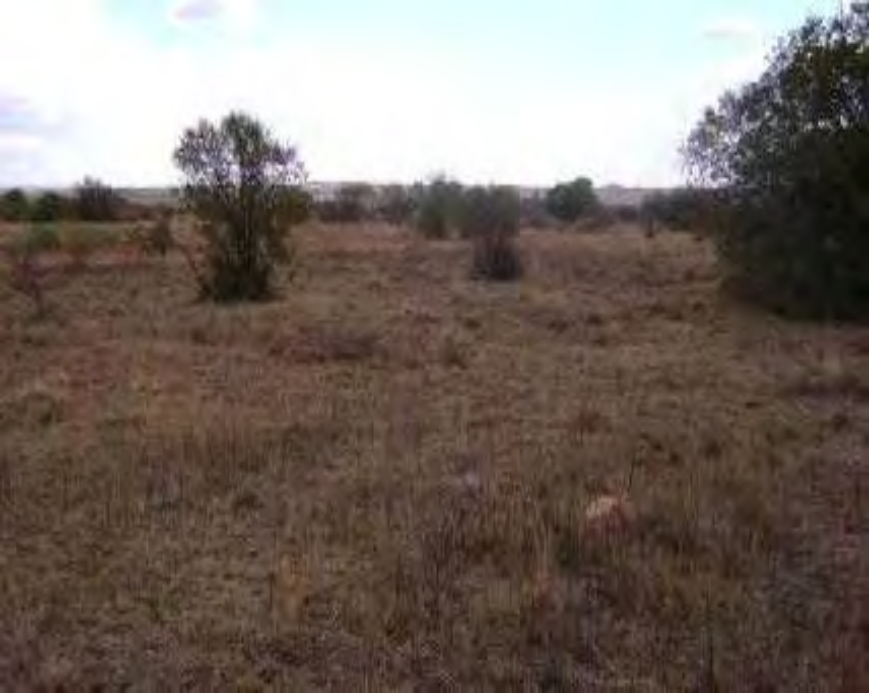
Site number	Site 9

Date visited	27-28/09/2007		
Land terrain Unit	Crest		
Geology / Soils	Quartzite (Sedimentary on geological map) / Hutton		
Soil description	Orthic A on Red Apedal B on Unspecified		
Soil texture A-horizon	Sandy Clay Loam		
Soil texture B-horizon	Sandy Clay Loam		
Soil depth A-horizon	200 mm		
Subsoil depth	400 mm		
Soil erodability	Moderate	Veld Condition	Slightly degraded
Dominant Species	Forbs and woody species = <i>Acacia caffra</i> , <i>Rhus lancea</i> Grasses = <i>Cynodon dactylon</i> Alien invaders and weeds = <i>Opuntia ficus-indica</i> , <i>Melia azedarach</i>		
Notes	<ul style="list-style-type: none"> • Biodiversity expectation = Good • Grazing area • Site near powerline 		
Red Data Plant Species Recorded	None recorded	Recommendation	<ul style="list-style-type: none"> • See main report

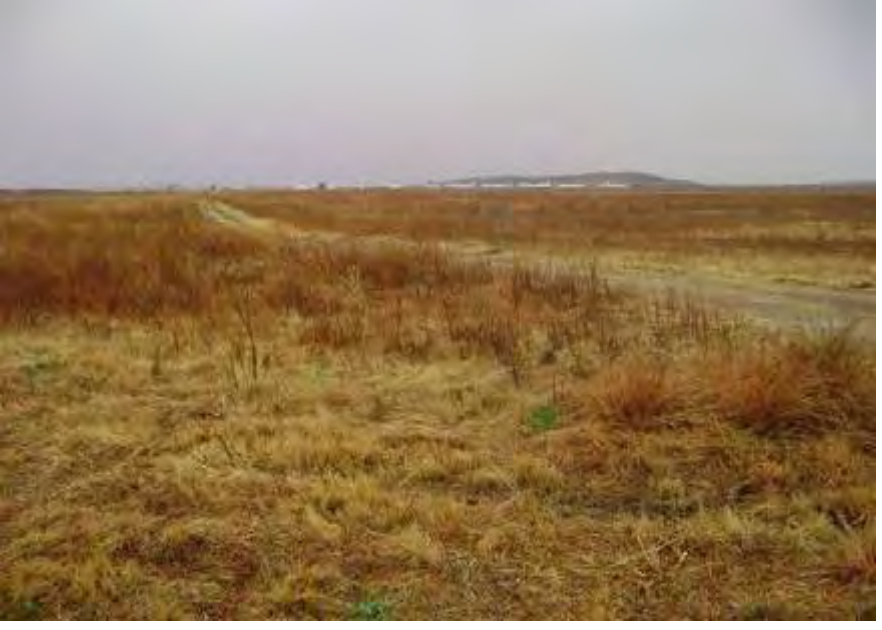
Site number	Site 20

Date visited	27-28/09/2007		
Land terrain Unit	Footslope		
Geology / Soils	Sedimentary / Sterkspruit		
Soil description	Orthic A on Prisma-cutanic B		
Soil texture A-horizon	Sandy Clay Loam		
Soil texture B-horizon	Sandy Clay		
Soil depth A-horizon	300 mm		
Subsoil depth	550 mm (B1) 550+mm (B2)		
Soil erodability	Very High	Veld Condition	Disturbed
Dominant species	Grasses = <i>Cynodon dactylon</i> Alien invaders and weeds = <i>Eucalyptus</i> sp.		
Notes	<ul style="list-style-type: none"> • Biodiversity expectation = Very poor • Old lands 		
Red Data Plant Species Recorded	None recorded	Recommendation	<ul style="list-style-type: none"> • See main report

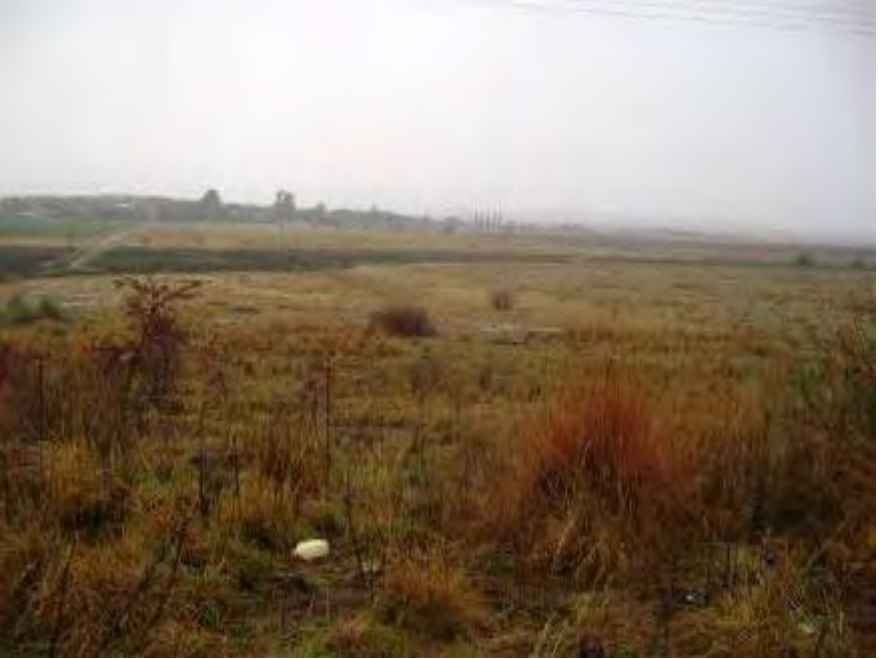
Site number	Site 24

Date visited	27-28/09/2007		
Land terrain Unit	Valley bottom		
Geology / Soils	Andesite / Hutton		
Soil description	Orthic A on Red Apedal B on Unspecified		
Soil texture A-horizon	Sandy Clay Loam		
Soil texture B-horizon	Sandy Clay Loam		
Soil depth A-horizon	Not assessed		
Subsoil depth	Not assessed		
Soil erodability	Very High	Veld Condition	Disturbed/Slightly degraded
Dominant Species	Forbs and woody species = <i>Ziziphus mucronata</i> Grasses = <i>Hyparrhenia hirta</i>		
Notes	• Biodiversity expectation = Poor to Very Poor (ploughed land) and Good to Very Good (grazing area)		
Red Data Plant Species Recorded	None recorded	Recommendation	• See main report

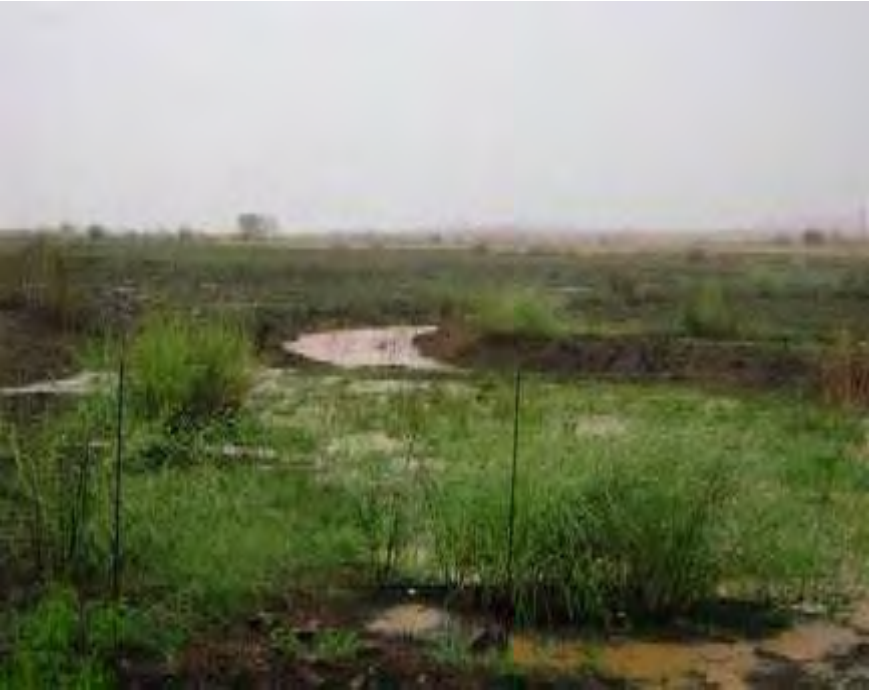
Site number	Site 25

Date visited	27-28/09/2007		
Land terrain Unit	Valley bottom		
Geology / Soils	Andesite / Sepane		
Soil description	Orthic A on Pedocutanic B on unconsolidated material with signs of wetness		
Soil texture A-horizon	Sandy Clay Loam		
Soil texture B-horizon	Sandy Clay		
Soil depth A-horizon	300 mm		
Subsoil depth	1000 mm (B1) 1000+ mm (B2)		
Soil erodability	Very High	Veld Condition	Overgrazed
Dominant Species	Forbs and woody species = <i>Acacia karroo</i> Grasses = <i>Cynodon dactylon</i>		
Notes	<ul style="list-style-type: none"> • Biodiversity expectation = Poor to Very Poor • Very sensitive soils • Riverbank • Site at water point 		
Red Data Plant Species Recorded	None recorded	Recommendation	<ul style="list-style-type: none"> • See main report

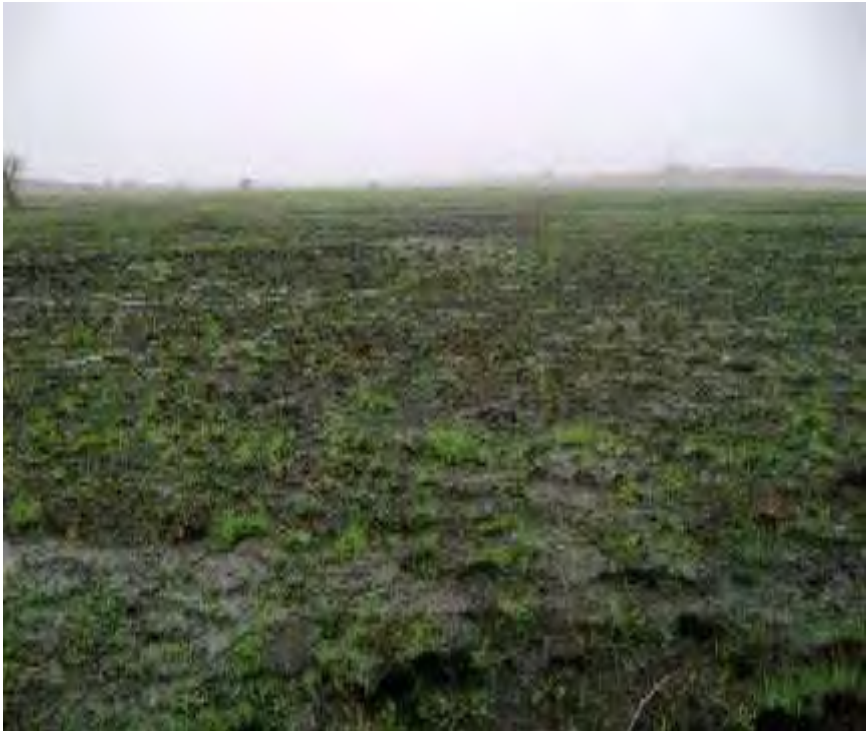
Site number	Site 26

Date visited	27-28/09/2007		
Land terrain Unit	Footslope-Valley bottom ecotone		
Geology	Andesite		
Soil description	Hydromorphic Not assessed (300m from road)		
Soil texture A-horizon	Not assessed		
Soil texture B1-horizon	Not assessed		
Soil texture B2-horizon	Not assessed		
Soil depth A-horizon	Not assessed		
Subsoil depth	Not assessed		
Soil erodability	Very High	Veld Condition	Not assessed
Dominant Species	Grasses = <i>Eragrostis curvula</i> , <i>Imperata cylindrica</i>		
Notes	<ul style="list-style-type: none"> • Biodiversity expectation = Good to Very Good • Near wetland/river 		
Red Data Plant Species Recorded	None recorded	Recommendation	<ul style="list-style-type: none"> • See main report

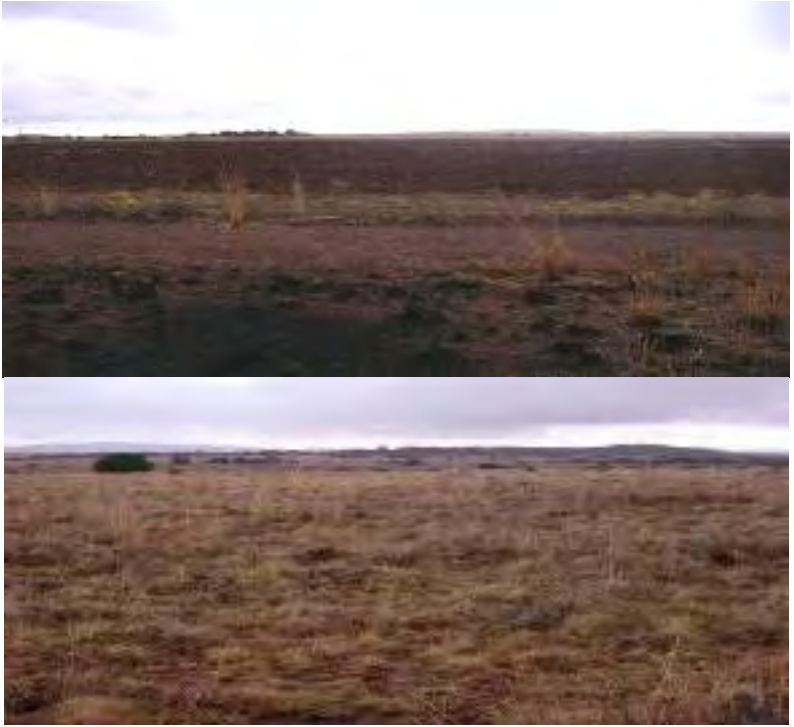
Site number	Site 29

Date visited	27-28/09/2007		
Land terrain Unit	Crest		
Geology / Soils	Andesite / Hutton		
Soil description	Orthic A on Red Apedal B on Unspecified		
Soil texture A-horizon	Sandy Clay Loam		
Soil texture B-horizon	Sandy Clay Loam		
Soil depth A-horizon	100 mm		
Subsoil depth	100+ mm		
Soil erodability	Slightly erodible	Veld Condition	Slightly degraded (south of road) and disturbed (north of road)
Dominant Species	Forbs and woody species = <i>Acacia karroo</i> Grasses = <i>Themeda triandra</i>		
Notes	<ul style="list-style-type: none"> • Biodiversity expectation = Very poor (north of road) and Moderate (south of road) • Ploughed (north of road) and grazing area (south of road) • Shallow soils 		
Red Data Plant Species Recorded	None recorded	Recommendation	<ul style="list-style-type: none"> • See main report

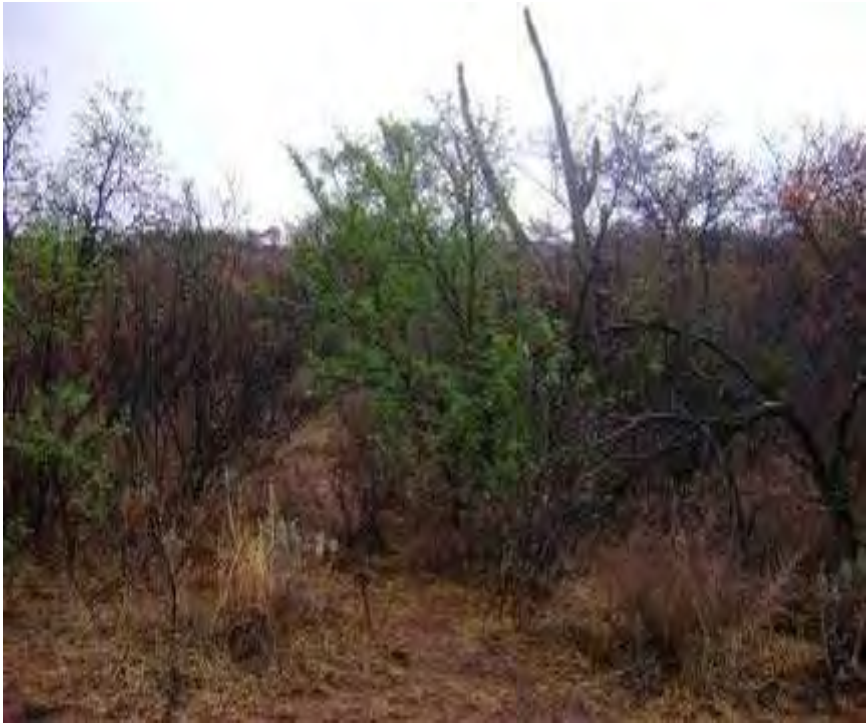
Site number	Site 36

Date visited	27-28/09/2007		
Land terrain Unit	Crest (Koppie)		
Geology / Soils	Andesite / Hutton		
Soil description	Orthic A on Red Apedal B on Unspecified		
Soil texture A-horizon	Sandy Clay Loam		
Soil texture B-horizon	Sandy Clay Loam		
Soil depth A-horizon	250 mm		
Subsoil depth	1200+ mm		
Soil erodability	Moderate	Veld Condition	Slightly degraded
Dominant Species	Forbs and woody species = <i>Acacia karroo</i> Grasses = <i>Themeda triandra</i> Alien invaders and weeds = <i>Cereus peruvianus</i>		
Notes	<ul style="list-style-type: none"> • Biodiversity expectation = Good to Very Good • Soil depth decreases closer to the koppie • Site at A53 road crossing 		
Red Data Plant Species Recorded	None recorded	Recommendation	<ul style="list-style-type: none"> • See main report

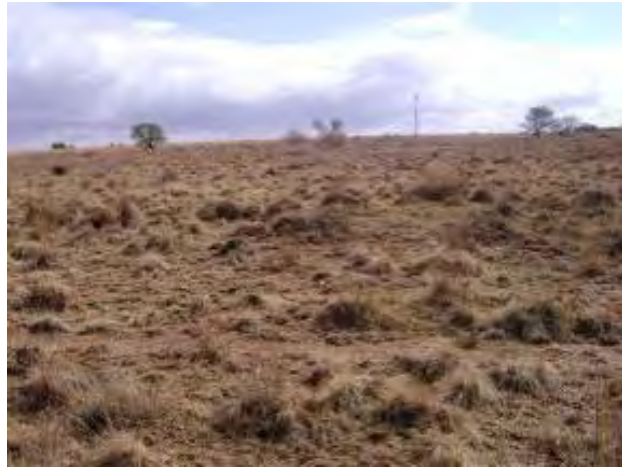
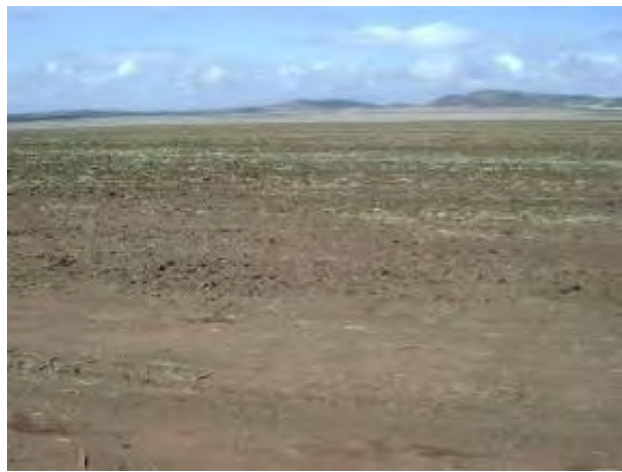
Site number	Site 38		
Date visited	27-28/09/2007		
Land terrain Unit	1. Midslope 2. Footslope		
Geology / Soils	Dolerite / Dresden		
Soil description	1. Orthic A on Hard plinthic B 2. Orthic A on Yellow-brown apedal B1 on Plinthic B2		
Soil texture A-horizon	Sandy Clay Loam		
Soil texture B-horizon	Sandy Clay Loam		
Soil depth A-horizon	1. 250mm 2. 250mm		
Soil subsoil depth of B-horizon to Plinthic horizon	1. 250+ mm 2. 400 mm (B1) 400+ mm (B2)		
Soil erodability	High	Veld Condition	Overgrazed (North-eastern side of road) and Disturbed (South-western side of road)
Dominant Species	Forbs and woody species = <i>Acacia karroo</i> Grasses = <i>Hyparrhenia hirta</i> Alien invaders and weeds = <i>Melia azedarach</i>		
Notes	<ul style="list-style-type: none"> • Biodiversity expectation = Very poor (South-west side of road) and Poor (North-east side of road) • Grazing on North-east side of road (midslope) • Ploughed on South-west side of road (fotslope)

Geophyte Data Plant Species Recorded	<ul style="list-style-type: none"> • <i>Boophane disticha</i> • <i>Bulbine abyssinica</i> 	Recommendation	<ul style="list-style-type: none"> • See main report

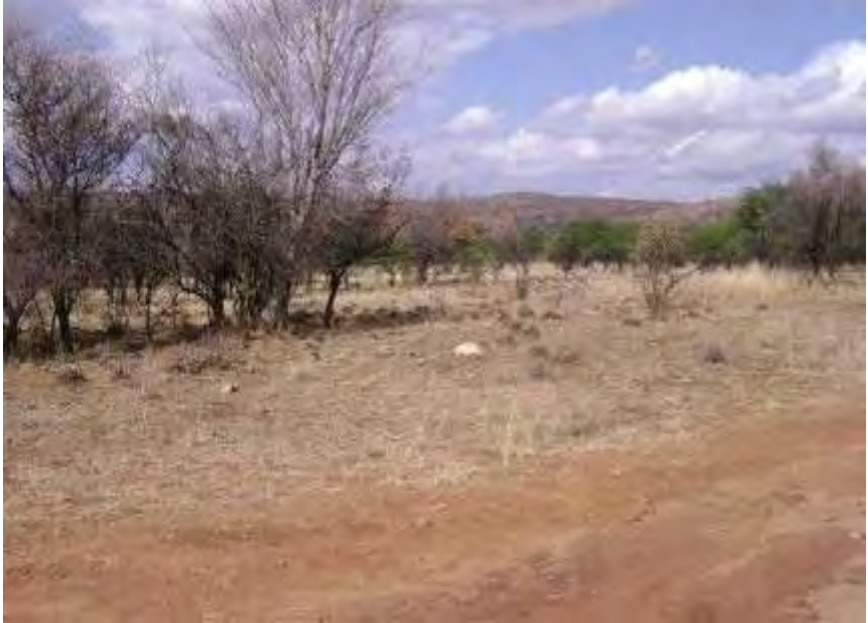
Site number	Site 41

Date visited	27-28/09/2007		
Land terrain Unit	Midslope		
Geology / Soils	Quartzite (Shale on geological map) / Mispah		
Soil description	Orthic A on Hard Rock		
Soil texture A-horizon	Loamy sand		
Soil texture subsoil horizon	N/a (hard rock)		
Soil depth A-horizon	200 mm		
Subsoil depth	200+ mm (Hard Rock)		
Soil erodability	Low	Veld Condition	Overgrazed
Dominant Species	Forbs and woody species = <i>Acacia karroo</i> Grasses = <i>Cynodon dactylon</i> , <i>Hyparrhenia hirta</i>		
Notes	<ul style="list-style-type: none"> • Biodiversity expectation = Good • Game Farm 		
Red Data Plant Species Recorded	None recorded	Recommendation	<ul style="list-style-type: none"> • See main report

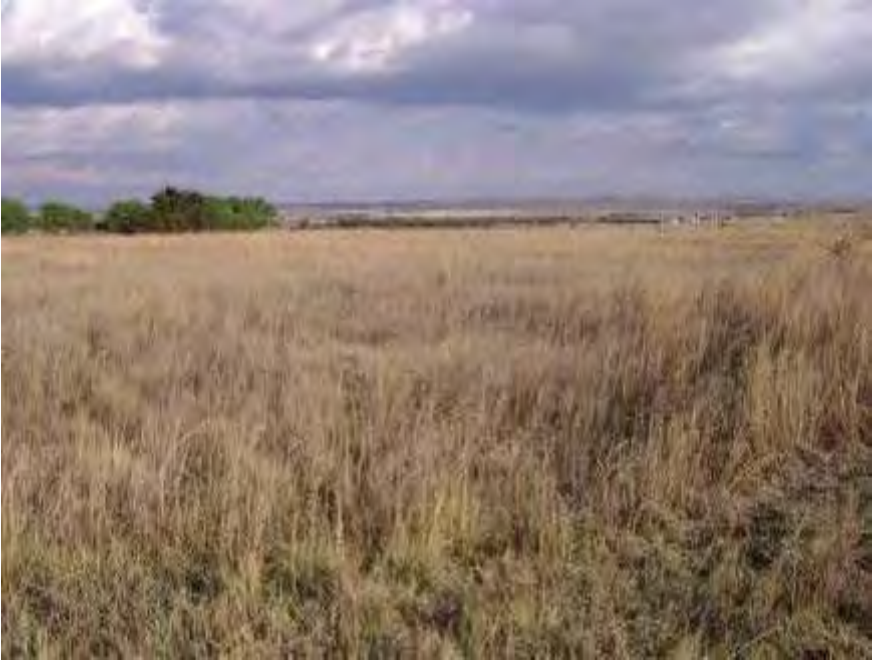
Site number	Site 42

Date visited	27-28/09/2007		
Land terrain Unit	Crest		
Geology / Soils	Dolerite / Hutton		
Soil description	Orthic A on Red Apedal B on Unspecified		
Soil texture A-horizon	Sandy Clay Loam		
Soil texture B-horizon	Sandy Clay Loam		
Soil depth A-horizon	250 mm		
Subsoil depth	1500+ mm		
Soil erodability	Moderate	Veld Condition	Disturbed (Old Land)
Dominant Species	Forbs and woody species = <i>Helichrysum</i> sp. Grasses = <i>Eragrostis curvula</i> Alien invaders and weeds = <i>Prosopis glandulosa</i>		
Notes	Biodiversity expectation = Very Poor		
Red Data Plant Species Recorded	None recorded	Recommendation	<ul style="list-style-type: none"> • See main report

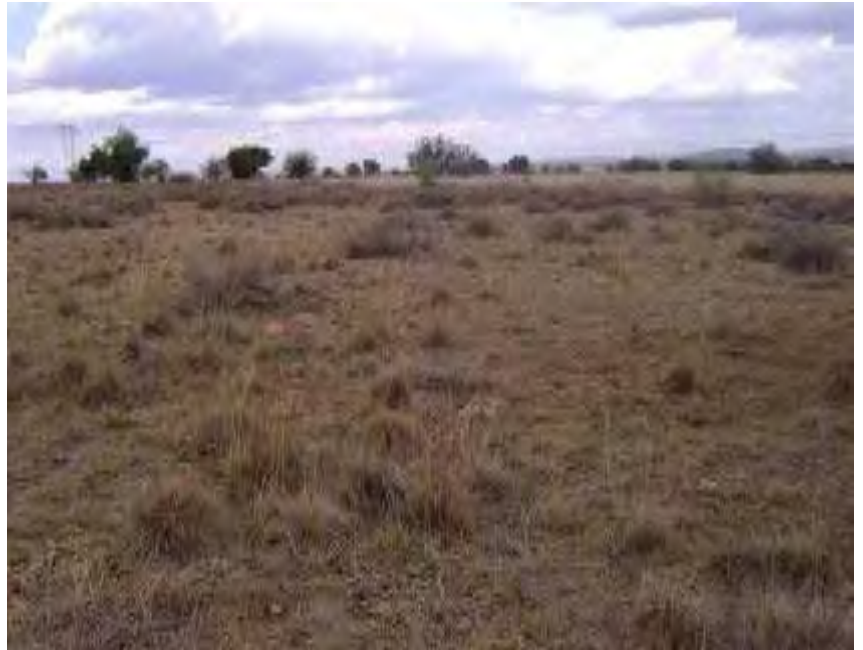
Site number	Site 44		
Date visited	27-28/09/2007		
Land terrain Unit	Crest/Plain		
Geology / Soils	Quartzite (Sedimentary on geological map)/ Mispah		
Soil description	Orthic A on Hard Rock		
Soil texture A- horizon	Loamy Sand		
Soil texture subsoil- horizon	n/a (hard rock)		
Soil depth A- horizon	300 mm		
Subsoil depth	300+ mm (Hard Rock)		
Soil erodability	Low	Veld Condition	Overgrazed
Dominant Species	Forbs and woody species = <i>Rhus lancea</i> , <i>Ziziphus mucronata</i> Grasses = <i>Themeda triandra</i>		
Notes	<ul style="list-style-type: none"> • Biodiversity expectation = Poor to Moderate • Grazing area • Site near power line 		
Red Data Plant Species Recorded	None recorded	Recommendation	<ul style="list-style-type: none"> • See main report

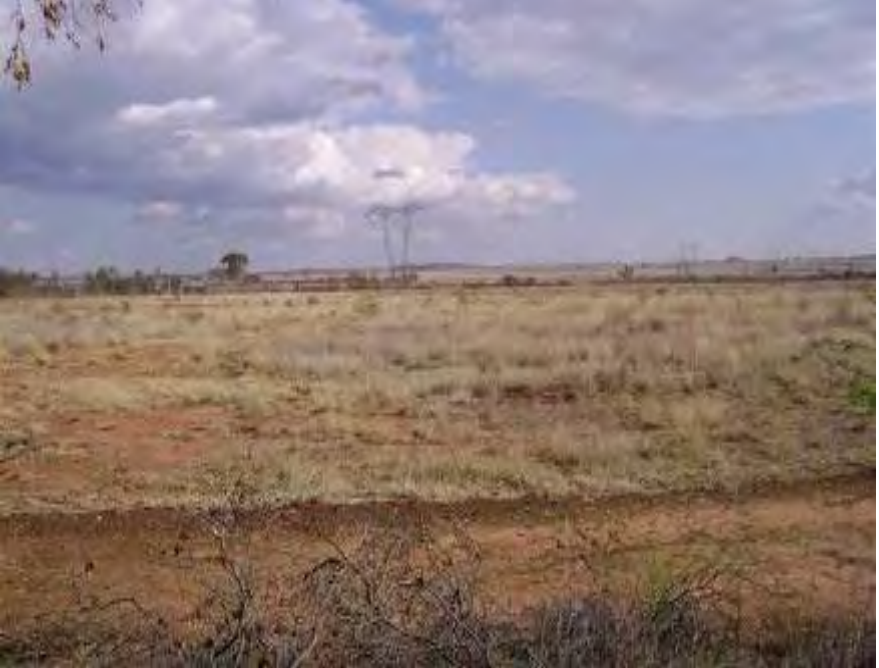
Site number	Site 45

Date visited	27-28/09/2007		
Land terrain Unit	Crest/Plain		
Geology / Soils	Sedimentary / Hutton		
Soil description	Orthic A on Red Apedal B on Unspecified		
Soil texture A-horizon	Sandy Clay Loam		
Soil texture B-horizon	Sandy Clay Loam		
Soil depth A-horizon	250		
Subsoil depth	410+		
Soil erodability	Moderate	Veld Condition	Disturbed
Dominant Species	Forbs and woody species = <i>Acacia karroo</i> Grasses = <i>Cynodon dactylon</i> Alien invaders and weeds = <i>Opuntia ficus-indica</i>		
Notes	<ul style="list-style-type: none"> • Biodiversity expectation = Poor • Grazing area • Site near power line 		
Red Data Plant Species Recorded	None recorded	Recommendation	<ul style="list-style-type: none"> • See main report

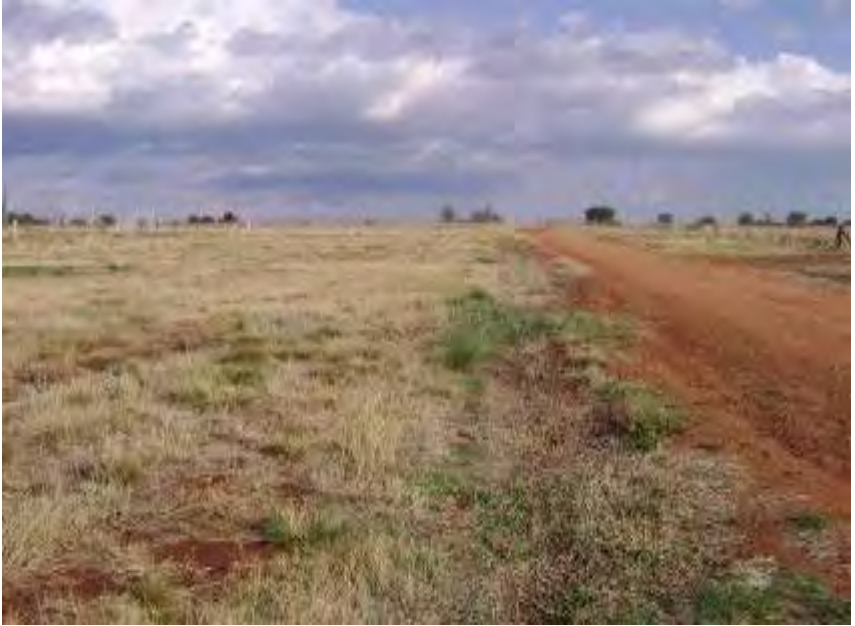
Site number	Site 48					
Date visited	27-28/09/2007					
Land terrain Unit	Crest					
Geology / Soils	Dolerite / Hutton					
Soil description	Orthic A on Red Apedal B on Unspecified					
Soil texture A-horizon	Sandy Clay Loam					
Soil texture B-horizon	Sandy Clay Loam					
Soil depth A-horizon	250 mm					
Subsoil depth	1500+ mm

Soil erodability				Moderate	Veld Condition	Disturbed
Dominant Species				Grasses = <i>Cynodon dactylon</i> , <i>Sorghum bicolor</i>		
Notes				<ul style="list-style-type: none"> • Biodiversity expectation = Very Poor • Site near chicken pens 		
Red Data Plant Species Recorded				None recorded	Recommendation	<ul style="list-style-type: none"> • See main report

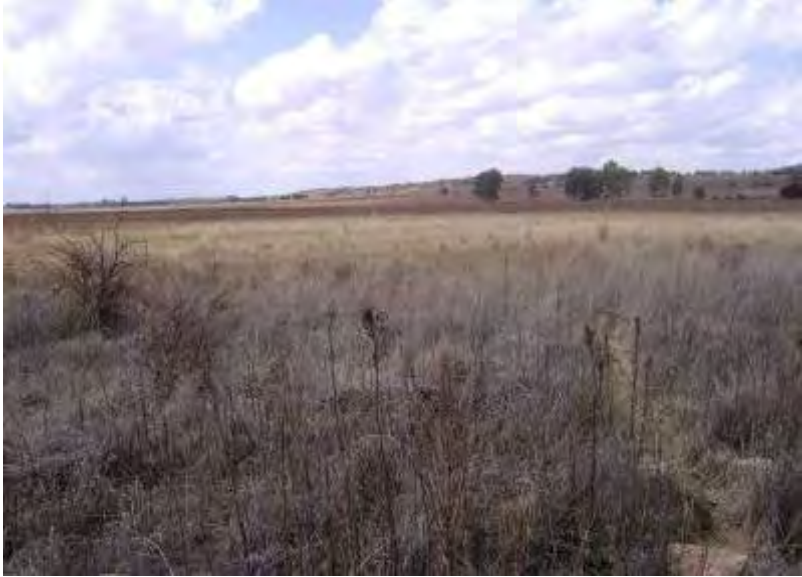
Site number	Site 49

Date visited	27-28/09/2007		
Land terrain Unit	Footslope		
Geology / Soils	Quartzite (Shale on geological) / Katspruit		
Soil description	Orthic A on G - horizon		
Soil texture A-horizon	Loam		
Soil texture G - horizon	Clay		
Soil depth A-horizon	250 mm		
Depth G - horizon	800+ mm		
Soil erodability	Very High	Veld Condition	Disturbed (old land)
Dominant Species	Forbs and woody species = <i>Acacia karroo</i> , <i>Ziziphus mucronata</i> Grasses = <i>Cynodon dactylon</i> Alien invaders and weeds = <i>Eucalyptus</i> sp., <i>Opuntia ficus-indica</i>		
Notes	<ul style="list-style-type: none"> Biodiversity expectation = Poor to Very poor Old land 		
Red Data Plant Species Recorded	None recorded	Recommendation	<ul style="list-style-type: none"> See main report

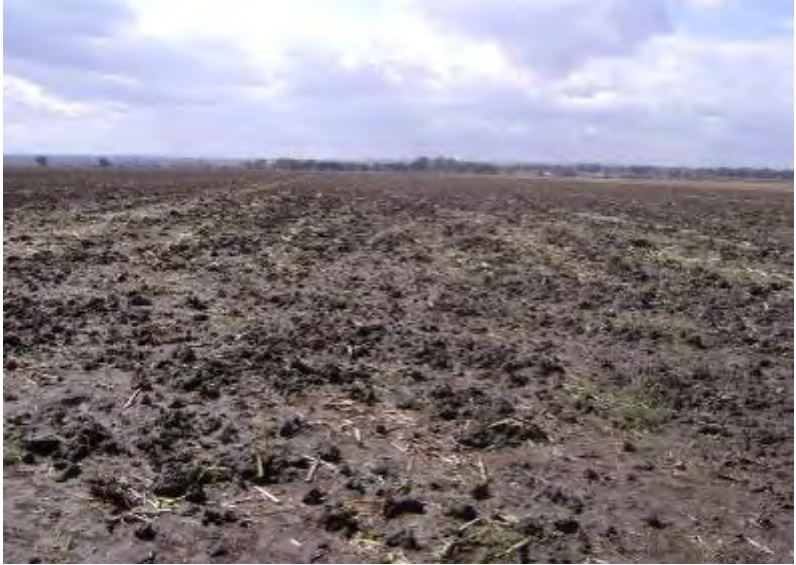
Site number	Site 50

Date visited	27-28/09/2007		
Land terrain Unit	Footslope		
Geology / Soils	Shale / Katspruit		
Soil description	Orthic A on G - horizon		
Soil texture A-horizon	Loam		
Soil texture G-horizon	Clay		
Soil depth A and B horizon ploughed	300+ mm		
Soil erodability	Very High	Veld Condition	Disturbed (Ploughed land)
Dominant Species	None recorded as site in ploughed land		
Notes	<ul style="list-style-type: none"> • Biodiversity expectation = Very poor • Ploughed land 		
Red Data Plant Species Recorded	<i>Bulbine abyssinica</i> (at edge of ploughed land)	Recommendation	<ul style="list-style-type: none"> • See main report

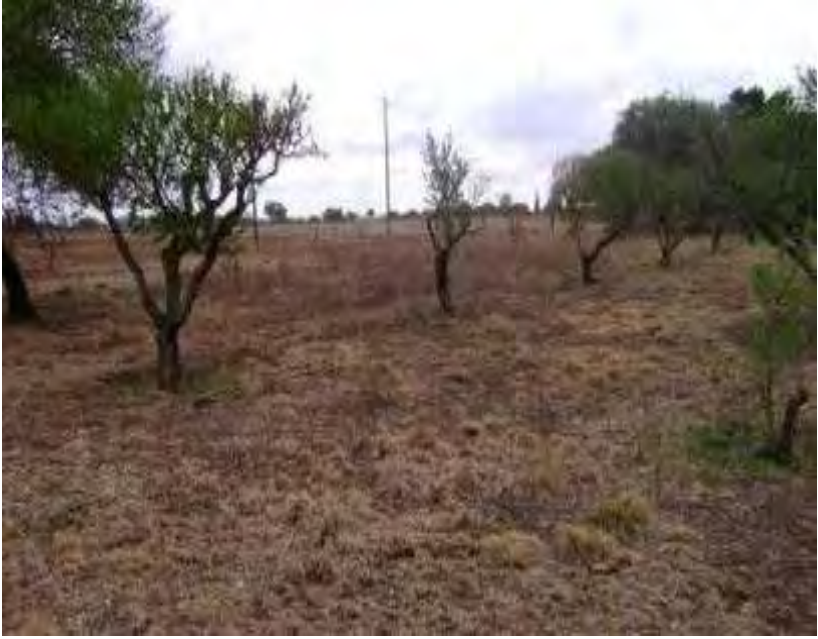
Site number	Site 53

Date visited	27-28/09/2007		
Land terrain Unit	Footslope		
Geology / Soils	Sedimentary / Bainsvlei		
Soil description	Orthic A on Red Apedal B on Plinthic B		
Soil texture A-horizon	Sandy Clay Loam		
Soil texture B1-horizon	Clay Loam		
Soil texture B2-horizon	Clay Loam		
Soil depth A-horizon	250 mm		
Soil subsoil depth of B-horizon to Plinthic horizon	250+ mm		
Soil erodability	Moderate to High	Veld Condition	Disturbed
Dominant Species	Forbs and woody species = <i>Acacia karroo</i> Grasses = <i>Eragrostis curvula</i>		
Notes	<ul style="list-style-type: none"> • Biodiversity expectation = Very poor • Small holding • Peach Orchard 		
Red Data Plant Species Recorded	None recorded	Recommendation	<ul style="list-style-type: none"> • See main report

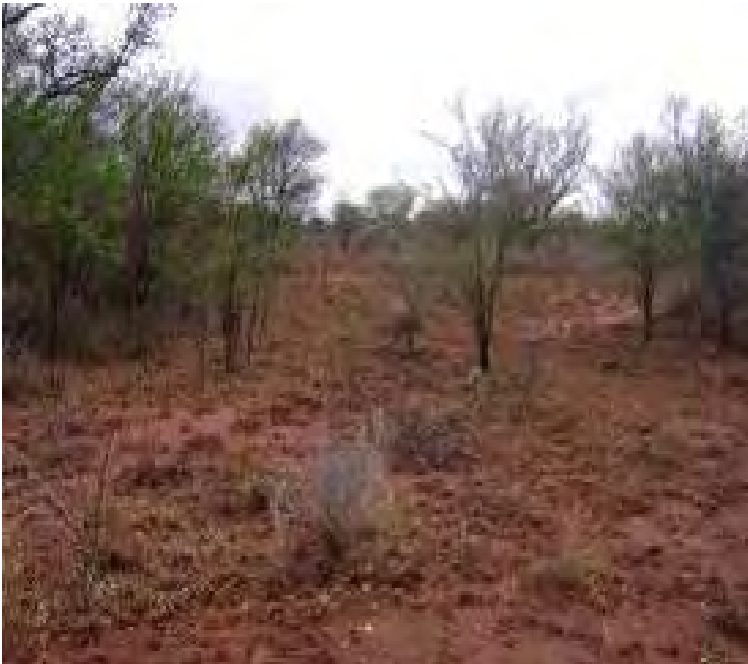
Site number	Site 54

Date visited	27-28/09/2007		
Land terrain Unit	Footslope		
Geology / Soils	Sedimentary (Dolerite on geological map)/ Hutton		
Soil description	Orthic A on Red Apedal B on Unspecified		
Soil texture A-horizon	Sandy Clay Loam		
Soil texture B horizon	Sandy Clay Loam		
Soil depth A-horizon	250 mm		
Subsoil depth	800 mm		
Soil erodability	Moderate	Veld Condition	Heavily grazed (northern side of road)
Dominant Species	Forbs and woody species = <i>Acacia karroo</i> Grasses = <i>Themeda triandra</i>		
Notes	<ul style="list-style-type: none"> • Biodiversity expectation = Very poor (ploughed area) and Moderate (grazing area) • Ploughed on southern side of road at small holding • Grazing on northern side of road 		
Red Data Plant Species Recorded	None recorded	Recommendation	<ul style="list-style-type: none"> • See main report

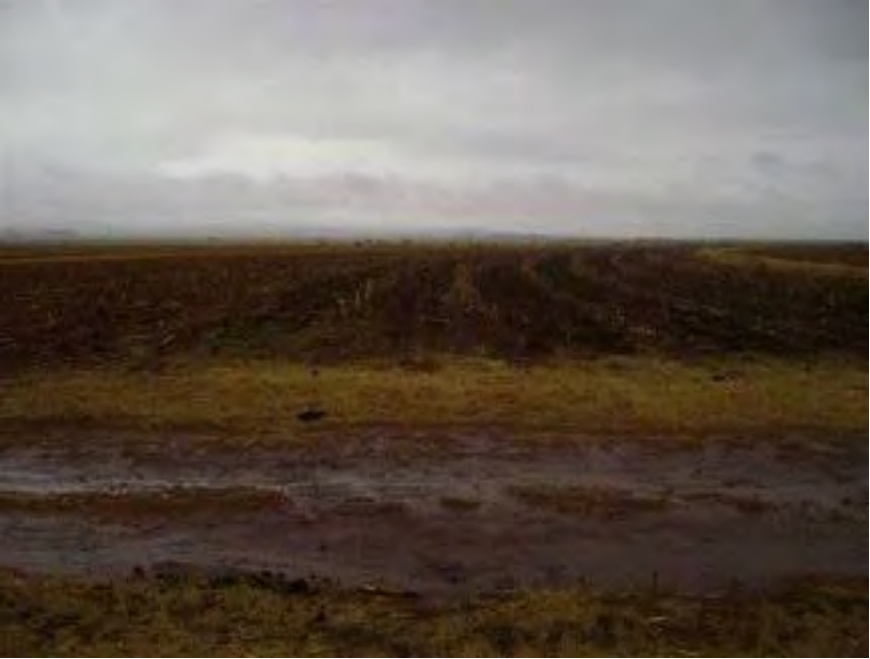
Site number	Site 56

Date visited	27-28/09/2007		
Land terrain Unit	Footslope		
Geology / Soils	Arenite / Hutton		
Soil description	Orthic A on Red Apedal B on Unspecified		
Soil texture A-horizon	Sandy Clay Loam		
Soil texture B-horizon	Sandy Clay Loam		
Soil depth A-horizon	250 mm		
Subsoil depth	1500 mm		
Soil erodability	Moderate	Veld Condition	Disturbed
Dominant Species	Forbs and woody species = <i>Acacia karroo</i> (in adjacent unploughed land) Grasses = <i>Cynodon dactylon</i> (in adjacent unploughed land)		
Notes	Biodiversity expectation = Very poor		
Red Data Plant Species Recorded	None recorded	Recommendation	<ul style="list-style-type: none"> • See main report

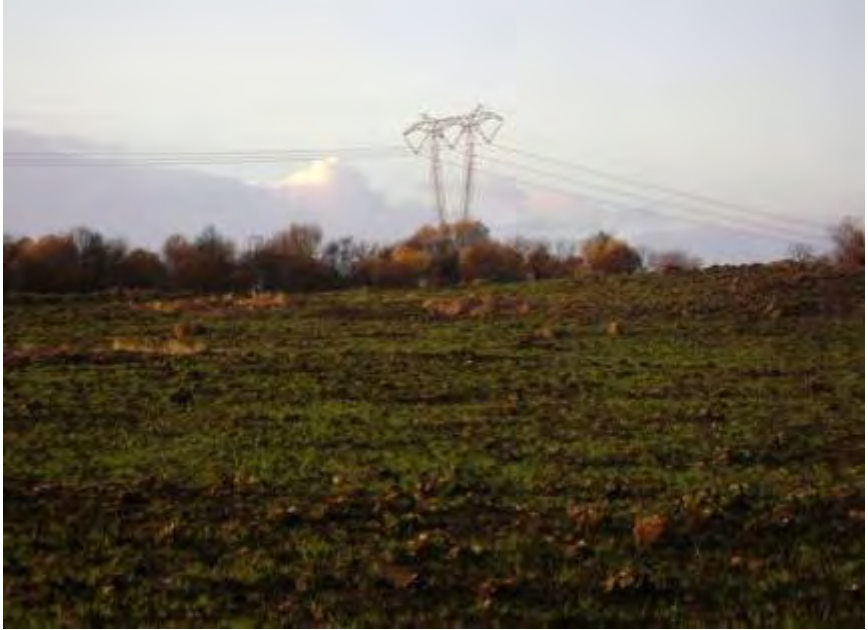
Site number	Site 69

Date visited	27-28/09/2007		
Land terrain Unit	Midslope		
Geology / Soils	/ Mispah		
Soil description	Orthic A on Hard Rock		
Soil texture A-horizon	Loamy Sand		
Soil texture subsoil-horizon	N/a (hard rock)		
Soil depth A-horizon	50 mm		
Subsoil depth	50+ mm (Hard Rock)		
Soil erodability	Slightly erodible	Veld Condition	(Grassland burnt)
Dominant Species	Forbs and woody species = <i>Rhus pyroides</i> Grasses = <i>Digitaria eriantha</i> , <i>Melinis repens</i> Alien invaders and weeds = <i>Opuntia ficus-indica</i>		
Notes	<ul style="list-style-type: none"> • Biodiversity expectation = Very Good • Site at Rossouw Koppie • Grassland burnt 		
Red Data Plant Species Recorded	None recorded	Recommendation	<ul style="list-style-type: none"> • See main report

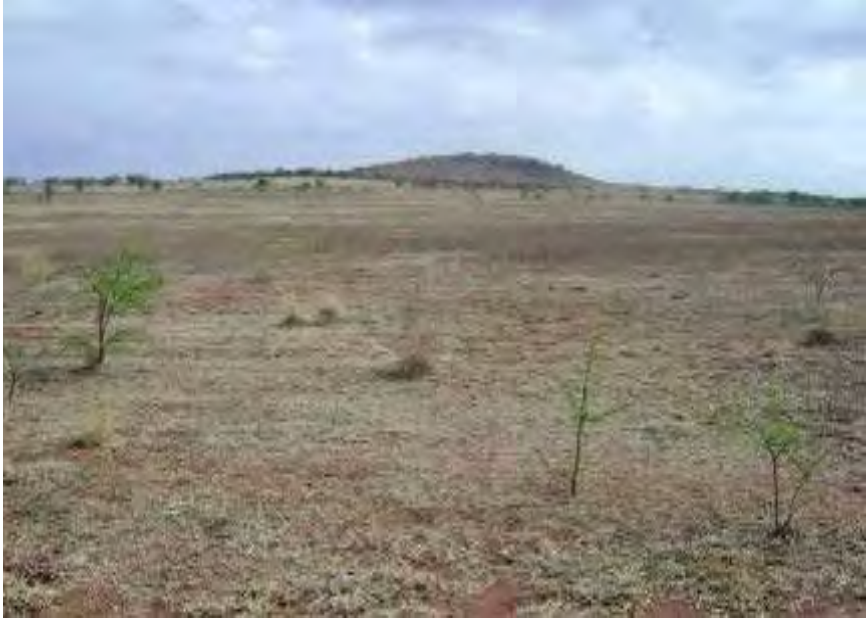
Site number	Site 70

Date visited	27-28/09/2007		
Land terrain Unit	Crest		
Geology / Soils	/ Hutton		
Soil description	Orthic A on Red Apedal B on Unspecified		
Soil texture A-horizon	Sandy Clay Loam		
Soil texture B-horizon	Sandy Clay Loam		
Soil depth A-horizon	250		
Subsoil depth	400+		
Soil erodability	Moderate	Veld Condition	Disturbed (Old land)
Dominant Species	Forbs and woody species = <i>Acacia karroo</i> Grasses = <i>Cynodon dactylon</i>		
Notes	<ul style="list-style-type: none"> • Biodiversity expectation = Very poor (Old land) and Very good (adjacent area) • Old land • Red data reptile species (<i>Cordylus</i> sp.) found in area adjacent to the site 		
Red Data Plant Species Recorded	None recorded	Recommendation	<ul style="list-style-type: none"> • See main report

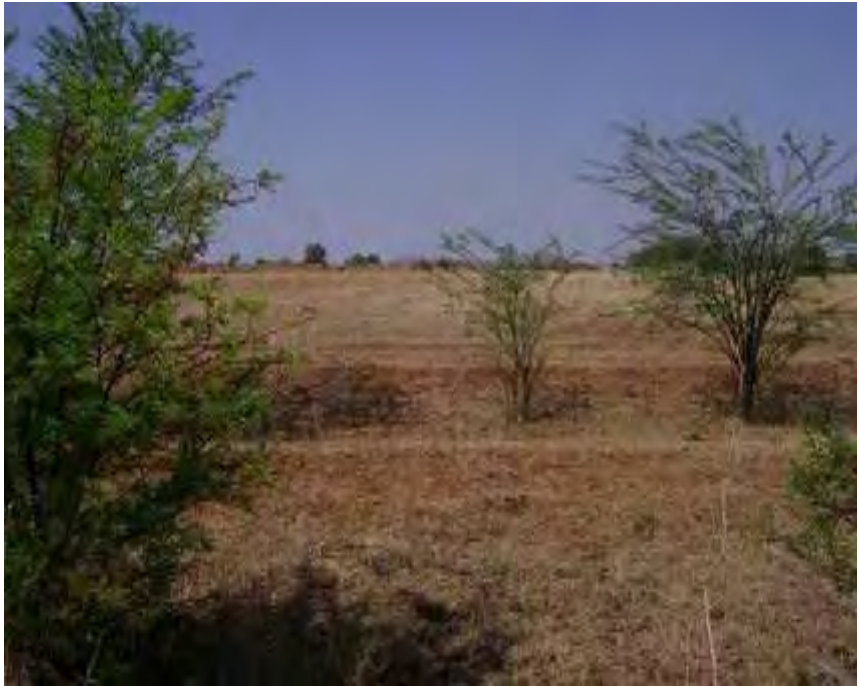
Site number	Site 71

Date visited	27-28/09/2007		
Land terrain Unit	Midslope		
Geology / Soils	Hutton		
Soil description	Orthic A on Red Apedal B on Unspecified		
Soil texture A-horizon	Sandy Clay Loam		
Soil texture B-horizon	Sandy Clay Loam		
Soil depth A-horizon	Not assessed		
Subsoil depth	Not assessed		
Soil erodability	Moderate	Veld Condition	Disturbed (old land and ploughed land)
Dominant Species	Forbs and woody species = <i>Acacia karroo</i> Grasses = <i>Cynodon dactylon</i> Alien invaders and weeds = <i>Tagetes minuta</i>		
Notes	Biodiversity expectation = Very poor in old land near compound and in ploughed land on western side of R53		
Red Data Plant Species Recorded	None recorded	Recommendation	<ul style="list-style-type: none"> • See main report

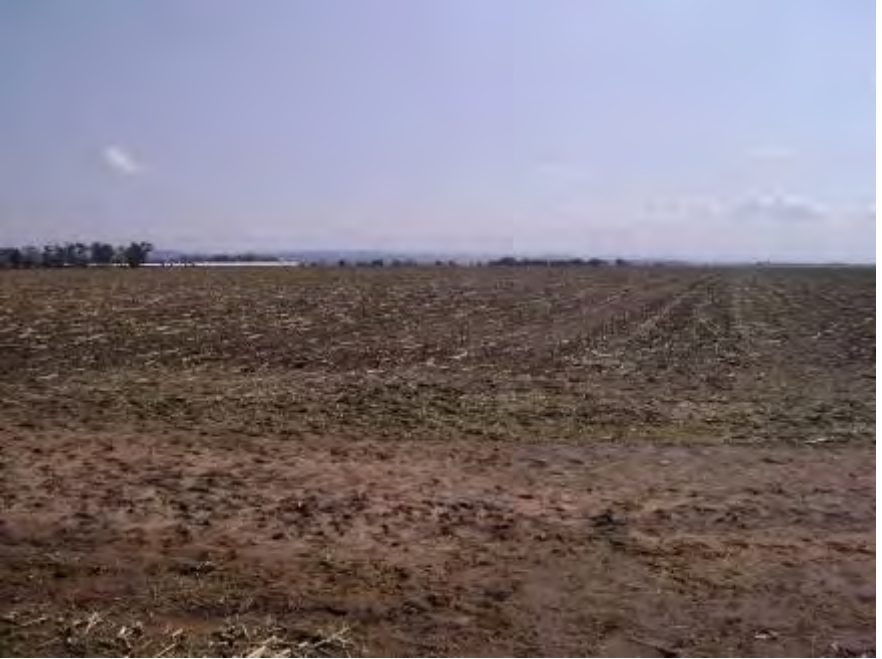
Site number	Site 72

Date visited	27-28/09/2007		
Land terrain Unit	Footslope		
Geology / Soils	/ Shortlands		
Soil description	Orthic A on Red Structured B		
Soil texture A-horizon	Sandy Clay Loam		
Soil texture B1-horizon	Sandy Clay		
Soil depth A-horizon	250 mm		
Subsoil depth	600+ mm		
Soil erodability	Very High	Veld Condition	Disturbed (ploughed maize land)
Dominant Species	None recorded as site in ploughed maize land		
Notes	Biodiversity expectation = Very poor		
Red Data Plant Species Recorded	None recorded	Recommendation	<ul style="list-style-type: none"> • See main report

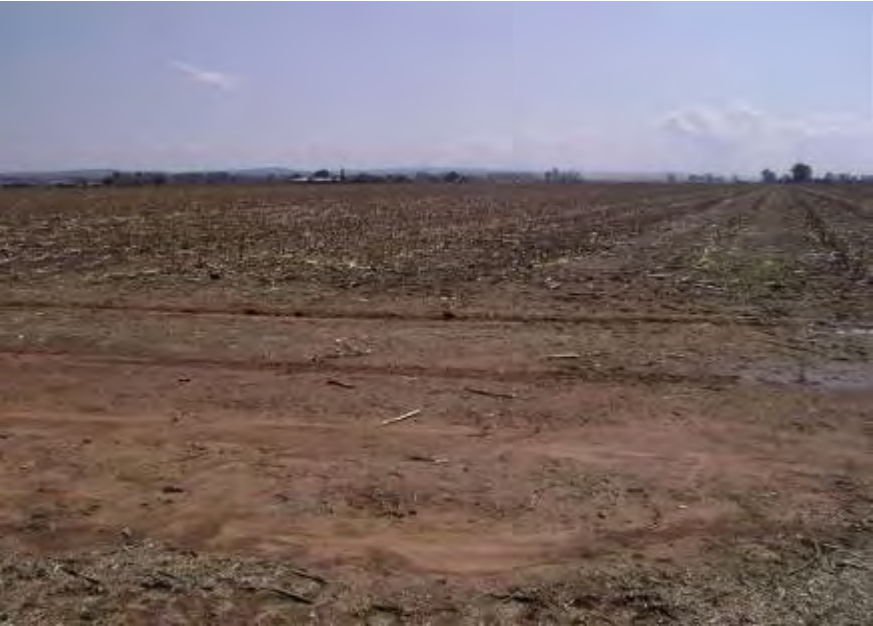
Site number	Site 73

Date visited	27-28/09/2007		
Land terrain Unit	Footslope		
Geology / Soils	/ Westleigh		
Soil description	Orthic A on Soft Plinthic B		
Soil texture A-horizon	Loamy Sand		
Soil texture B-horizon	Not Assessed		
Soil depth A-horizon	250 mm		
Depth to Plinthic horizon	450+ mm		
Soil erodability	Moderate to high	Veld Condition	Disturbed (ploughed maize land)
Dominant Species	None recorded as site in ploughed maize land		
Notes	<ul style="list-style-type: none"> Biodiversity expectation = Very poor 		
Red Data Plant Species Recorded	None recorded	Recommendation	<ul style="list-style-type: none"> See main report

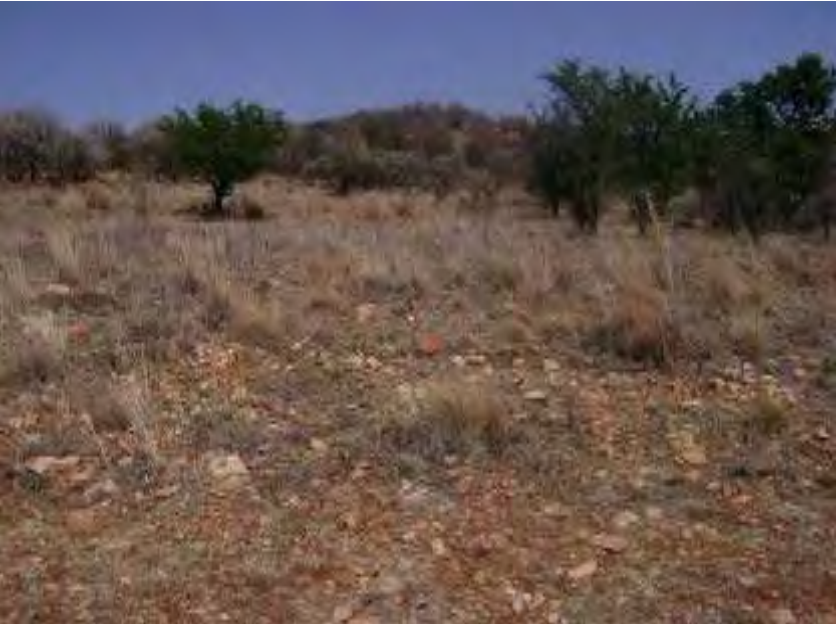
Site number	Site 74

Date visited	27-28/09/2007		
Land terrain Unit	Midslope		
Geology / Soils	Quartzite / Mispah		
Soil description	Orthic A on Hard Rock		
Soil texture A-horizon	Loamy Sand		
Soil texture underlying-horizon	N/a (hard rock)		
Soil depth A-horizon	250		
Soil subsoil depth of B-horizon to Plinthic horizon	n/a		
Soil erodability	Low	Veld Condition	Slightly degraded
Dominant Species	Forbs and woody species = <i>Acacia robusta</i> Grasses = <i>Cynodon dactylon</i> , <i>Hyparrhenia hirta</i> Alien invaders and weeds = <i>Melia azedarach</i>		
Notes	<ul style="list-style-type: none"> • Biodiversity expectation = Good • Koppie • Farm houses 		
Red Data Plant Species Recorded	None recorded	Recommendation	<ul style="list-style-type: none"> • See main report
