Komati Power Station
DRAFT HYDROCENSUS REPORT

FEBRUARY 2009

Project no.: 149-17-mon.537
Current Phase: Phase 39
Report no.: RVN 537.3/907

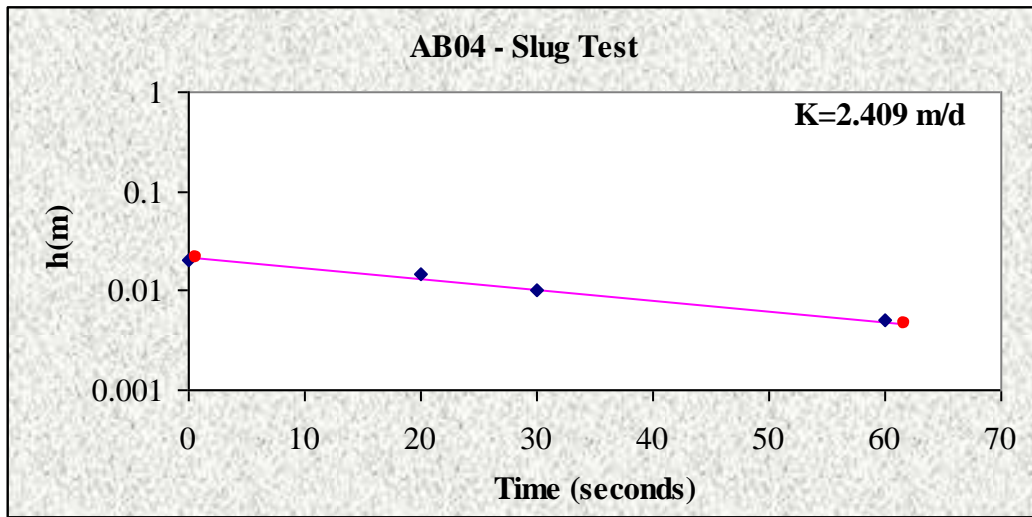
Figure 4. Results of the permeability test performed on AB04.

The Bouwer-Rice method was used to analyse the permeability tests performed on eight of the Power Station boreholes (refer to Appendix A – Map 1). The results of the tests are presented in Figure 1 to Figure 8 and Table 7.

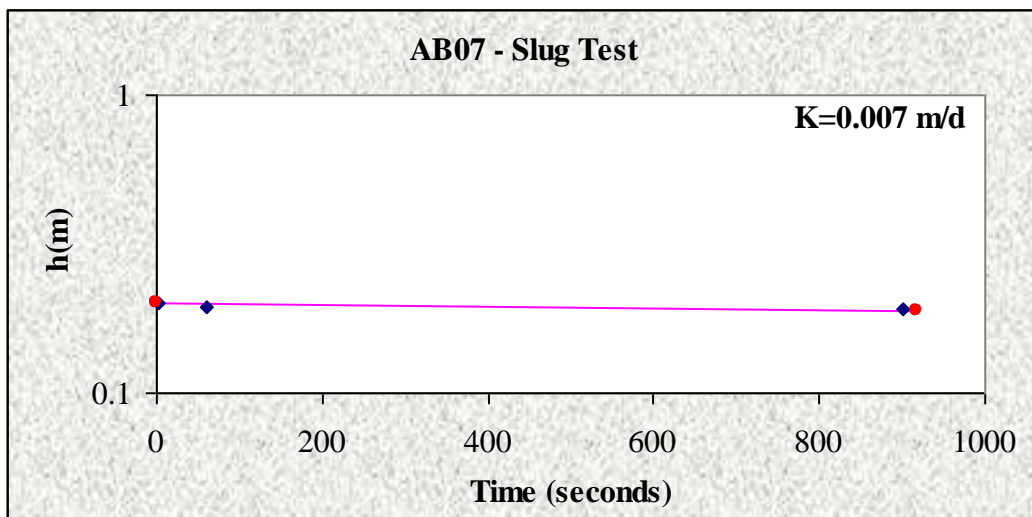
Figure 6. Results of the permeability test performed on AB07.

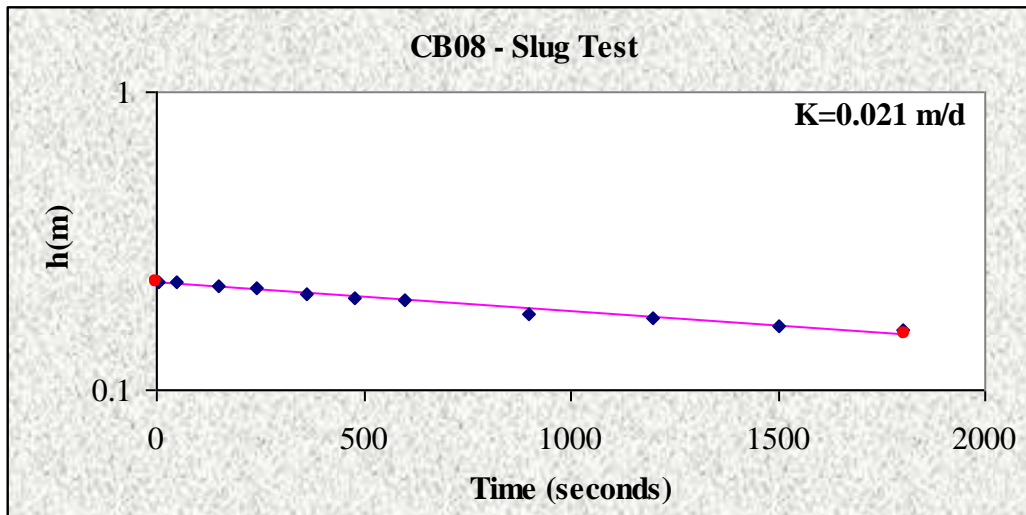
Figure 7. Results of the permeability test performed on CB08.
