NUCLEAR POWER STATION ('NUCLEAR 1') AND ASSOCIATED INFRASTRUCTURE

Second Addendum to Dune Geomorphology Impact Assessment: New western access routes and 2011 - 2012 floods

June 2013

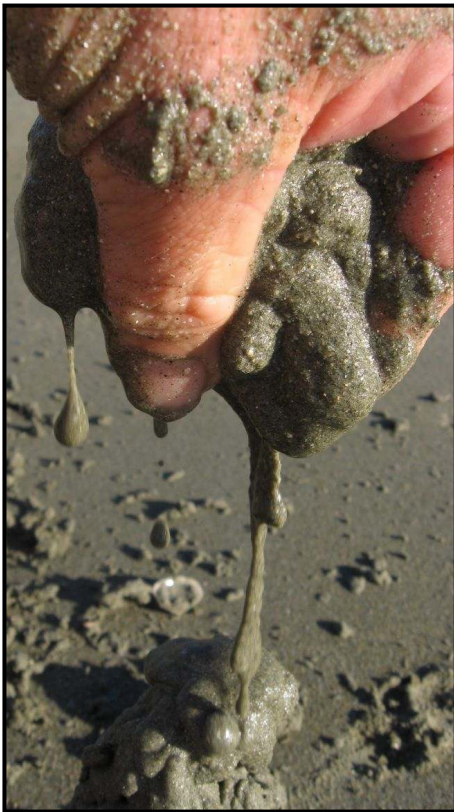
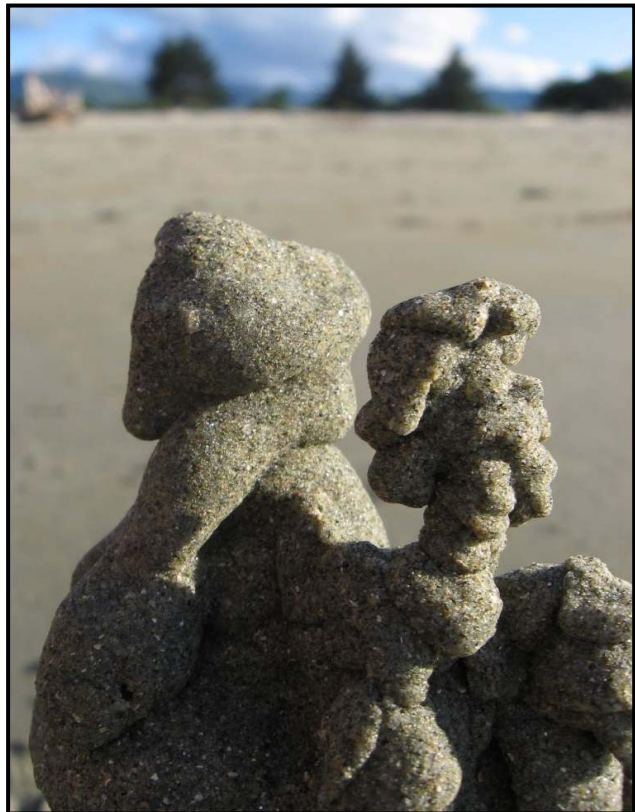
Figure 2.2 A “drip-sand castle”, as commonly built by children on a beach. The high porosity of sand allows the water to flow away rapidly, causing the sand to freeze into fascinating shapes. A debris flow is not created.

This is correct. Figure 2.2 illustrates this rapid de-watering that happens when one makes “drip-sand castles”, causing sand movement to freeze virtually instantaneously, so there is no flow. If water dams up behind a dune, the sideways pore pressure may liquidize the sand, causing slumping and piping resulting in catastrophic failure of the sandy “dam wall”. The sand is carried by flowing water, and not as a slurry, so it is not a debris flow (see Addendum Report for a detailed explanation; also standard textbooks, e.g. Hsu, 2004).

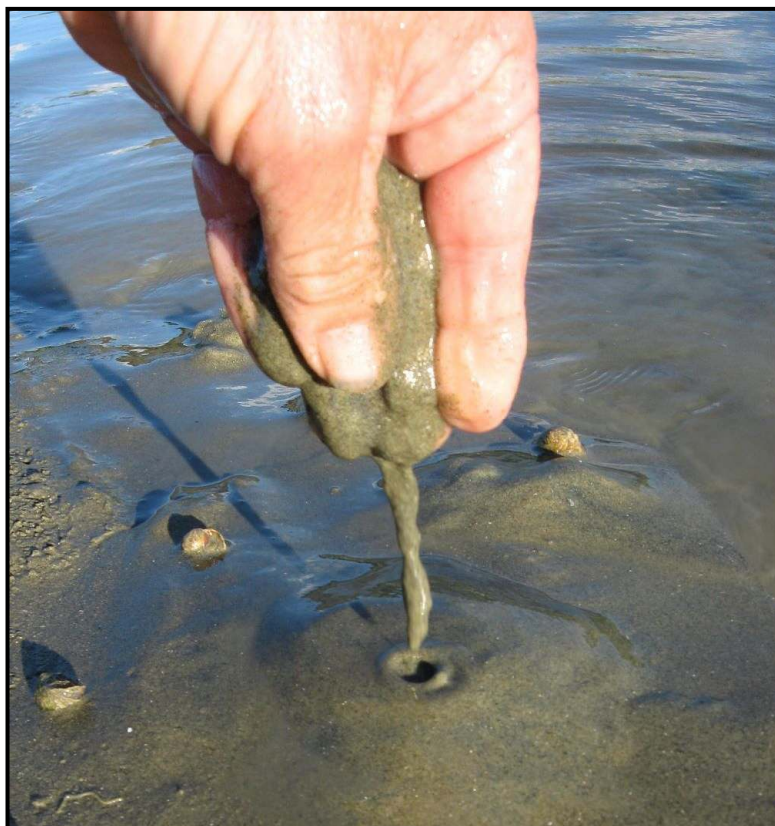
Figure 2.3 A mixture of mud and sand will produce a debris flow, and not a dripsand castle. The mud/sand mix flows away from the point of initiation and flow is sustained until the gradient is reduced to a low angle.

A mixture of mud and sand will produce a debris flow, as illustrated in Figure 2.3. The mixture flows easily to produce a deposit with a low angle of repose.

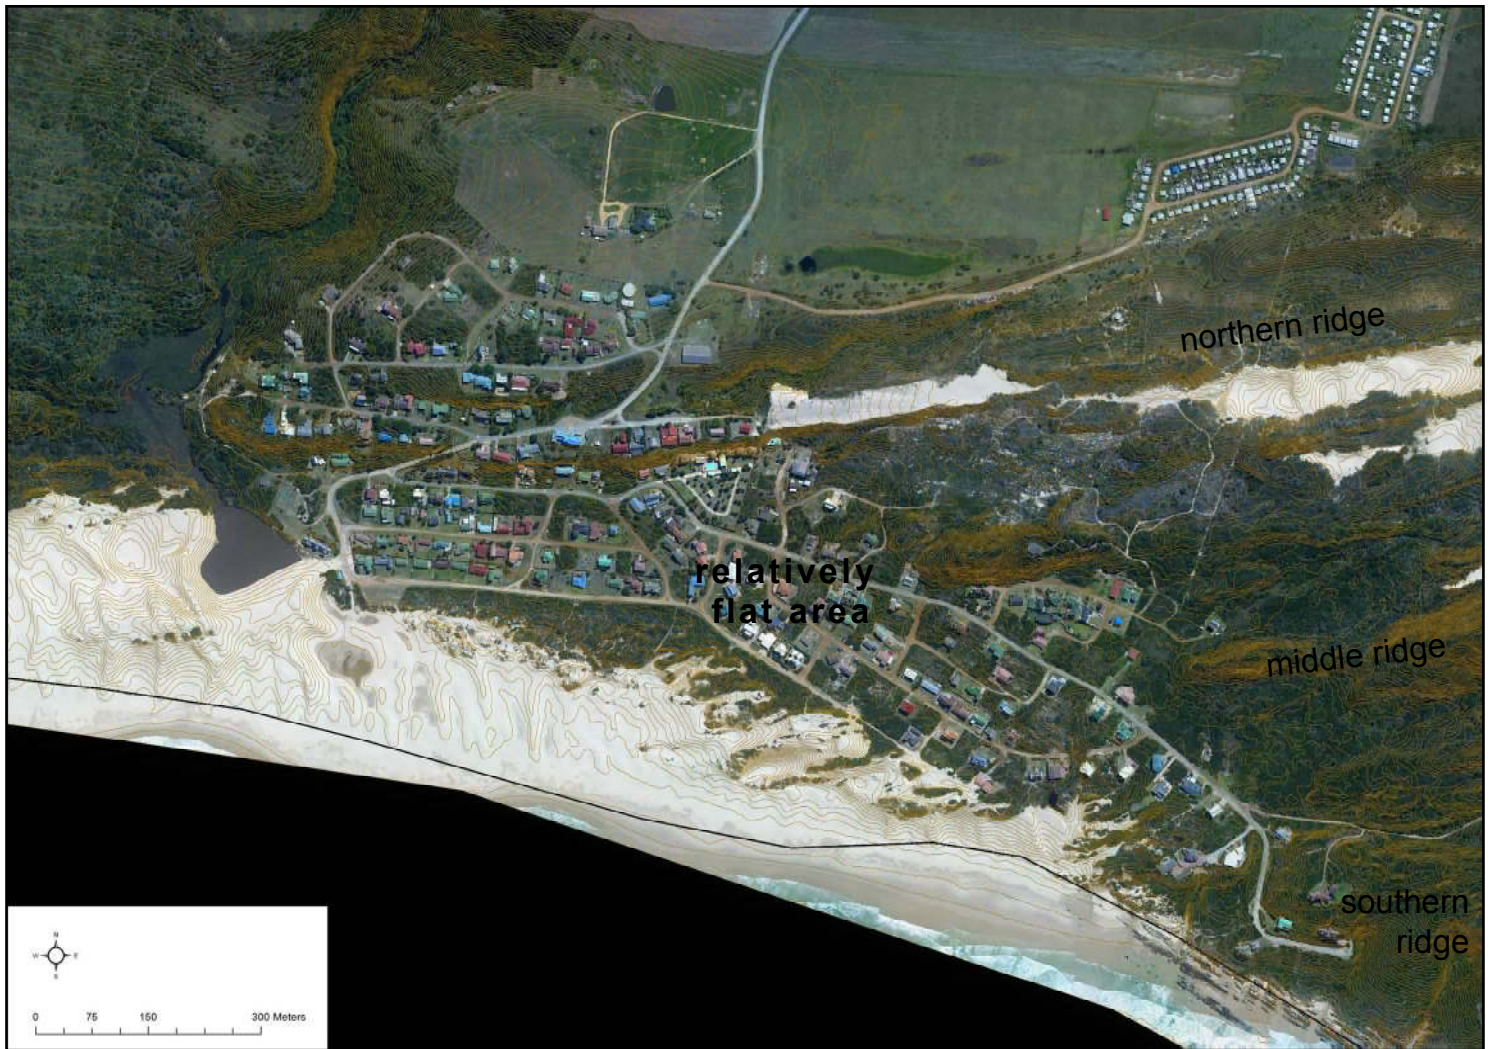
Figure 3.2 Oyster Bay area on 24 March 2011 with contours at 1 metre intervals.

If natural processes are allowed to continue unencumbered, the first parabolic dunes at Oyster Bay would reach the area between the middle and southern ridges (Fig.3.2) in about 50 years and the area between the northern and ridges middle would be reached in about 100-200 years. It would take many years for the feeder zone to become fully operational.

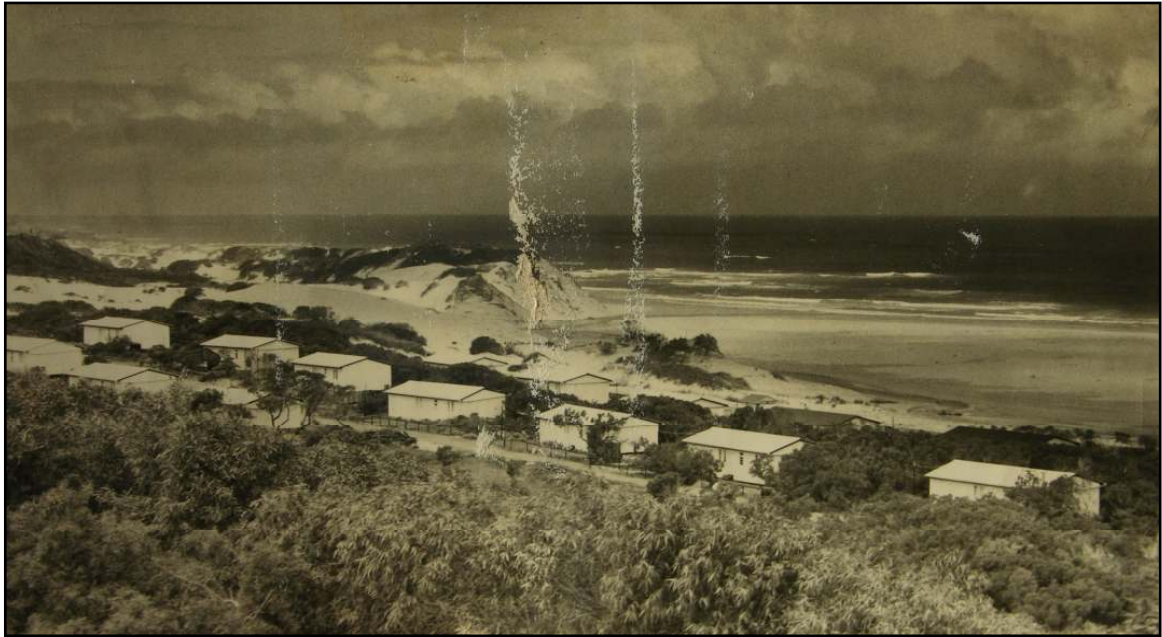
Figure 3.4 Oyster Bay Village in the 1960's, shortly after the artificial dune ridge had been partially flattened. Photograph supplied by Nick Borman, Oyster Bay Beach Lodge.

As discussed above, the Department of Forestry embarked on a program of stabilization in the area around Oyster Bay from 1917. Stabilization consisted of building drift fences along the shore and planted with alien vegetation, mostly rooikrans (*Acacia cyclops*). This resulted in the accumulation of sand to form an artificial dune ridge parallel to the shore. Because of the high wind energy, blowouts and parabolic dunes initiated along the ridge, and constant maintenance was required to keep the ridge stabilized. The ridge became higher and wider with time, because sand was constantly being fed off the beach onto the ridge. The ridge was flattened in the 1960's by bulldozing the sand into the sea (Figure 3.4) and again in the 1970's. (Nick Borman, pers. comm., 2012). The dune ridge is no longer being stabilized routinely, and is currently engulfing roads and houses in Oyster Bay Village (Figure 3.5).

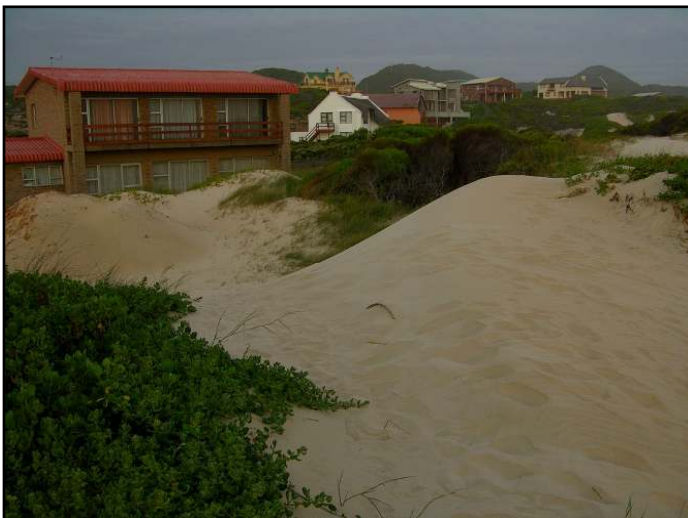
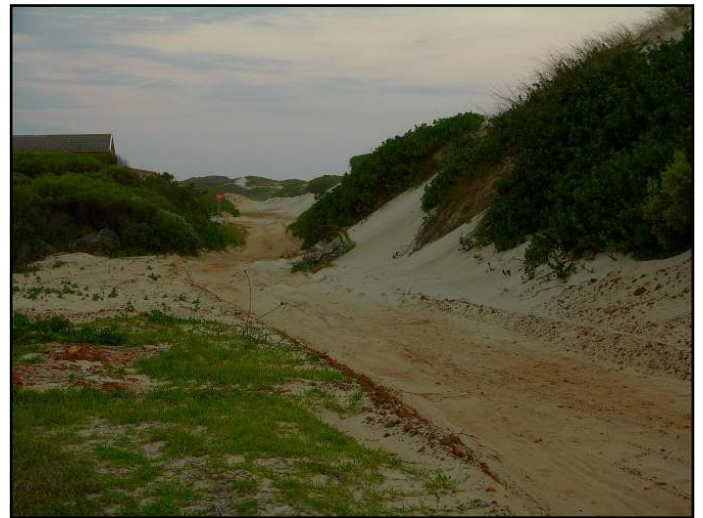
Figure 3.5 The artificial dune ridge along the Oyster Bay beach is no longer being stabilised routinely, and is currently engulfing roads and houses in the village.

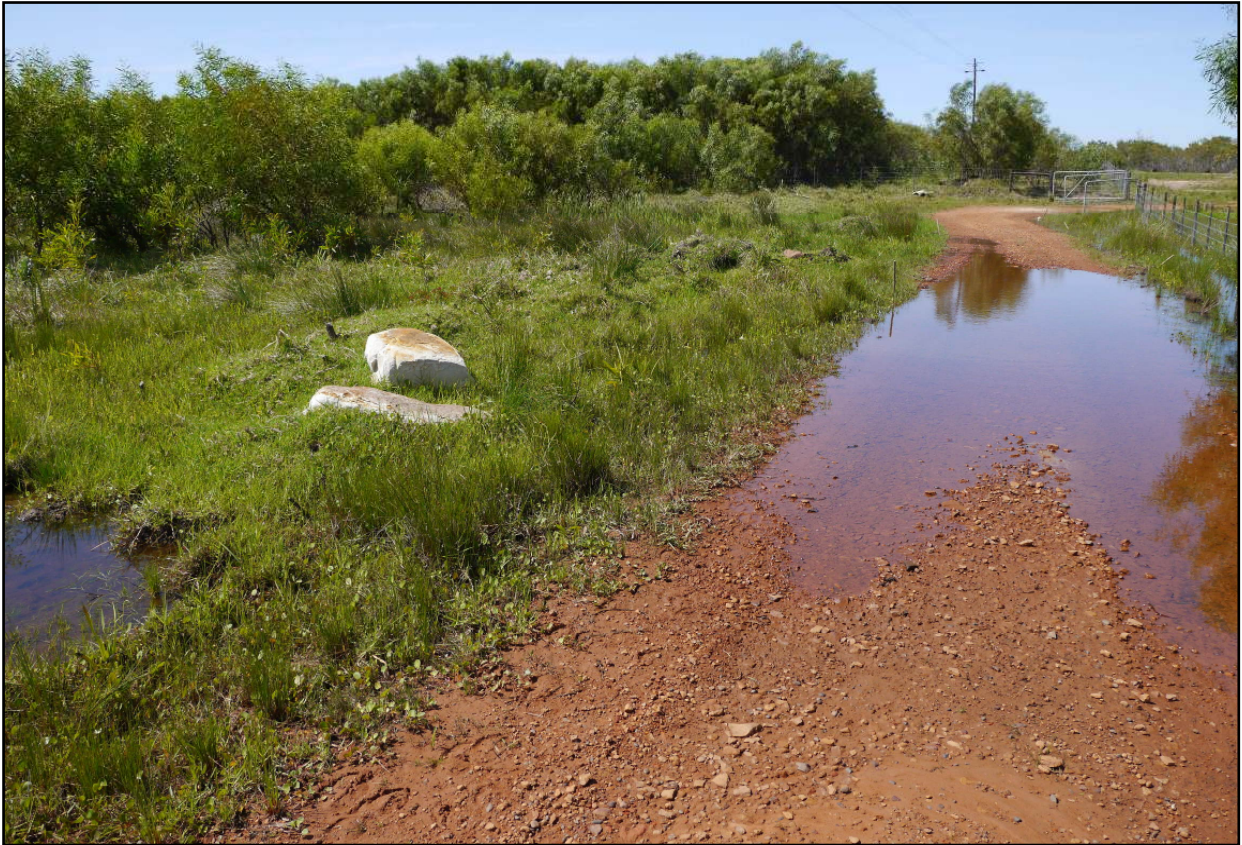
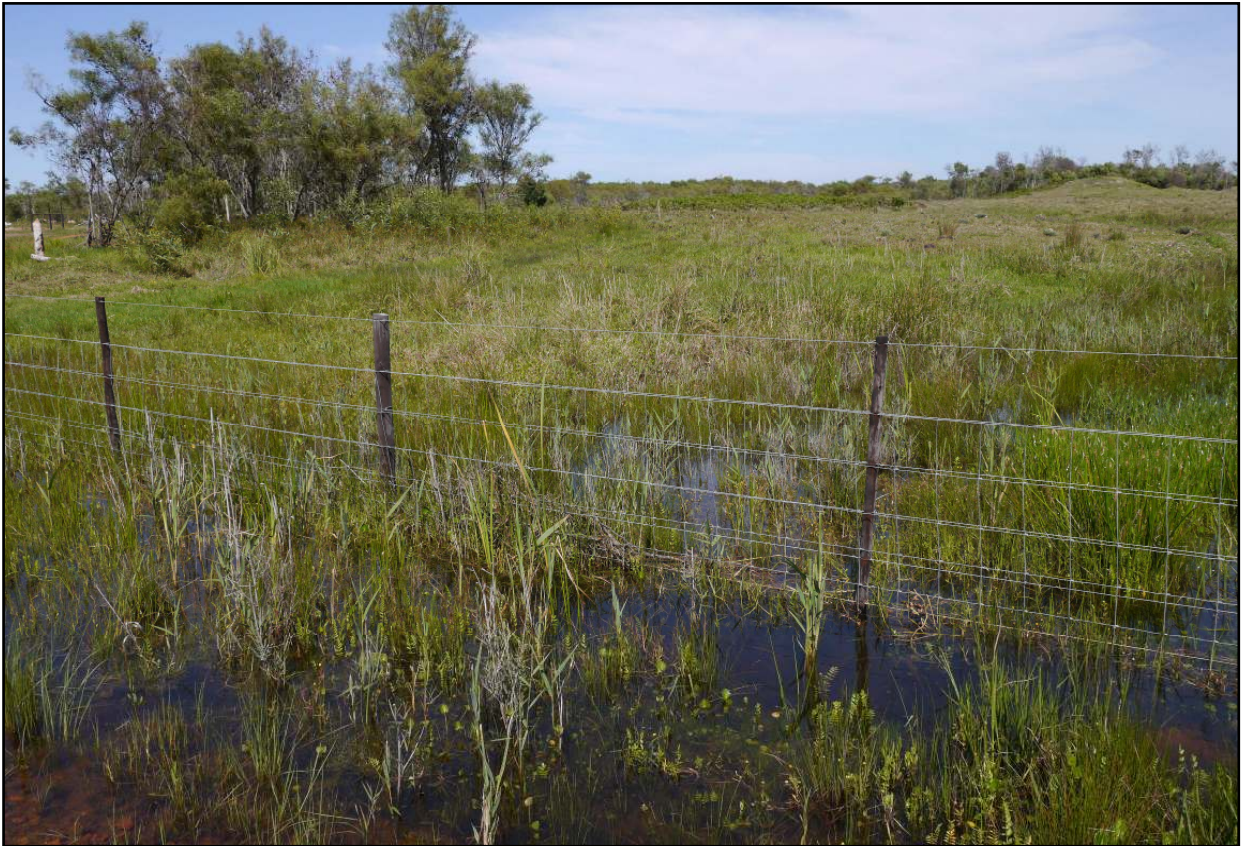
Figure 6.1 The lowermost end of the Sand River farmland catchment. Flow is slow through the wetland vegetation

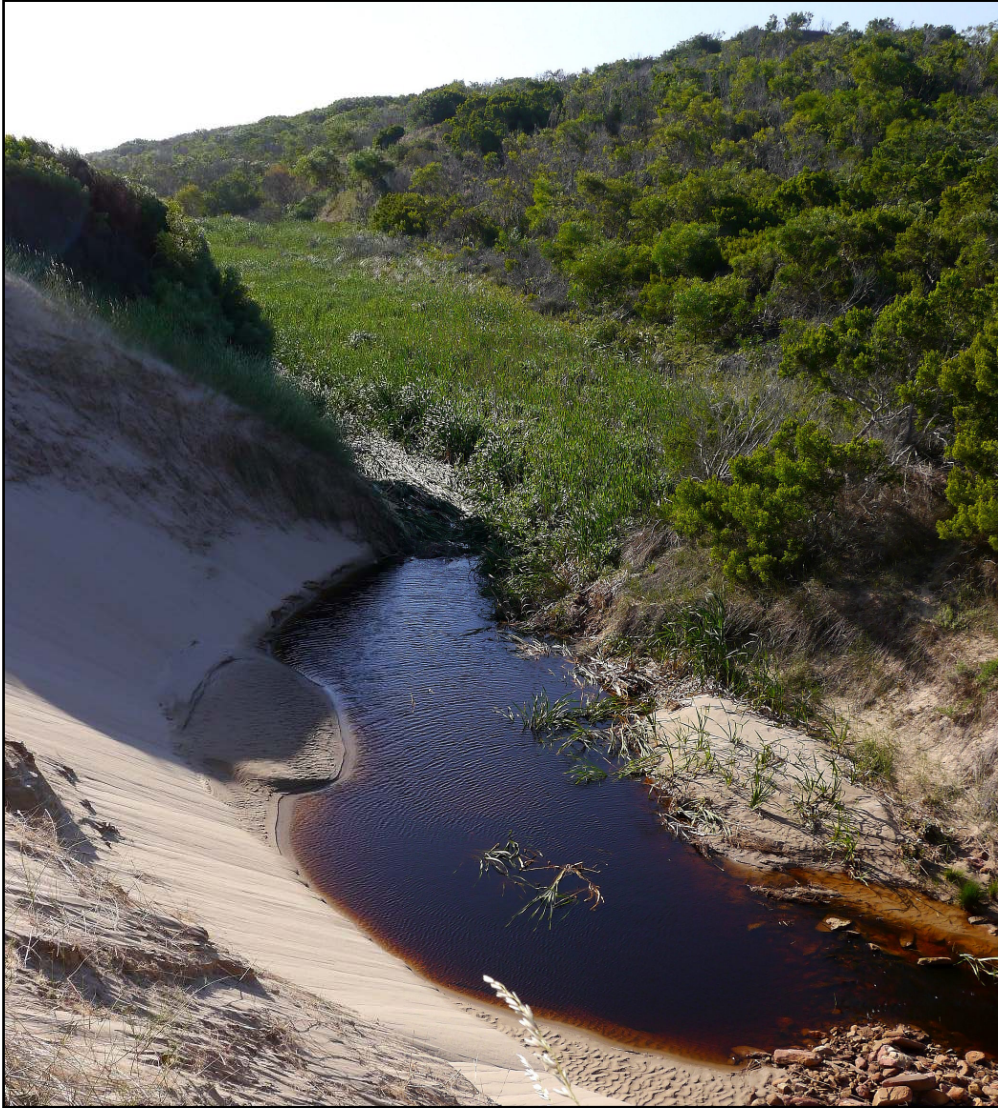
Figure 6.4
The Sand River at the point where the quartzite ridge ends, choked with wetland vegetation

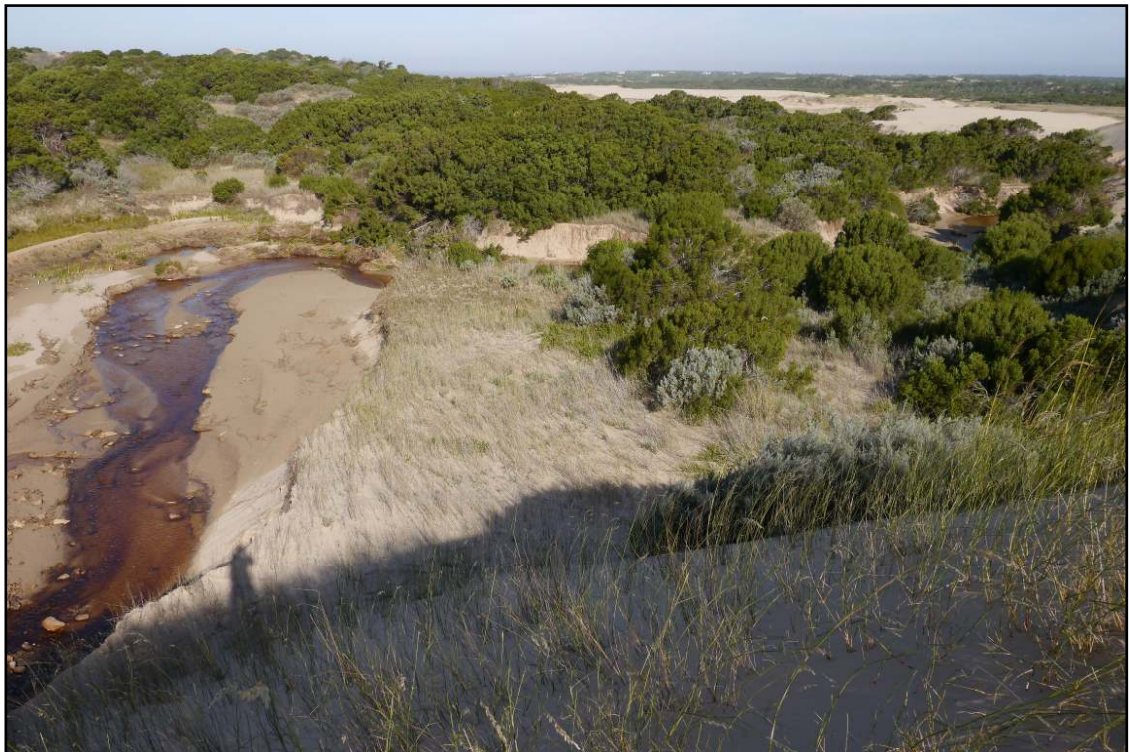
Figure 6.5
The Sand River where it turns east-north-eastward and enters the currently active Oyster Bay dunefield

At the point where the quartzite ridge ends, the river turns east-north-eastward and enters the currently active lower eastern end of the Oyster Bay dunefield (Fig 6.5). The gradient is steeper, about 1:70. During dry periods, moving dunes can completely block the river course, as documented in the Geomorphology Addendum Report (Illenberger, 2010b). When a wet period ensues, the river will dam up against the dunes until the dune is overtopped or ruptured by piping and liquefaction. A flash-flood will result, forming a sandy floodplain on which eroded plants and loose vegetation are strewn, as is the typical appearance of the Sand River in this area after high rainfall events (Figure 4.6). The river will erode dunes that are in its way (Figure 4.7), entraining much sand that is carried downstream until where the Sand River debouches into the Kromme River estuary, where the sand is deposited to form the Sand River delta.

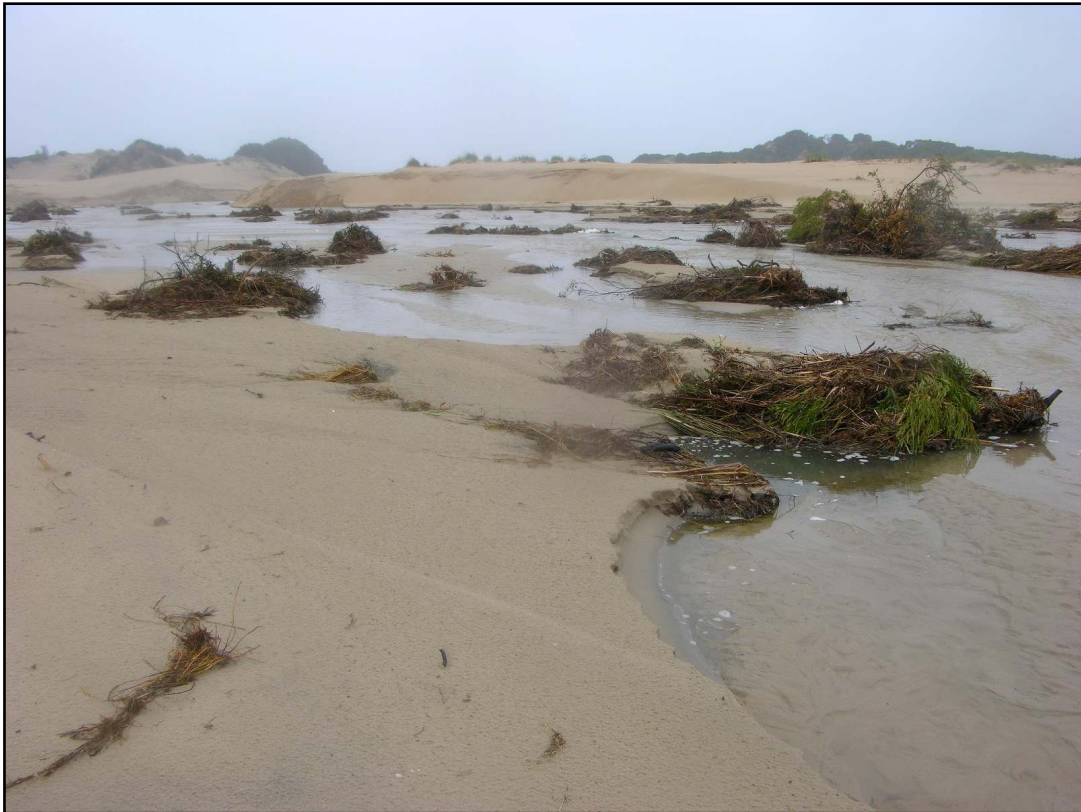
Figure 6.6. The lower Sand River after a high rainfall event (the flood of 3 August 2006). It has a wide sandy floodplain on which eroded plants and loose vegetation are strewn. The river has eroded into the dune in the background. Photographed 19 August 2006.

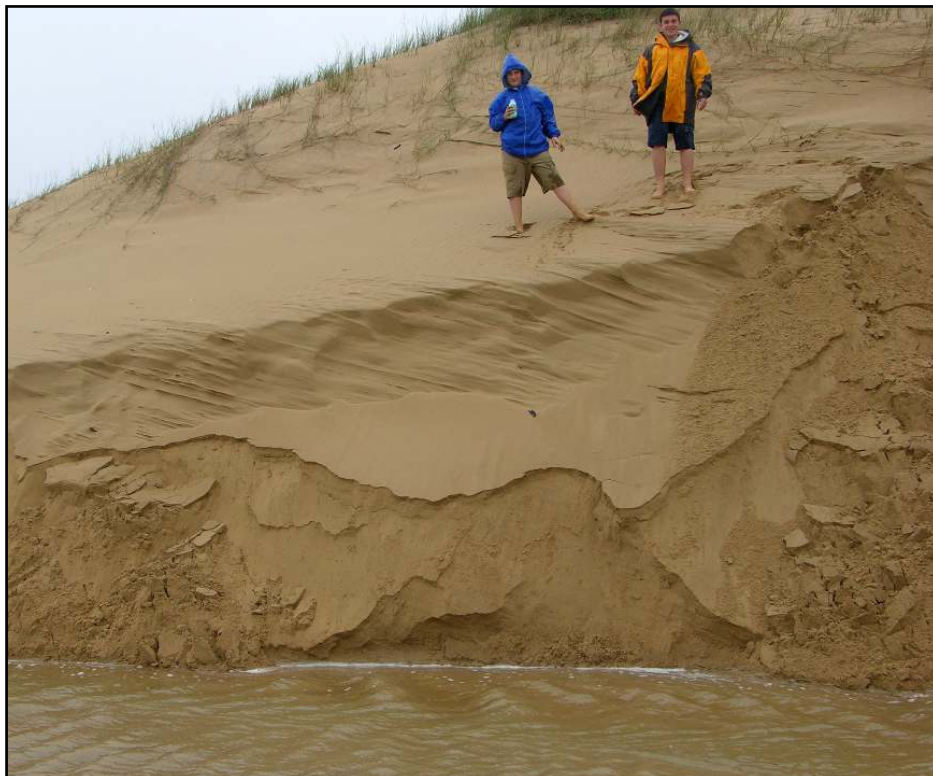
Figure 6.7. The Sand River after a high rainfall event (the flood of 3 August 2006), eroding a dune and entraining much sand. Photographed 19 August 2006.

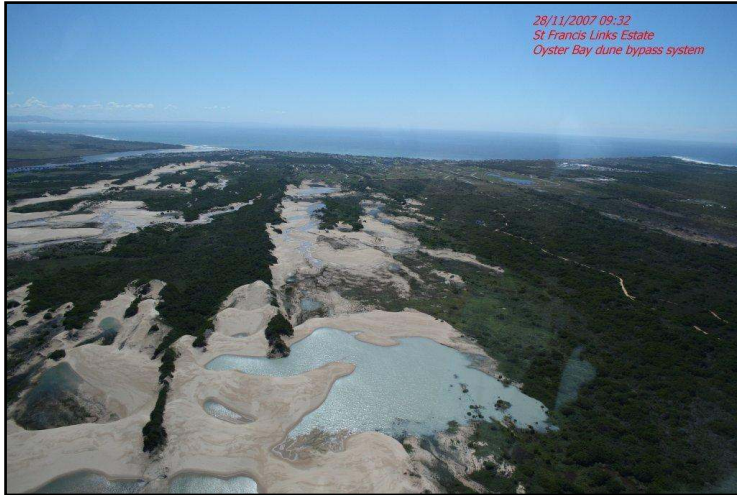
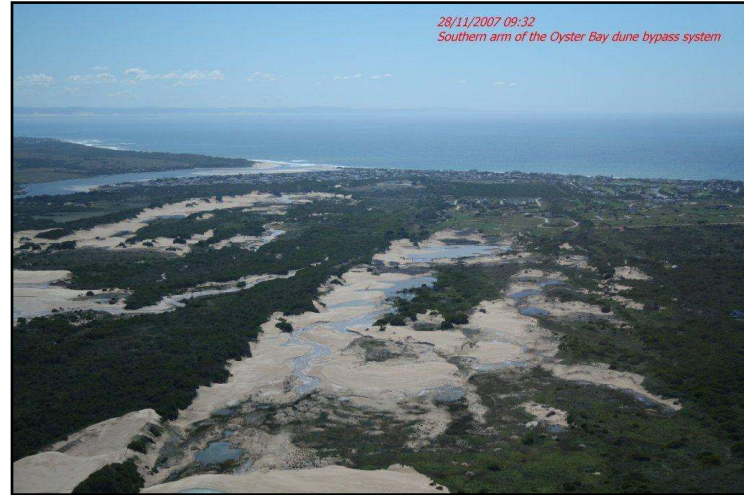
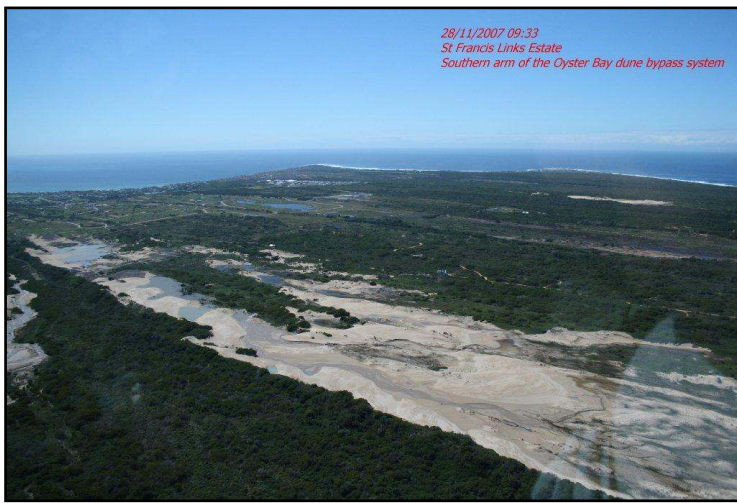
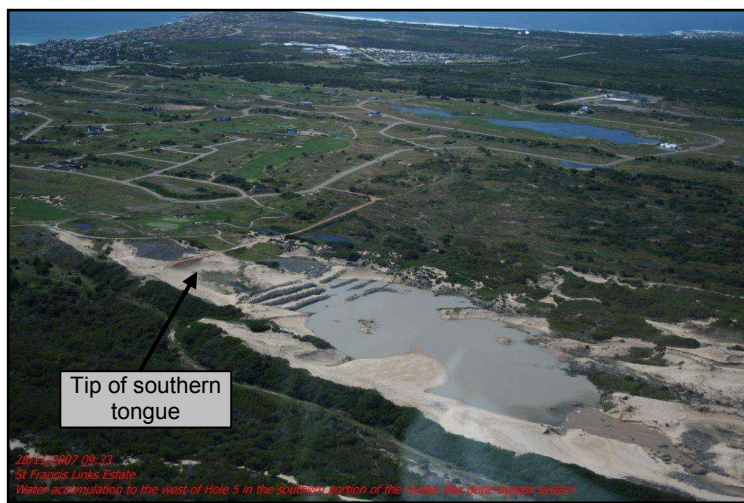
Figure 7.1 The southern tongue of the Oyster Bay dunefield soon after the November 2007 flood. Photographs from Silberbauer (2009)

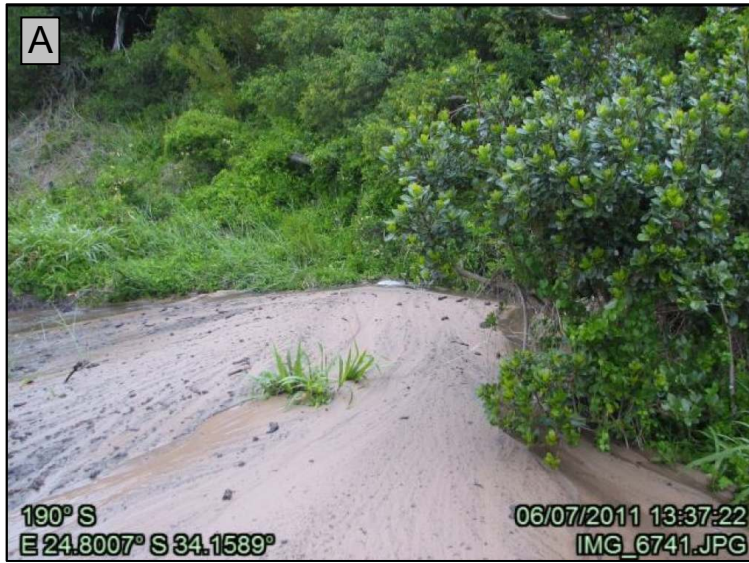
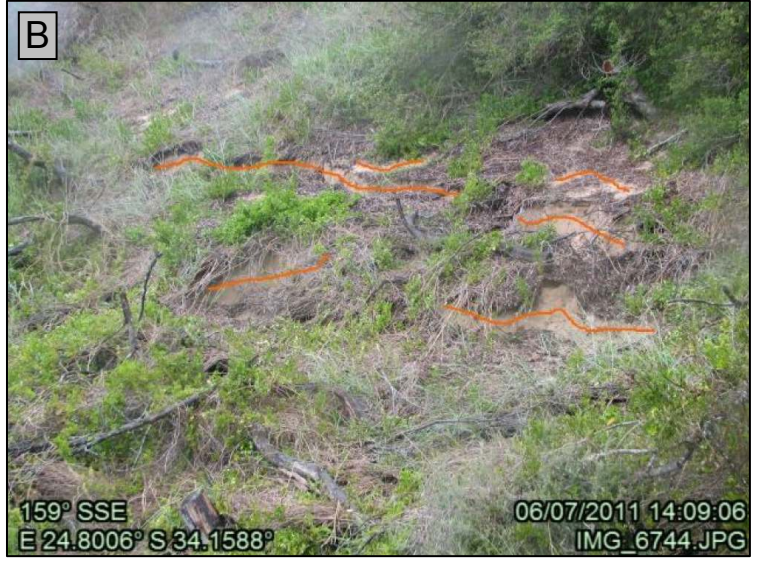
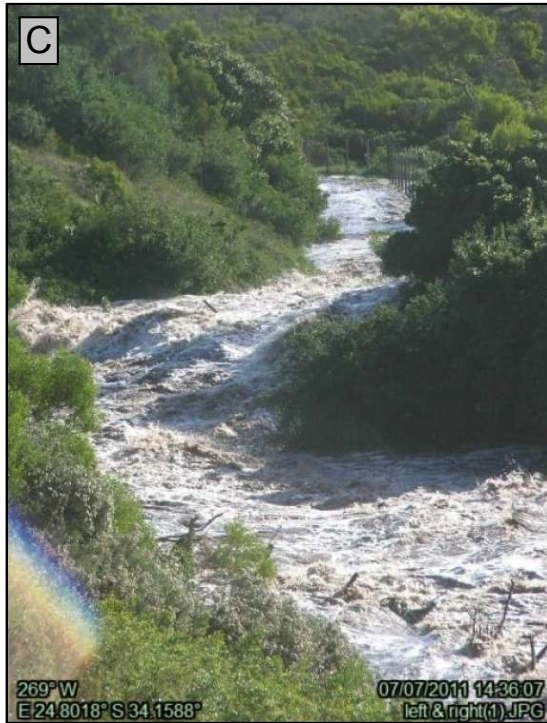
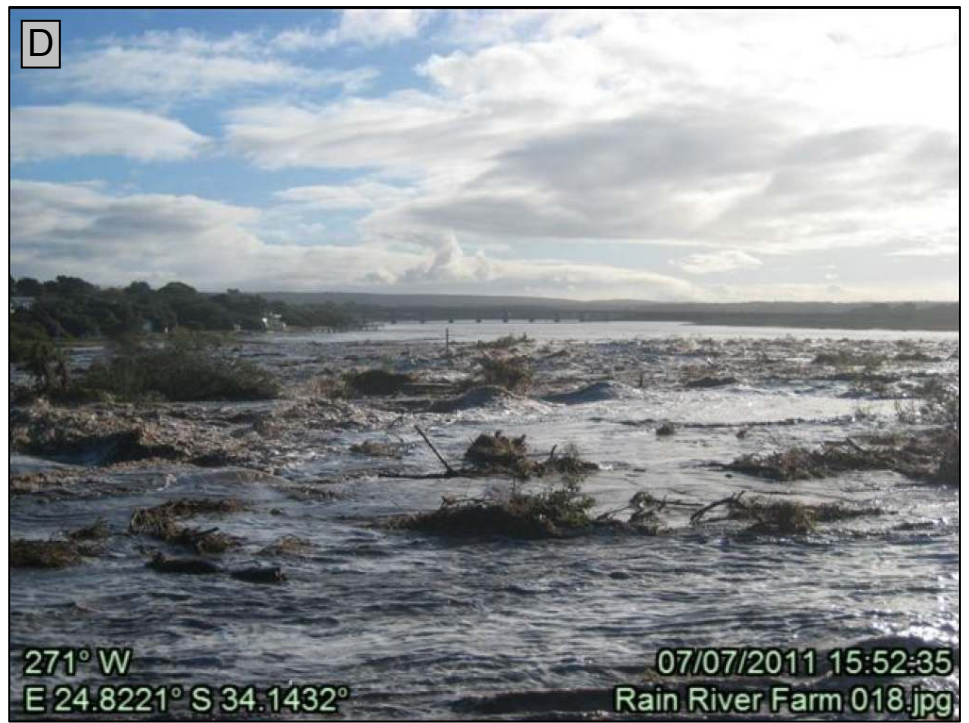
Figure 7.5 Events culminating in the breach of the southern tongue of the Oyster Bay dunefield, 7 July 2011. A: “piping” (water flowing through the base of the sidewall of the southern tongue, depositing sandy material). B: slumping along the sidewall of the southern tongue. C: the torrent of water released by the breach. D: sand and debris deposited on the Sand River delta in the Kromme estuary. Photographs from Silberbauer (2011a).

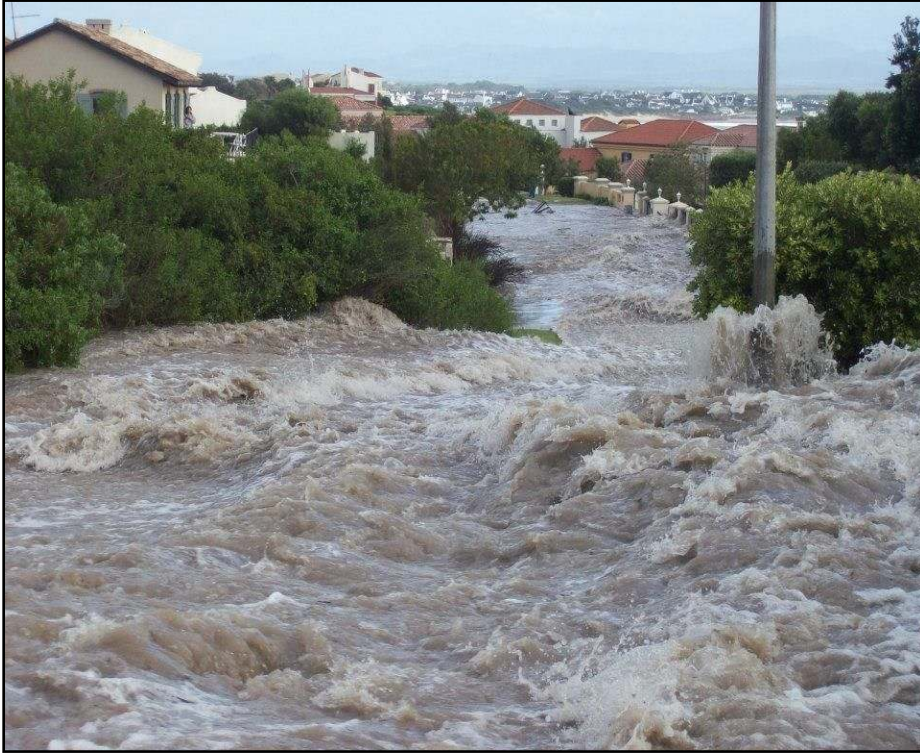
Figure 8.1 The flash-flood that flowed through Santareme on 15 September 2012. The photograph was taken in Tom Brown Boulevard; source of photograph: St Francis Chronicle. The flood resulted from the rupture of an interdune pond in the Santareme dunefield. The dunefield has been artificially stabilized, preserving the transverse dune topography that dams surface runoff.

The Santareme event of 15 September 2012 provides a dramatic example of the flash-flood that can result when an interdune pond breaches (Figures 8.1 & 8.2). The flood resulted from the rupture of an interdune pond in the Santareme dunefield. The dunefield had been artificially stabilised, preserving the transverse dune topography that dams surface runoff.

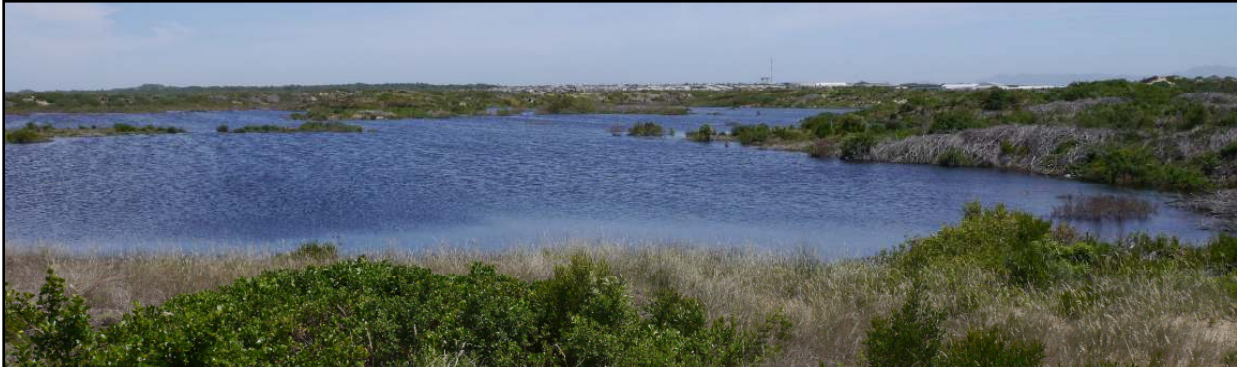
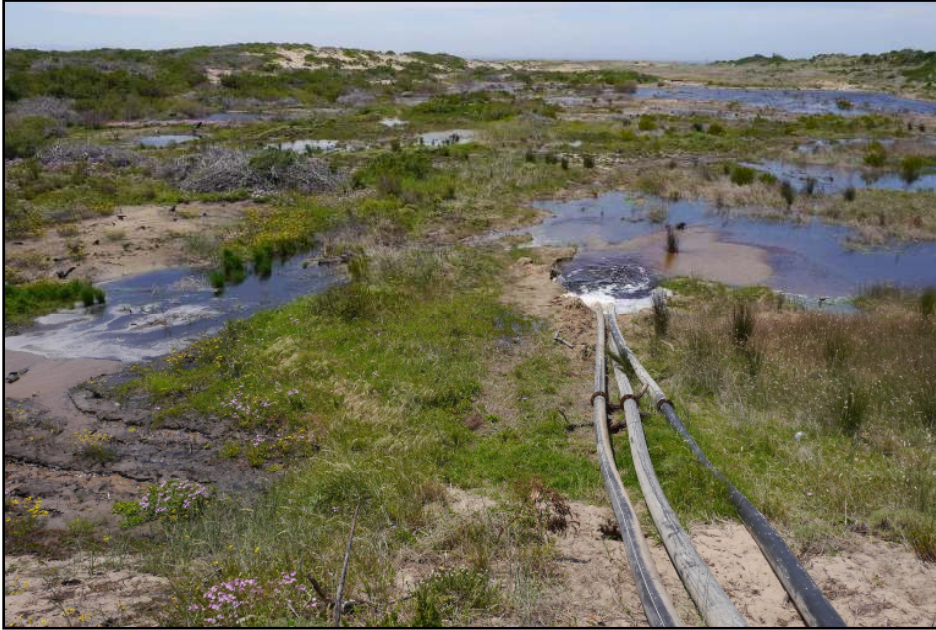
Figure 8.2 Above: An interdune pond in the Santareme dunefield “upstream” of the pond that ruptured on 15 September 2012. Left: three pipes were installed as siphons to drain the pond gradually, so as to avoid a further flashflood.

Persons who observed the build-up of water in the Santareme dunefield realised the potentially dangerous situation and made the authorities aware of this. The damage that resulted when the interdune pond breached could have been avoided if the authorities had heeded the warnings. The installation of siphon pipes to safely drain an interdune pond upstream of the one that had breached on 15 September 2012 (Fig. 8.2) illustrates an easy way to alleviate the problem.

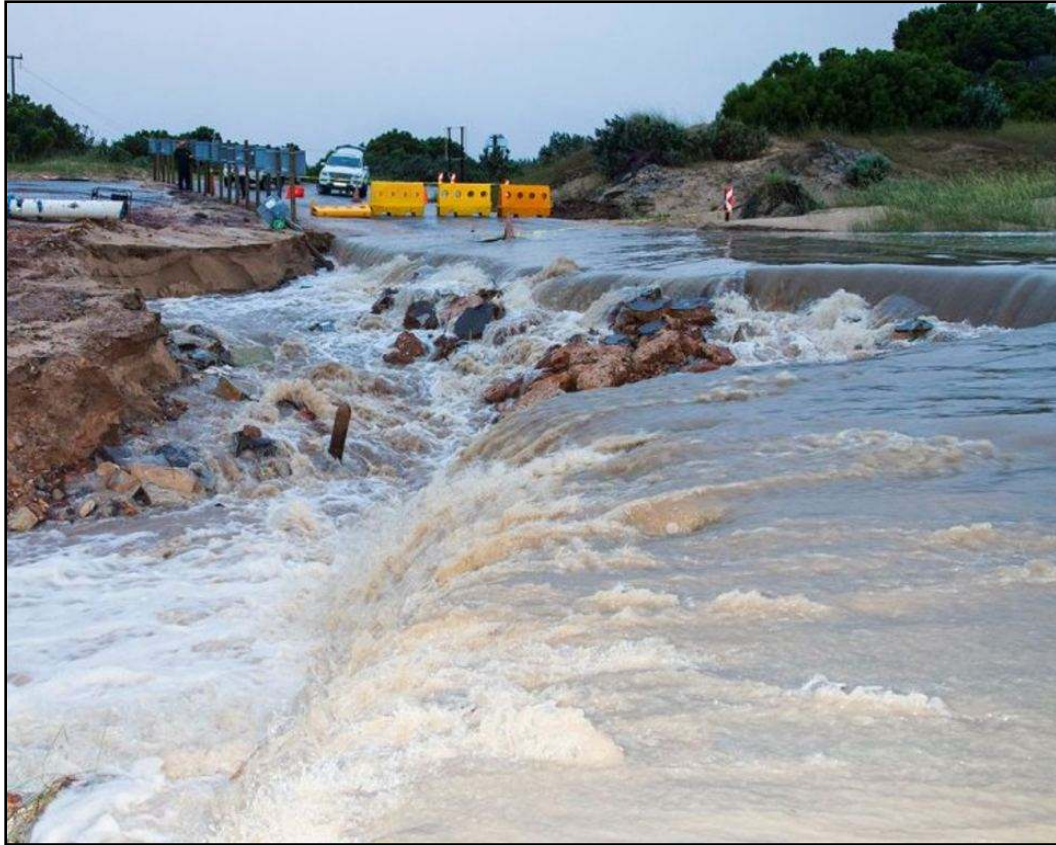
Figure 8.3 The dying moments of the Sand River culvert on 22 October 2012

The temporary Sand River culvert needs to be replaced urgently with a suitably designed permanent structure.

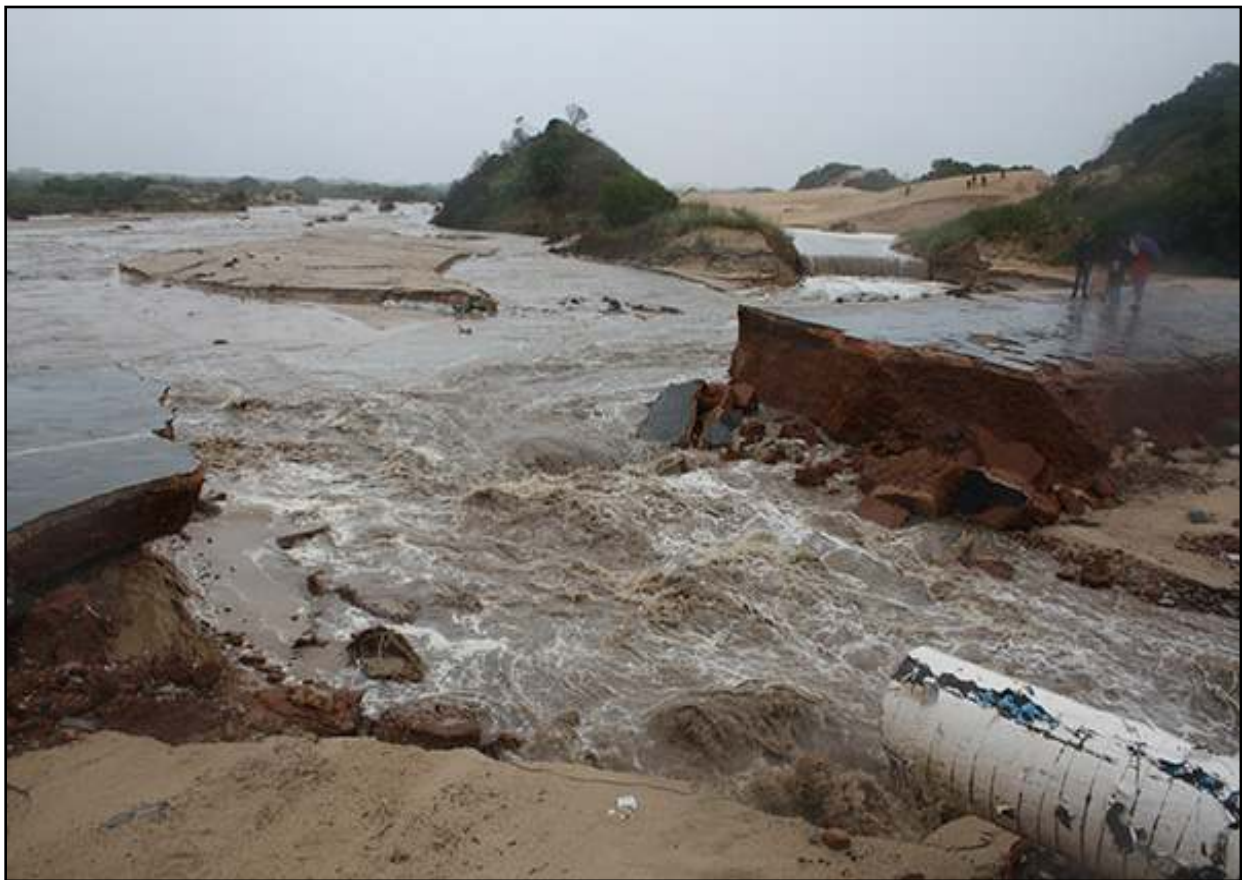
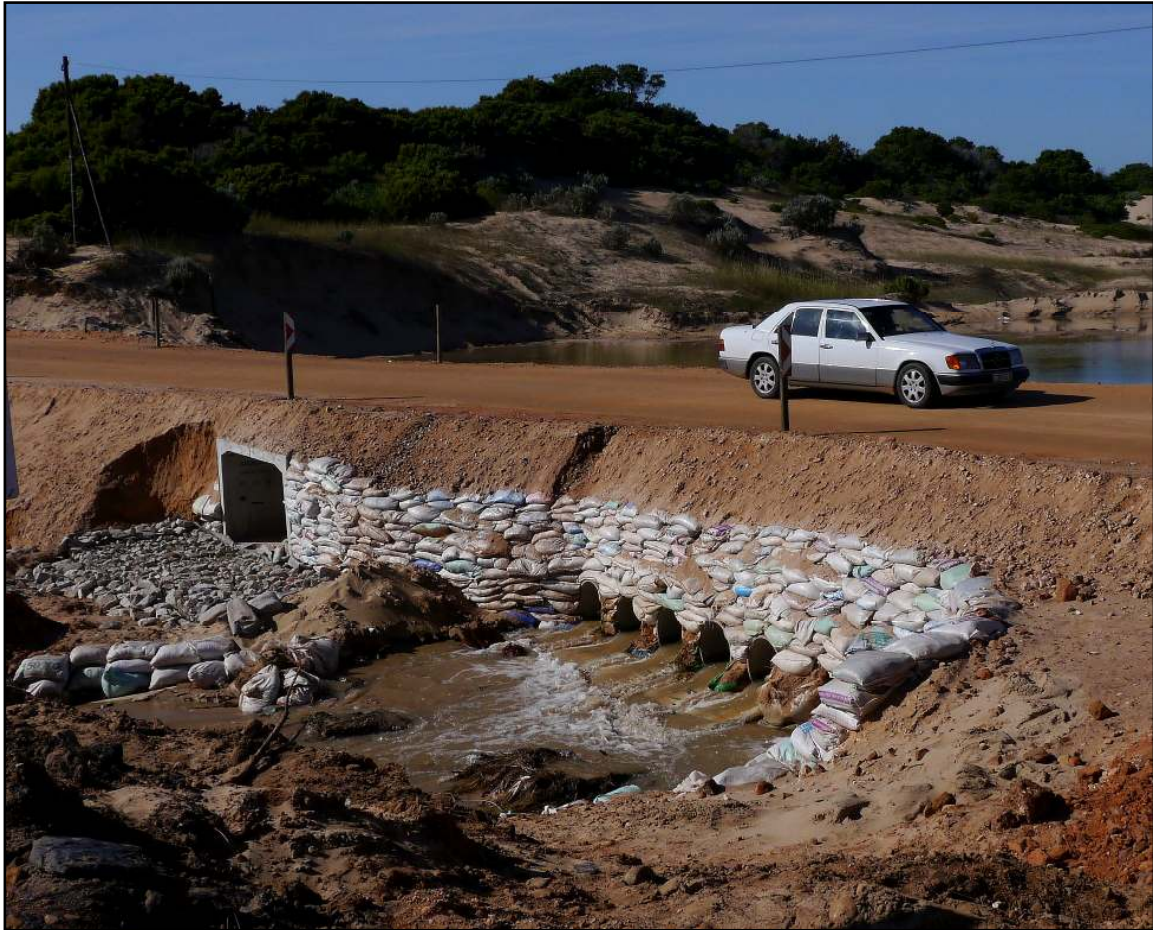
Figure 8.4 The temporary culvert over the Sand River built in October 2012

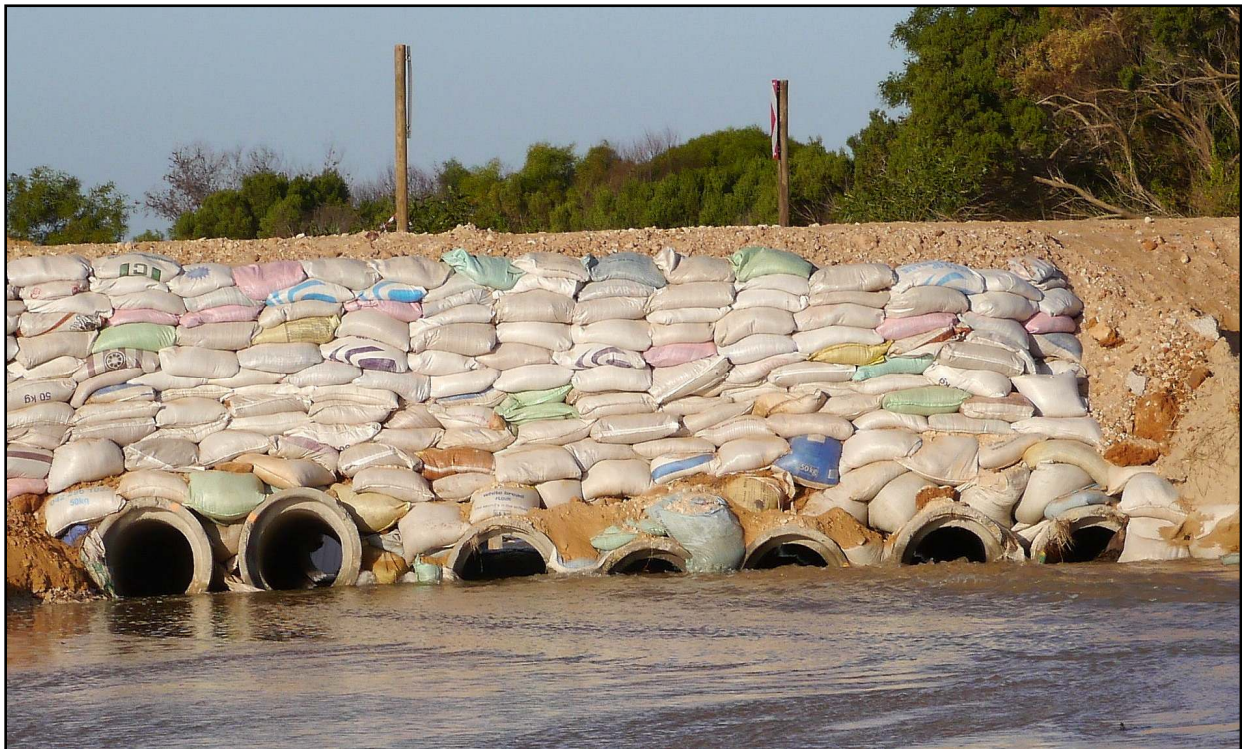
Figure 8.5 The seven pipes on the upstream side of the 2012 culvert. The pipes are not at the same level, so some of these pipes could potentially be blocked.
