NUCLEAR POWER STATION ('NUCLEAR 1') AND ASSOCIATED INFRASTRUCTURE

Second Addendum to Dune Geomorphology Impact Assessment: New western access routes and 2011 - 2012 floods

June 2013

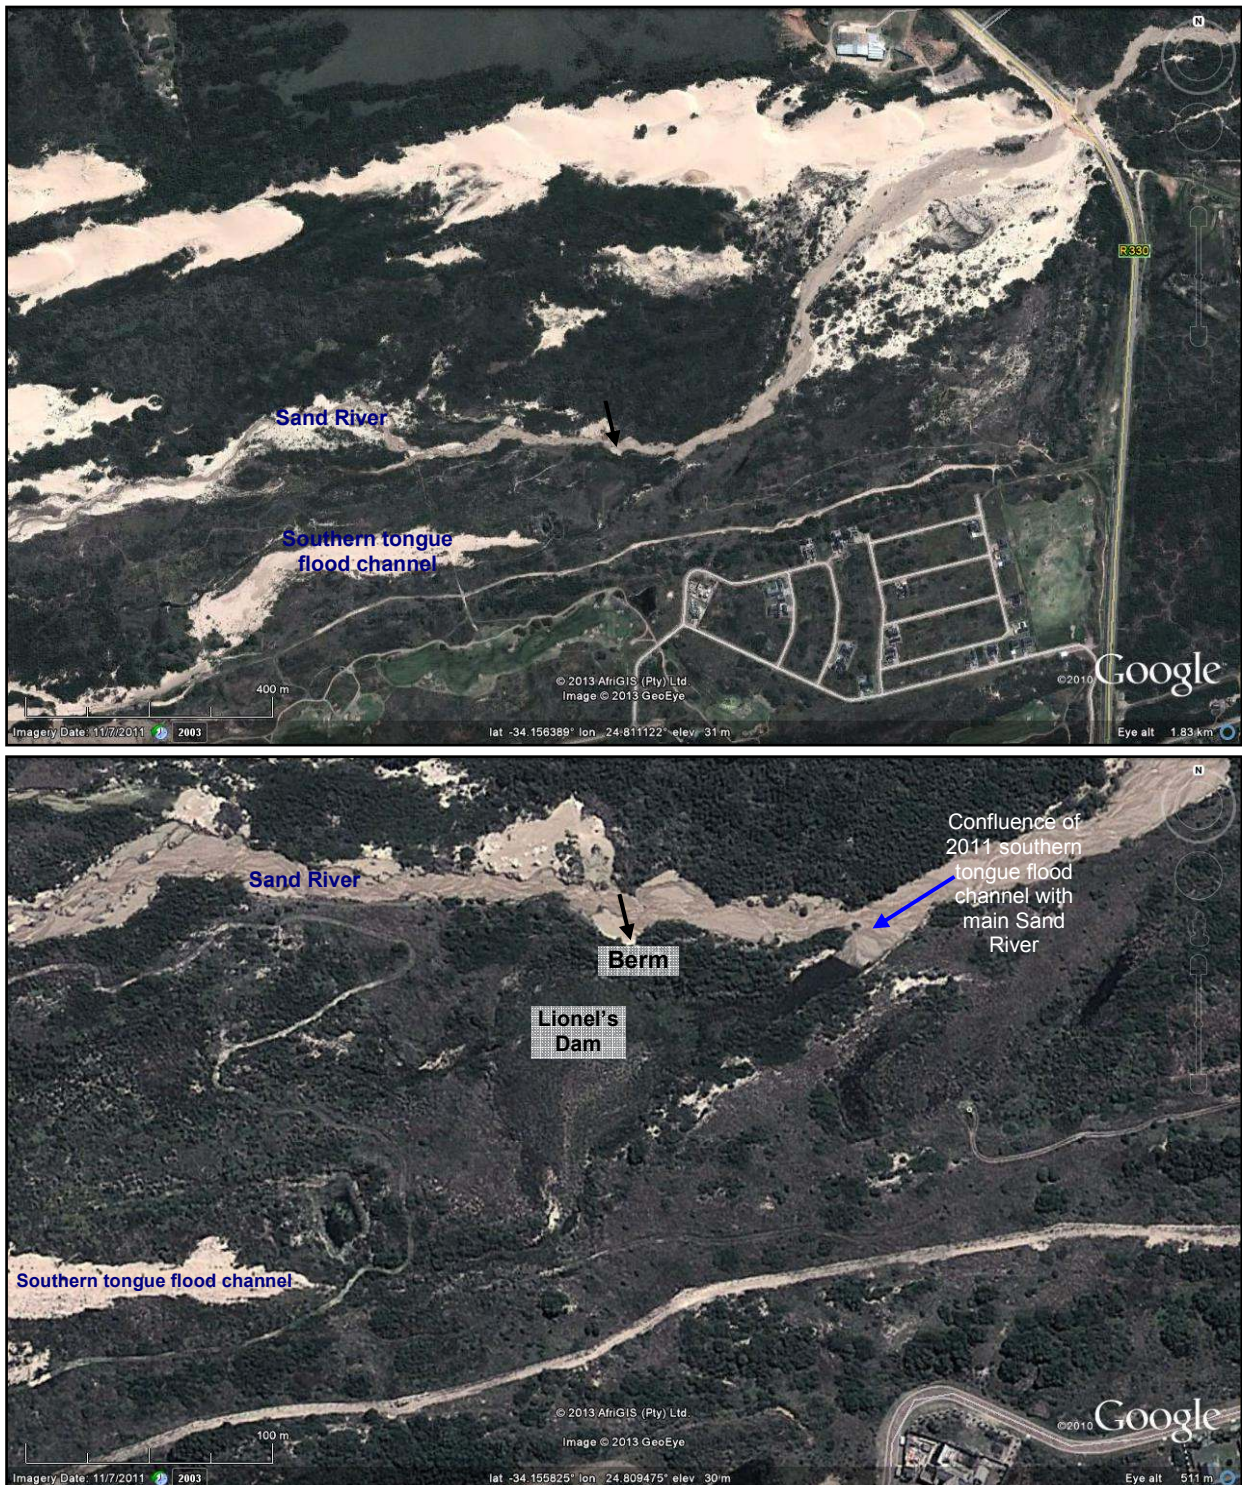
Figure 10.1 Locality of the supposed debris deposit (black arrow) and Lionel’s Dam. GPS co-ordinates of the deposit from Ellery & Elkington (2011). Image 7 November 2011.

Frank Silberbauer (pers. comm. 2012 and Silberbauer, 2011b) demonstrated that the supposed debris flow deposits identified by Prof. Ellery and his colleagues (Ellery & Elkington, 2011; Elkington, 2012) are actually bulldozer deposits made when a berm was built to protect a dam (“Lionel’s Dam”) from the Sand River (Figure 10.1).

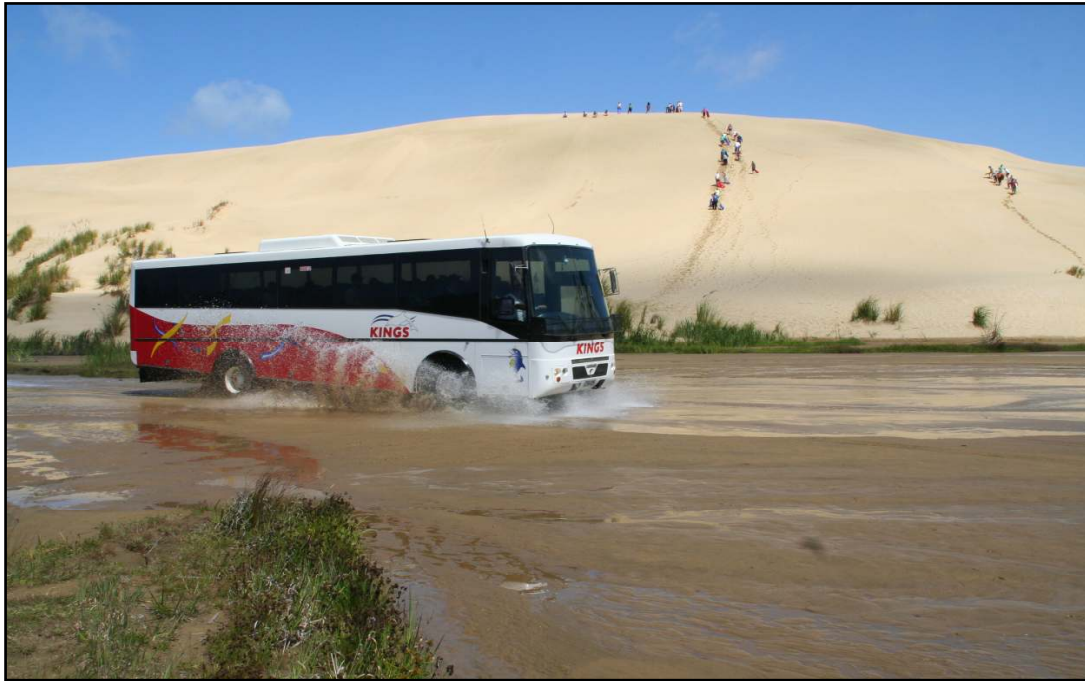
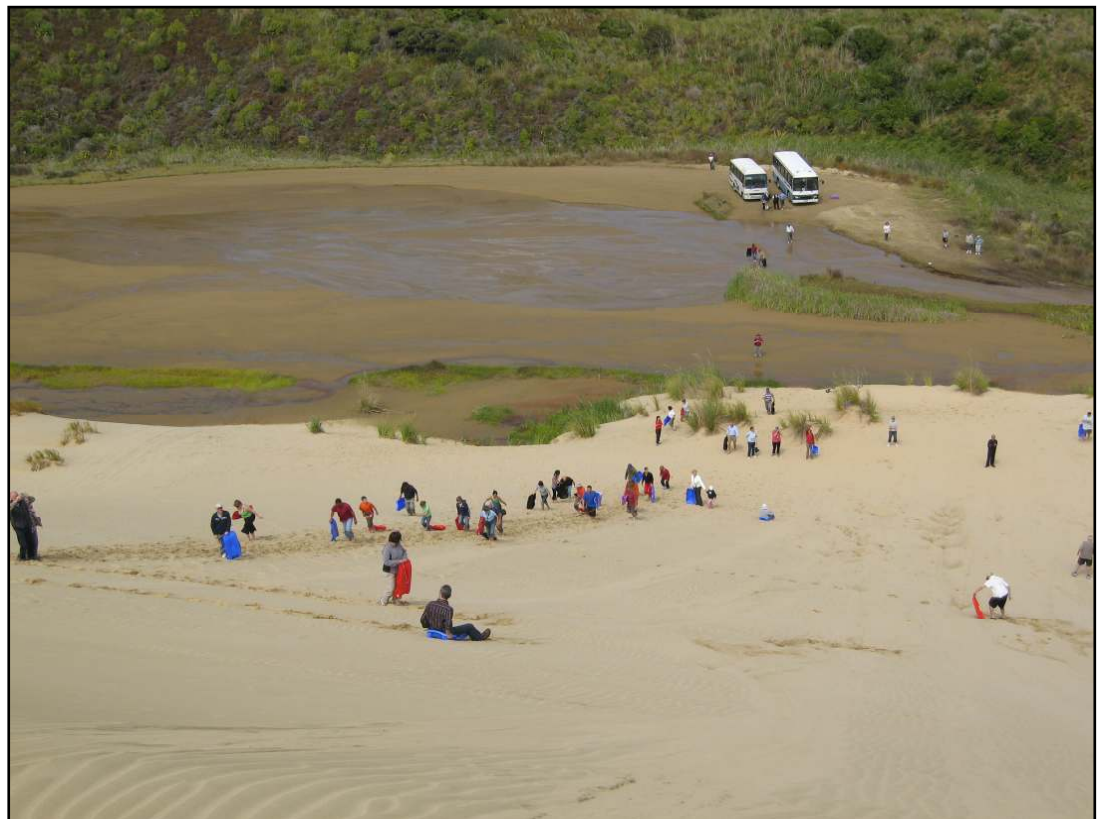
Figure 11.1 The Te Paki River that flows through the dunefield adjacent to Ninety Mile Beach, New Zealand.

The Sand River carries a very high sediment load that is pure sand. Rivers like this do occur in nature in other parts of the world. Figure 11.1 illustrates a dunefield and river in New Zealand. It seems that such systems can take “physical punishment”.
