Eskom Hendrina Wet Ash Disposal Facility

Aquatic Specialist Study

Environmental Impact Assessment Phase

Ash Disposal Facility and Associated Infrastructure

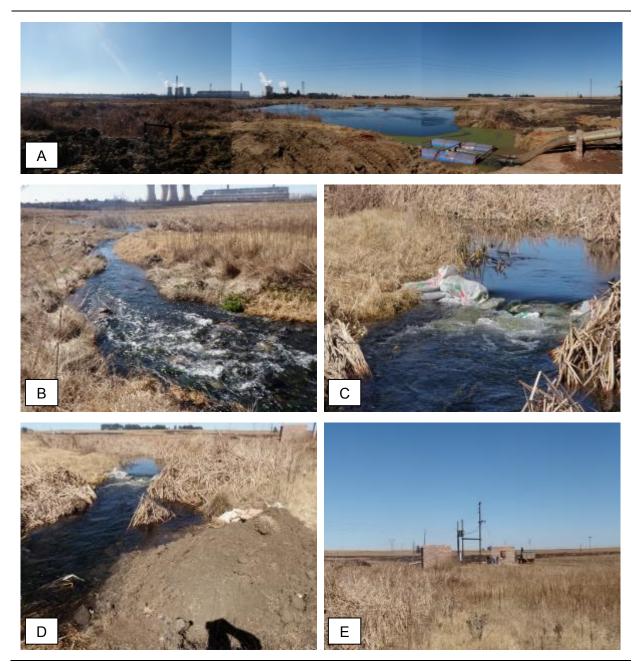
Figure 9-3: Site HA2 (monitoring site 2) is located to the north-west of Alternative E showing (A) panoramic view, (B) riffle section located downstream of the dam, (C) sand bags altering the flow, (D) loose sediment placed on the left bank, (E) construction activities.

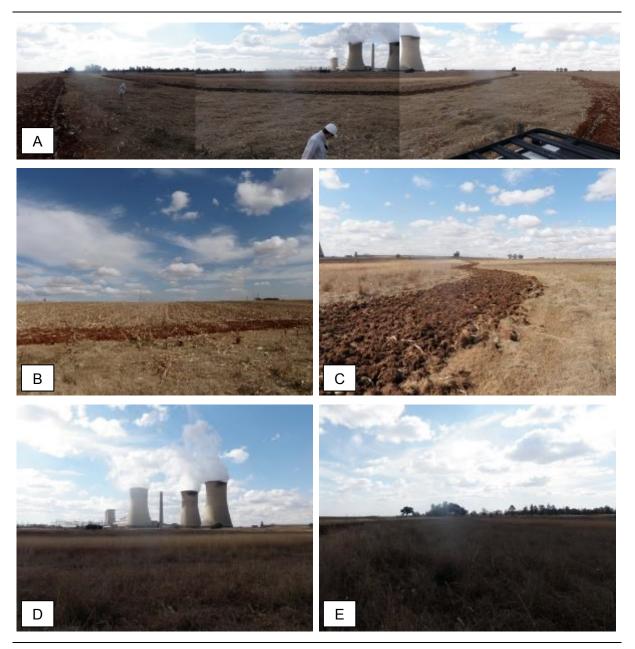
Figure 9-4: HGM 11 is situated in the north-eastern portion of Alternative E reflecting (A) panoramic view of the wetland with exciting impacts: (B) maize fields, (C) fire breaks, (D) Hendrina Power Station and (E) a farm property.

- HGM 11, much like HGM 1, falls within the direct footprint of the proposed development. The wetland is substantially altered from natural conditions with large parts of its catchment and functional unit infringed on by industrial and agricultural activities (Figure 9-4 A-E). The wetland is traversed by a tar road. Low permeable fencing also restricts the movement of wetland fauna.

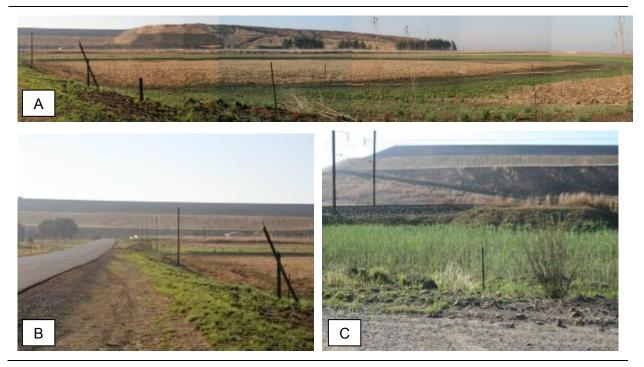
Figure 9-6: HGM 15 and 16 are situated to the south of Alternative E reflecting (A) a panoramic view of the wetland with exciting impacts: (B) tar road and (C) exciting Hendrina ash disposal facility.

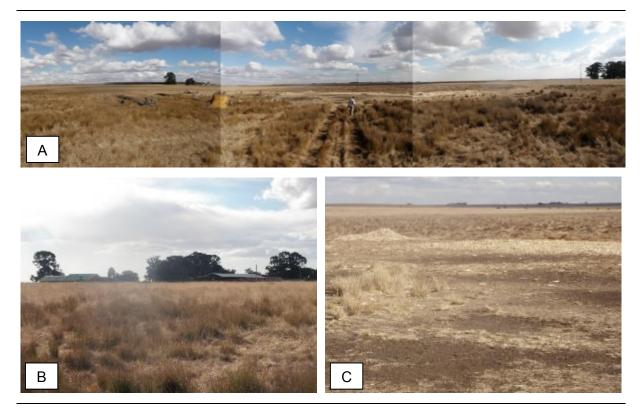
Figure 9-7: HGM 13 and 14 are situated to the south-west of Alternative E reflecting (A) a panoramic view of the wetland with exciting impacts: (B) farm property, (C) maize husks deposited within the seasonal zone, (D) trampling via cattle and (E) power lines.

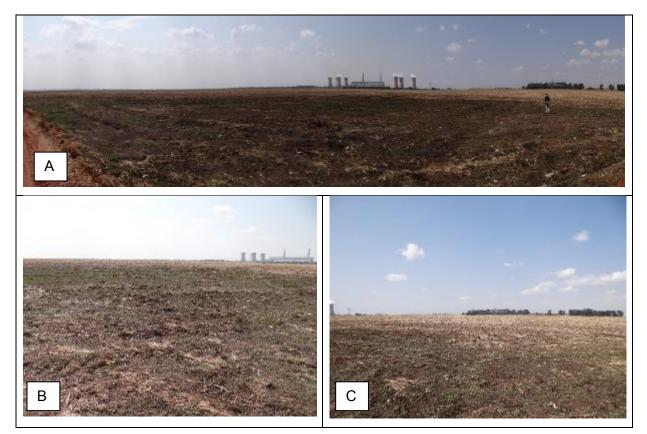
Figure 10-1: Wetland 3 (HGM8) located west of Alternative E indicating A) a panoramic view of the wetland, B) and C) surface denudation through burning and ploughing.

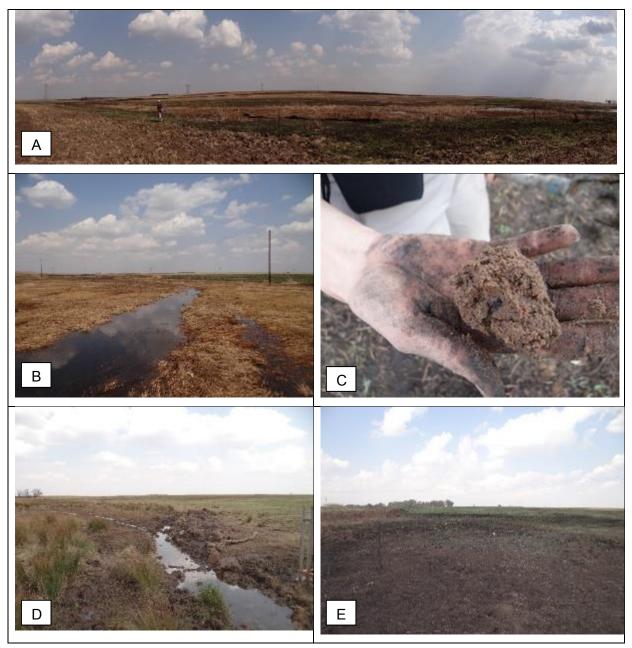
Figure 10-4: Wetland 10 (HGM 17, 18 and 19) locate south of proposed activities indicating A) panoramic view of HGM 17, B) proximity of permanent zone to ploughed fields, C) Sandy hillslope soil type from HGM 18, D) trenching within HGM17, and E) denudation and burning of HGM18.

Most of the temporary and seasonal edge of HGM 18 and 19 of Wetland 10 has been ploughed, resulting in a decline in hydrological integrity and therefore the ability of Wetland 10 to provide ecosystem services (**Figure 3-14**). However, Wetland 10 may still be capable of providing valuable streamflow regulation by releasing water to the downstream environment during low-flow periods. Due to the prominent agricultural practices within the catchment of Wetland 10, the wetland further provides potential water purification through nitrate removal.

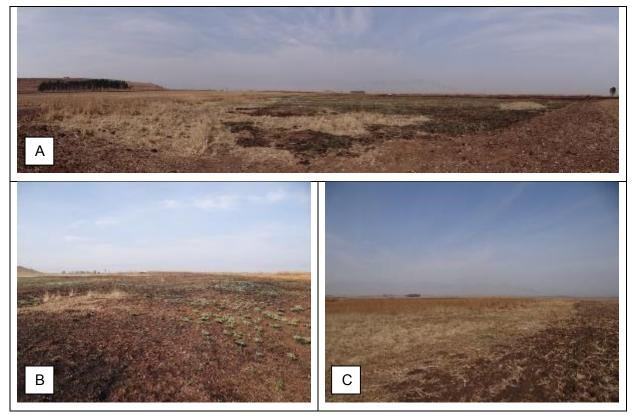
Figure 10-5: Wetland 11 located south of proposed distribution lines indicating A) panoramic view of wetland, B) denudation through burning, and C) loss of temporal and seasonal zone through ploughing.

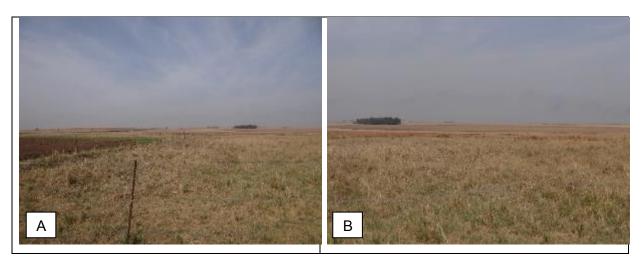
Figure 10-6: Wetland 12 located south of proposed distribution lines indicating A) encroachment of agriculture on wetland habitat, B) trampling and grazing of wetland vegetation.
